## INTENSIVE ARCHEOLOGICAL SURVEY OF AIRPORT ROAD – AREA 1 CITY OF GEORGETOWN, WILLIAMSON COUNTY, TEXAS

Final Report – Public Copy

Terracon Project No. 96167734A

Antiquities Permit No. 8031

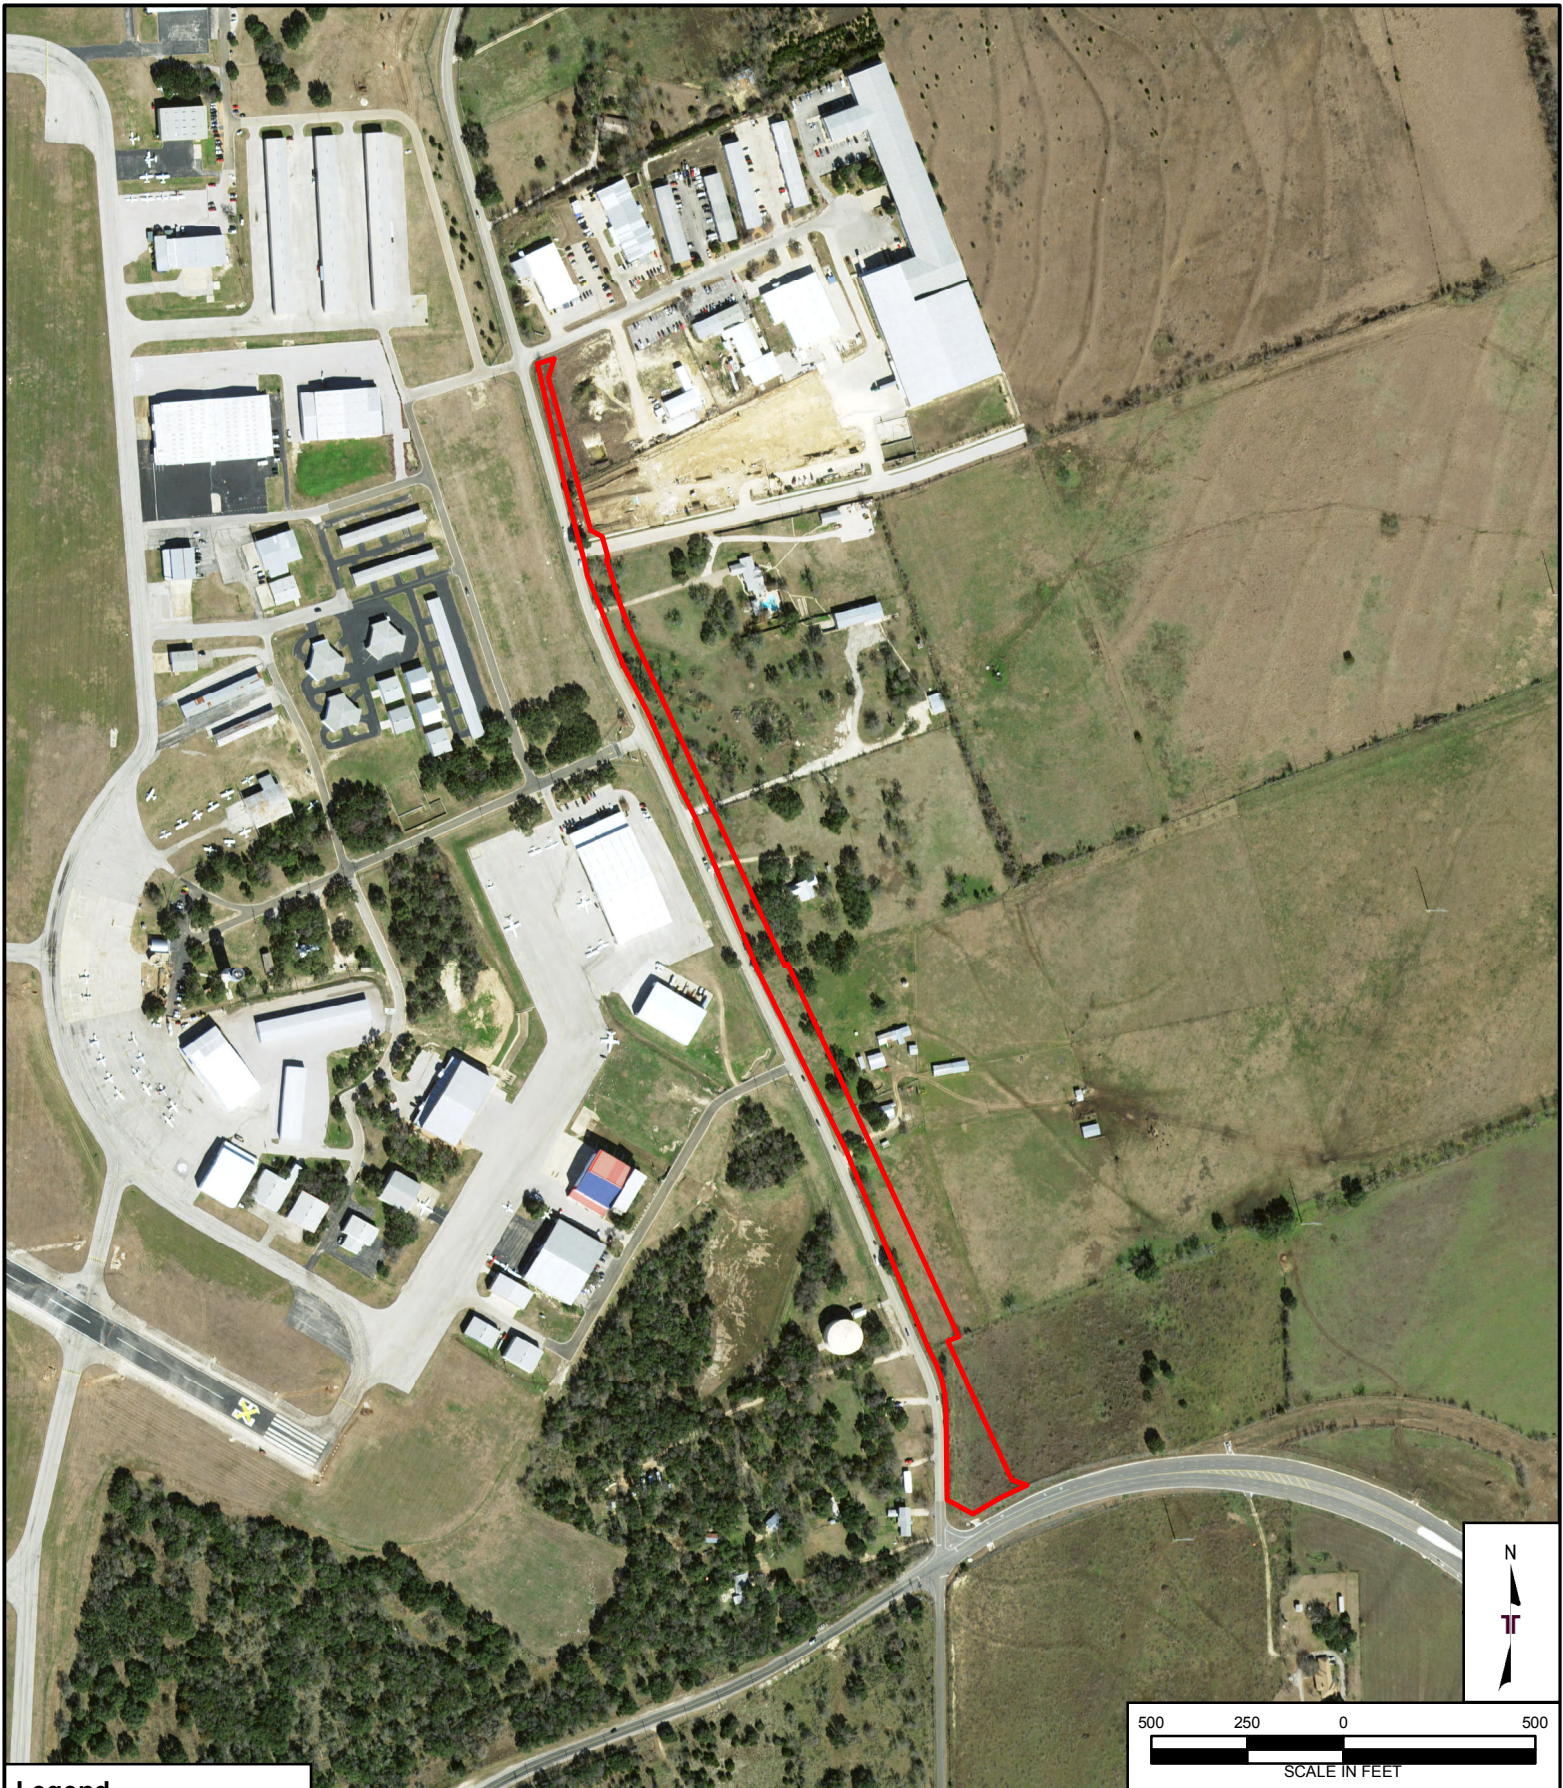
EXHIBIT
1

1995 USGS Topographic Maps: Georgetown  
 Airport Road - Area 1  
 Airport Road (Lakeway Drive to Halmar Cove)  
 Georgetown, Williamson County, Texas

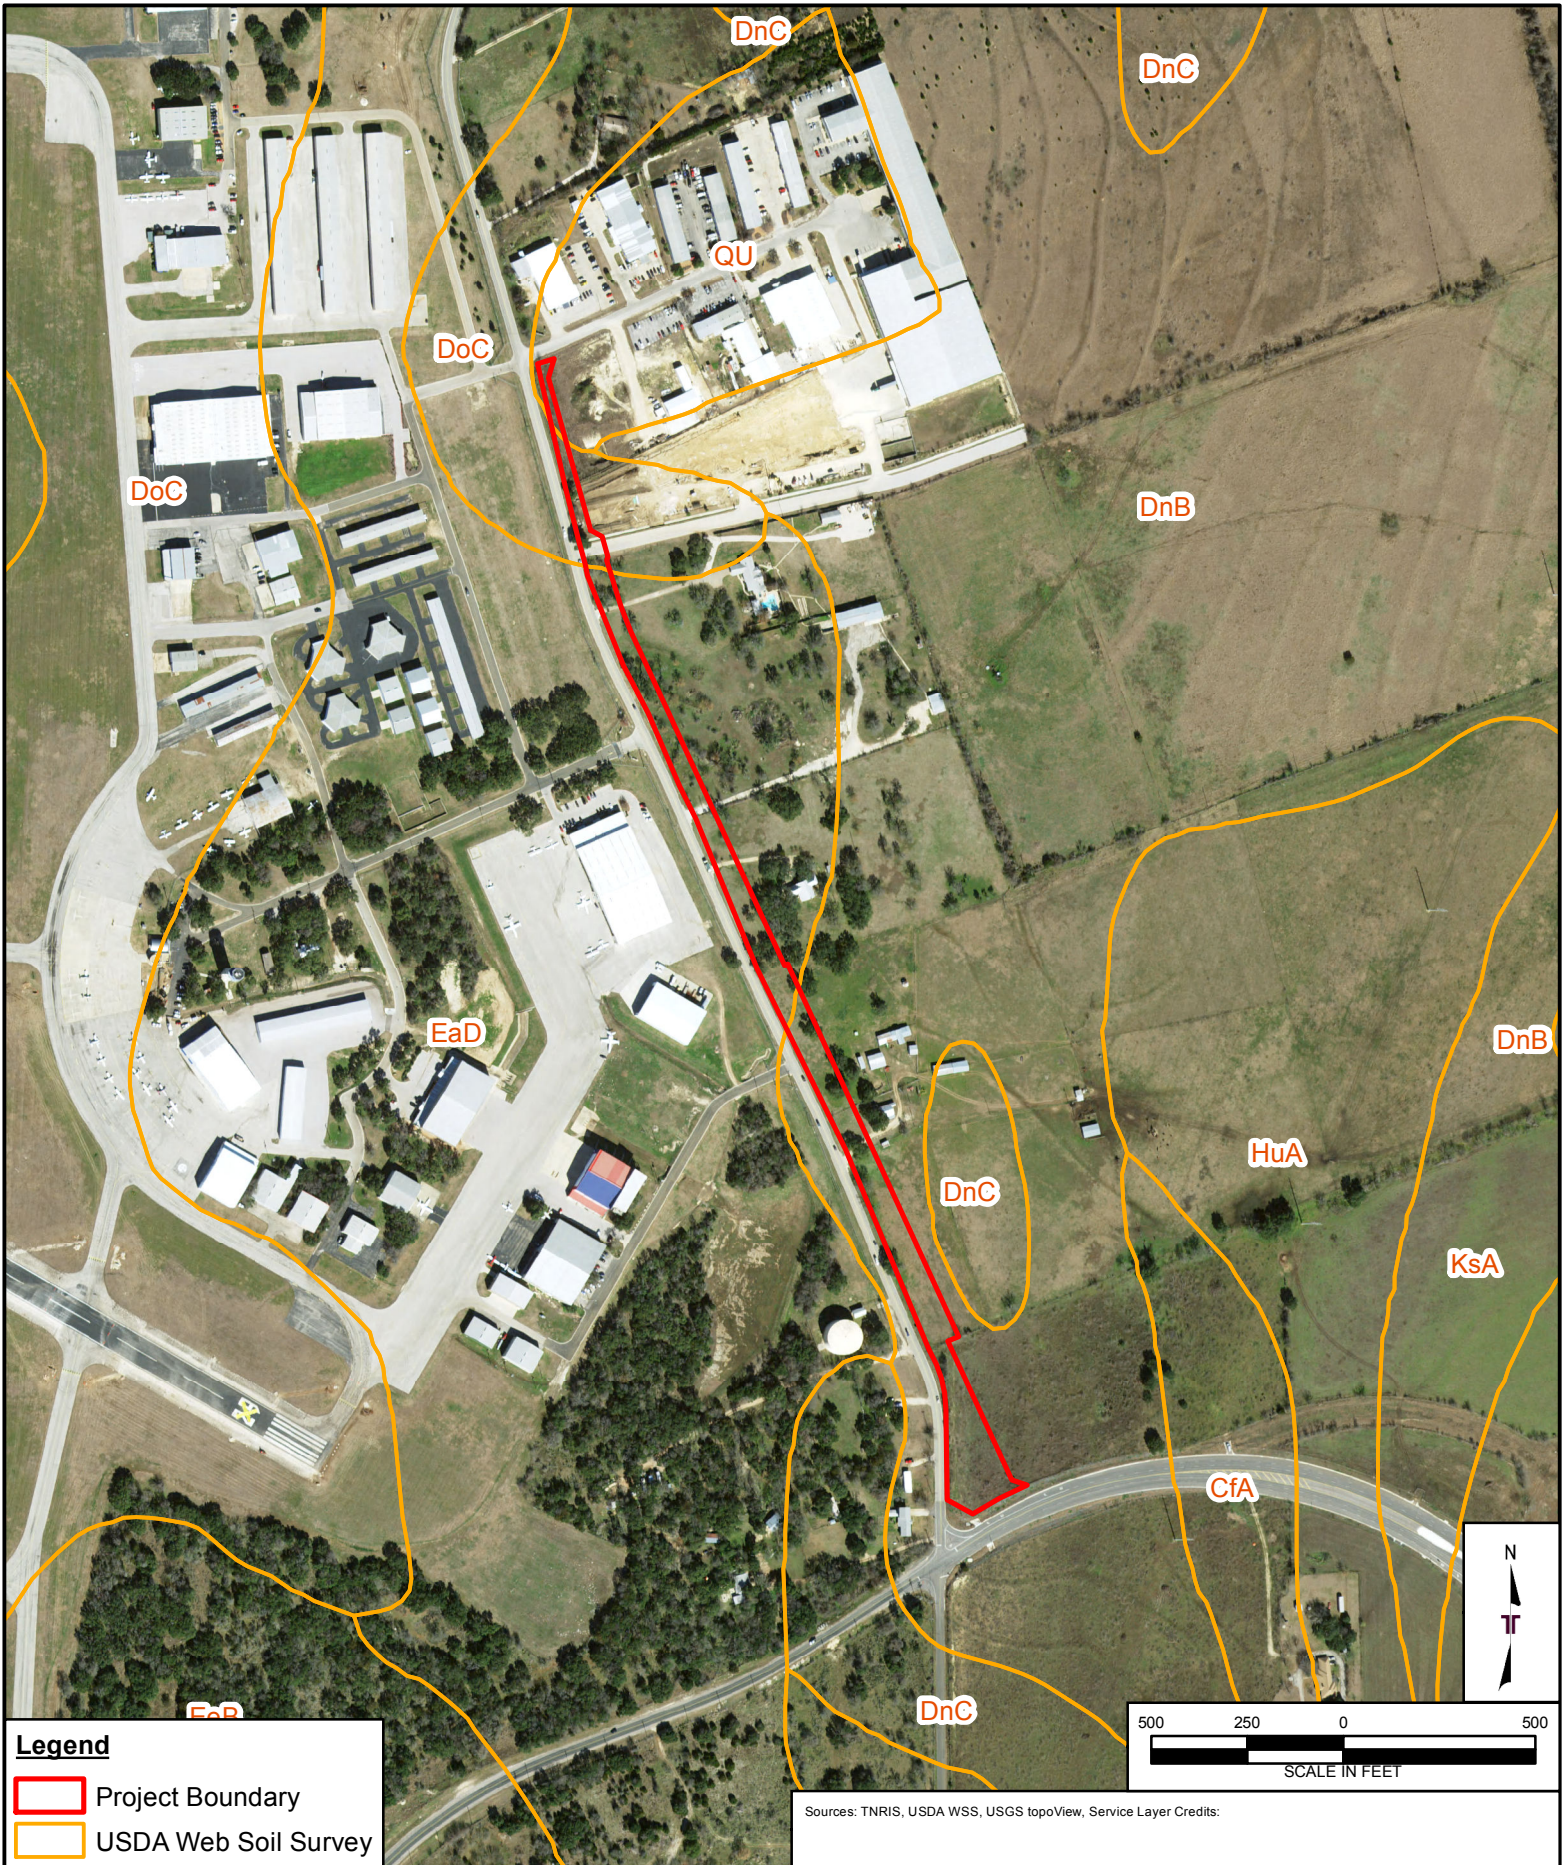
EXHIBIT
3

The bedrock geology of the project area is identified as Georgetown Limestone (Phanerozoic | Mesozoic | Cretaceous-Early periods) (Kgt) consisting of limestone, mudstone, and marine mega fossils, which are common (Barnes 1992). Three soils and a quarry, which has been filled in are mapped within the APE (Appendix A, Exhibit 3) (USDA NRCS 2017; Werchan and Coker 1983). Doss silty clay, 1 to 3 percent slopes (DoC) is a shallow (19 inches to bedrock), well-drained soil located on hillslopes. Eckrant cobbly clay, 1 to 8 percent slopes (EaD) is a shallow (12 inches to

bedrock), well-drained soil located on ridges. Denton silty clay, 1 to 3 percent slopes (DnB) is a deep (52 inches to bedrock), well-drained soil located on hillslopes.

USDA Soils Map  
 Airport Road - Area 1  
 Airport Road (Lakeway Drive to Halmar Cove)  
 Georgetown, Williamson County, Texas

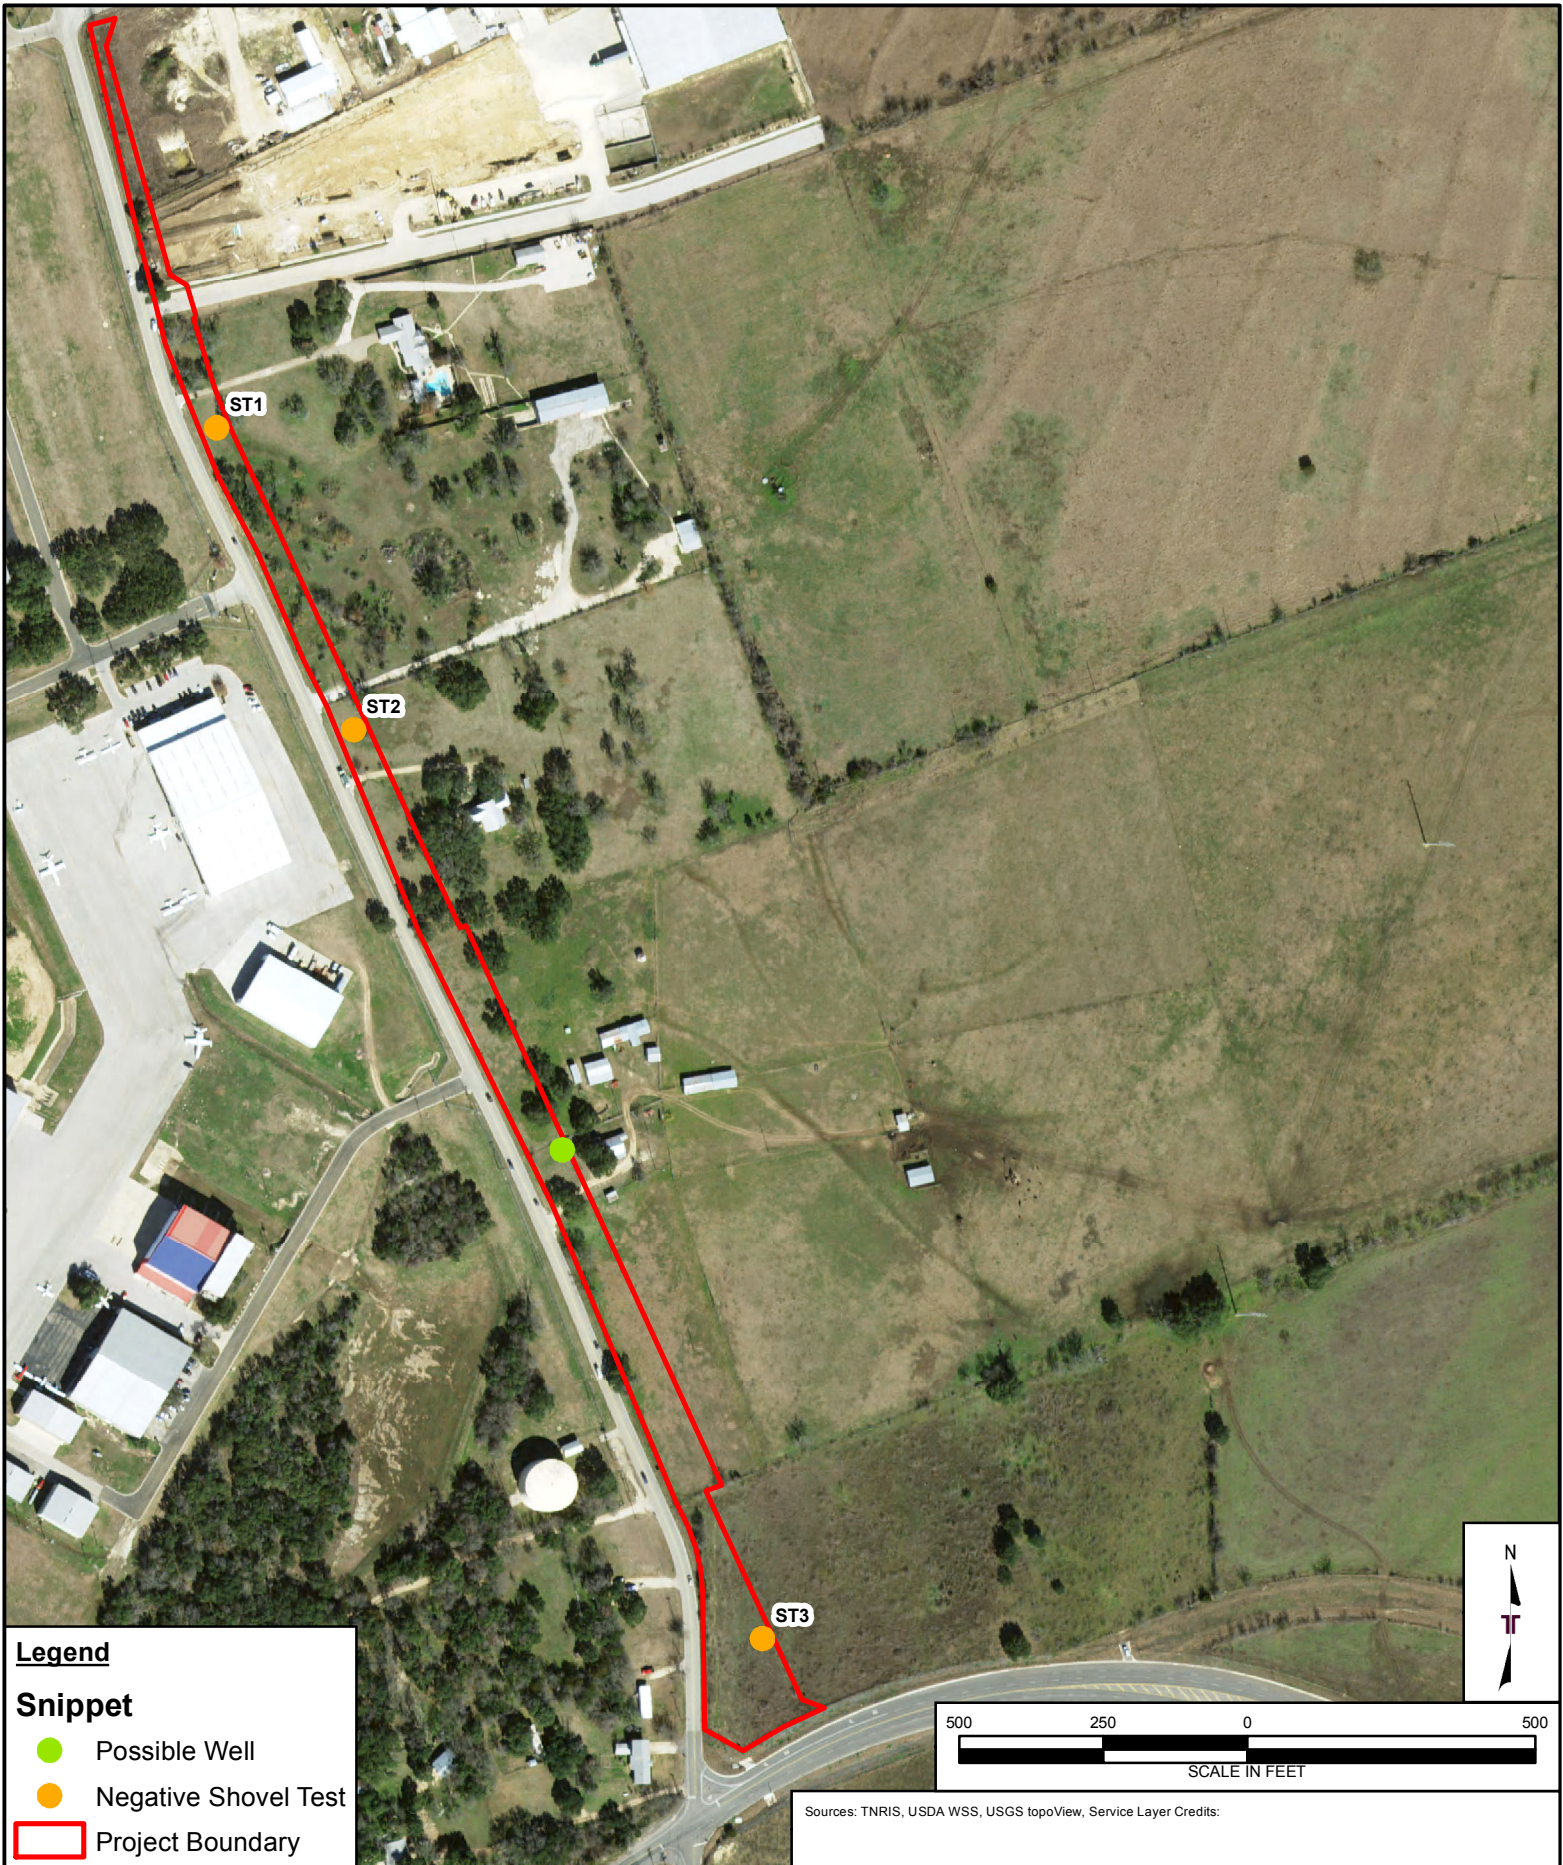
EXHIBIT
4

The intensive pedestrian survey of the APE resulted in thorough coverage of the parcel at 5 to 10 m intervals and the excavation of three shovel tests (Appendix A, Exhibit 4). The APE was located east of the existing Airport Road and was relatively flat in topography. The APE was covered in short, local grasses and leaf litter from oak trees; overall ground surface visibility was moderate and averaged 30 to 50 percent (Appendix B, Photos 1 and 2). Three shovel tests were placed in areas that appeared undisturbed and had less than 30 percent visibility (Appendix B, Photo 3) (see Appendix C for shovel test log). No cultural materials were observed during shovel testing.

**Results Map**

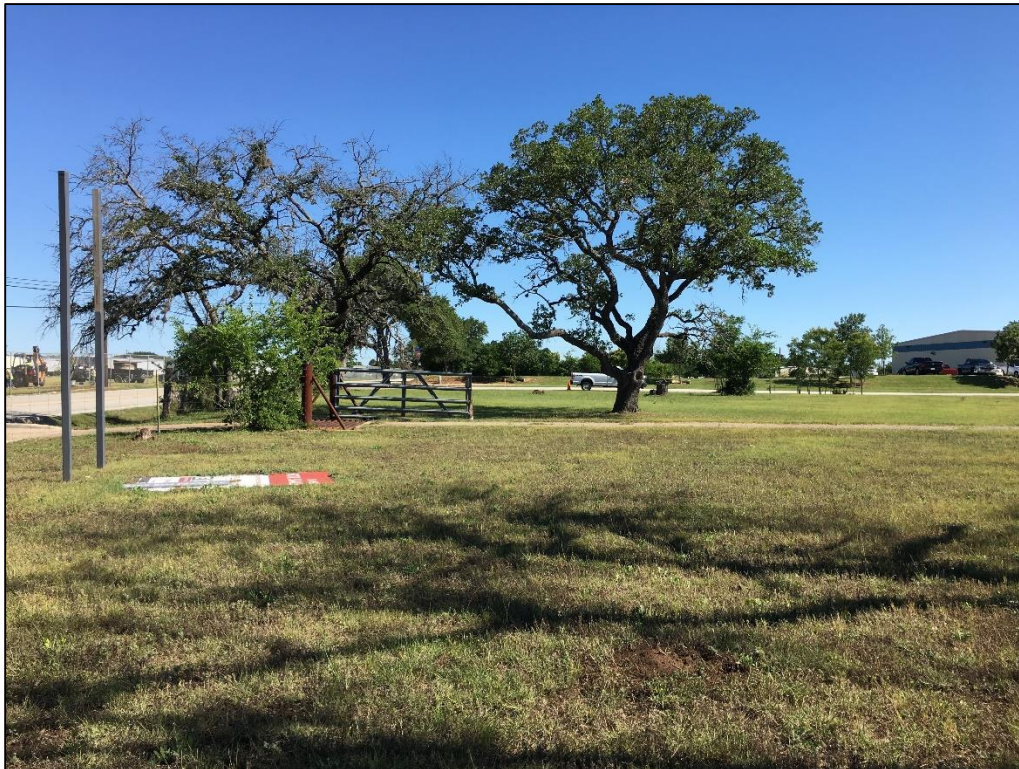
**Photo 1. Northern end of alignment. Note short grasses and good ground visibility. View to the north.**

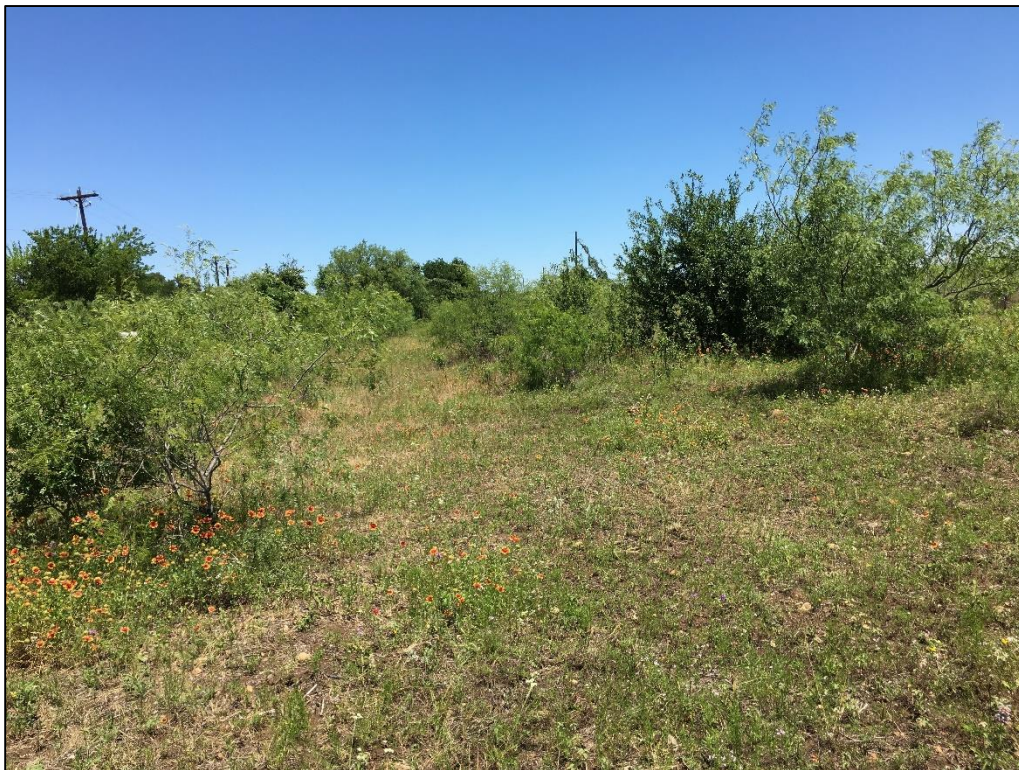
**Photo 2. Southern end of alignment. Note excellent ground surface visibility. View to the north.**

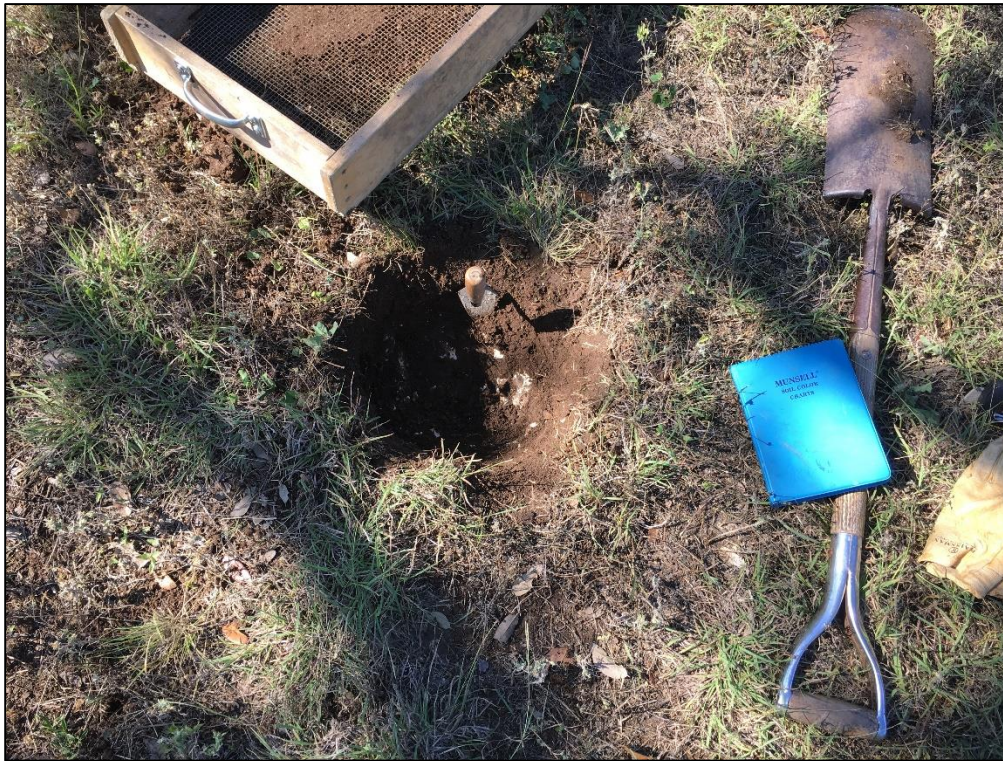
**Photo 3. Shovel Test 1. Note shallow soils.**

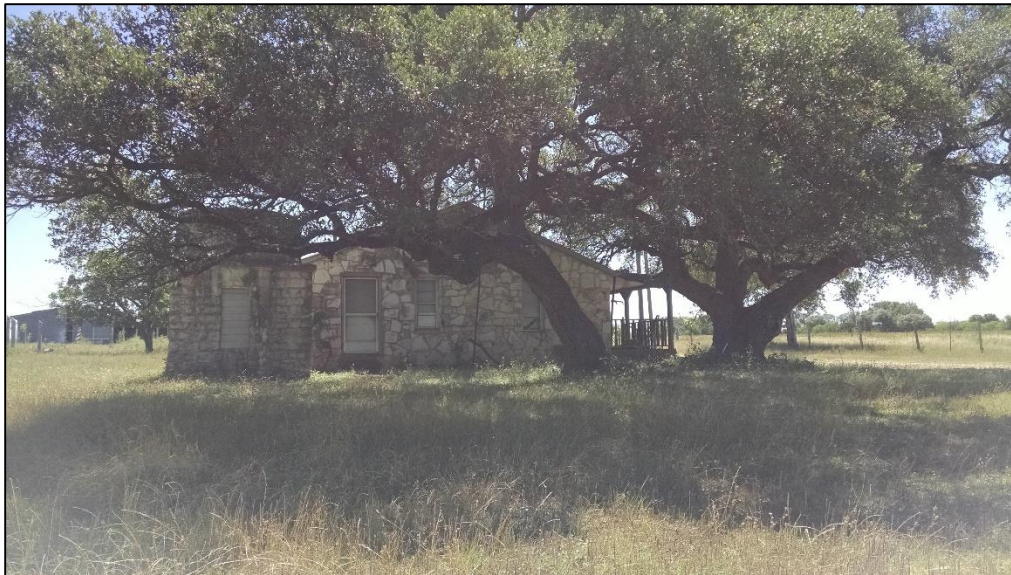
One historic house, observed on the aerials and topographic maps, was located outside of the project APE (Appendix B, Photo 4). The house and surrounding features could not be closely examined given that they were located outside of the right-of-way (ROW) alignment for the project. A possible historic feature, a hole covered with concrete and limestone blocks, was located west of the house within the APE (Appendix B, Photo 5). The feature, possibly a well, was marked with a GPS unit (See Appendix A, Exhibit 4). The ground surface near the feature and house was carefully inspected for cultural material. Three small glass shards were observed consisting of two clear flat glass fragments that were found near the possible well, and one piece

**Photo 4. Side view of historic house located outside of the project APE. View to the east.**

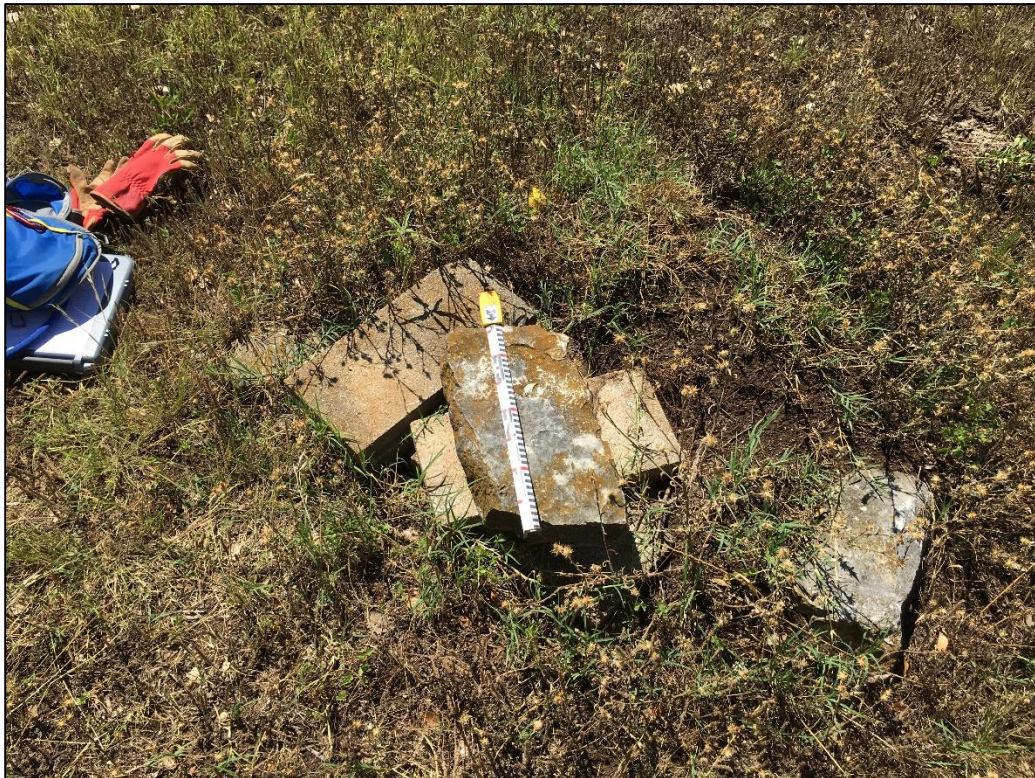
**Photo 5. Possible historic well. Note good ground visibility around feature.**

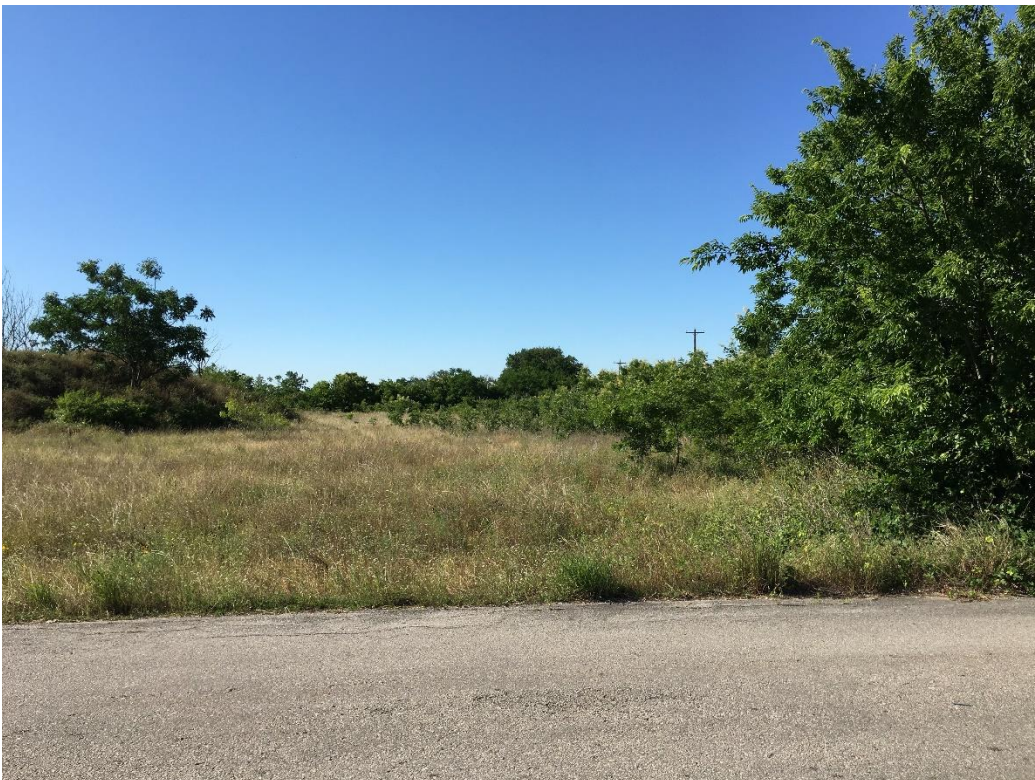
The northern portion of the alignment, in between Halmar Cove and Aviation Drive, could not be surveyed due to lack of Right of Entry (ROE). A large portion of this area is an abandoned quarry (see Appendix A, Exhibit 3), and thus, would not contain intact cultural materials. In addition, the area without ROE was observed from public roadways. It is clear that it has been heavily disturbed from landscaping activities and would likely not contain intact cultural materials (Appendix B, Photos 6 and 7).

**Photo 6. View of filled in quarry and no access property from Halmar Cove. View to the south.**

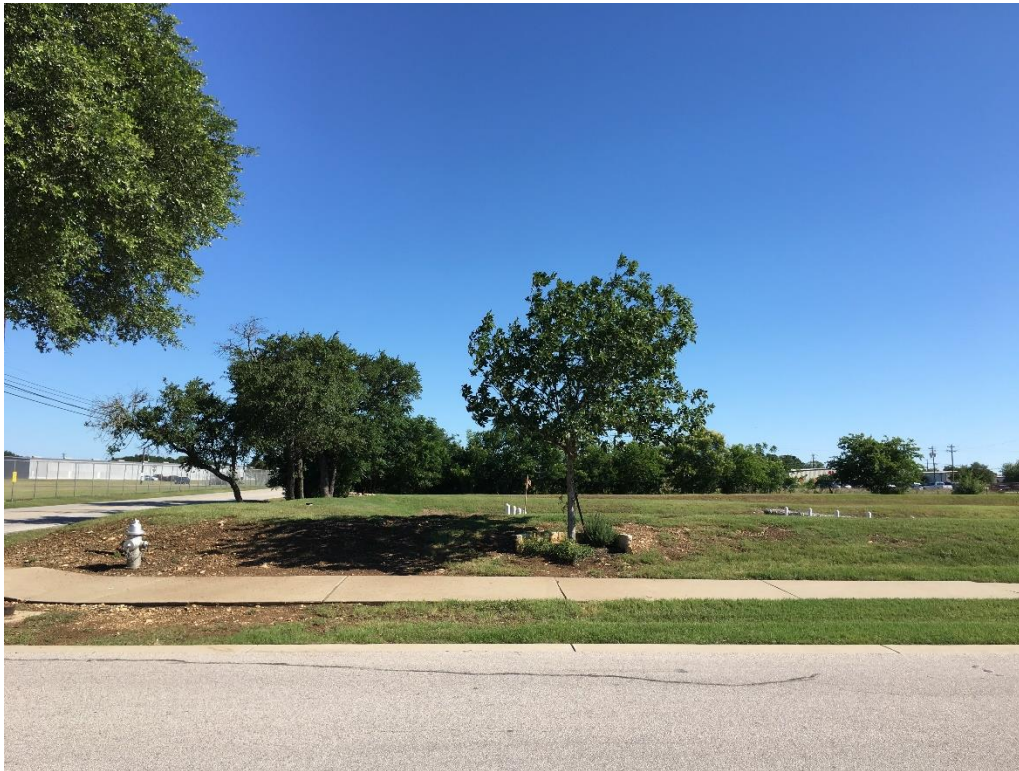
**Photo 7. View of no access property from Aviation Drive. Note ground disturbances from landscaping activities. View to the north.**
