Report for Archeological Survey

Intensive Archeological Survey of
Burleson-Retta Road at Village Creek,
Tarrant County, Texas

CSJ: 0902-48-744

October 31, 2017

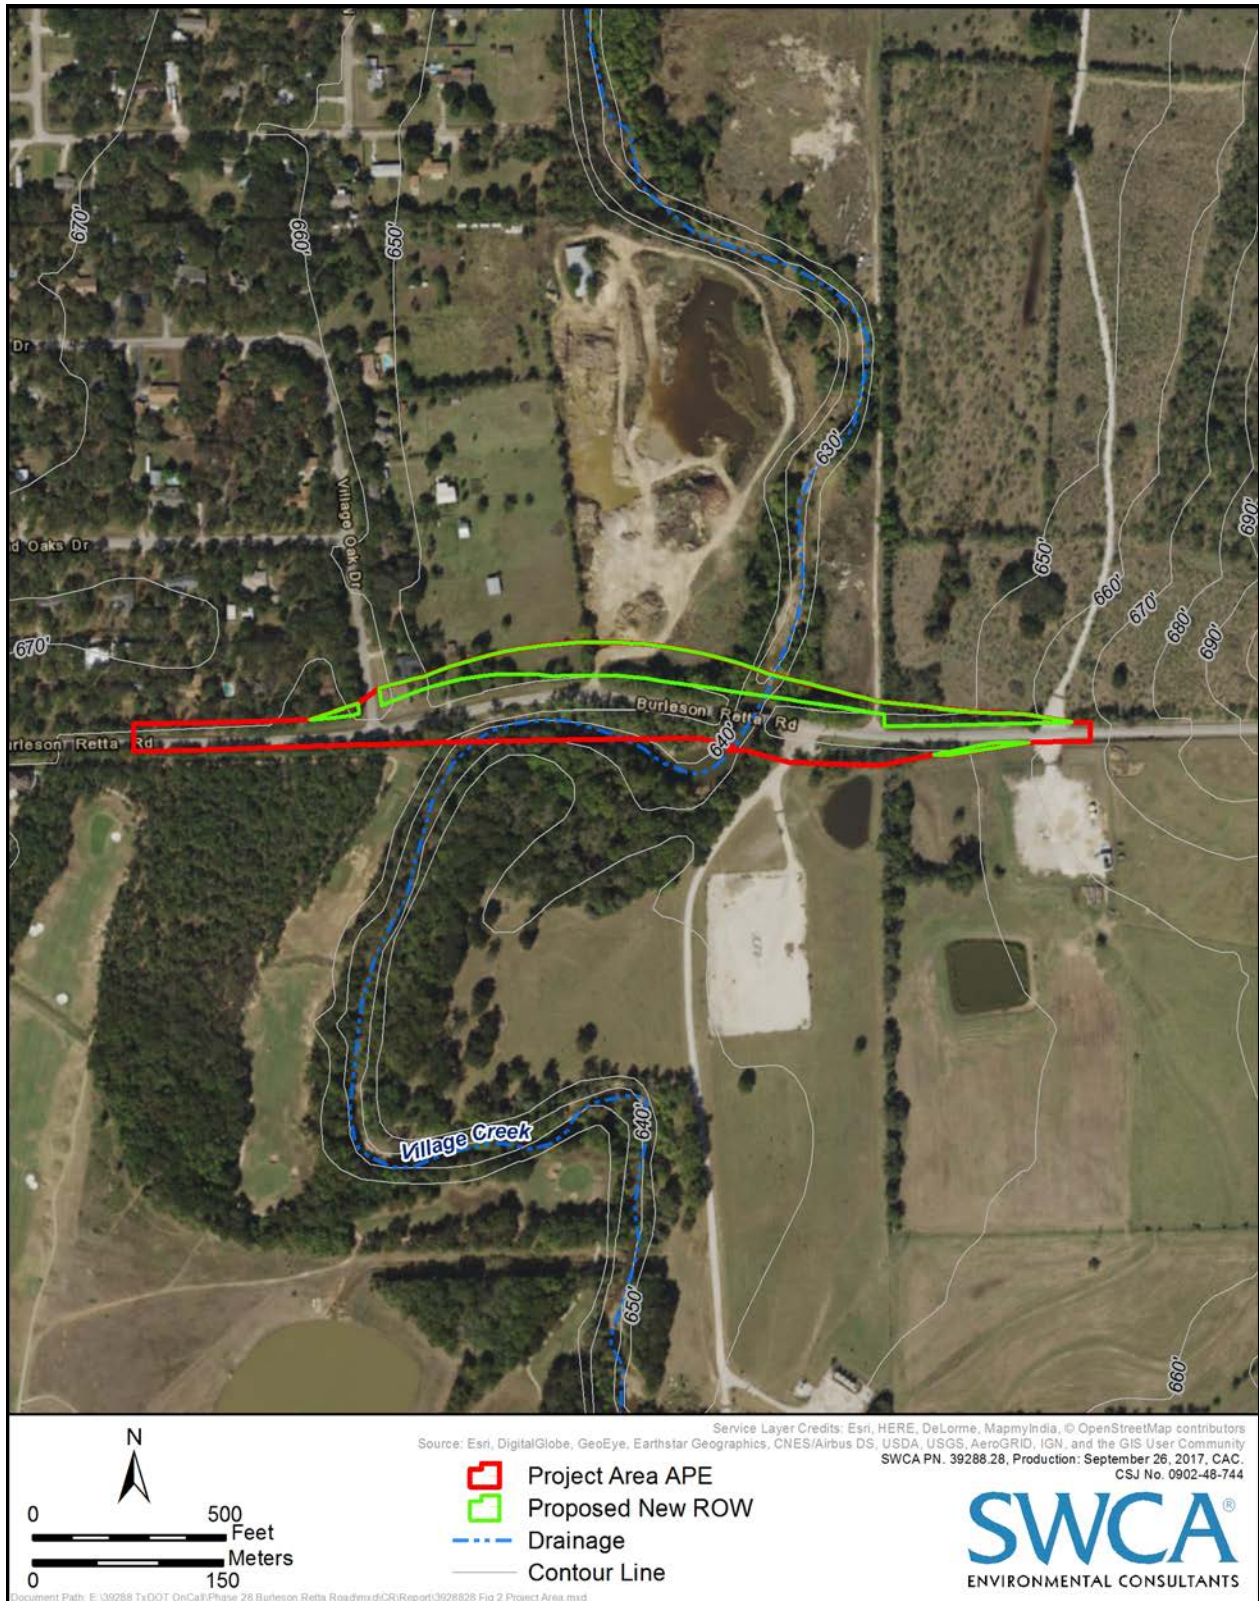
Figure 2. Project Area.

- **Area of Potential Effects (APE):** The APE is defined as 8.8 acres comprising the existing bridge and approaches, as well as 2.39 acres of new ROW (Figure 2).

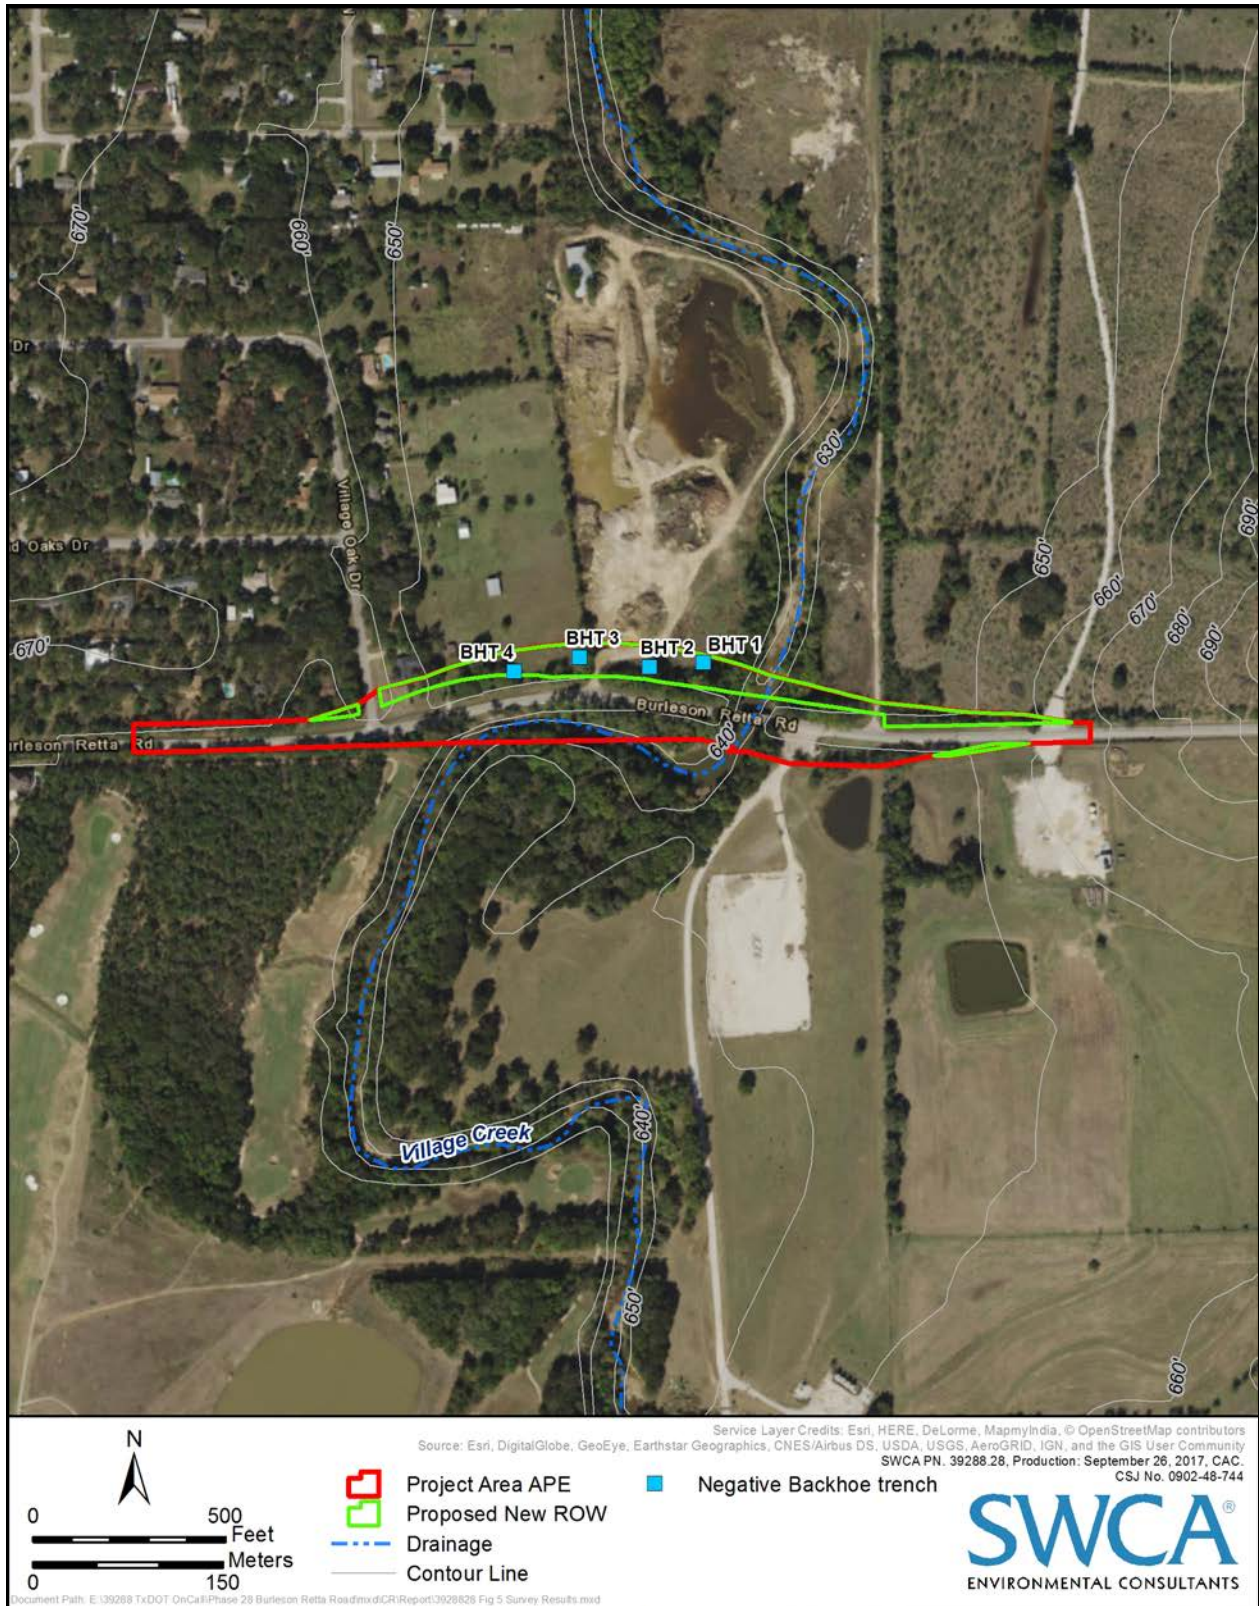
Figure 5. Survey results.

- **Project Area Description:** SWCA archeologists conducted backhoe trenching in soils with high potential for buried cultural material (Figure 5). The investigations revealed that the proposed project APE has been significantly disturbed from the construction of the current Burleson-Retta road and bridge, and its associated shoulders and other infrastructure. In addition, at least three buried utilities are present within the existing ROW, two of which parallel Burleson-Retta Road. Due to evident disturbances throughout most the APE, subsurface investigations were restricted to the new ROW (see Figure 5).

- **Backhoe Trenching:** SWCA excavated a total of 4 BHTs within the new ROW of the proposed project APE (Appendix A). All 4 trenches (BHT1-BHT4) were placed to the north of the existing ROW, on the west side of Village Creek. The BHTs were excavated to varying depths, ranging from a minimum of 133 cm below surface (cmbs) (BHT3) to a maximum of 333 cmbs (BHT2), to assess the potential for deeply buried cultural deposits. Trench dimensions were typically 90 cm wide, 7 m long, and excavated to pre-Holocene deposits.

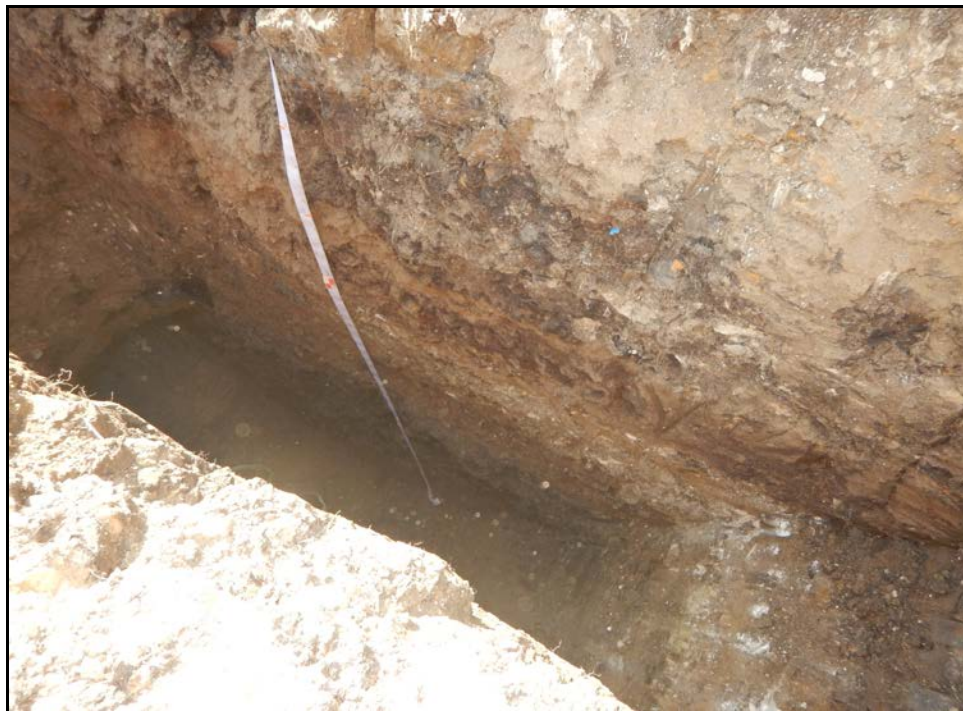
The stratigraphy in the trenches varied somewhat; however, the identified stratigraphy typically consisted of three strata in profile. The upper disturbed stratum consisted of a brown (10YR 4/3) sandy loam to dark brown (10YR 3/3) sandy loam or silt loam. Below Stratum II, the soil became a dark yellowish brown (10YR 4/6-4/4) sandy loam to depth (Stratum III). BHT1 and BHT2, near Village Creek, also presented with modern trash and construction fill to the depth of trench or 180 cmbs (Figure 6). All three stratigraphic layers exhibited limestone gravels throughout with the lower strata containing calcium carbonate filaments (Figure 7). The bottom stratum is likely a pre-Holocene unit, likely representing Pleistocene formation deposits mapped in the area.

Figure 6. Soil profile of BHT2 to 333 cmbs. Note the layers of disturbed fill.

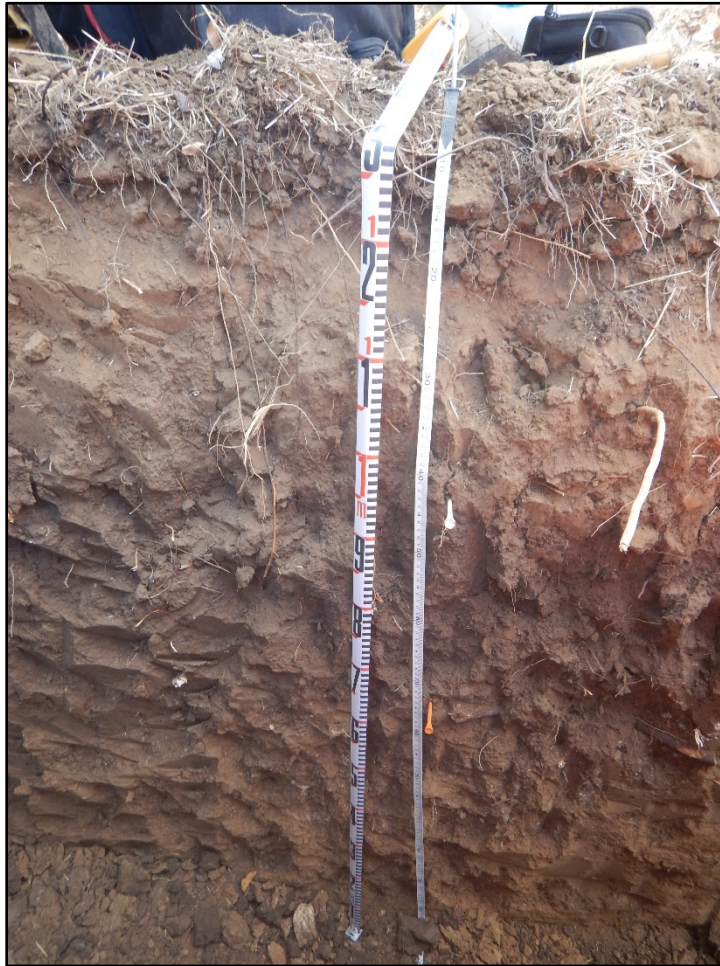
Figure 7. Soil profile of BHT3 showing three strata.
