Intensive Archeological Survey of the Highway US 69 and Farm-to-Market 779 Interchange, Wood County, Texas

Report for Archeological Survey

Tyler District

CSJ: 0203-05-039

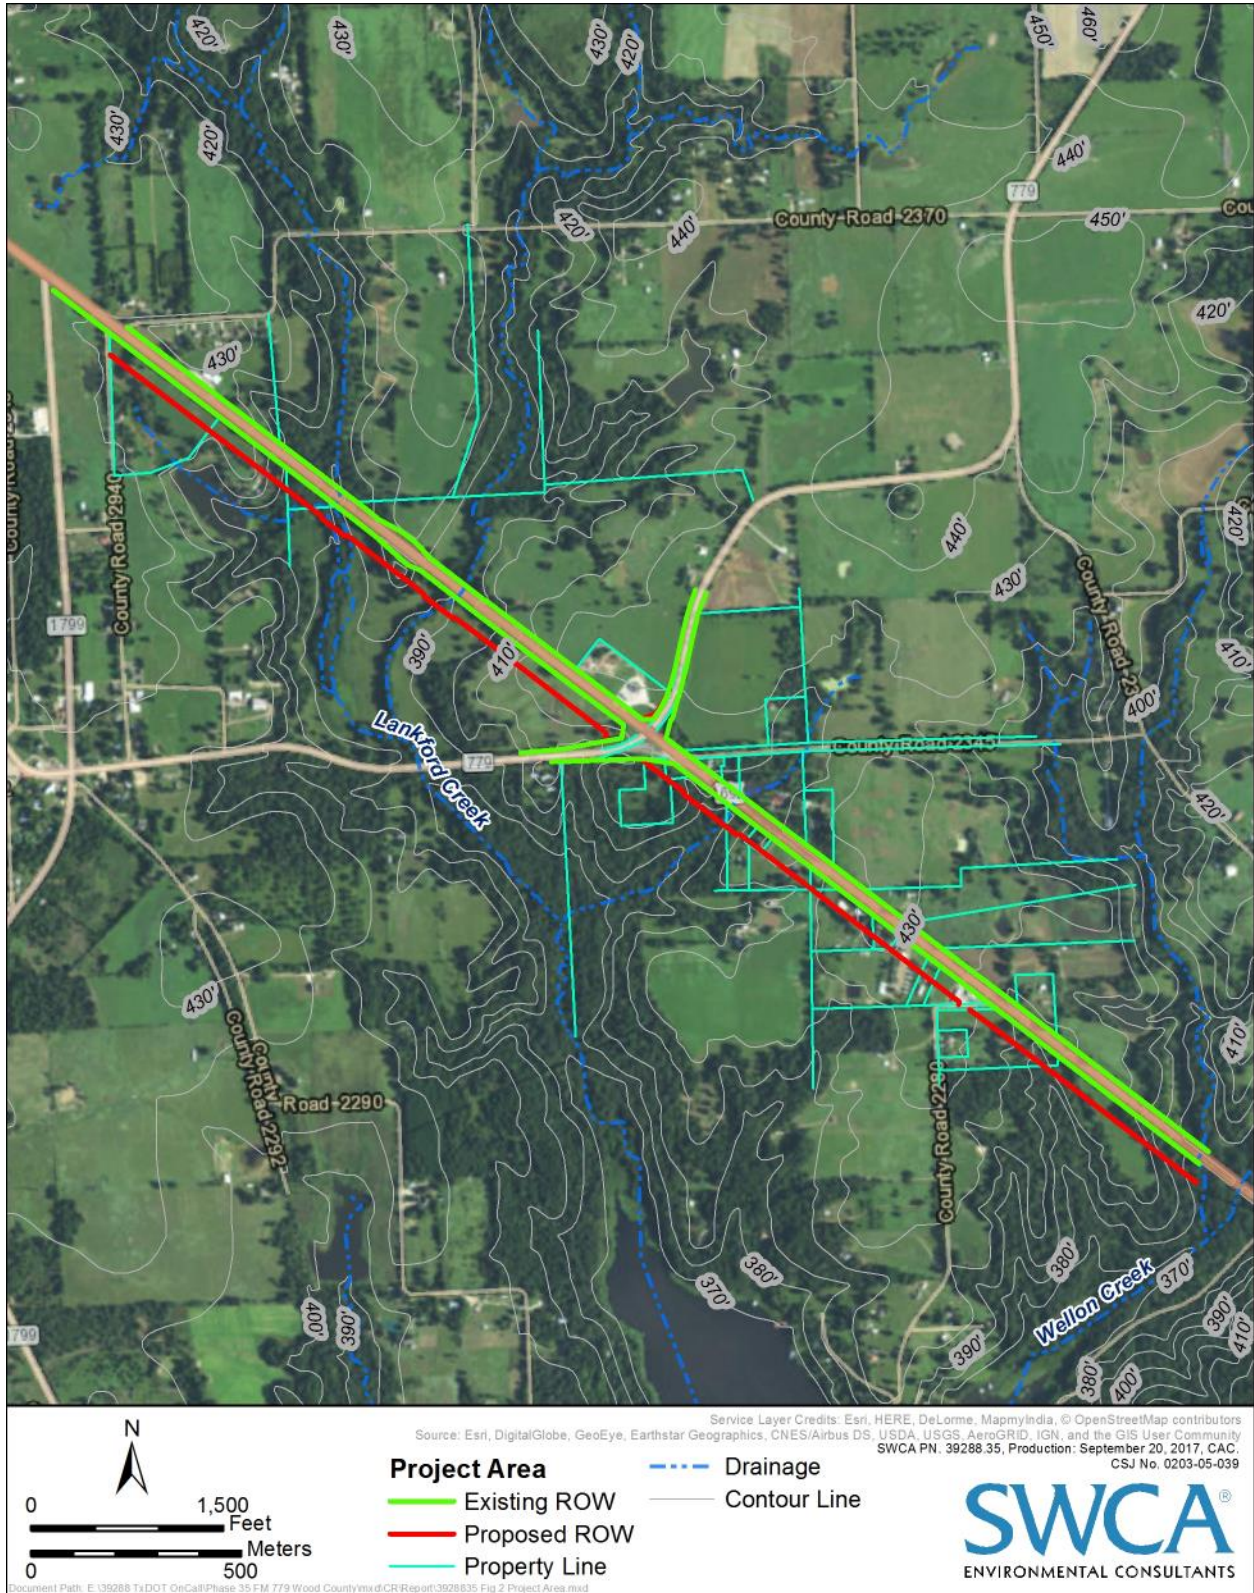
Figure 2. Project Area.

- **Area of Potential Effects (APE):** The APE is defined as a two-mile long stretch of US 69 between the limits outlined above, and a 0.17-mile long stretch along FM 779, and includes the existing 120-foot-wide ROW and an additional 25.19 acres (from 19 parcels) of new ROW along the southwest side of existing ROW. Total project area is about 57.69 acres, of which about 32.5 acres is existing ROW and 25.19 acres is new ROW. Typical depths of impact are anticipated to be approximately two feet, while maximum depths of impacts up to six feet at culvert locations (Figure 2).

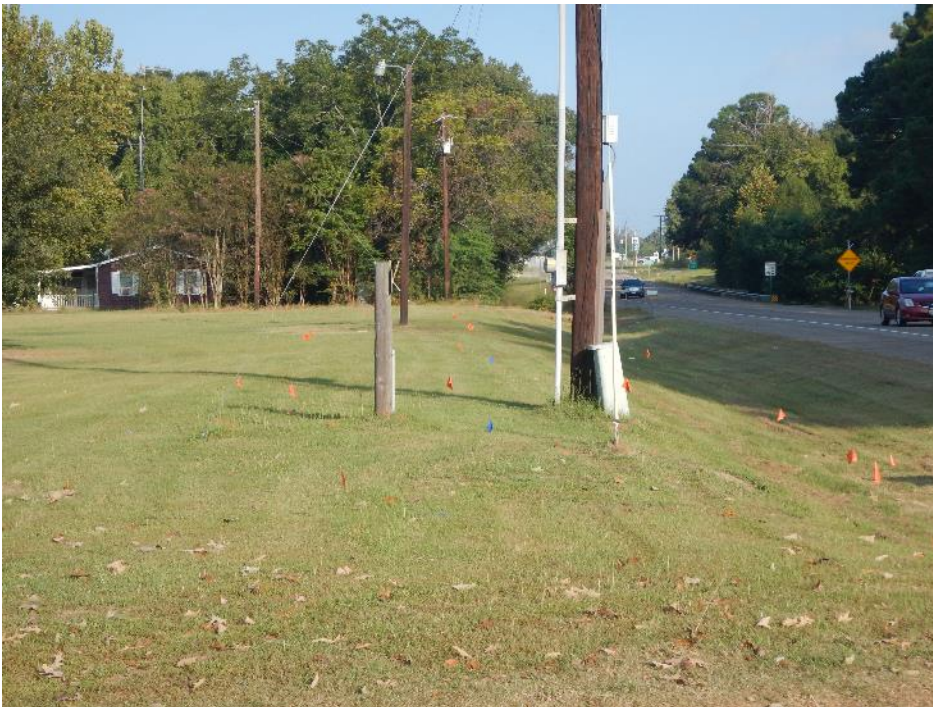
Figure 8. Manicured lawn south of US 69 with pin flags marking multiple utilities, facing northwest.

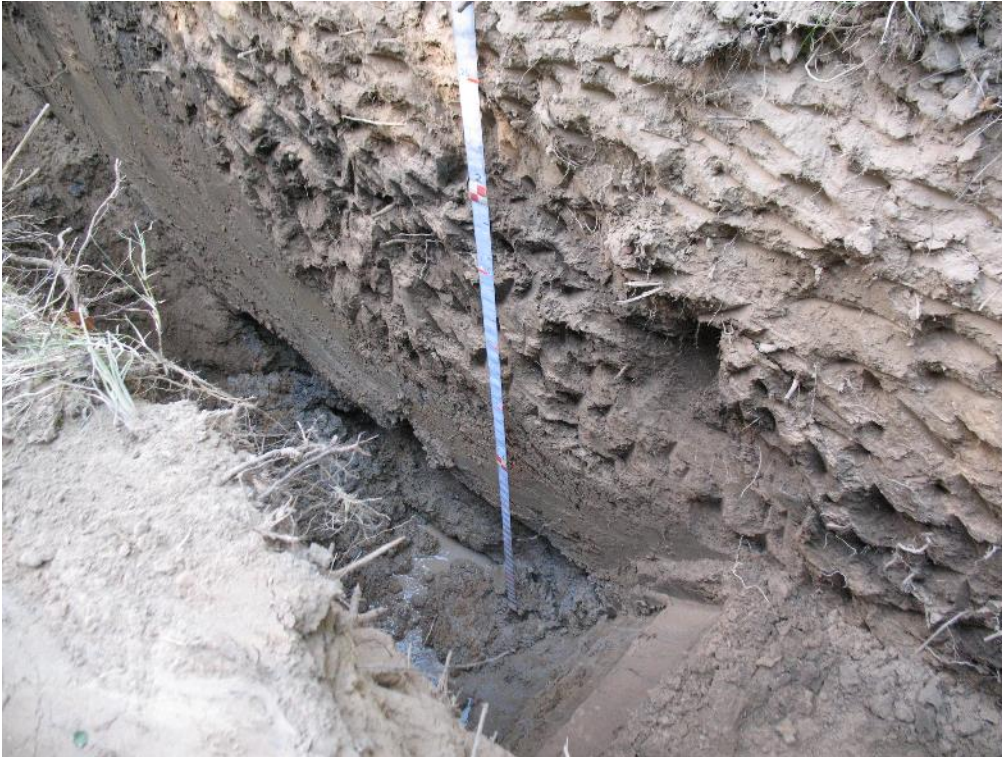
The stratigraphy in the trenches varied somewhat; however, the identified stratigraphy typically consisted of three to five standard strata in profile. The upper strata consisted of a brown (7.5YR 4/3) to yellowish brown (10YR 5/4) sandy loam over sandy clay loams ranging in color from dark gray (10YR 4/1) to dark yellowish brown (10YR 4/4). The substrate, representing pre-Holocene deposits, consisted of red (2.5YR 4/8) clays, brown to pale brown (10YR 5/3-6/3) clay loams, or gray (10YR 6/1) to dark grayish brown (10YR 4/2) sandy clay loams. The water table was encountered in BHT 4 (Figure 9). Bioturbation from roots, insects, crayfish, and mammals was common throughout the trench profiles (Figure 10).

Figure 9. Soil profile of BHT 4. Note water table and slumping at bottom of trench.

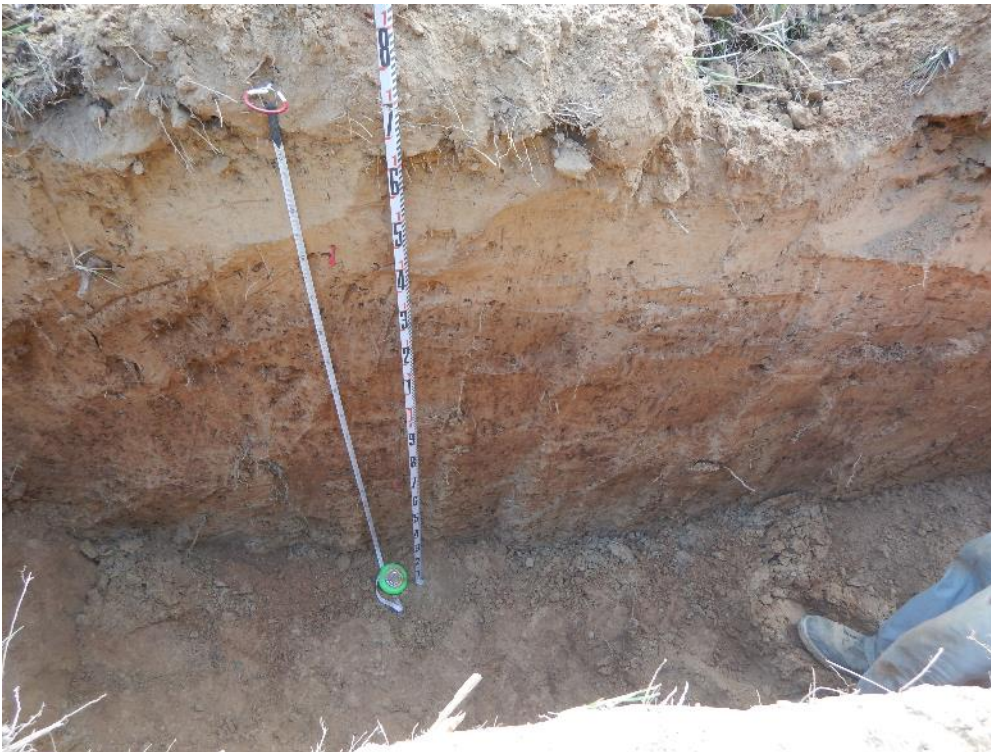
Figure 10. BHT 5 showing common bioturbation throughout upper loose sandy soil over rubified clay loam, facing west.
