### CULTURAL RESOURCES SURVEY OF THE SPARKS DRIVE CONNECTOR PROJECT, CITY OF CLEBURNE, JOHNSON COUNTY, TEXAS

Prepared for:  
Texas Historical Commission  
Texas Antiquities Permit #8126

On Behalf of:  
City of Cleburne  
&  
Childress Engineers

Cultural Resources Report  
September 2017

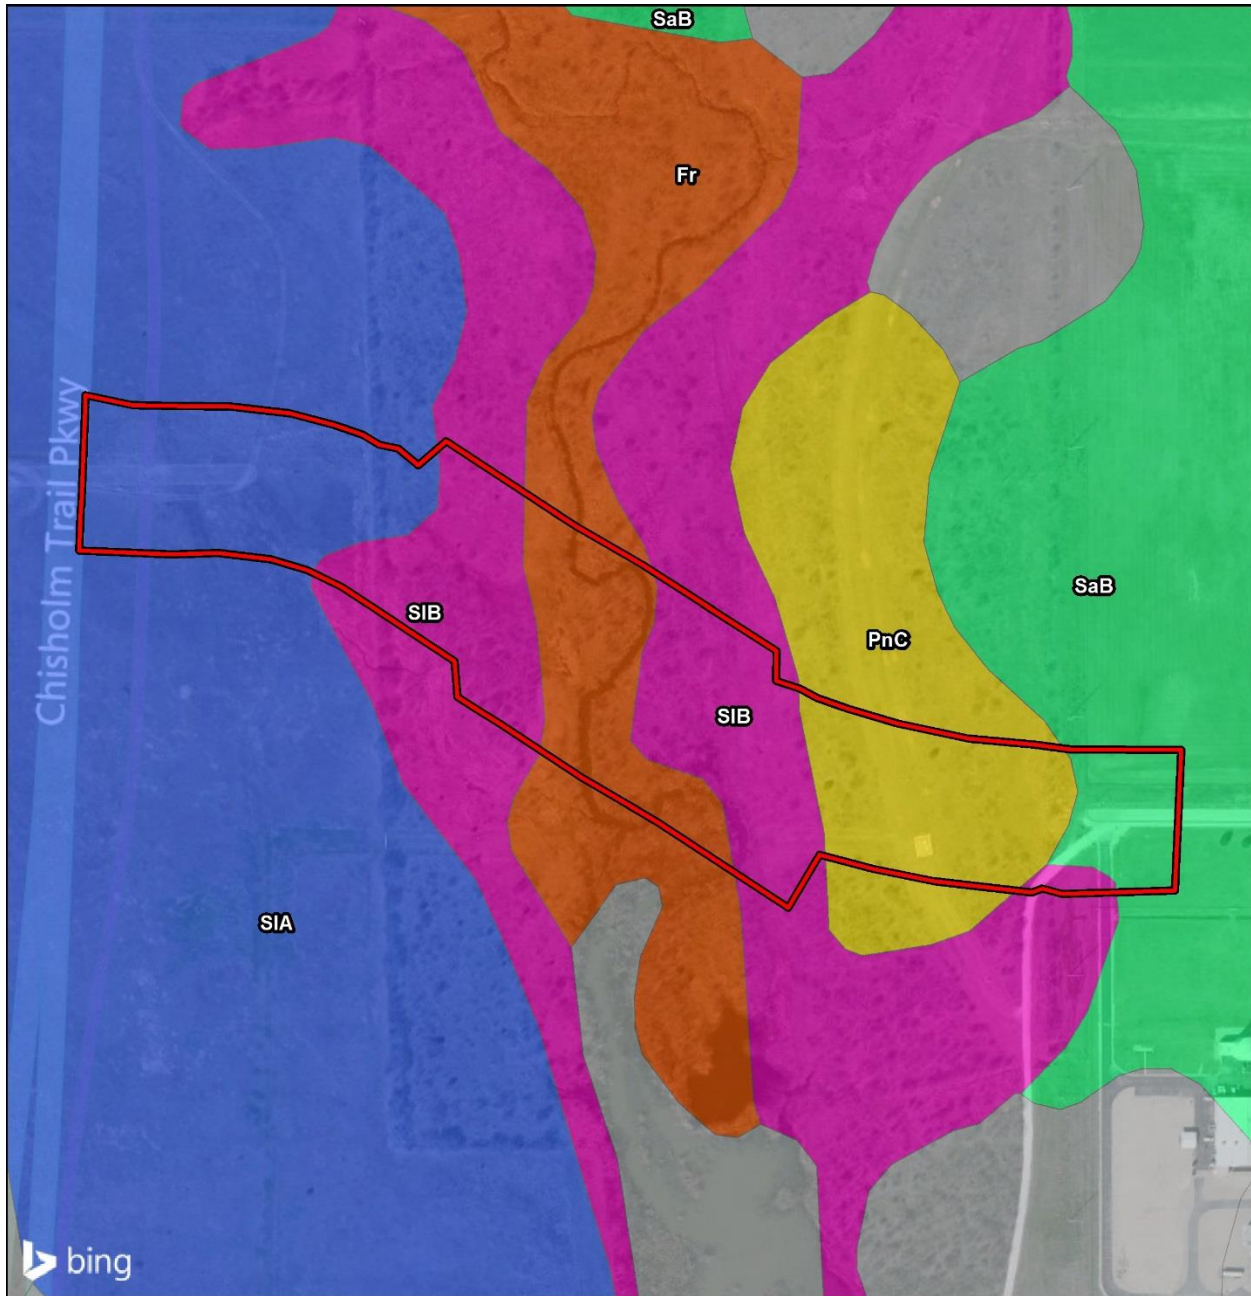
Figure 2.2  
Soil Map Units Located Within and  
Adjacent to the APE

As shown by the *Soil Survey of Johnson County, Texas*, there are five mapped soils within the APE (**Table 2.1**) (Coburn 1985). Approximately 82.3 percent of the APE contains upland soils typical of the Eastern Cross Timbers and Grand Prairie ecoregions. The remaining 17.7 percent of the APE contains occasionally flooded soils near West Buffalo Creek. Soil data was viewed from the USDA Natural Resources Conservation Service (NRCS) Web Soil Survey (**Figure 2.2**) (Web Soil Survey 2017).

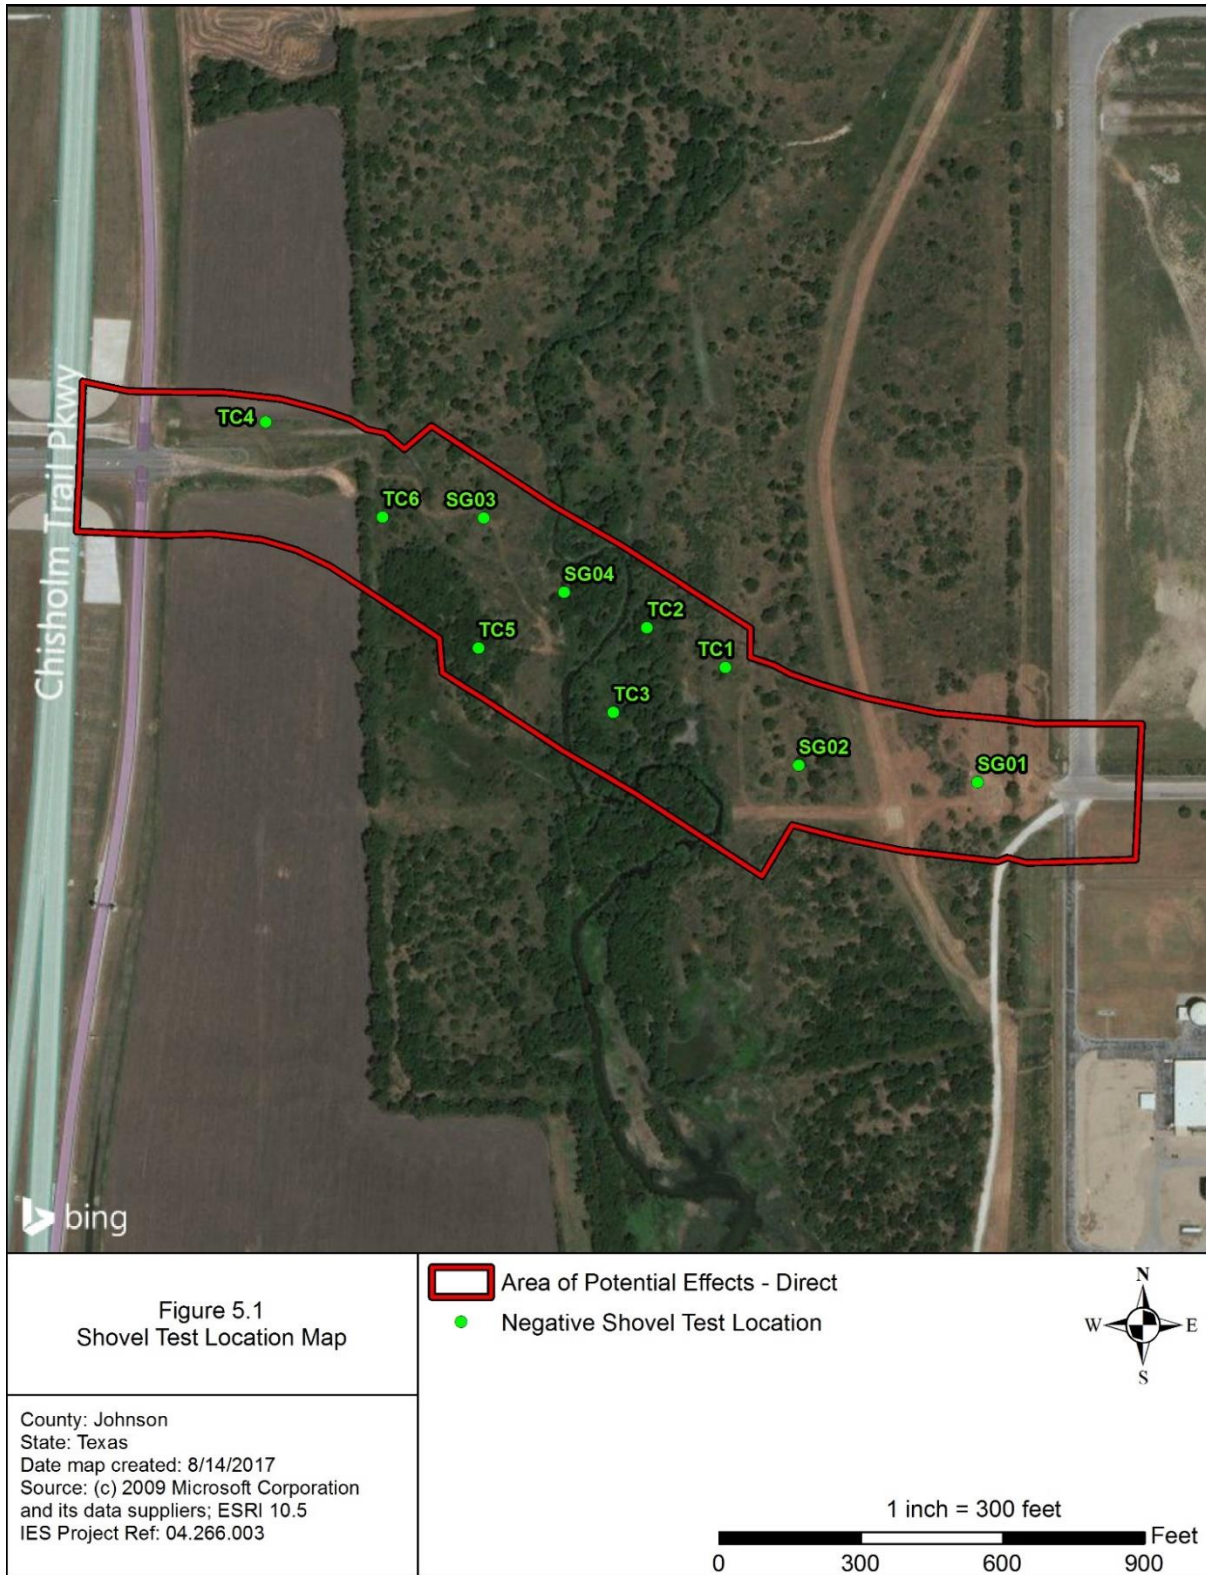
During the pedestrian survey, 10 negative shovel tests were excavated throughout the APE (see **Figure 5.1**). Shovel Test TC1 was located within the lower potential extents of the APE and encountered a very dark grayish brown (10YR 3/2) clay loam with frequent gravel less than 0.5 cm in size. This overlaid a very dark brown (10YR 2/2) clay loam with no inclusions. The large occurrence of gravel was likely a result of runoff from the nearby overgrown unpaved roadway approximately 30 m to the south. The remaining nine shovel tests were situated within the undisturbed central portion of the APE. These shovel tests revealed clay loam that ranged from brown (10YR 4/2) along the margins of the central portion to very dark brown (10YR 2/2) near West Buffalo Creek. Shovel tests were terminated between 40 and 60

cmbs due to observed disturbances and the presence of culturally sterile soil. Additionally, subsurface exposures including animal burrows, disturbed patches, and the banks of West Buffalo Creek were examined.

During the pedestrian survey, no cultural resources were encountered within the 19.1-acre APE. Shovel test locations are illustrated in **Figure 5.1**. A photograph location map and photographs are located in **Appendix A**.

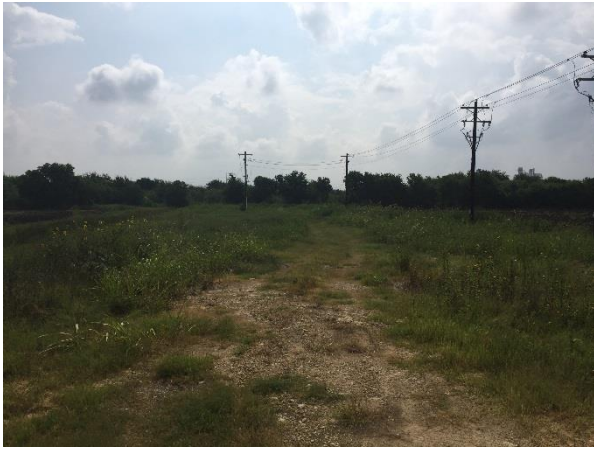
Photograph 1 – Looking East – Disturbance

During the survey, field investigations verified that the past land use and development within and surrounding the APE have disturbed portions of the APE. The APE was located within a varied environment that ranged from agricultural fields to a thinly wooded corridor situated along West Buffalo Creek. The topography within the APE was primarily very gently sloping and the western and eastern extent of the APE exhibited clear signs of modification from past transportation development.

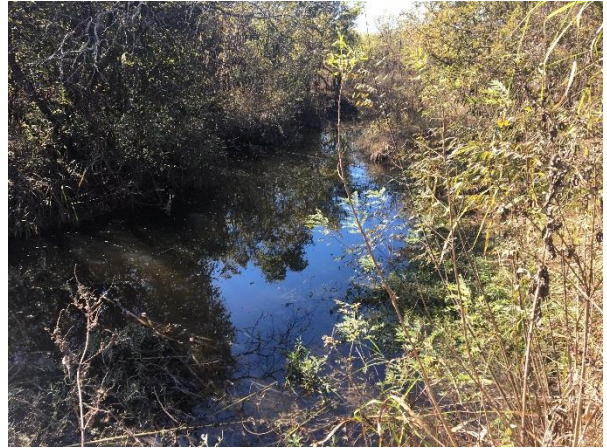
Photograph 4 – Looking South – West Buffalo Creek

Although vegetation was thick along the banks of West Buffalo Creek (**Appendix B, Photograph 4**), several cutbank exposures were assessed during the survey for evidence of buried cultural deposits and to gauge the potential that cultural deposits could be deeply buried (**Appendix B, Photograph 11**). On average, the cutbanks along West Buffalo Creek rose approximately 3 to 4 feet above the active channel. No cultural deposits were observed within the West Buffalo Creek cutbank exposures, nor were any deeply buried soils. For these reasons, it was determined that backhoe trenching would not be required to assess for deeply buried cultural deposits.

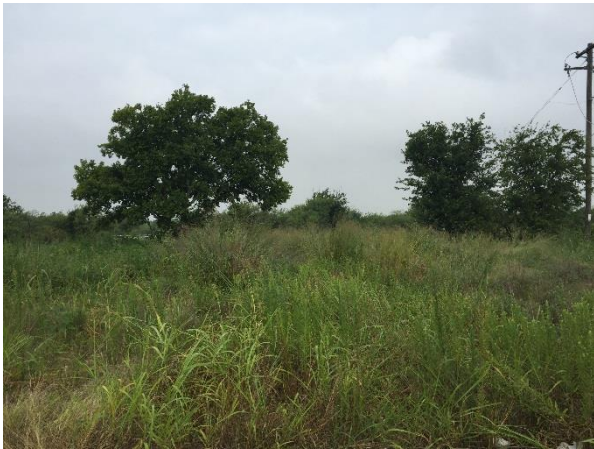
Photograph 9 – Looking West – General Overview

Overall, approximately 30 percent of the APE was located within areas that are routinely mowed or plowed. The western 615 feet of the APE incorporated portions of two agricultural fields, an overgrown unpaved roadway, utility lines, and infrastructure associated with Sparks Road and Chisholm Trail Parkway (**Appendix A, Photographs 1 and 2**). An additional dry drainage feature was observed north of the unpaved road. The central approximate 0.3-mile portion of the APE was centered along West Buffalo Creek. This portion of the APE featured thin woody vegetation intermixed with tall grasses that abutted the creek (**Appendix A, Photographs 3 through 6**). Minimal ground disturbances observed within this portion of the APE pertained to the 75-foot wide maintained easement serving the gas and sanitary sewer pipelines and connector site constructed prior to 2005 (**Appendix A, Photographs 7 and 8**). The eastern 260 feet of the APE was comprised of Sparks Drive, unnamed roadways serving surrounding businesses, a utility line, and maintained right-of-way (ROW) and utility easement (**Appendix A, Photographs 9 and 10**).
