Intensive Archeological Survey of
County Road 541 in Montague County,
Texas

Wichita Falls District

Texas Antiquities Permit No. 8226

CSJ: 0903-28-064

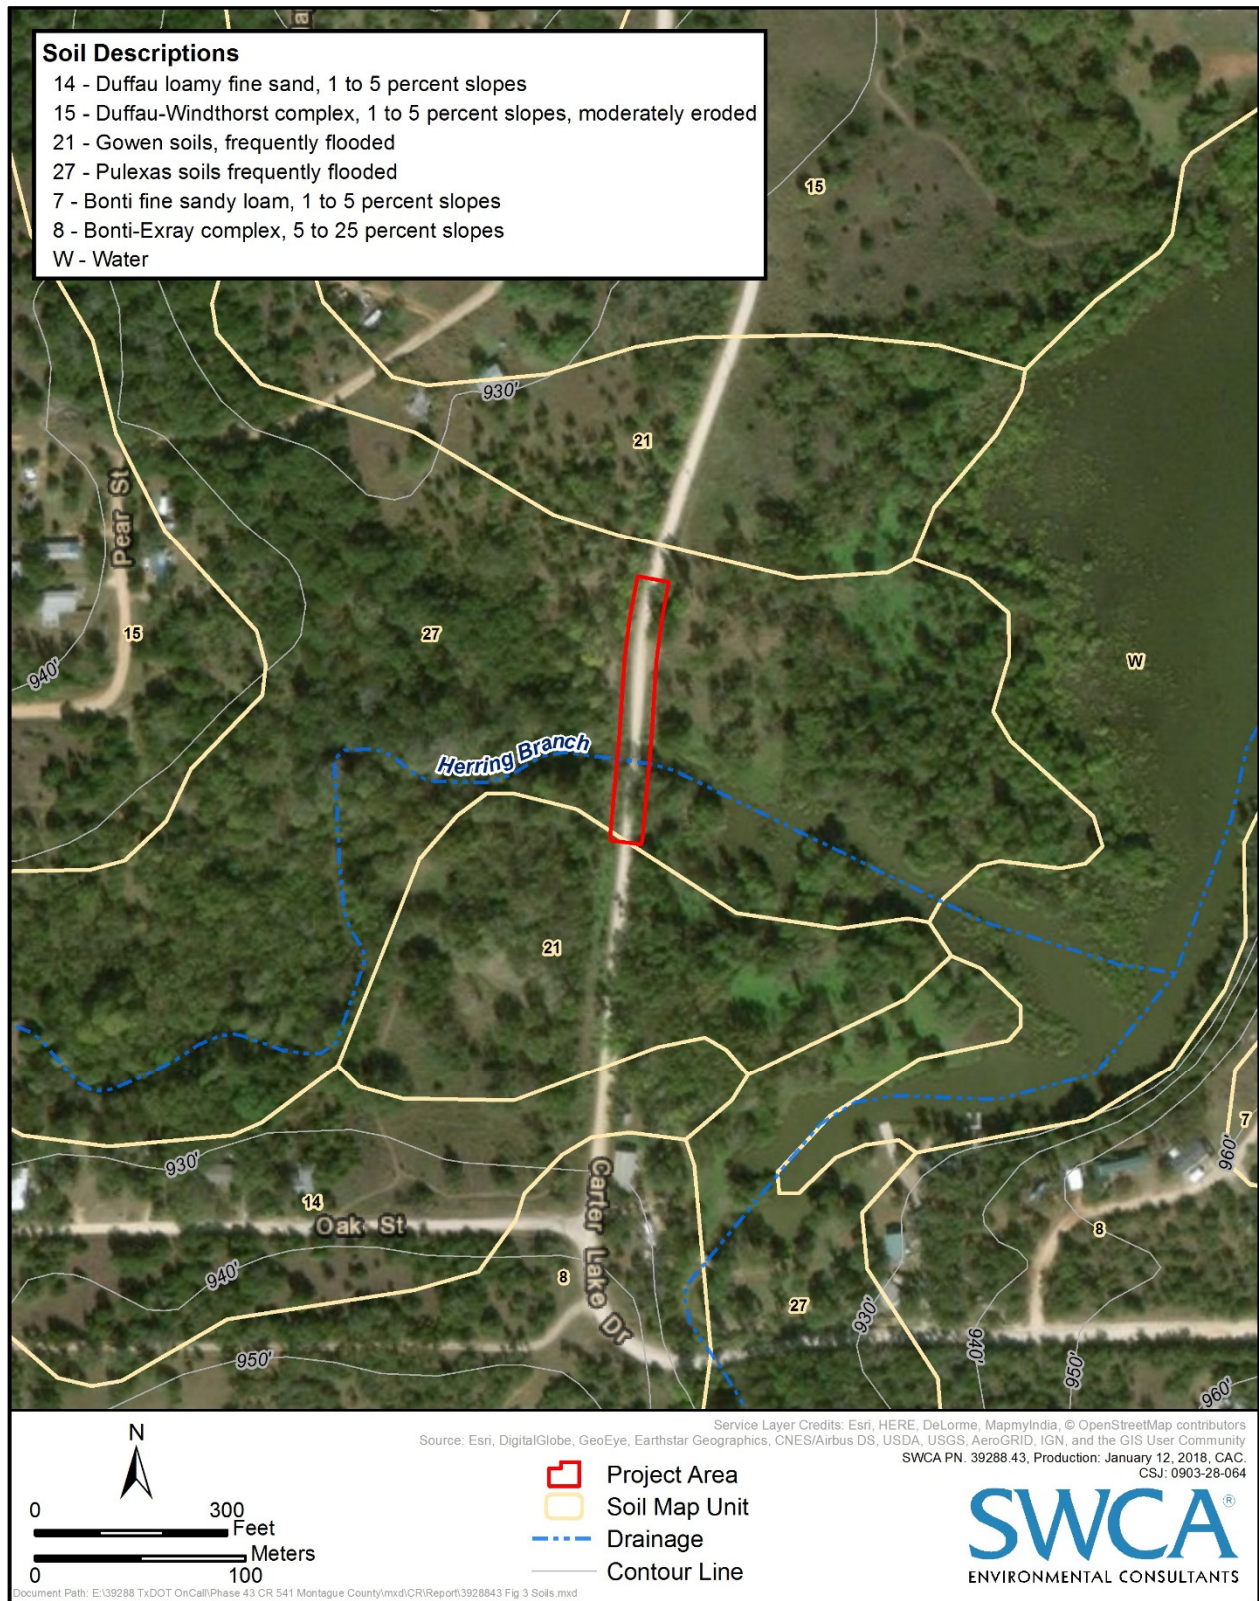
Figure 4. Project area soils.

Soils: According to the U.S. Department of Agriculture Natural Resources Conservation Service (NRCS) Web Soil Survey, the APE is located entirely within the Pulexas series (27) soil (Figure 4). The Pulexas series consists of a very deep, well-drained loamy alluvium, which is frequently flooded. The soils are found in nearly level floodplains with slopes ranging from 0 to 1 percent, and are described as a brown fine sandy loam overlying a brown to dark brown loam (NRCS 2018).

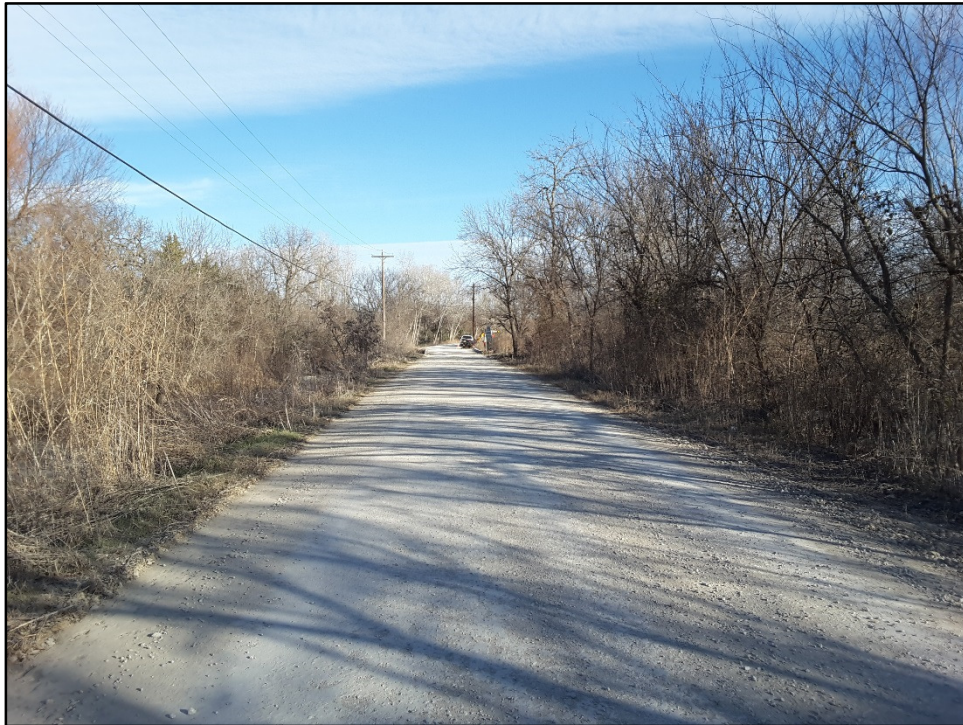
Vegetation: Vegetation within the APE consists of small patches of mixed grasses directly adjacent to the existing roadway, surrounded by riparian woodland and inundated floodplain (Figures 5 and 6).

Figure 5. Overview of the APE from the northern terminus (bridge in background), facing south.

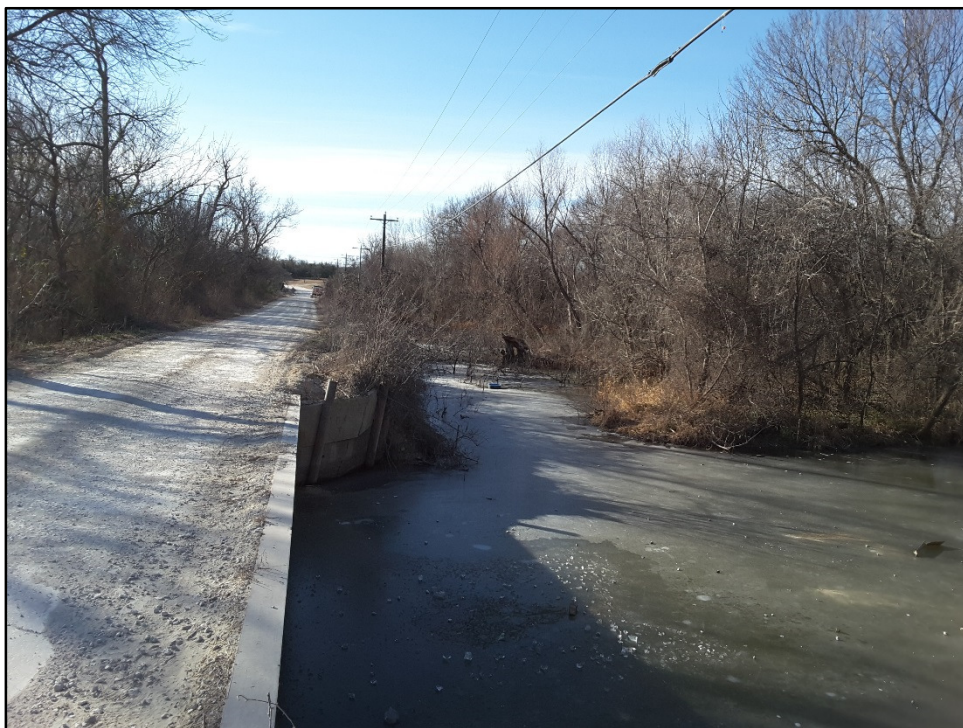
Figure 6. Overview of bridge and Herring Branch crossing showing inundated areas within APE, facing south.

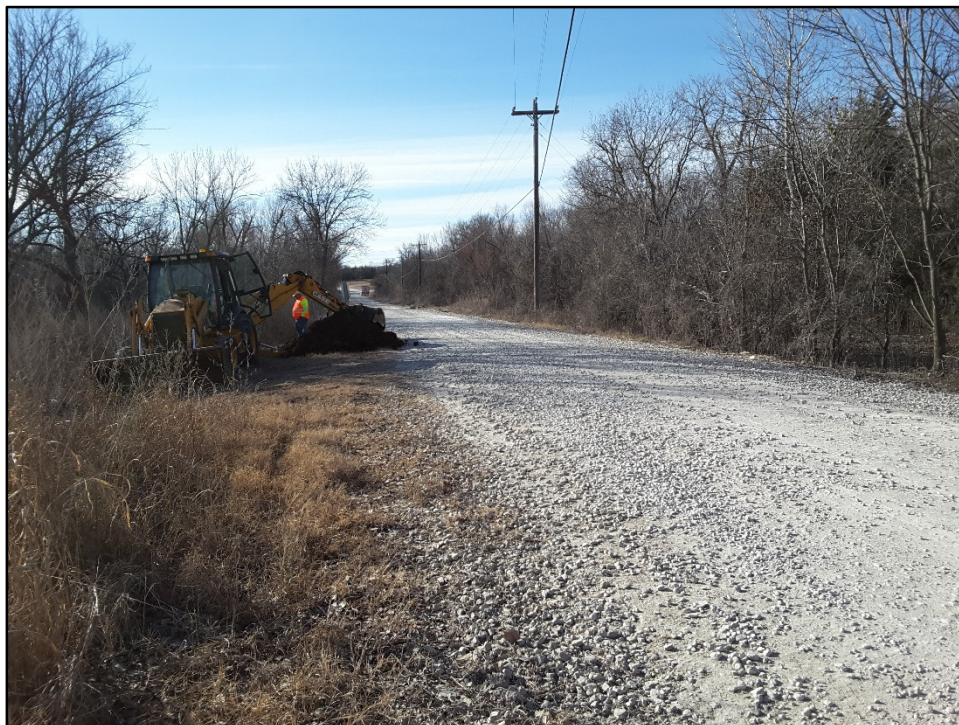
SWCA excavated a single BHT within the proposed project APE (Table 2). Due to inundation, road fill, overhead utilities, and the existing roadway within the narrow APE, only one BHT could be excavated. The trench was approximately 15 feet (4.6 meters [m]) in length, 4 feet (1.2 m) wide, and reached a depth of approximately 7.2 feet (2.2 m) (Figure 8). The first level of the BHT was heavily disturbed by road fill to a depth of 1.3 feet (40 cm) (Figure 9). Below the disturbance, the trench profile was composed of a brown (10YR 4/3) sandy clay loam overlying a strong brown clay loam (7.5YR 5/8). The trench began to fill with water at a depth of approximately 6.6 feet (200 cm). No evidence of cultural resources was observed within the trench.

Figure 8. Overview of the selected BHT area, facing south.

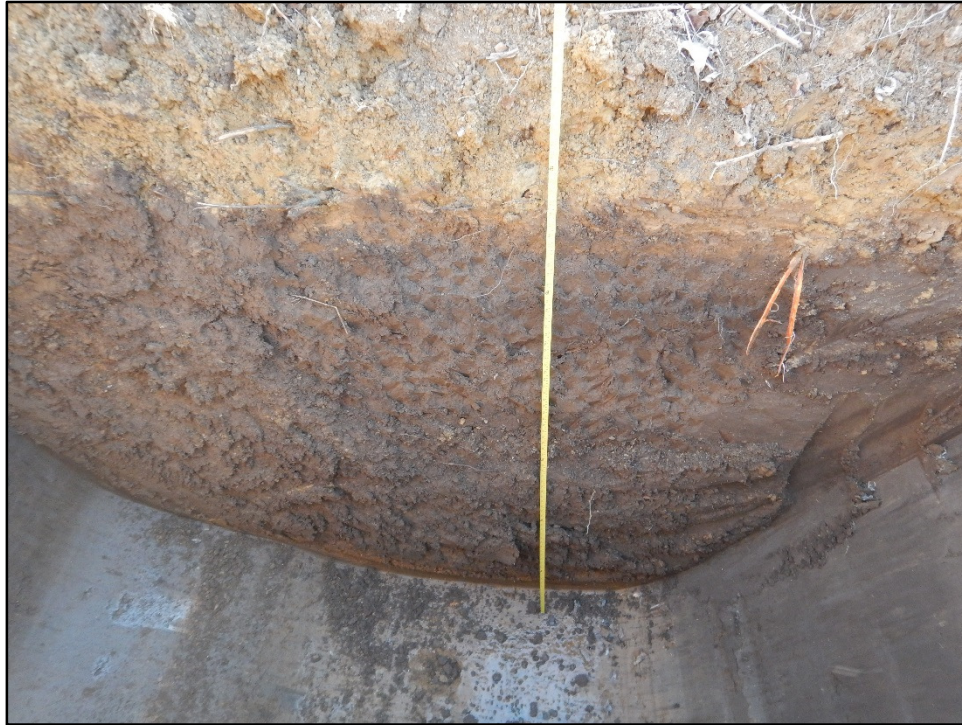
Figure 9. Profile of BHT01, facing east.
