## INTENSIVE ARCHEOLOGICAL SURVEY OF THE KEGLEY ROAD IMPROVEMENTS CITY OF TEMPLE, BELL COUNTY, TEXAS

January 22, 2018

Final Report – Public Copy

Terracon Project No. 96177014

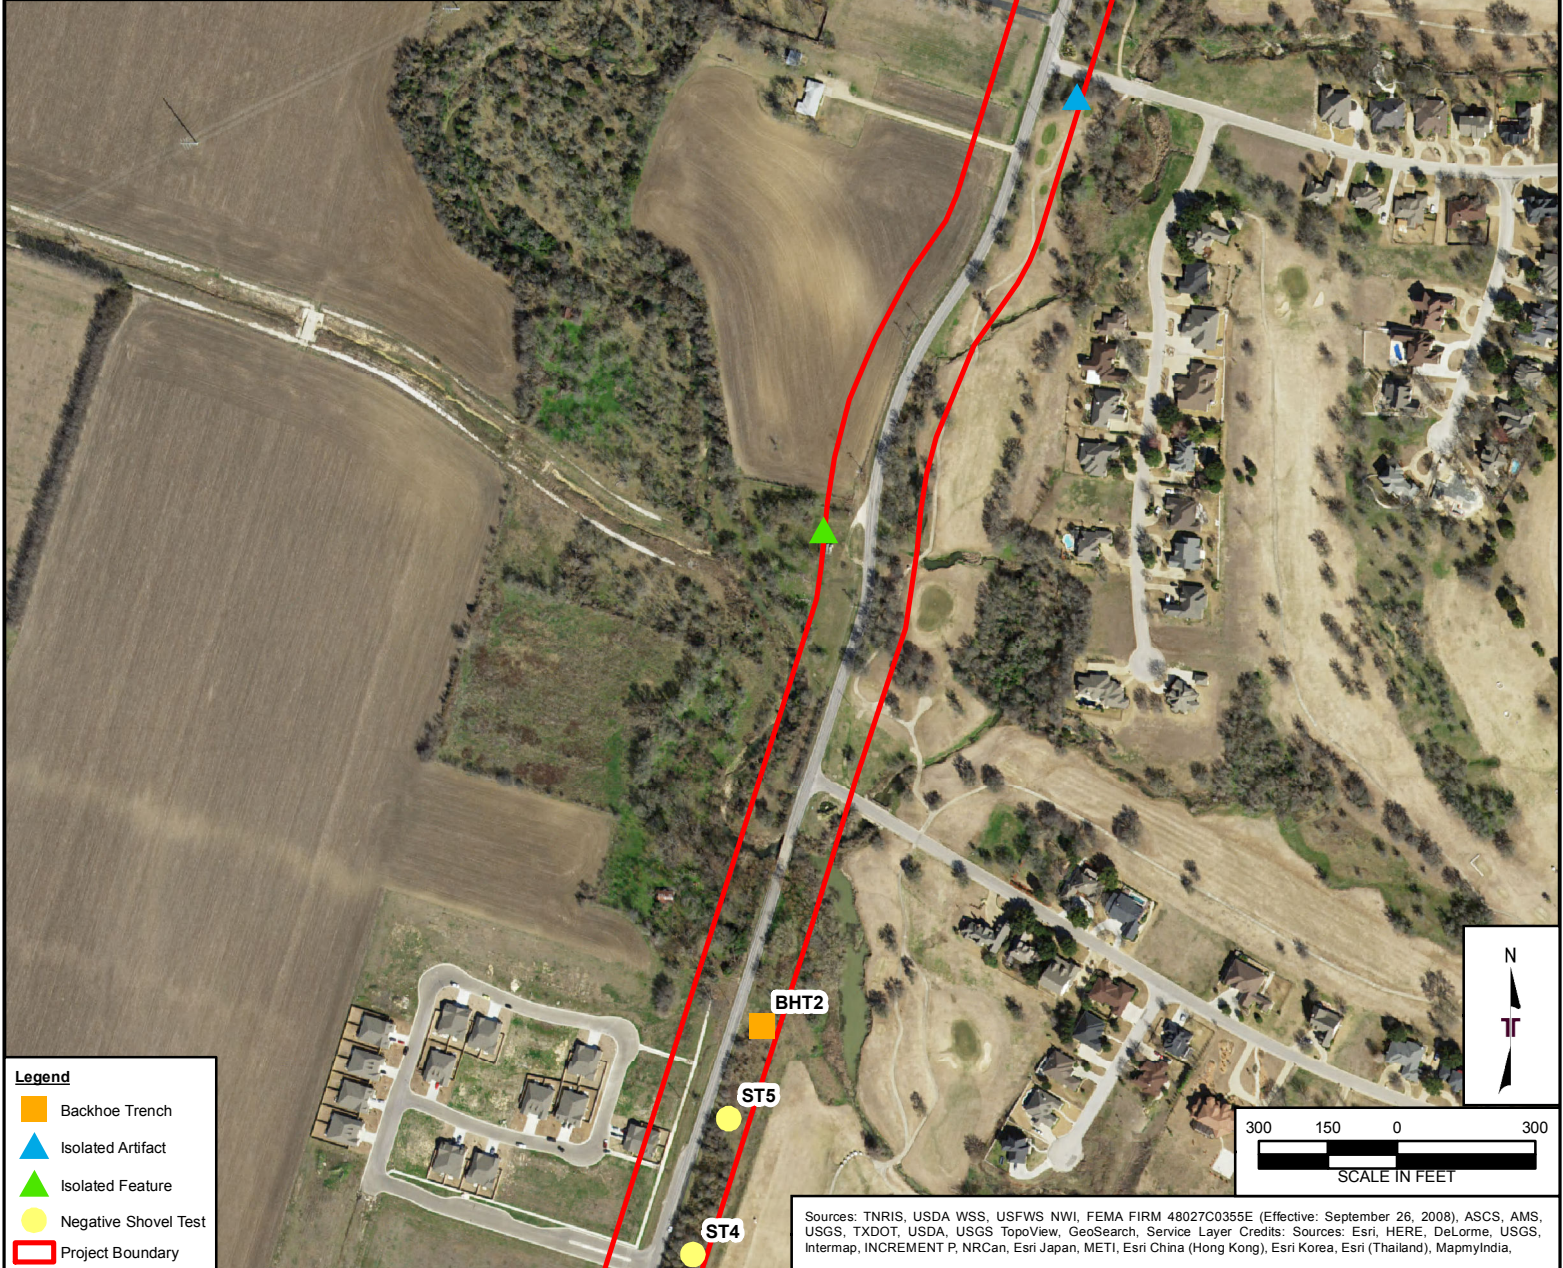
EXHIBIT  
**4a**

**Kegley Road-Phases II, III & IV**  
 Kegley Road from Charter Oak Drive to Adams Avenue  
 Temple, Bell County Texas

Two backhoe trenches were placed in the alignment (See Appendix A, Exhibit 4a and 4b). Samples of soil were screened for artifacts as presented in Methods section. Trenching did not reveal historic or prehistoric artifacts or features. David Yelacic, Project Geoarcheologist, summarizes the results of the trenching program below.

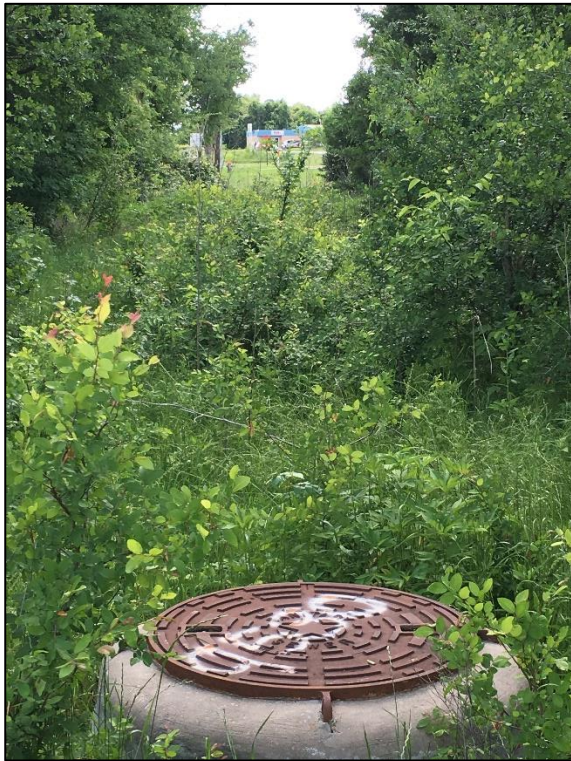
**Photo 1. Southern end of alignment. Note sewer line. Other utilities in background. View to the south.**

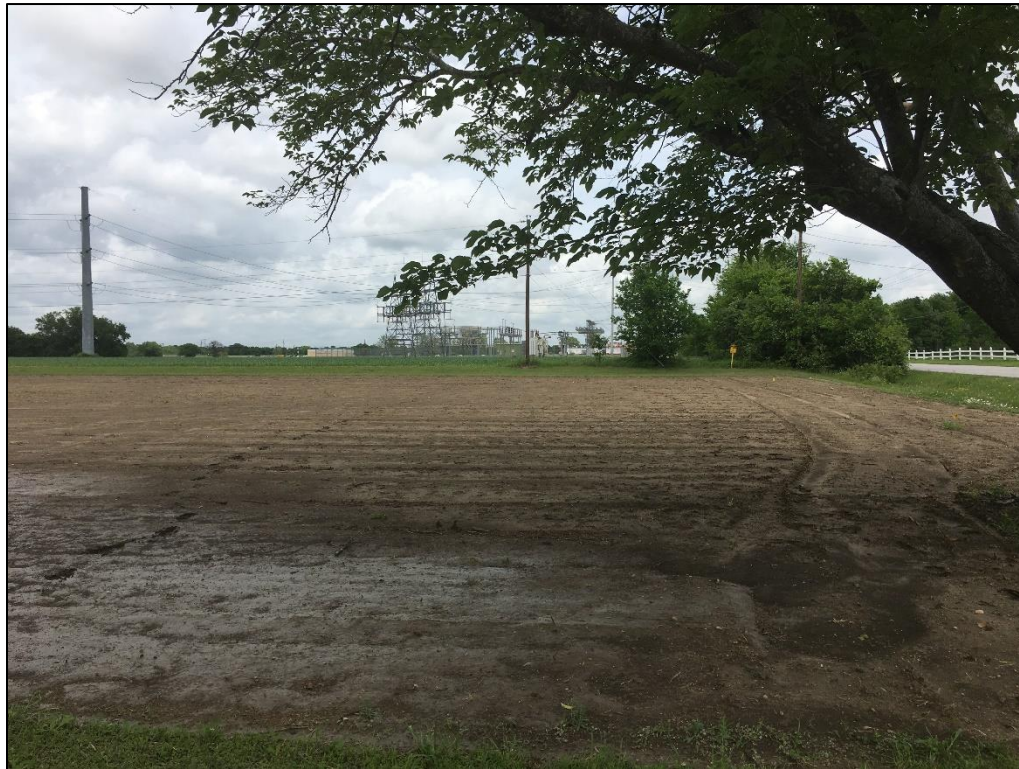
**Photo 2. Northern end of alignment. Note good ground visibility and utilities in background. View to the north.**

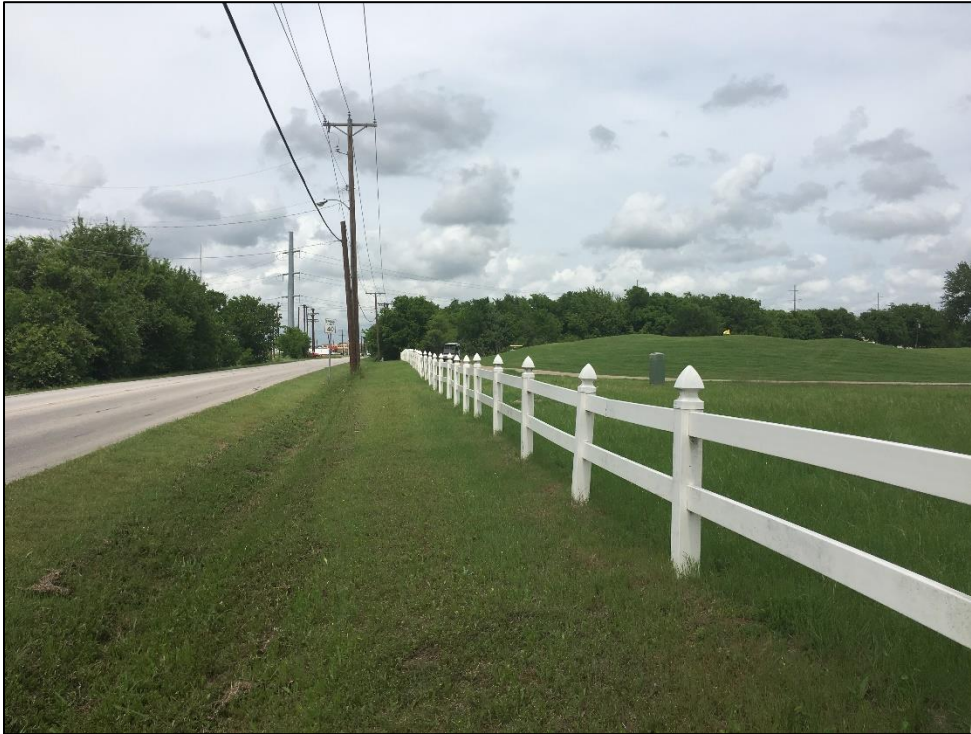
**Photo 3. Alignment near golf course. Note disturbances from utilities and ground modification from road and golf course. View to the north.**

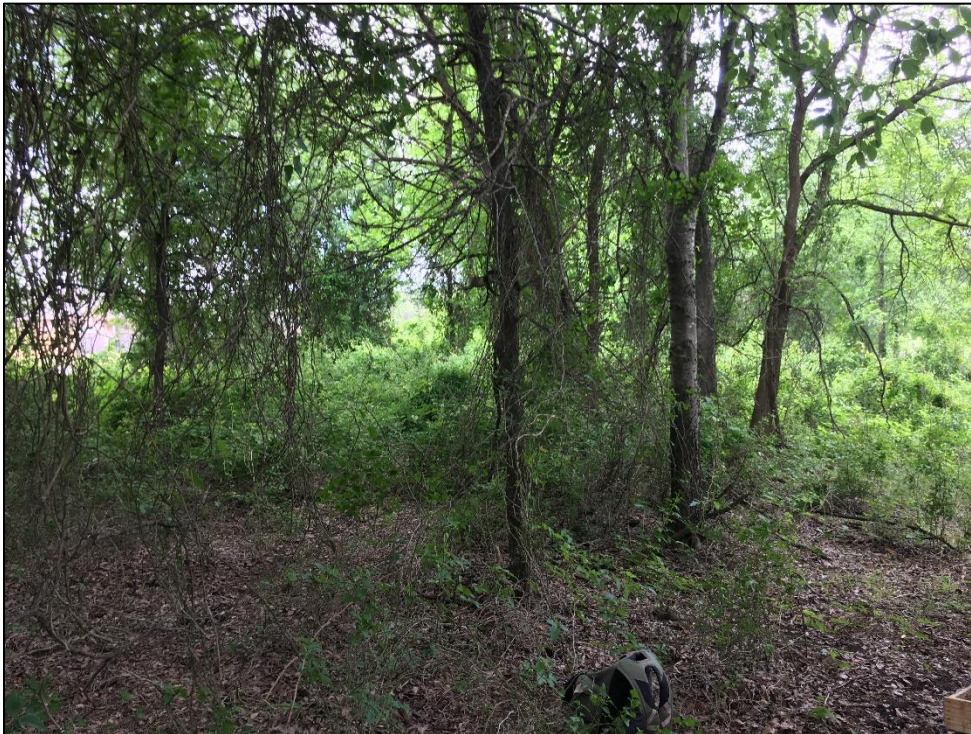
**Photo 4. Alignment near Shovel Test 4. Note poor ground surface visibility. View to the north.**

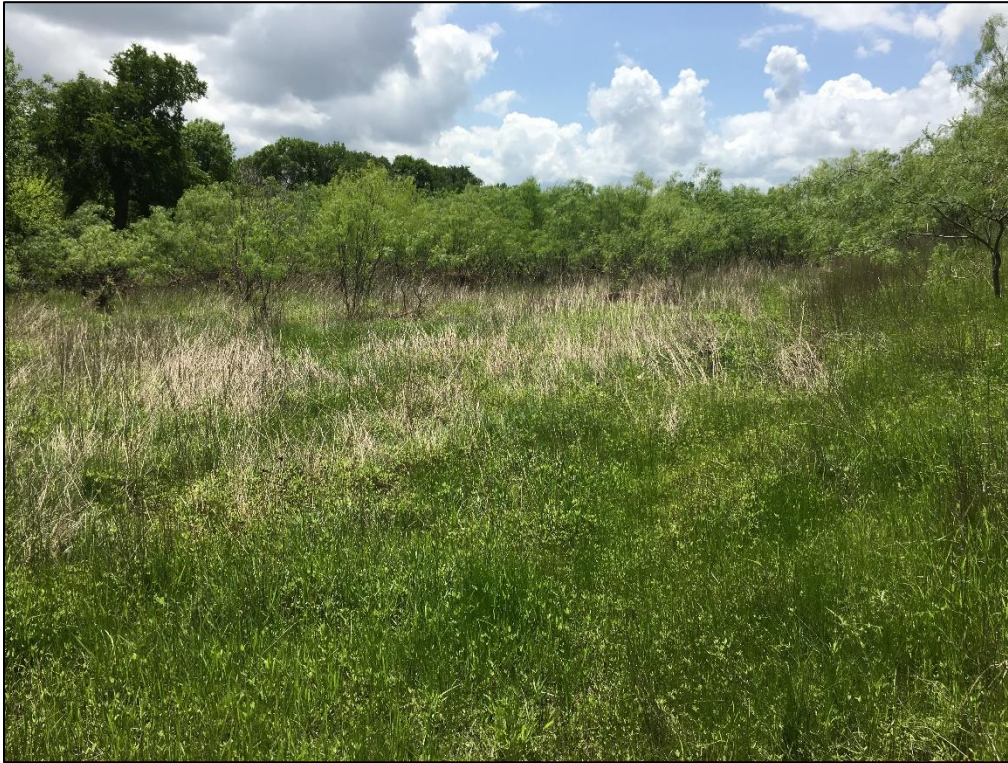
**Photo 5. Typical alignment with standing water near center of APE. Note wetland vegetation. View to the south.**

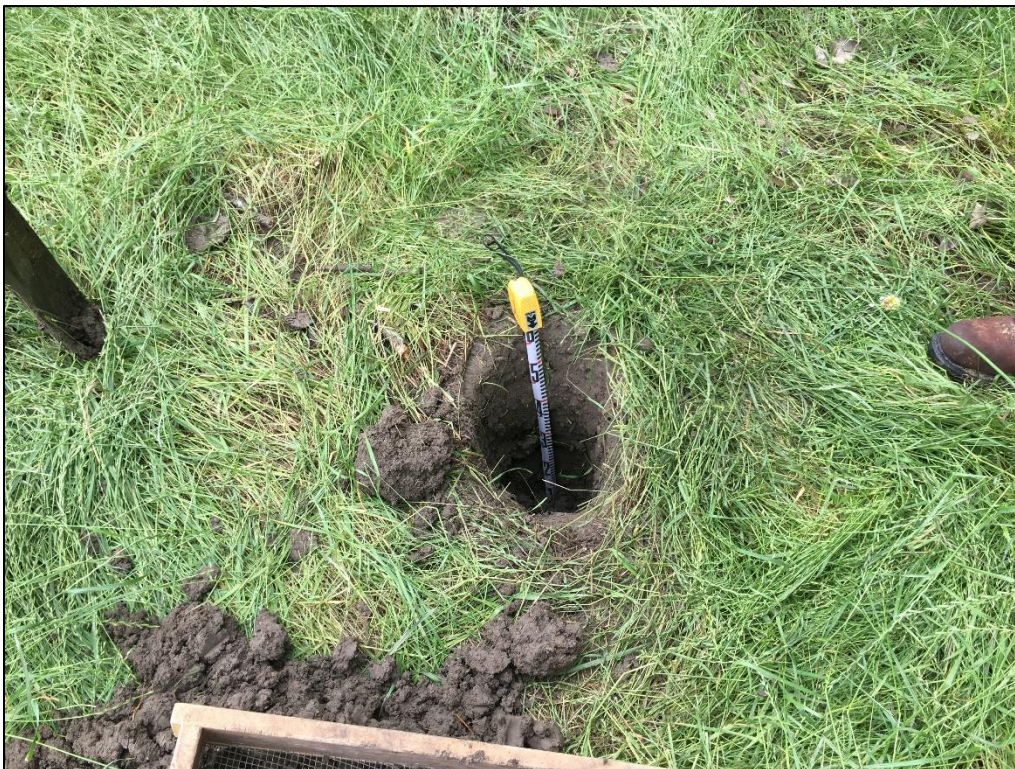
The soil in the shovel tests was predominately clay. Shovel tests were terminated at 50-60 centimeters below surface due to increasing amounts of calcium carbonates. No cultural material was observed during the excavation of the shovel tests. See Appendix C for details in the Shovel Tests Log.

**Photo 6. Shovel Test 2a.**

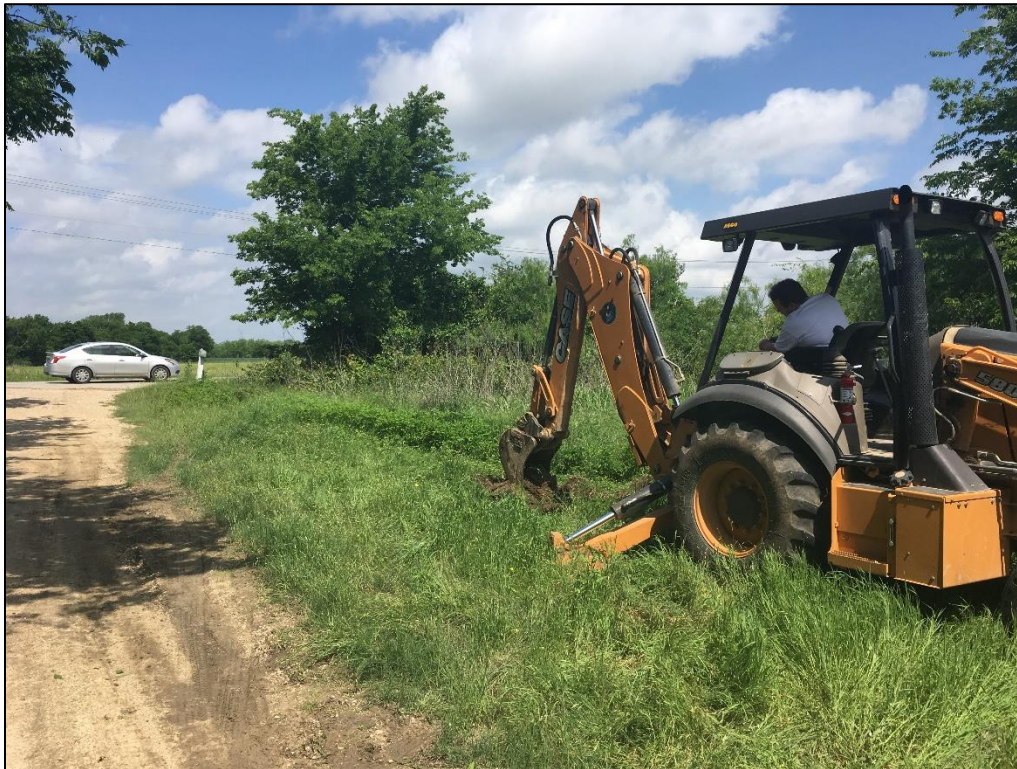
Backhoe Trench (BHT) 1 was located near the south end of Wildflower Country Club Golf Course just north of the club's maintenance road. The location was identified as having the potential for site burial because of proximity to Pepper Creek. BHT 1 was excavated approximately perpendicular to the creek and to Kegley Road, and the excavated pit measured approximately one meter wide, four meters long, and 1.5 meters deep. The profile exposure revealed what appeared to be a well-developed soil with an A horizon sitting atop a calcareous and clayey subsoil (Appendix B, Photo 10). No cultural materials were identified in the excavated sediment or in the profile exposure.

**Photo 7. Excavation of Backhoe Trench 1. View to the west.**

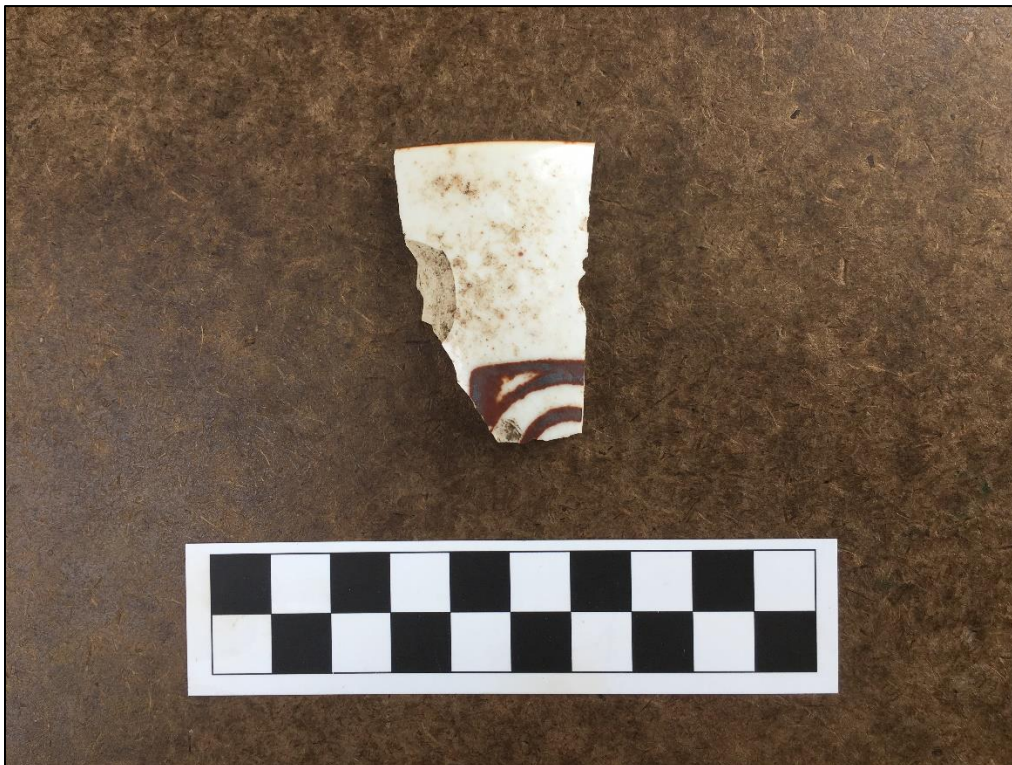
One isolated artifact, a historic whiteware ceramic sherd with brown decoration, was observed (Appendix B, Photo 8). No other artifacts or historic features were observed in the vicinity of this isolated find, and the artifact had likely been deposited in the area by sheetwash from recent rains. One isolated historic feature, a rectangular pit, was also observed (Appendix B, Photo 9). No historic artifacts or other features were observed near the pit. The feature could not be dated, but it appears to be pre-1960s in age. The pit is located near where site 41BL1066 is marked in the Atlas database, but is not part of the site, as site 41BL1066 did not contain a historic component. No prehistoric features or artifacts or features which might be associated with 41BL1066 were observed in the area.

**Photo 8. Isolated historic artifact. Ceramic whiteware sherd with brown decoration.**

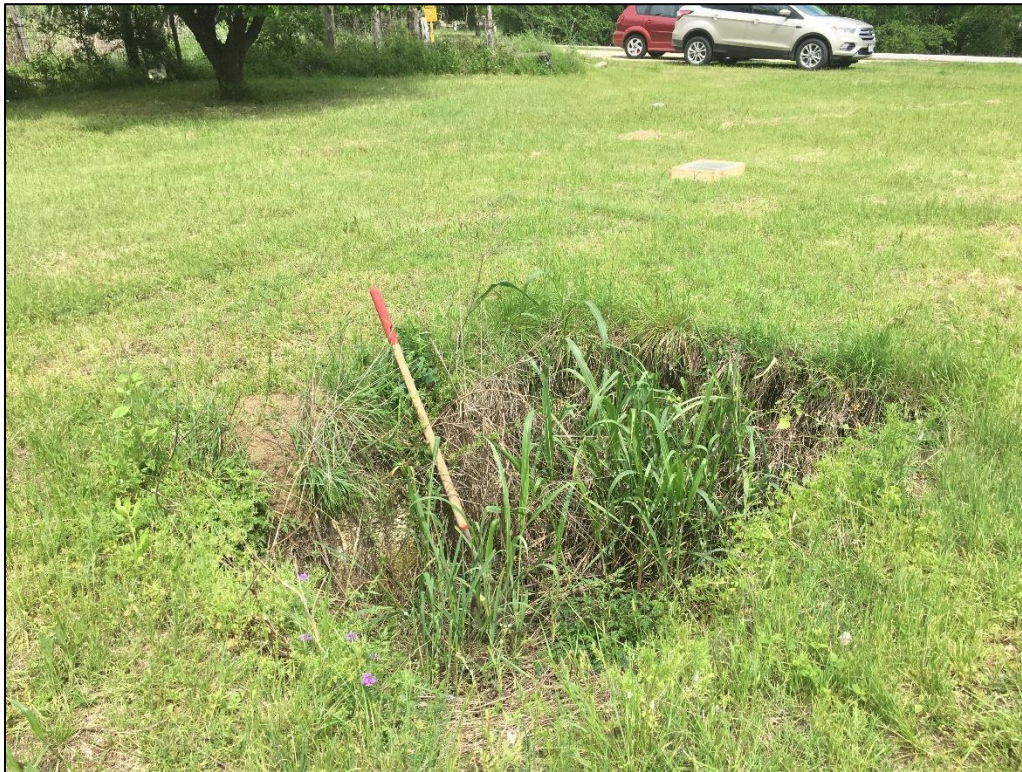
**Photo 9. Isolated historic feature. Rectangular pit.**

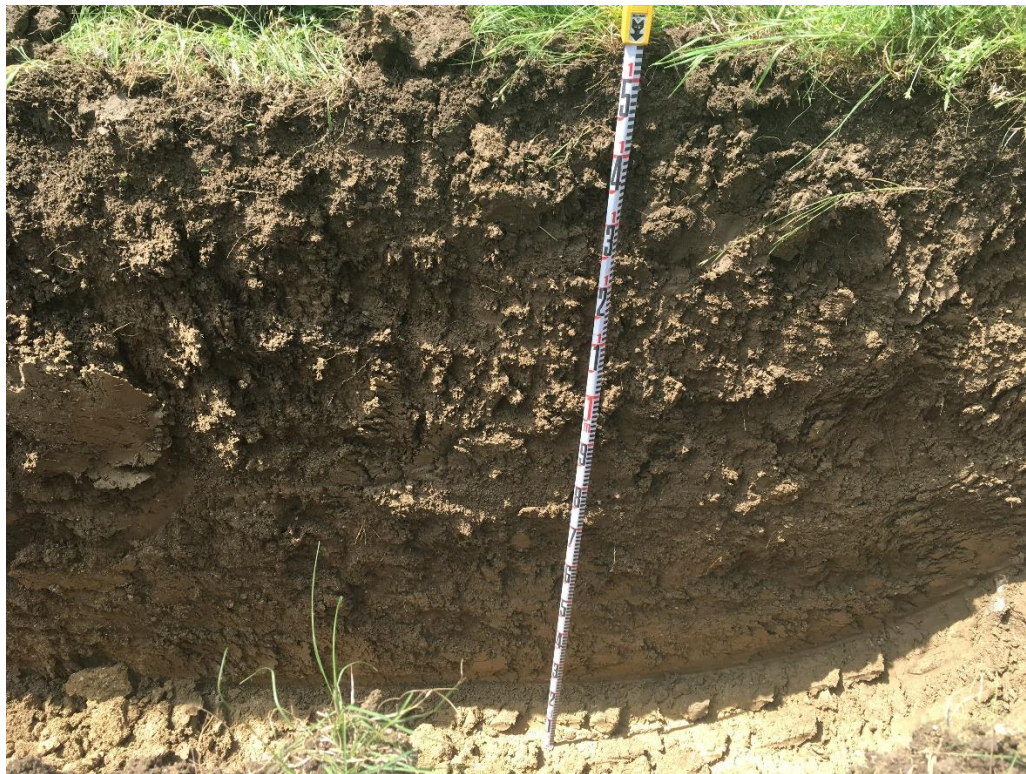
**Photo 10. Backhoe Trench 1, south wall profile.**

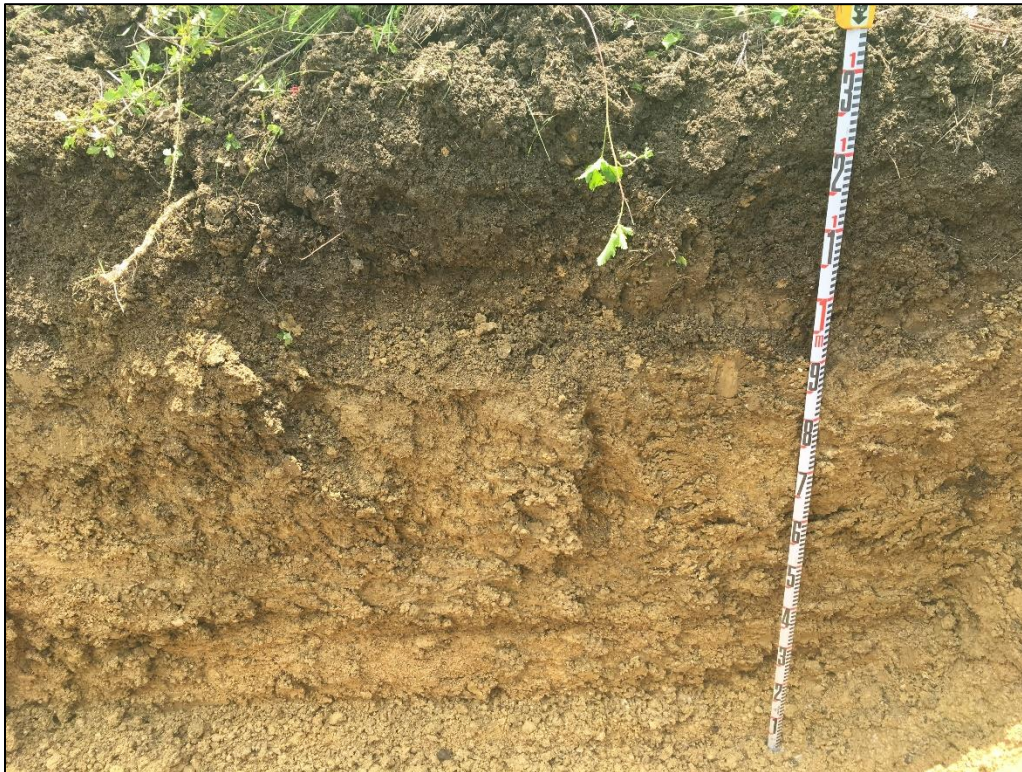
BHT 2 was excavated at the northern-most crossing of Pepper Creek into the top of a terrace situated more than 10 feet above the modern channel. The trench was oriented southwest-northeast, approximately perpendicular to the long axis of the channel, and the trench measured approximately one meter wide, four meters long, and 1.35 meters deep. The profile exposure of BHT 2 revealed a relatively thin soil atop gravelly clay parent material conveying water downslope (Appendix B, Photo 11). In other words, the trench was excavated below a water table, which was present in the gravelly subsoil. Trench excavation ceased at the water table, and so it was not clear if the sediment and water table was perched atop bedrock or another impenetrable material. Nonetheless, soil formation at the top of the profile indicated that the surface had been stable for relatively great period of time. No cultural materials were identified in the excavated sediment or in the profile exposure.

**Photo 11. Backhoe Trench 2, southeast wall profile.**
