## **An Intensive Cultural Resources Survey of the Portions of Enterprise Crude Pipeline LLC's Proposed Loving to Midland Pipeline ROW on Public Land in Midland and Martin Counties, Texas**

Texas Antiquities Committee Permit No. 8095  
HJN 170063 AR

Whitenton Group, Inc.  
San Marcos, Texas

Horizon Environmental Services, Inc.  
Austin, Texas

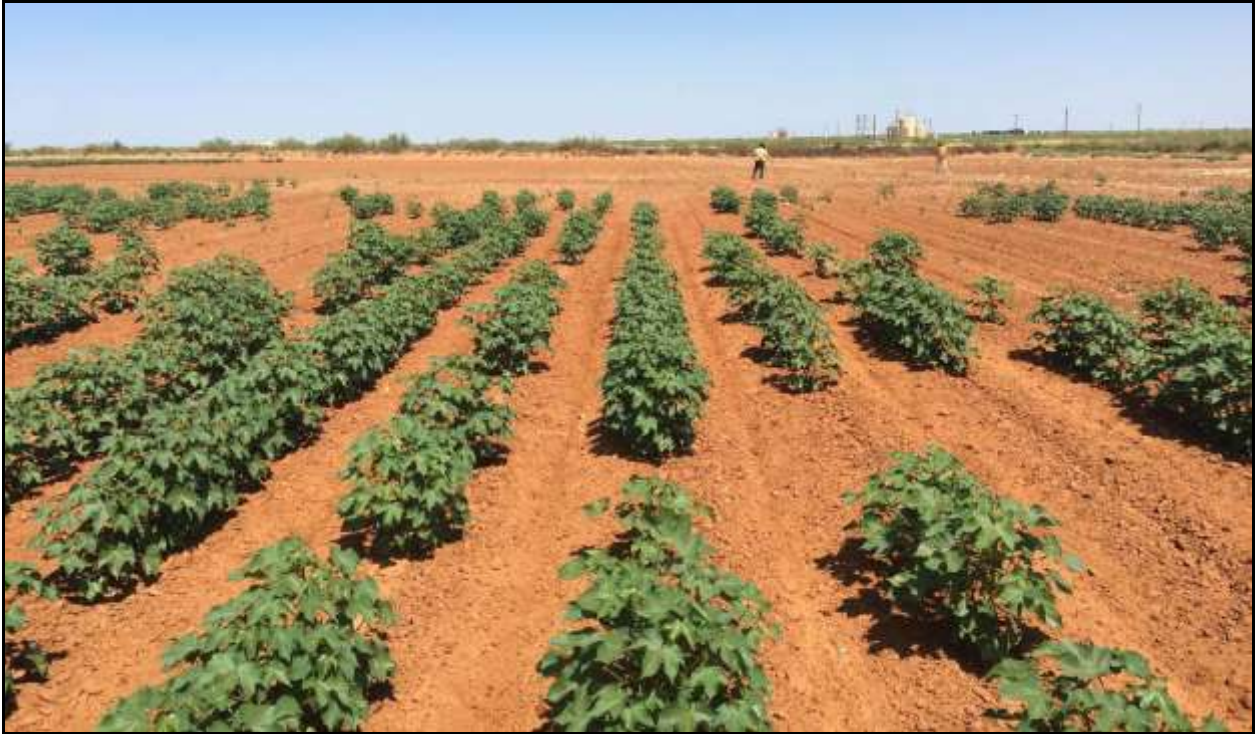
Upon returning to the described location during the current survey efforts along the rerouted alignment of the Project Area, the Horizon field crew also observed a sparse scattering of burned caliche specimens within an active cotton field to the west of the small playa basin noted by Hughes (1985; Figures 6-1 and 6-2). This scatter is located entirely to the west of an existing north-south lease road and artificial berm, while the proposed reroute of the Project Area is located entirely to the east of this existing lease road and artificial berm. As it is located within an active cotton field, the vegetation across the site currently consists of short cotton plants (Figures 6-3 and 6-4). The surface visibility across the site range from 75% to 100%.

**Figure 6-3. General view of site 41MT78, facing north**

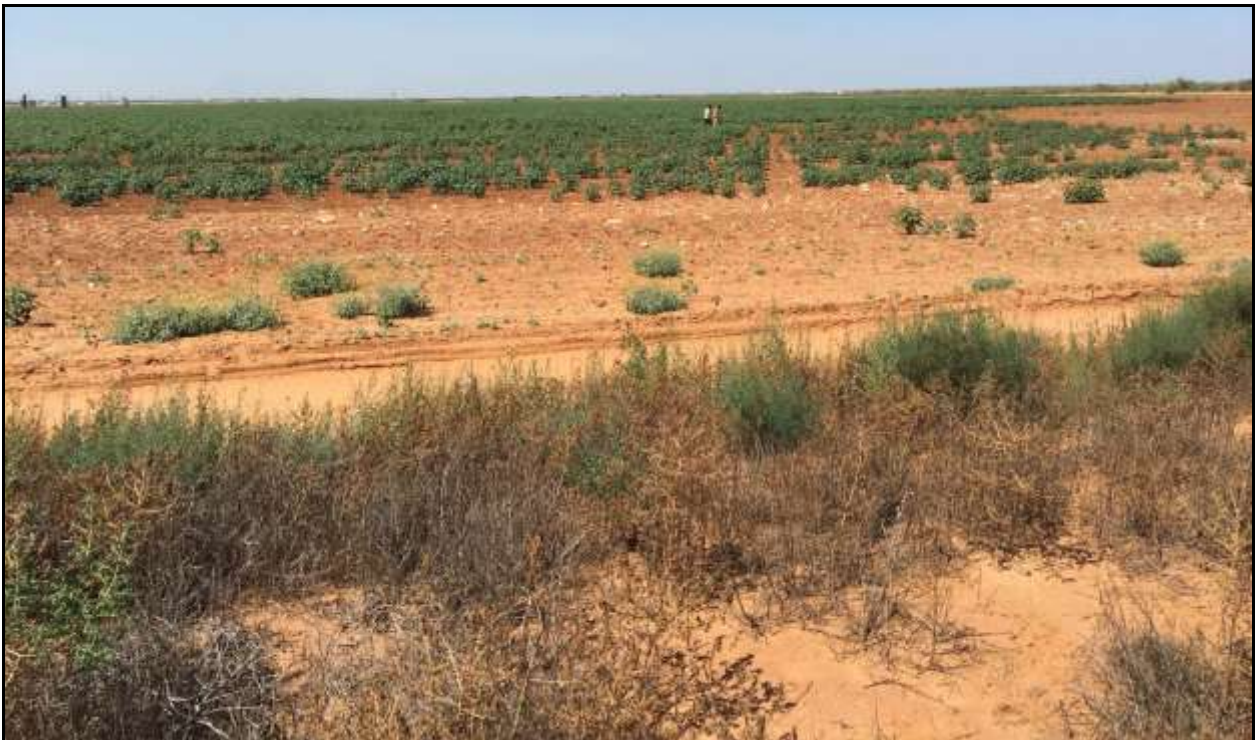
**Figure 6-4. General view of site 41MT78, facing west from Project Area**

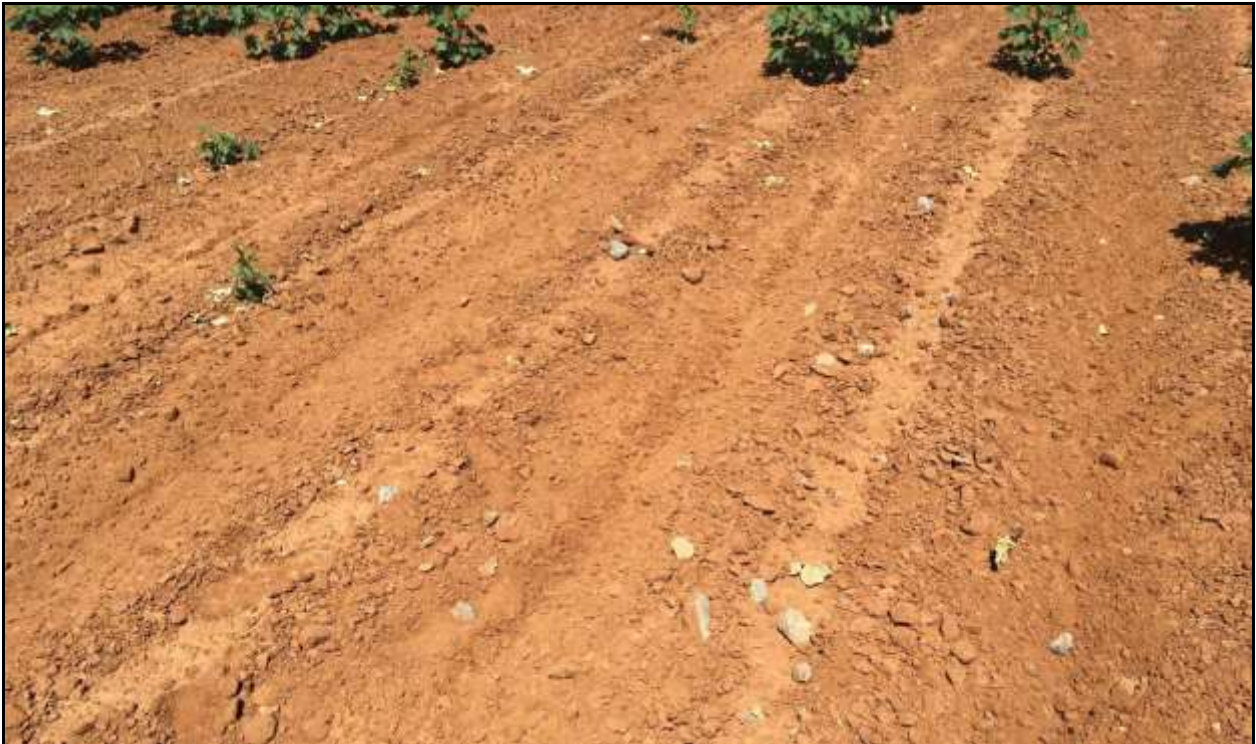
Observed cultural materials on site 41MT78 consist of a sparse scatter of burned caliche specimens within an active cotton field (Figure 6-5). Aside from burned caliche specimens, no other cultural materials of any sort (e.g. lithic tools, ceramics, bone, charcoal, etc.) were observed during the reevaluation of site 41MT78.

No evidence of any intact cultural features was observed on the modern, plowed ground surface of the site or within any of the 7 shovel tests excavated to the east of site 41MT78. However, the presence of scattered burned caliche at this location suggests that small hearths or other cooking features may have once been utilized on this site.

**Figure 6-5. View of burned caliche specimens on surface of site 41MT78**

Site 41MT78 is located just outside of the limits of the current Project Area to the west and will not be impacted by the current undertaking. Horizon only elected to formally document it due to its relative proximity to the Project Area as well as the fact that it was never formally documented when originally observed in 1985. As it is not located within the current Project Area, its assessed significance has no relevance in regard to the current undertaking. However, considering the lack of buried deposits, formal tools, temporally diagnostic material, and preserved floral and faunal remains, it is Horizon's opinion that site 41MT78 would not qualify for formal designation as a SAL if it ever needs to be considered in compliance with the ACT.
