Intensive Archeological Survey of Farm-to-Market 148 in Kaufman County, Texas

Intensive Archeological Survey of Farm-to-Market 148 in Kaufman County, Texas Dallas District

Kevin Hanselka, Principal Investigator
Texas Antiquities Permit No. 8246
CSJ: 0751-02-027
January 12, 2018

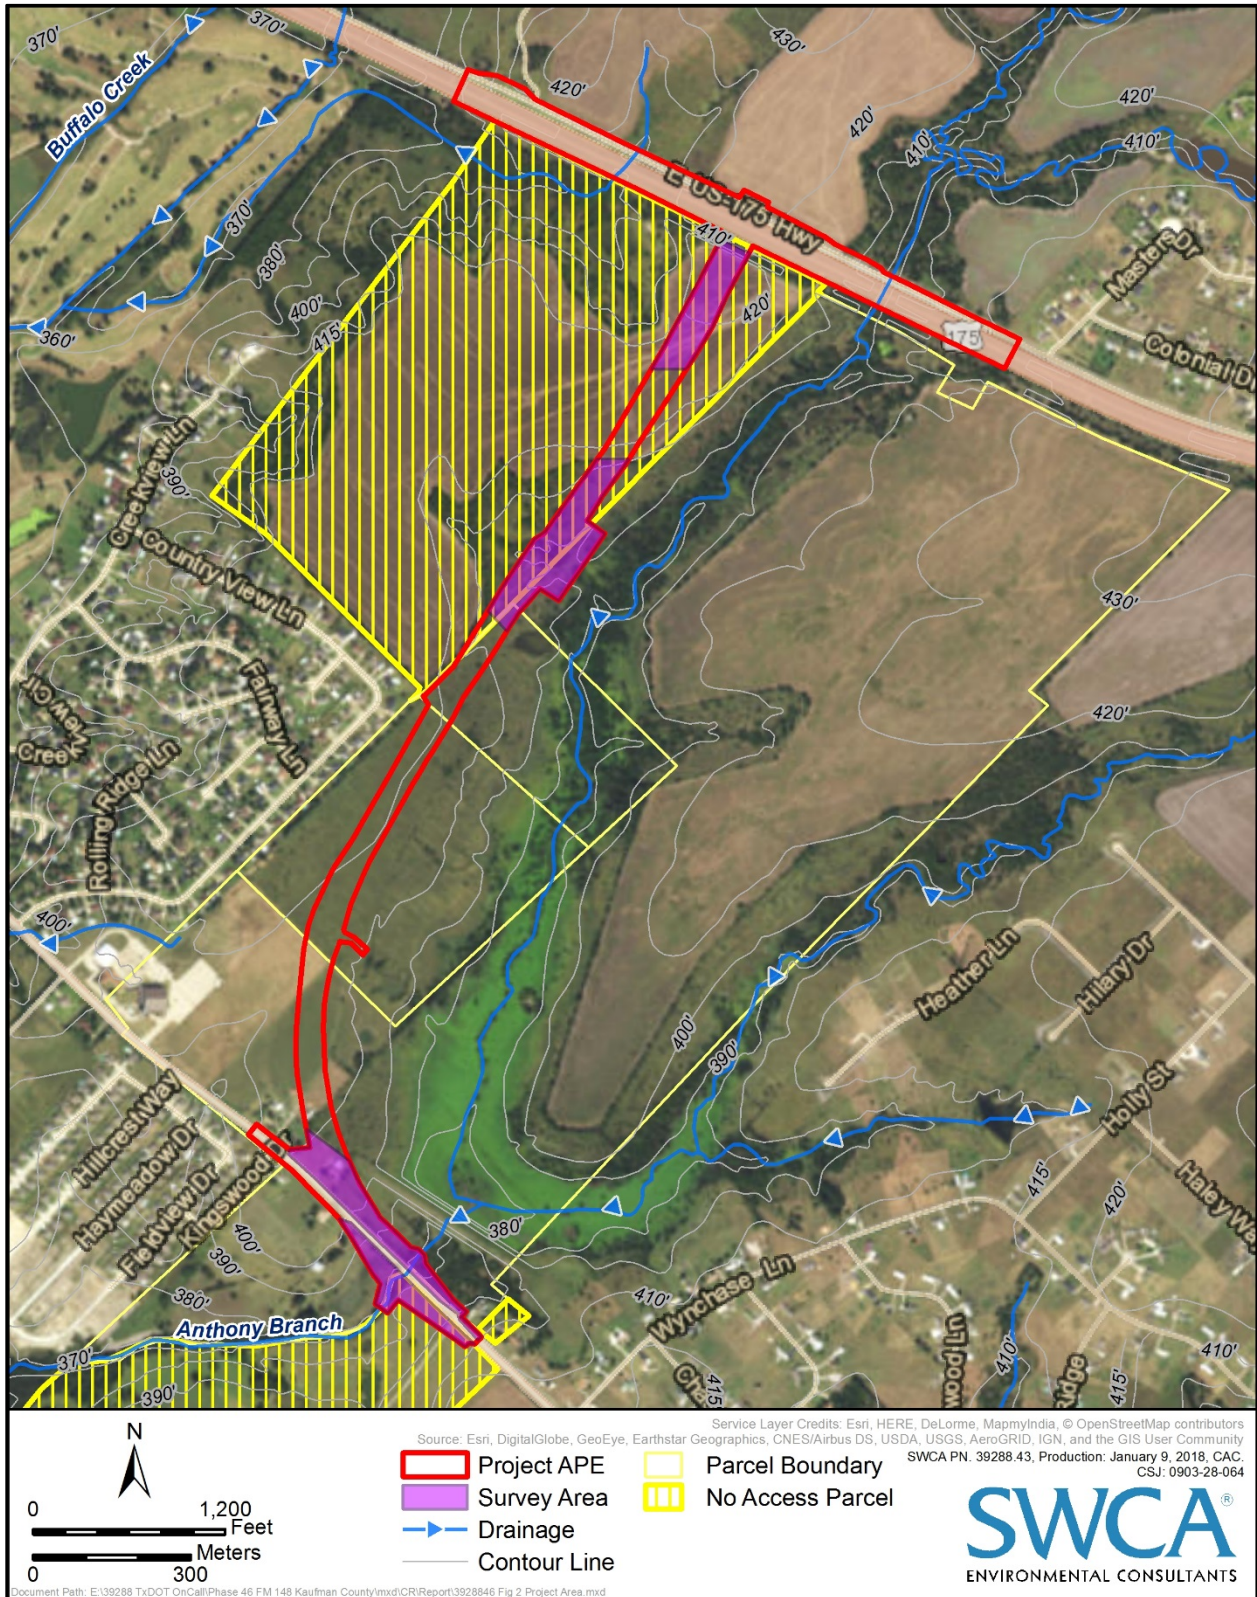
Figure 2. Project area.

Project Description and Impacts: The proposed project is located between the existing FM 148, near Anthony Branch and U.S. Route (US) 175 to the north, southeast of Crandall in Kaufman County, Texas (Figure 1). The project would construct a new FM 148 alignment that will primarily consist of two 12-foot-wide lanes with 8-foot-wide shoulders. Additional 12-foot-wide turning lanes will be needed at the intersection of the proposed FM 148 connector road that will connect the proposed FM 148 alignment with the existing FM 148 roadway. Approximately 3,850 feet of US 175 would be reconstructed to create an overpass crossing of the FM 148 Bypass. The proposed FM 148 alignment is approximately 1.6 miles long, extending from US 175 to existing FM 148 near its crossing of Anthony Branch.

Area of Potential Effects (APE): The total APE encompasses approximately 58.7 acres and is defined as the footprint of the proposed project to the maximum depth of impact, including all easements and project-specific locations (Figure 2). The APE comprises 23.5 acres of existing state ROW and 33.0 acres of proposed new ROW. Road ROW ranges in width from 155 to 324 feet, but typically falls between 160 to 220 feet in width. The remaining 2.2 acres pertain to proposed drainage easements that extend outside existing and proposed state ROW. The majority of vertical impacts within the APE will be restricted to the ground surface; however, the proposed designs call for grading, the installation of bridge support piers within the existing US 175 ROW, and the placement of box culverts that will have deeper subsurface disturbances. The deepest subsurface impacts will occur at the proposed culverted crossing of Anthony Branch and at the US 175 main lane bridge spanning the FM 148 Bypass.

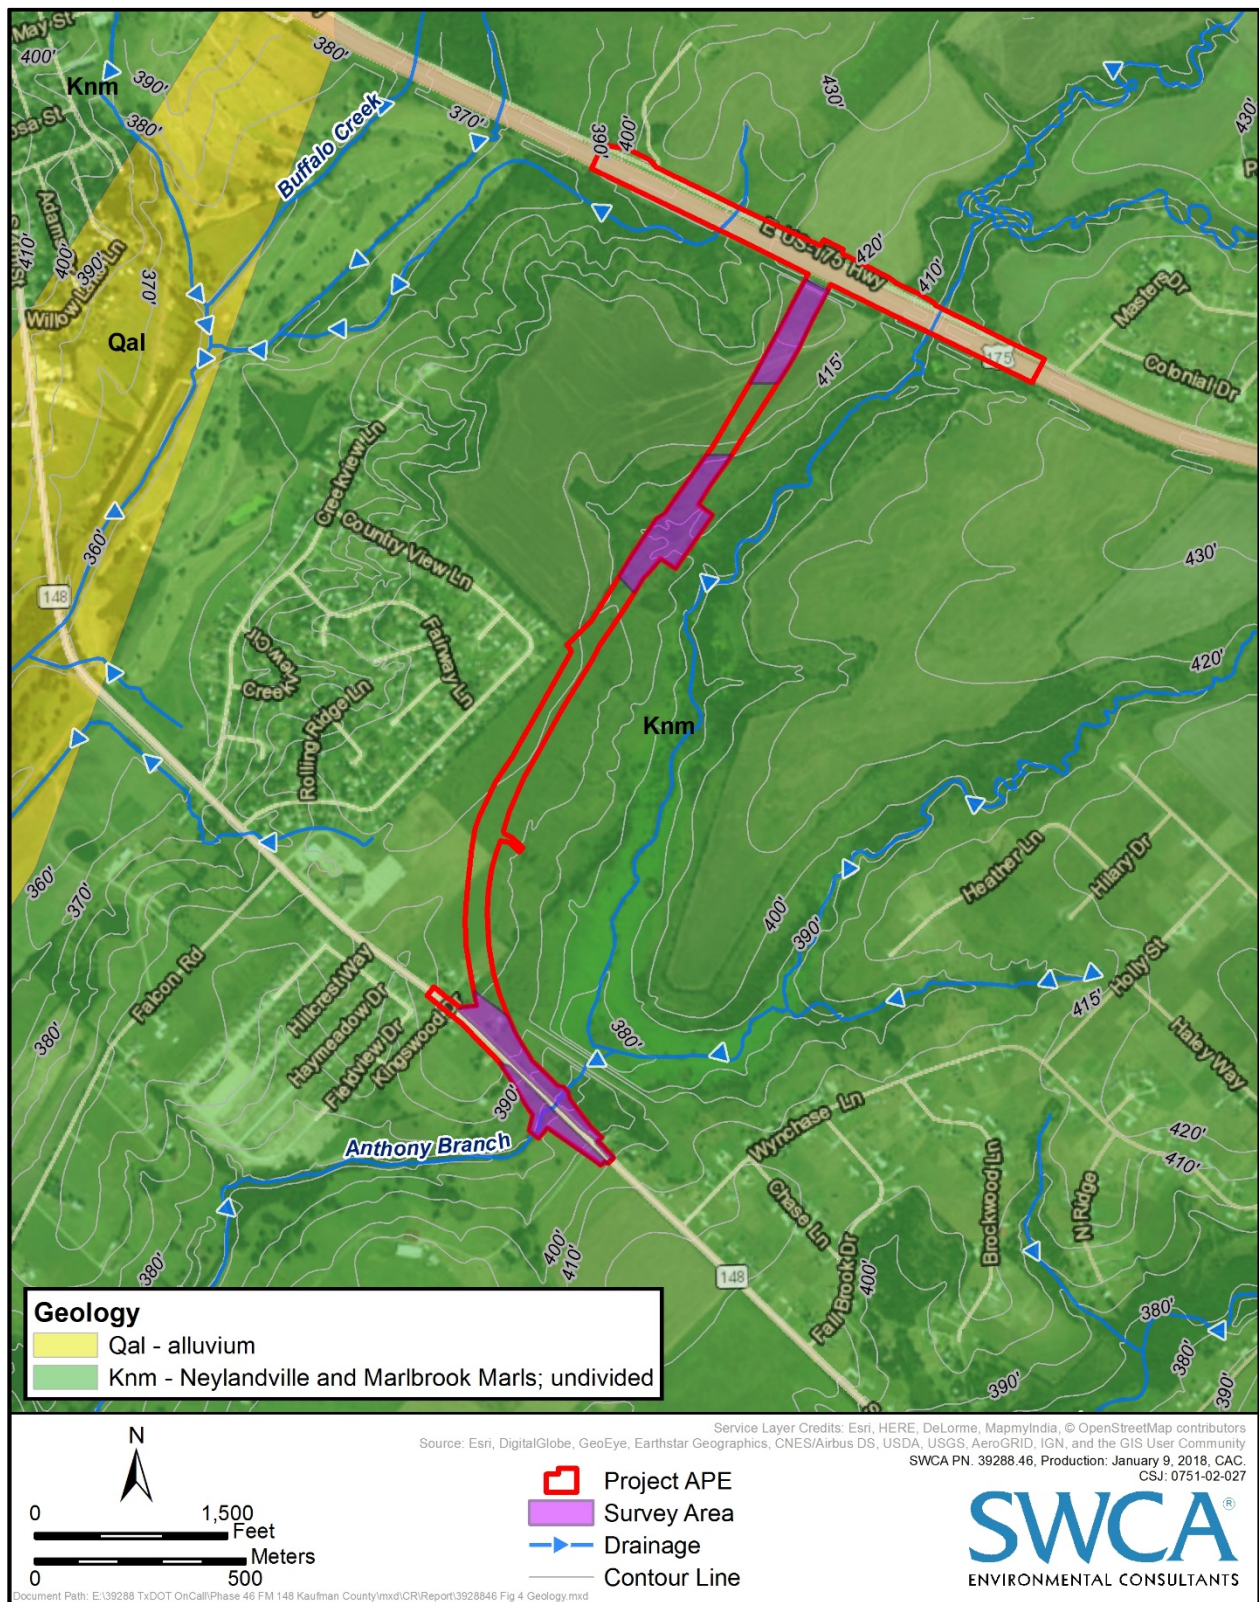
Figure 3. Project area geology.

Geology: According to the Geologic Atlas of Texas, Dallas sheet, the APE is underlain by Mesozoic-age Neylandville and Marlbrook Marl (Figure 3) (Barnes 1972). These predominantly clay deposits can reach thicknesses of 450 to 475 feet (Barnes 1972).

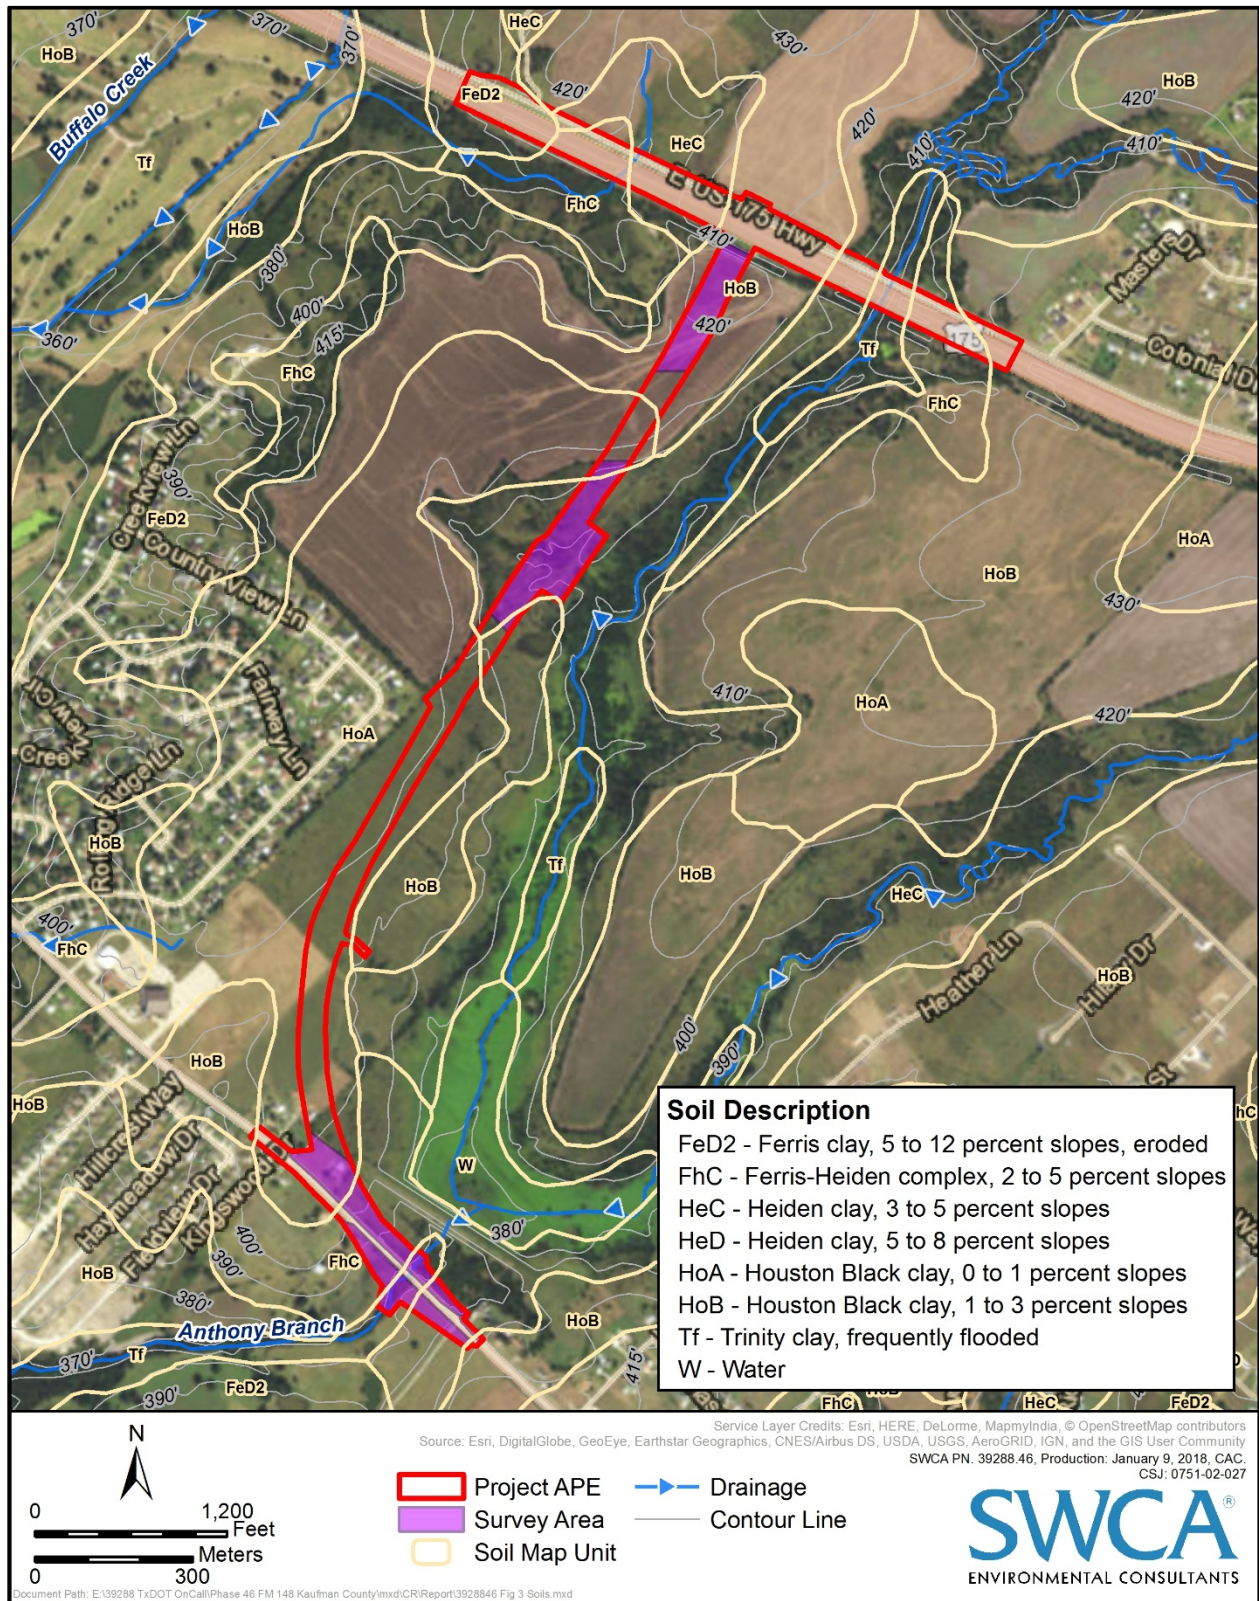
Figure 4. Project area soils.

Soils: According to the U.S. Department of Agriculture Natural Resources Conservation Service (NRCS) Web Soil Survey, the APE consists of a mosaic of five soil series (Figure 4). From south to north, the APE crosses the Ferris-Heiden complex, Trinity, Houston Black, Heiden, and Ferris series (NRCS 2018).

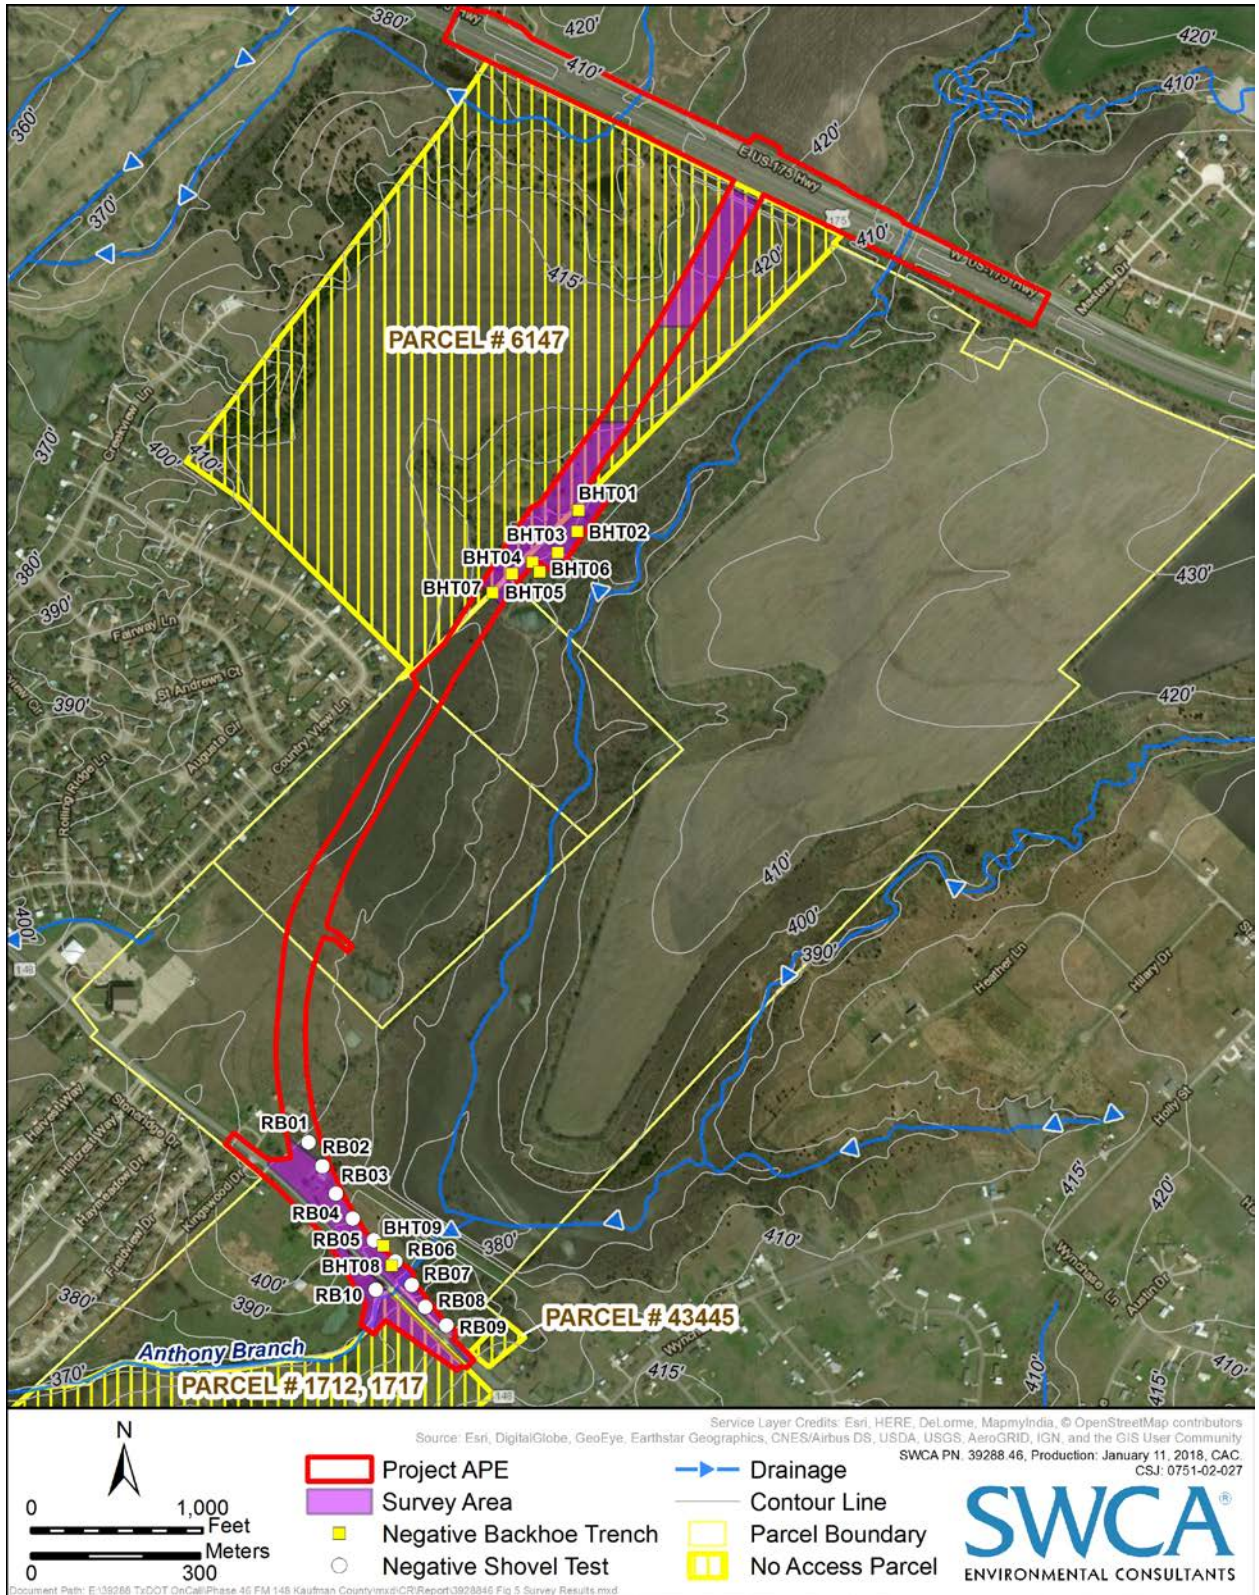
Figure 5. Survey Results Map

SWCA archeologists conducted backhoe trenching, pedestrian survey, and shovel testing within the APE for which right-of-entry had been granted (Figure 5; Table 2). A total of nine BHTs were excavated, and trenching efforts were centered within the floodplain of Anthony Branch, both at the southern terminus and approximately midway between the existing FM 148 and US 175 roadways. These areas were identified as areas with a moderate to high probability for containing both shallow and deeply buried archeological deposits requiring survey based on various background review factors. Shovel testing efforts focused at the southern terminus, along the existing FM 148 where the historic map review indicated a high potential for historic resources. A total of 10 STs were excavated within the designated area. The northern terminus, near the intersection with the US 175 roadway was also identified as having a high potential for historic resources, but access for this portion of the project had yet to be granted at the time of the survey. The remaining accessible APE is either situated within existing ROW that has been heavily impacted by previous construction, or has been identified as having a low potential for buried cultural resources.

Further Work: No further work is recommended within the surveyed portion of the APE. However, no access was granted for four parcels (see Figure 5), three of which (i.e., Parcels 1712, 1717, and 43445) are located along FM 148 at the southern end of the APE. The three parcels cover very minor portions of the APE. Based on assessments from adjacent accessible areas, no further work is recommended on these three southern inaccessible parcels.

The fourth inaccessible tract (Parcel 6147), located at the northern end of the APE along US 175, encompasses two areas (i.e., central and northern survey areas) within the APE scheduled for survey. Backhoe trenching in accessible areas within the central survey area yielded a low potential for archeological deposits, and based on these findings, no further work is recommended in the inaccessible portions of the central survey area. However, once access is granted, an intensive archeological survey is recommended on the northern survey area to address the potential for historic resources. In summary, SWCA recommends survey

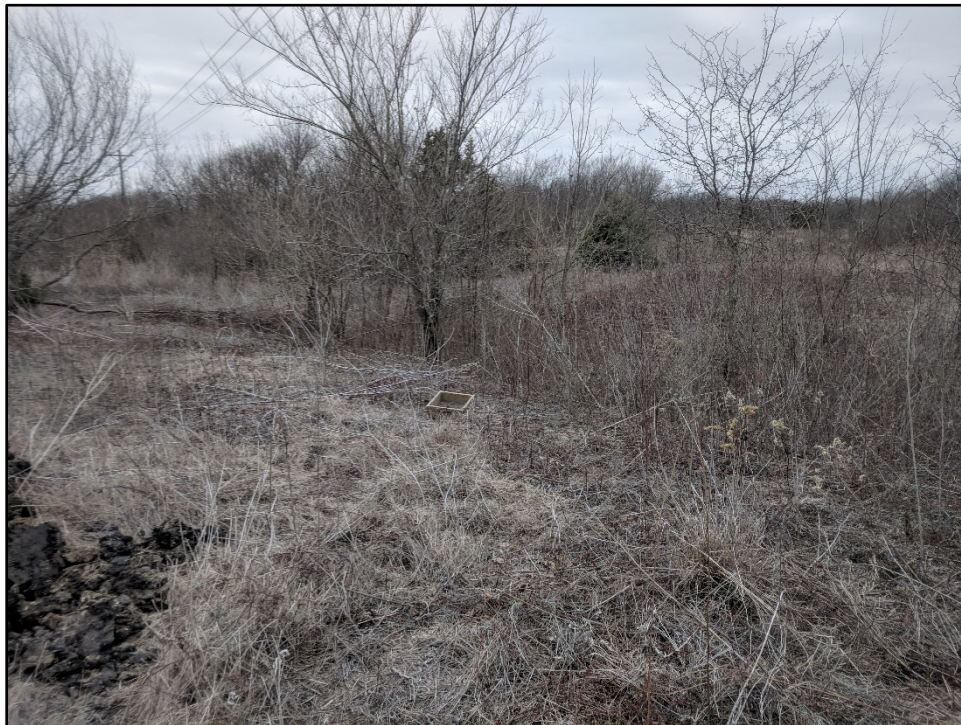
SWCA excavated seven BHTs within the Anthony Branch floodplain approximately midway between the existing FM 148 and US 175 roadways (Figure 6). All seven BHTs have a similar profile with a black (10YR 2/1) clay to clay loam overlying a gray (10YR 5/1) clay to clay loam, and a bottom level of a light brownish gray (10YR 6/2) clay to clay loam. None of the seven trenches displayed any evidence of artificial soil disturbance; however, SWCA field archeologists recorded evidence of natural soil movement in nearly all of the seven BHTs.

Profiles contained vertical cracks with upper level soil infill. These cracks could be seen as deep as 5.6 feet (170 cm) in BHT 6. Calcium carbonate nodule inclusions generally occur around 2.6 feet (80 cm), increasing in frequency with depth.

Figure 6. Overview near the center of the APE (BHT 1), facing south.

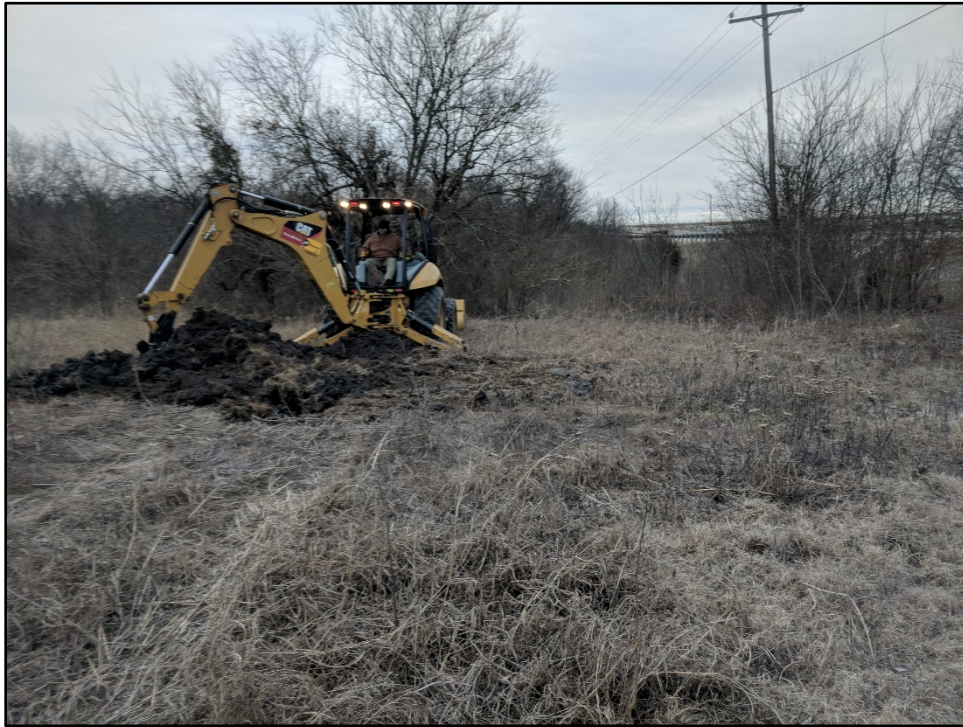
SWCA also excavated two BHTs (8 and 9) near the southern terminus of the APE, within the Anthony Branch floodplain (Figure 7). Backhoe trenching locations were selected in areas with the least amount of visible indications of disturbance and care was taken to avoid buried utilities (Figure 8). Both BHTs 8 and 9 have a similar profile with gray (10YR 5/1) clay to clay loam overlying light brownish gray (10YR 6/2) clay to clay loam. BHT 8 contained modern buried trash, including barbed wire and metal wire fragments as deep as 3.6 feet (110 cm). This disturbance is due to the previous road construction, as well as buried and overhead utilities. Calcium carbonate nodules generally occur around 2.6 feet (80 cm) and increase in frequency with depth.

Figure 7. Overview of BHT 8 being excavated along the existing FM 148 ROW, facing southeast.

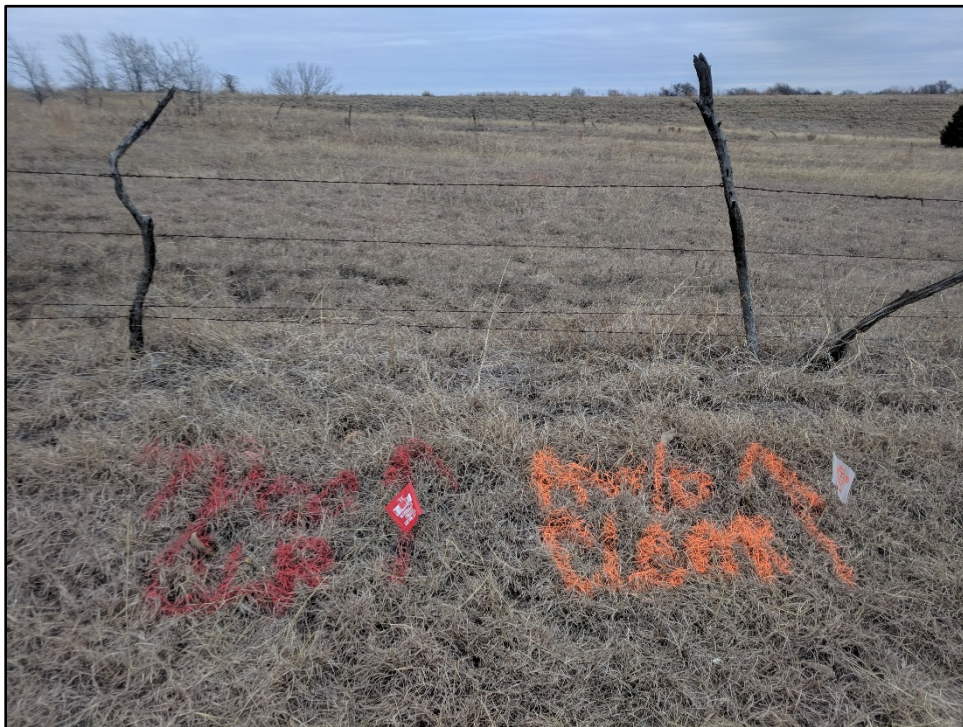
Figure 8. Example of buried utilities along the existing FM 148 ROW, facing north.

APE Integrity: The proposed APE within and adjacent to the existing FM 148 and US 175 ROWs exhibits evidence of prior disturbance, due to road and bridge construction and the installation of buried and overhead utilities, thereby compromising the integrity of the survey areas near the existing roadways. SWCA did not identify evidence of prior artificial disturbance within the backhoe-trenched portion of the APE approximately midway between the existing FM 148 and US 175 roadways.
