**Intensive Cultural Resources
Survey of Proposed
Improvements to Farm-to-Market
Road 16 from 4.0 Miles West of
Farm-to-Market Road 849, East
to United States Highway 69,
Smith County, Texas**

CSJ: 0522-04-032

Texas Antiquities Permit No. 7926
SWCA Cultural Resources Report No. 17-116

December 2017

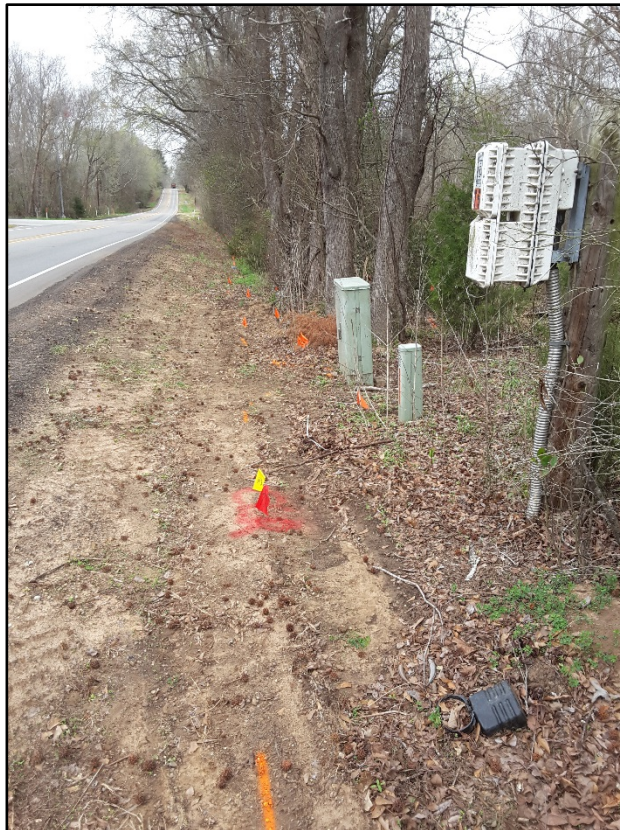
Figure 9. Numerous buried and marked utilities on edge of existing TxDOT ROW, facing northwest.

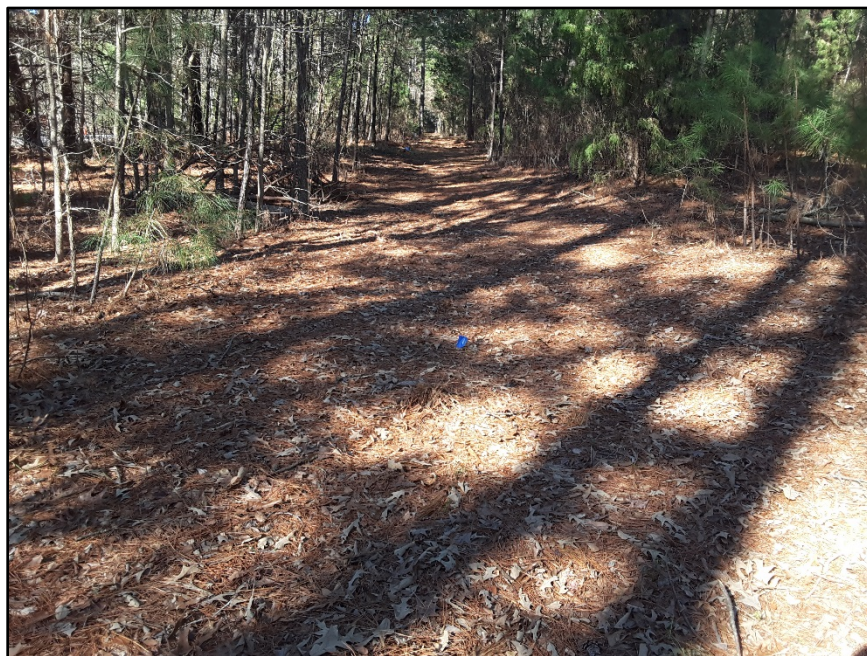
Figure 10. Parcel 11 with young and old pine wood and cleared water pipeline easement (blue flags). Note FM 16 in left background, facing northwest.

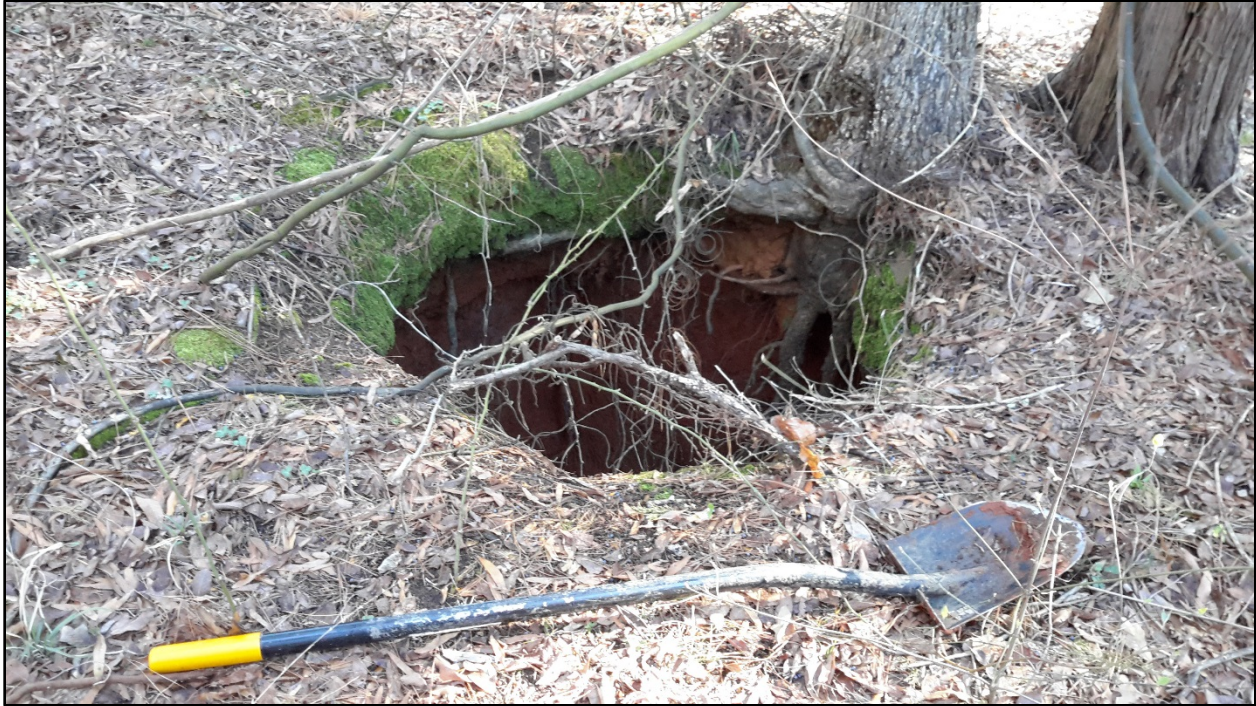
Figure 11. Sinkhole or eroded well located just outside the proposed ROW on parcel 12, facing northeast.

The general setting of the proposed road expansion and associated infrastructure varies between eroding sandy uplands to the west, an inundated valley in the middle, and a deep sandy upland to the east. The western portion of the project area is characterized by upland ridges populated by mixed piney woods or medium grass pastures in residential or agricultural use. The soils are a mix of pre-Holocene bed clays at surface to a thin loamy sand above the pre-Holocene clays or sandstone bedrock at approximately 30–60 cmbs. The western portion, like the entire project, contained numerous buried fiber optic and water utilities within the existing FM 16 ROW, as well as the proposed ROW (Figure 9). Starting on the western terminus, the buried water line and cleared corridor paralleled the road on the north side (Figure 10), with numerous perpendicular branches to supply residential structures on both sides of the road, until parcel 20 when it traveled under the road and continued paralleling FM 16 along the south side for the remainder of the project area. Additionally, on the west side, SWCA identified a sink hole or eroded well on parcel 12, just north of the proposed ROW (Figure 11).

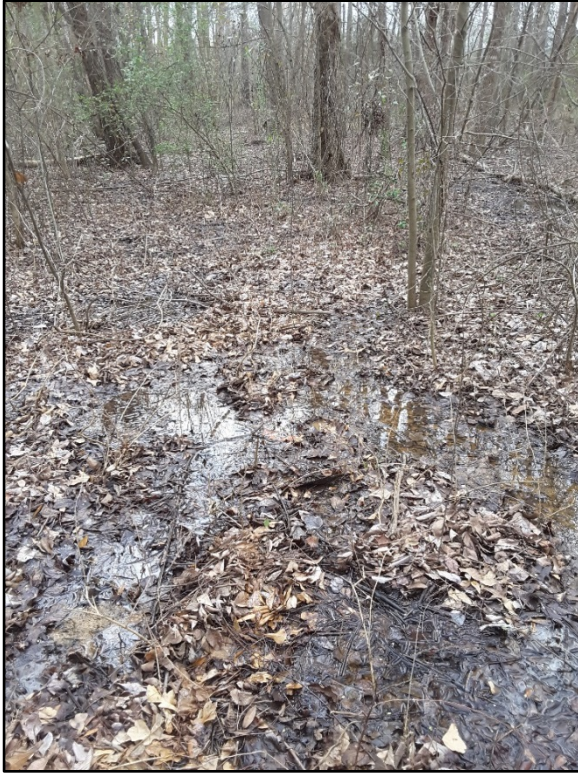
Figure 12. Saturated ground within wooded floodplain on parcel 26, facing east.

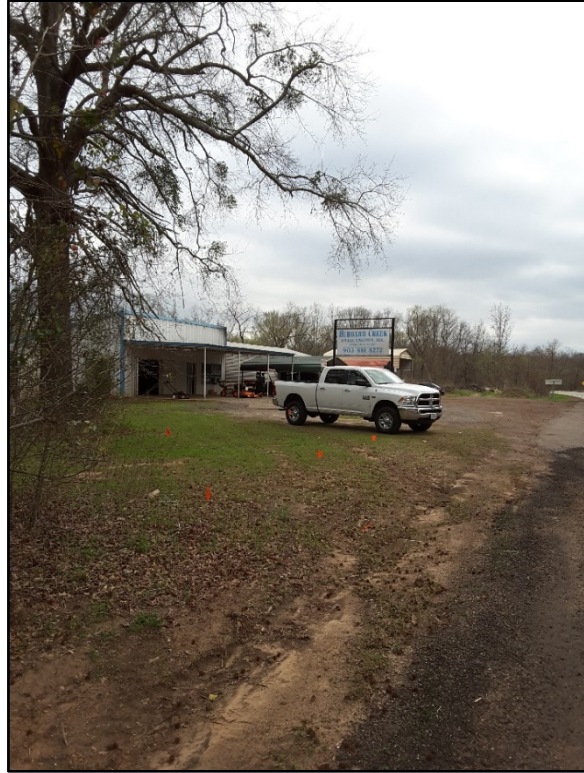
Figure 13. Mechanics shop on parcel 50, north side of FM 16 with flagged buried fiber optic cables, facing east.

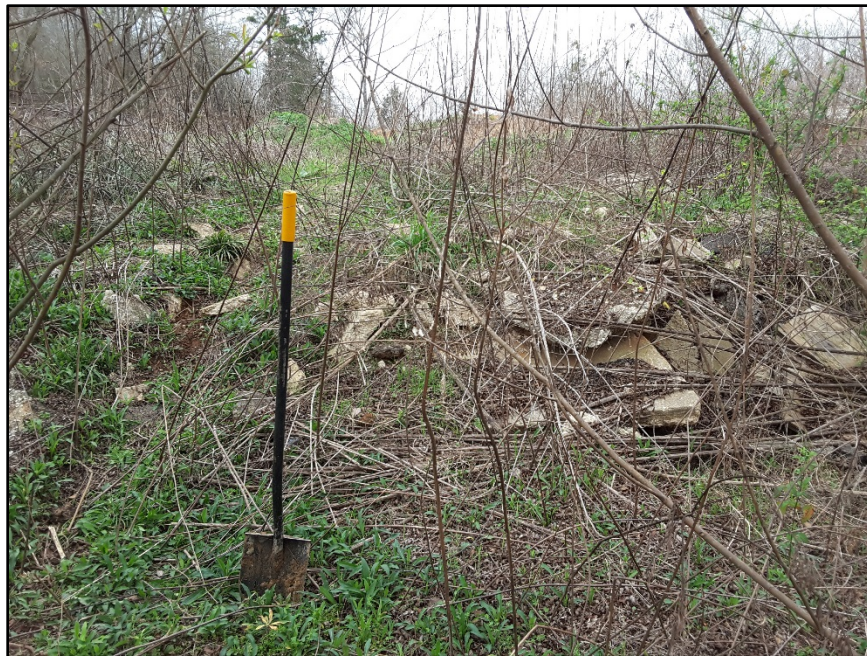
Figure 14. Large concrete boulders and asphalt push piles on southeastern edge of modified terrace of the mechanic's shop on parcel 50, facing west. Note the uneven terrace step (and riser) in the background depicting piles of added fill being pushed down the slope.

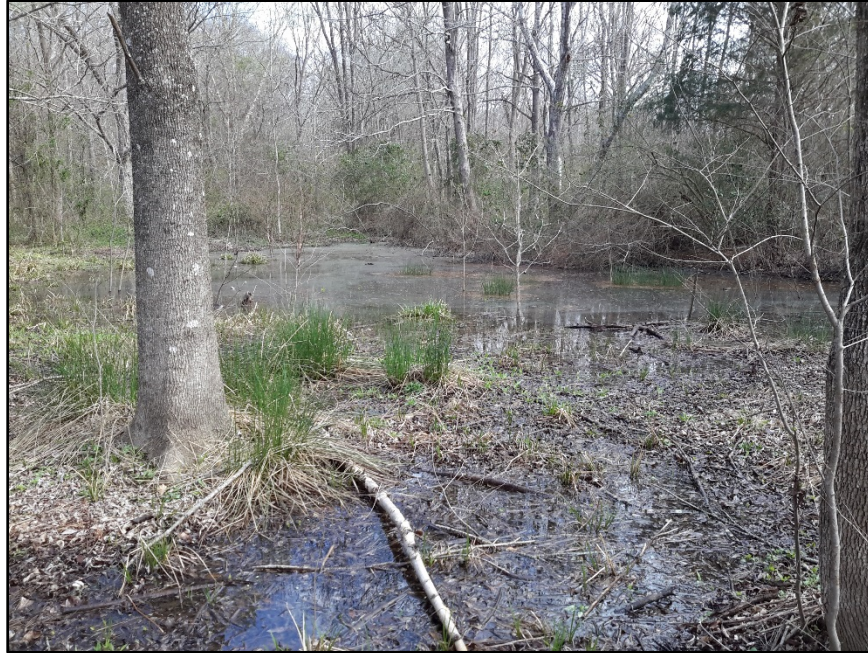
Figure 15. Standing water in forested wetland on parcel 50. In the right background of the frame is the start of the terrace near bridge over Hubbard Creek, facing southeast.

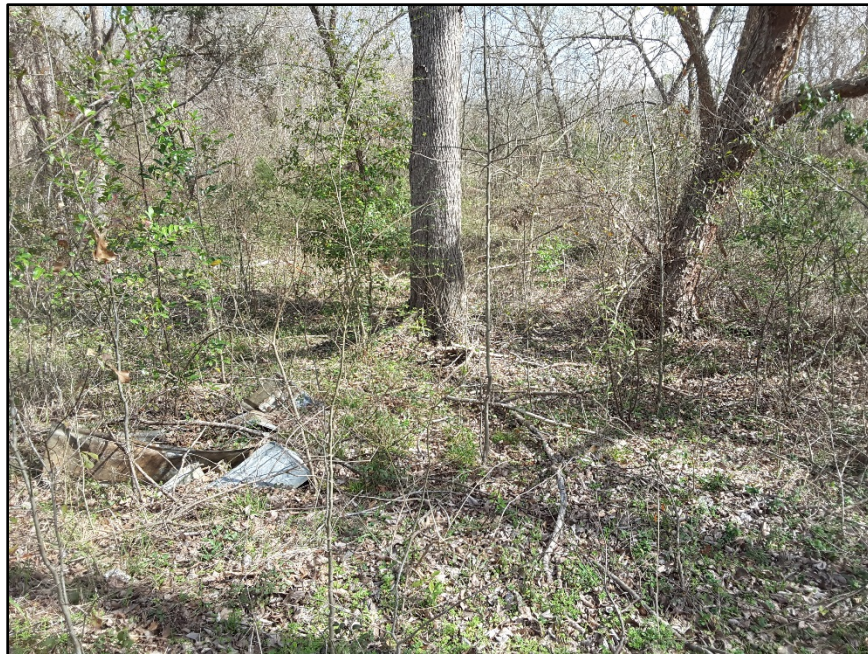
Figure 16. Terrace on parcel 50 and west bank of Hubbard Creek, facing north.

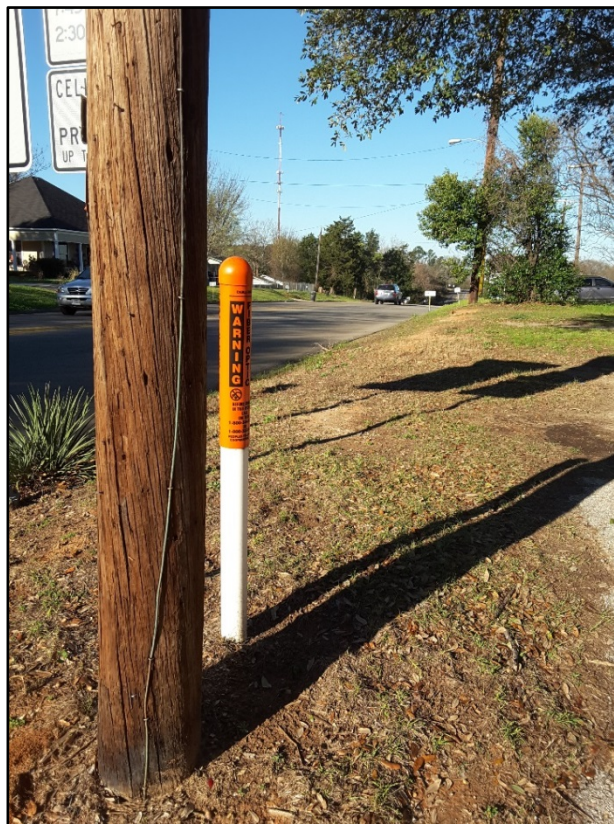
Figure 17. Raised telephone lines and buried fiber optic lines within the existing FM 16 ROW near Lindale, facing west.

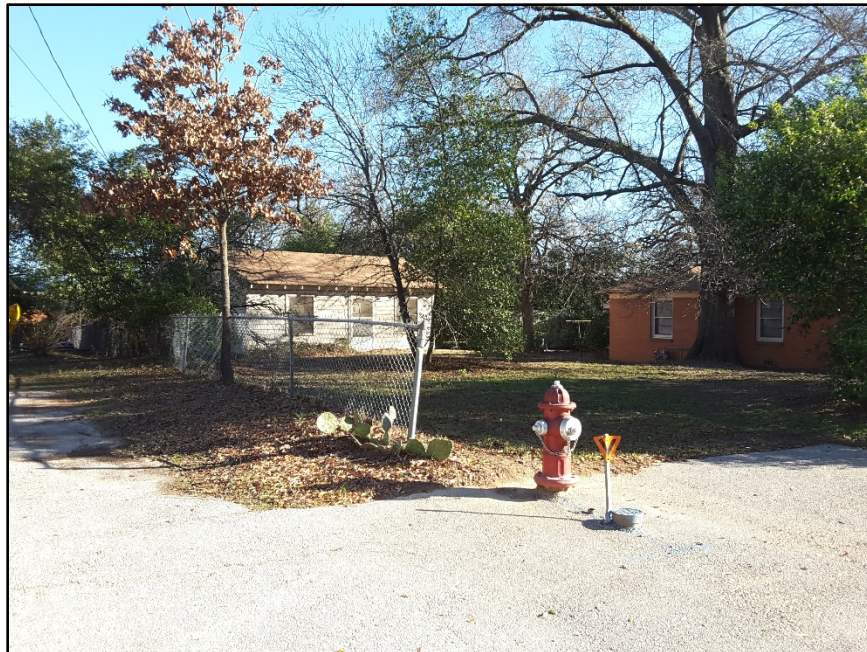
Figure 18. Buried water main and heavily modified residential property typical of the proposed ROW on the eastern portion of the project area, facing southeast on parcel 151.

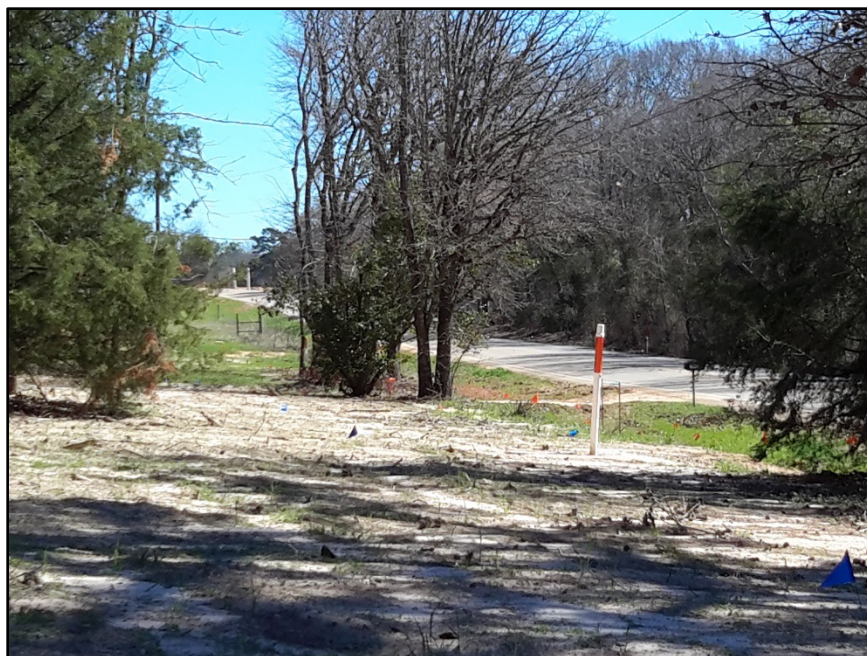
Figure 19. Heavily graded and disturbed proposed ROW with numerous marked fiber optic and water utilities typical of parcels near the Toll 49 construction area, facing southeast on parcel 57. Note that columns for Toll 49 can be seen in background.

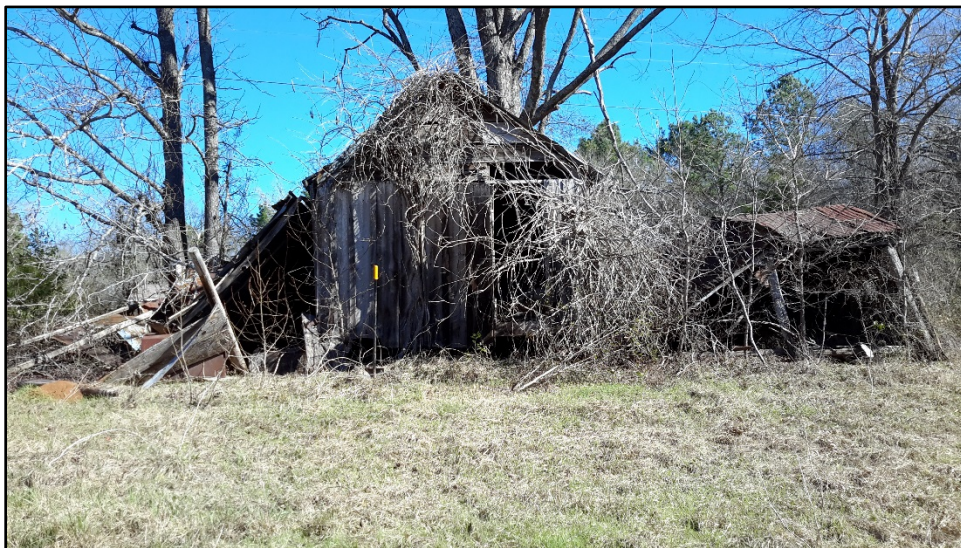
Figure 20. Site 41SM483 overgrown barn with collapsed shed additions, facing northeast on parcel 43.

The barn measures 34 feet east/west by 14 feet north/south. The central section has a corrugated metal, front gable roof. The open bays on the northwest elevation has collapsed, but was likely a shed style roof. The southeast bay has a side gable roof and was likely a later addition. The barn has a pier-and-beam foundation with board-and-batten wood siding on all four sides of the central room and a corrugated metal siding on three sides of the southeast bay. Wire nails were observed throughout the structure, which suggests a twentieth century construction date. There are no window openings. There is evidence of a hinged door, but it is no longer in place. Inside the central room are a number of modern agricultural and mechanical debris, such as galvanized pipes, central air vents and fans, and tires. There is moderate to dense vegetation overgrowth around the structure, causing damage to the walls and roof (Figure 22). It is possible that the structure was moved sometime after 1960. The *Lindale, TX* 1960 USGS topographic 7.5-minute quadrangle map depicts an ancillary structure approximately 230 feet southeast of where the barn at site 41SM483 now sits (Foster 2006). This structure is in the location of one of the non-historic barns. The original structure likely represents the historic barn's original location.

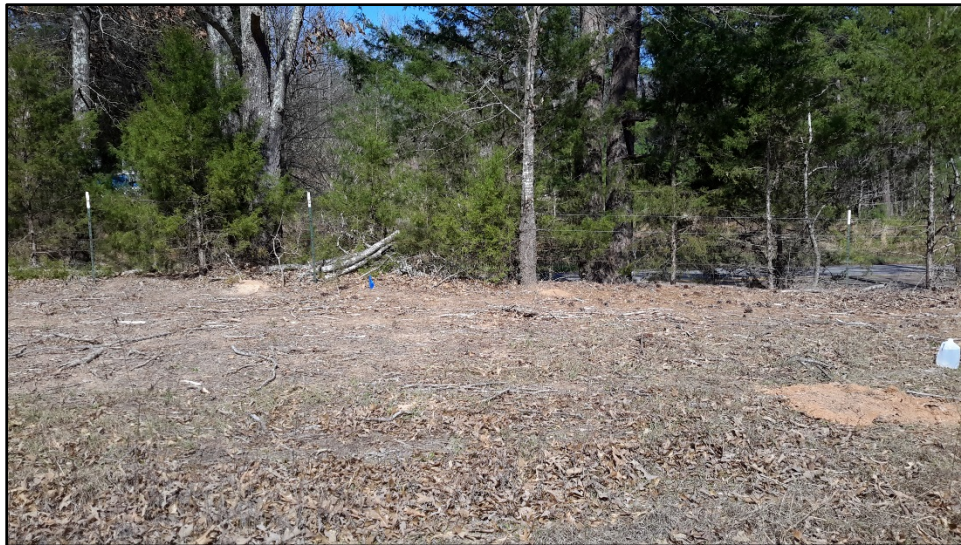
Figure 24. Site 41SM484 overview facing FM 16 with flagged buried water line in foreground, facing northeast on parcel 46.

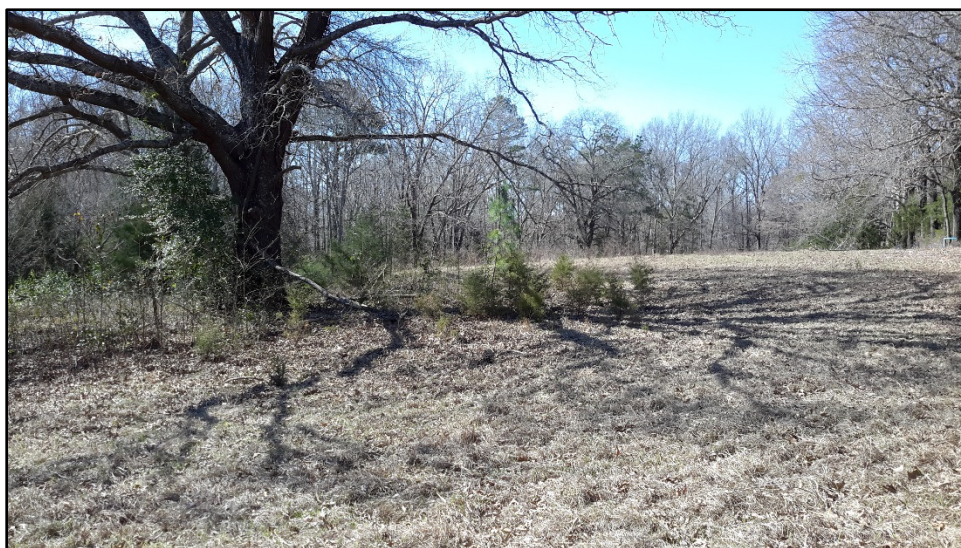
Figure 25. Site 41SM484 overview of upland ridge with lone large oak grass pasture, facing west on parcel 46. The woods in the background indicate the drainage of Luckeible Branch with the tree line on the right side of the picture indicating the southern fence line of FM 16. Note the blue pipe to the right jutting out of the buried water pipe paralleling FM 16.

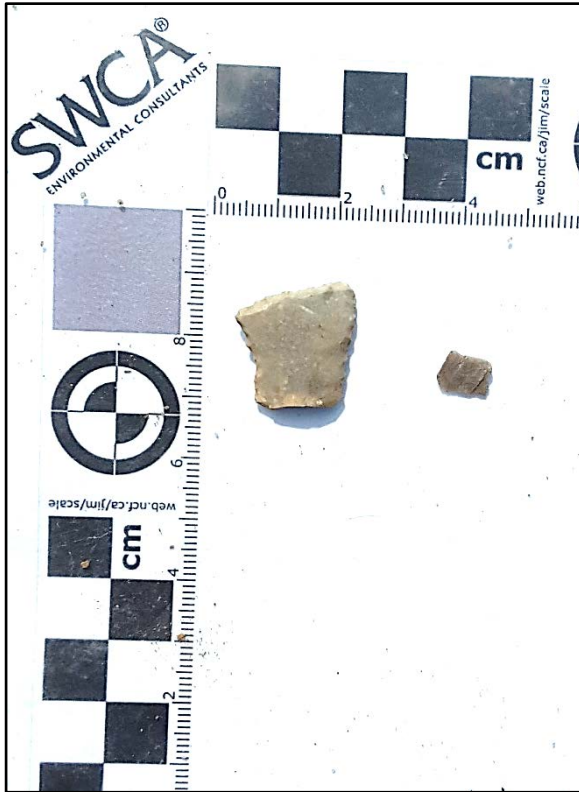
Figure 26. Site 41SM484 surface finds with bifacial thinning flake and modified flake tool. The flake tool has steep unifacial flaking on three edges. Identified on parcel 46.

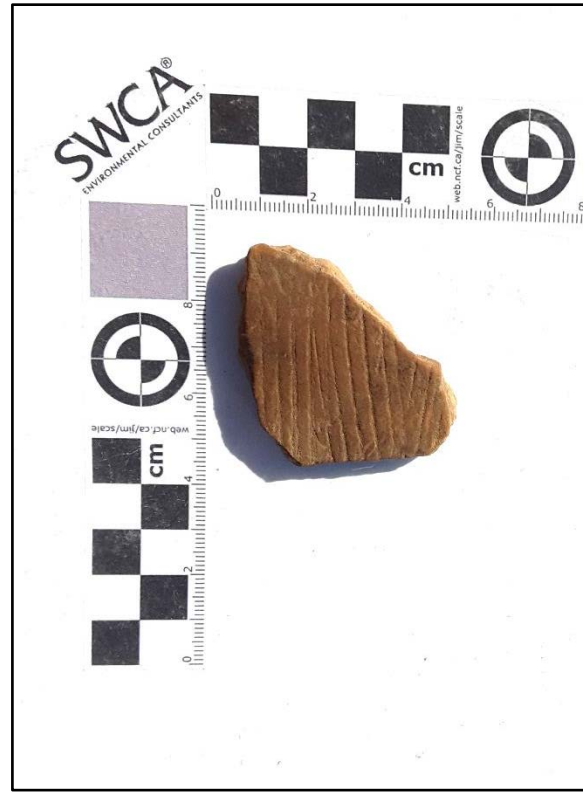
Figure 27. IF1 ceramic sherd with incised marks along the exterior. The interior shows coiling perpendicular to the marks shown here. Identified on parcel 52.

Finally, IF1, consisting of one possible Caddo bottleneck ceramic sherd with parallel incised lines discovered in a single shovel test (DR26) between artificial berms east of Hubbard Creek. There are several Caddo ware styles with similar incised lines, all which date to A.D. 900–1300 (Pertulla 2004). No additional cultural material was encountered and the isolated sherd does not warrant designation as an archaeological site and no further work is recommended. However, should the proposed APE change and shift northward into the adjacent parcel, additional survey may be necessary prior to construction.
