INTENSIVE ARCHEOLOGICAL SURVEY OF POISON OAK ROAD REALIGNMENT CITY OF TEMPLE, BELL COUNTY, TEXAS

April 12, 2018

Final Report – Public Copy

Terracon Project No. 96177272C

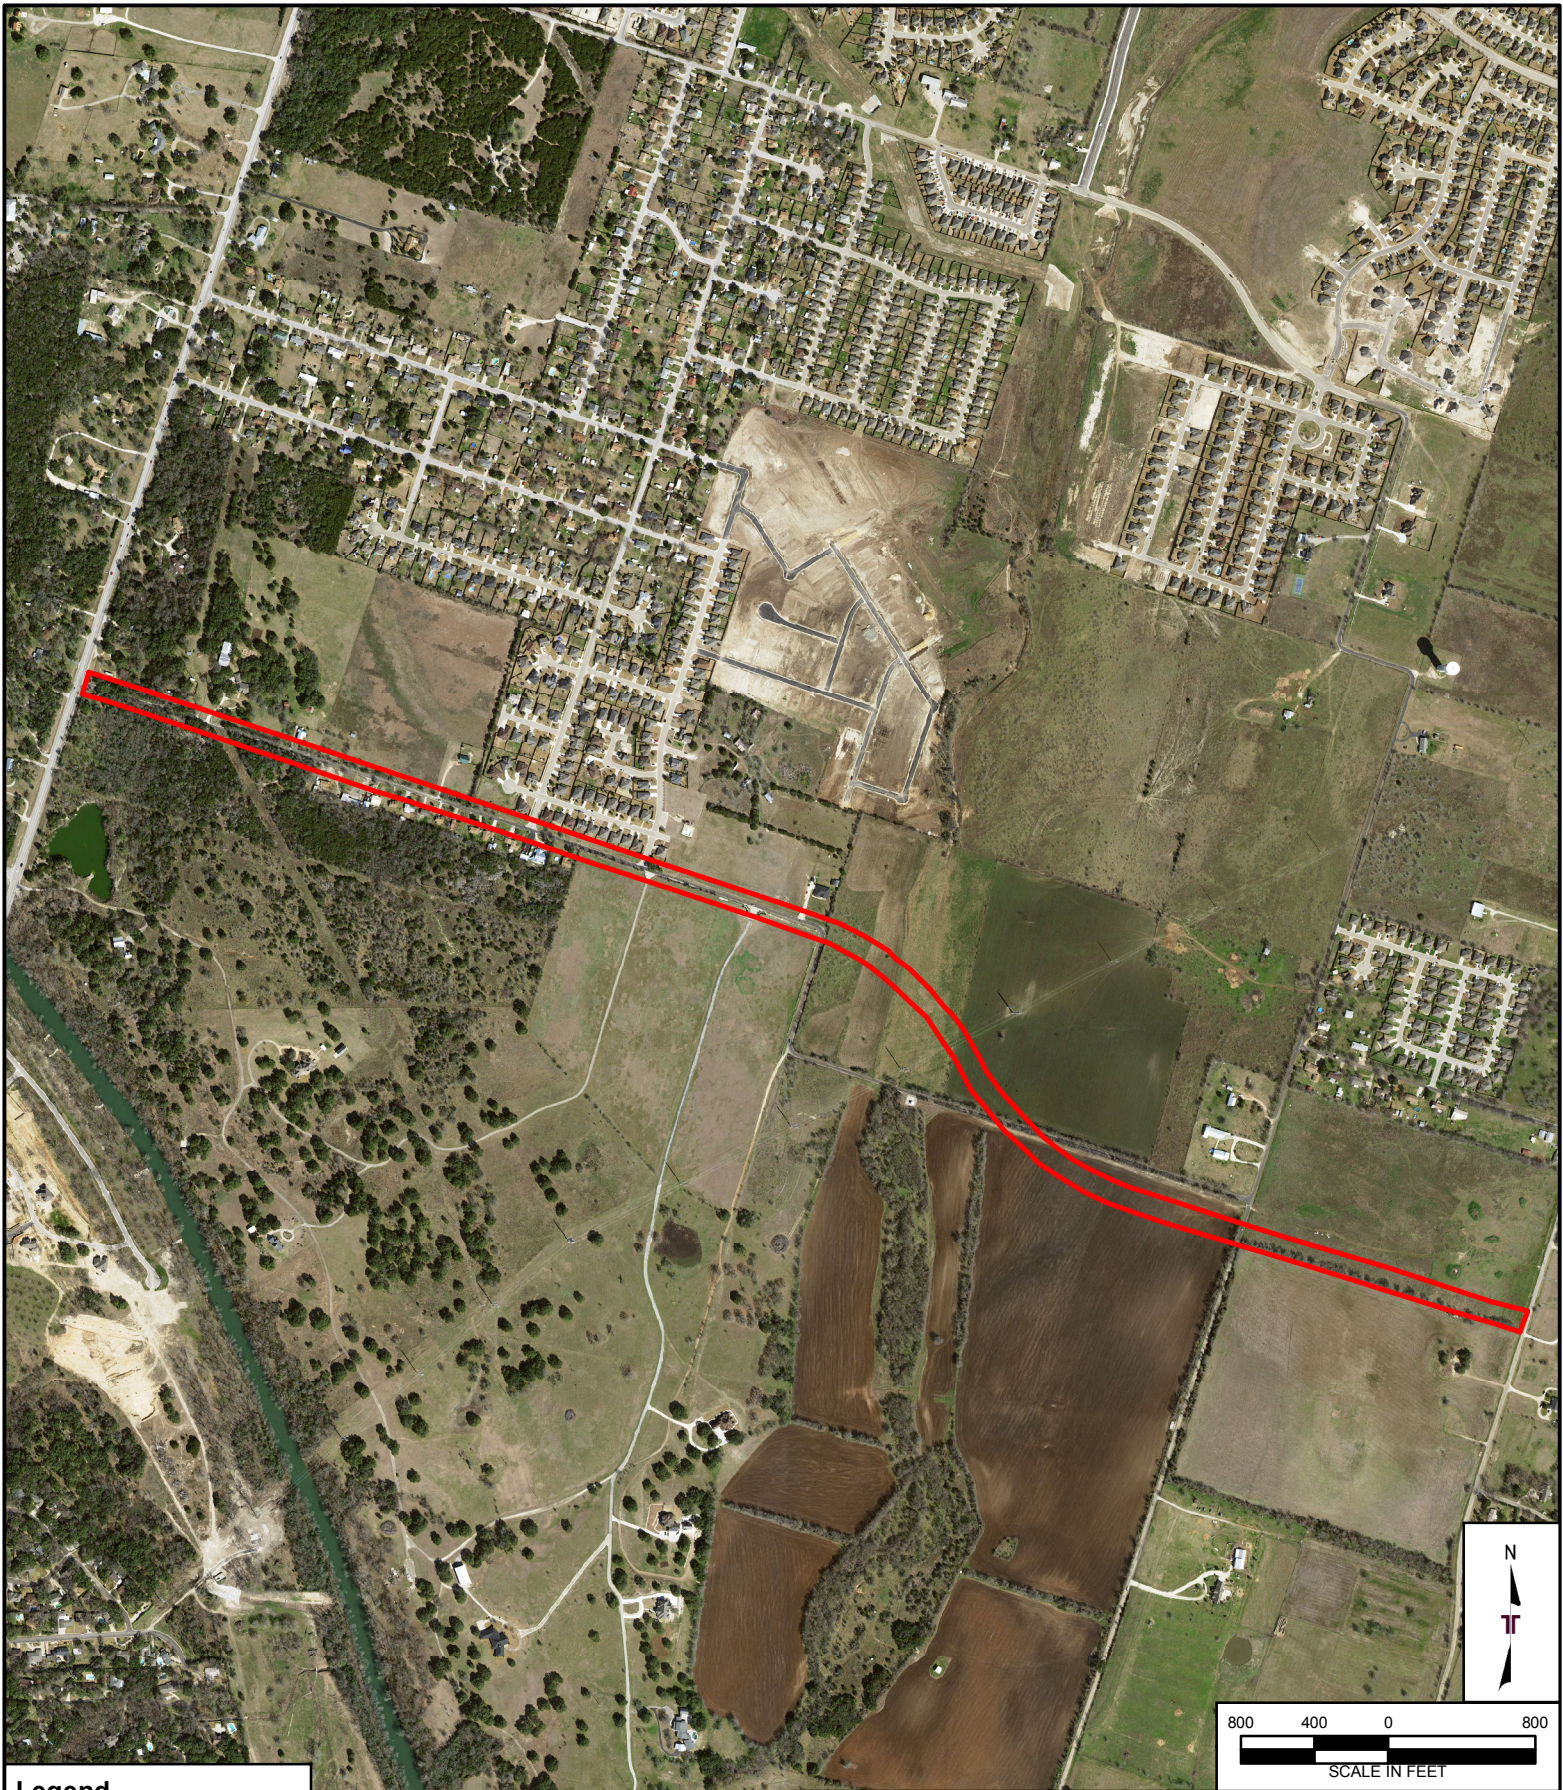
EXHIBIT
 2

2015 Aerial Photograph
 Poison Oak Road Realignment
 Poison Oak Road
 Temple, Bell County, Texas

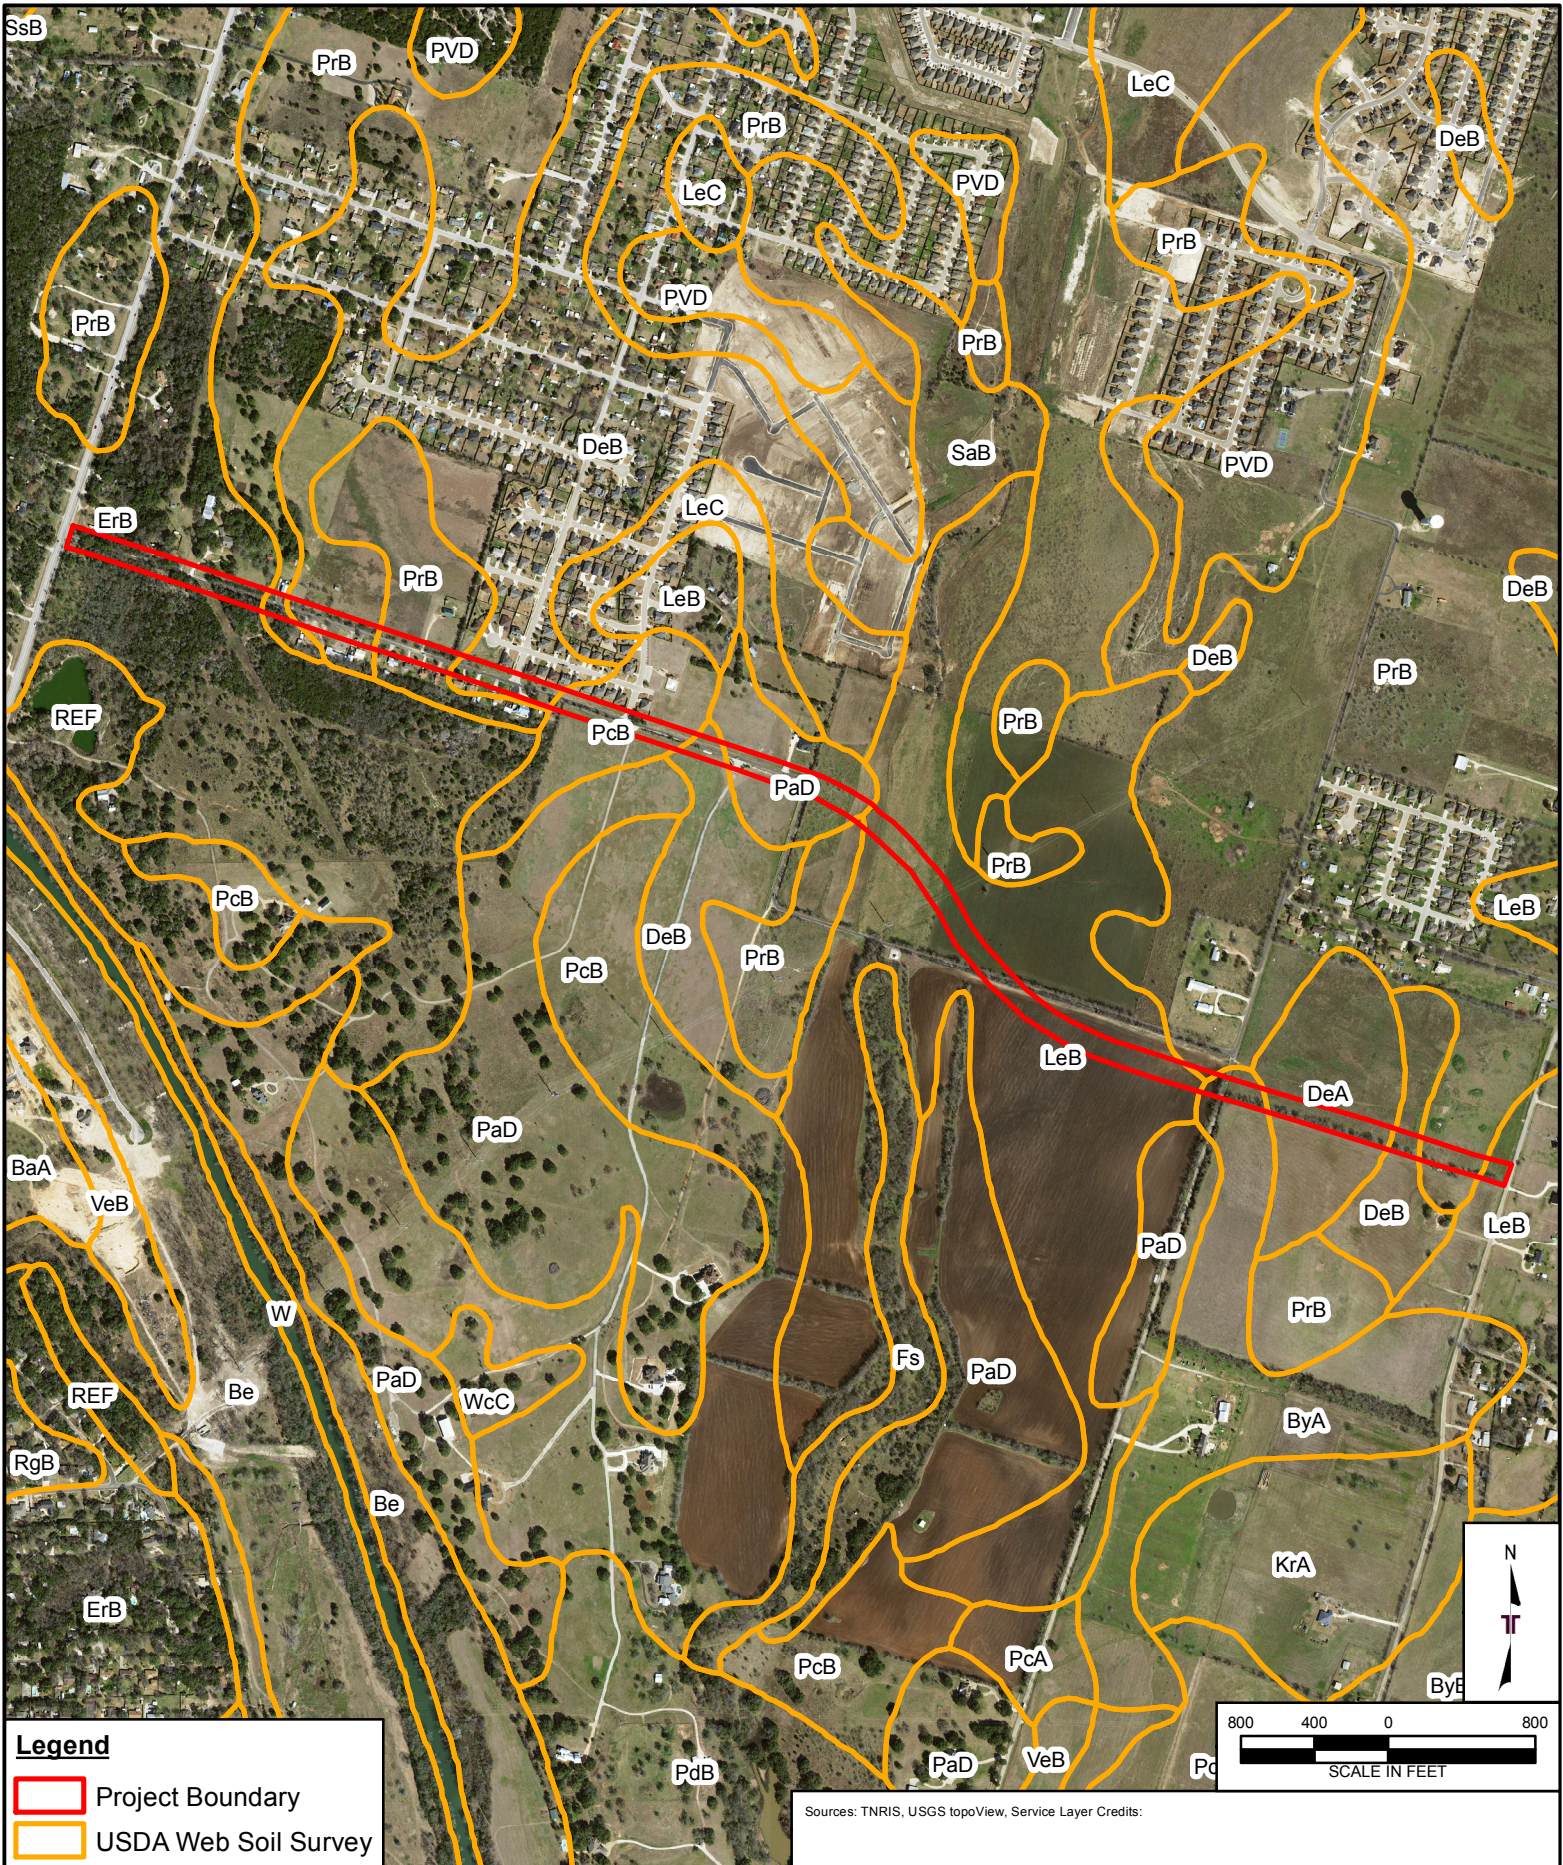
EXHIBIT
3

Eight soils are mapped within the APE (Appendix A, Exhibit 3) (Huckabee et al. 1977; USDA NRCS 2018). Eckrant-Rock outcrop complex, 1 to 8 percent slopes, extremely stony (ErB) is a shallow (12 inches to bedrock), well-drained soil located on ridges. Purves silty clay, 1 to 4 percent slopes (PrB) is a shallow (14 inches to bedrock), well-drained soil located on ridges. Denton silty clay, 1 to 3 percent slopes (DeB) is a deep (52 inches to bedrock), well-drained soil located on ridges. Payne loam, 1 to 3 percent slopes (PcB) is a deep (72 inches to bedrock), well-drained soil located on stream terraces. Patrick soils, 1 to 8 percent slopes (PaD) is a deep (120 inches to bedrock), well-drained soil located on paleoterraces. Lewisville silty clay, 1 to 3 percent slopes (LeB) is a deep (62 inches to bedrock), well-drained soil located on stream terraces. Branyon clay, 0 to 1 percent slopes (ByA) is a deep (80 inches to bedrock), moderately well drained soil located on stream terraces. Denton silty clay, 0 to 1 percent slopes (DeA) is a deep (52 inches to bedrock), well-drained soil located on ridges.

USDA Soils Map
Poison Oak Road Realignment
 Poison Oak Road, E of FM 317
 Temple, Bell County, Texas

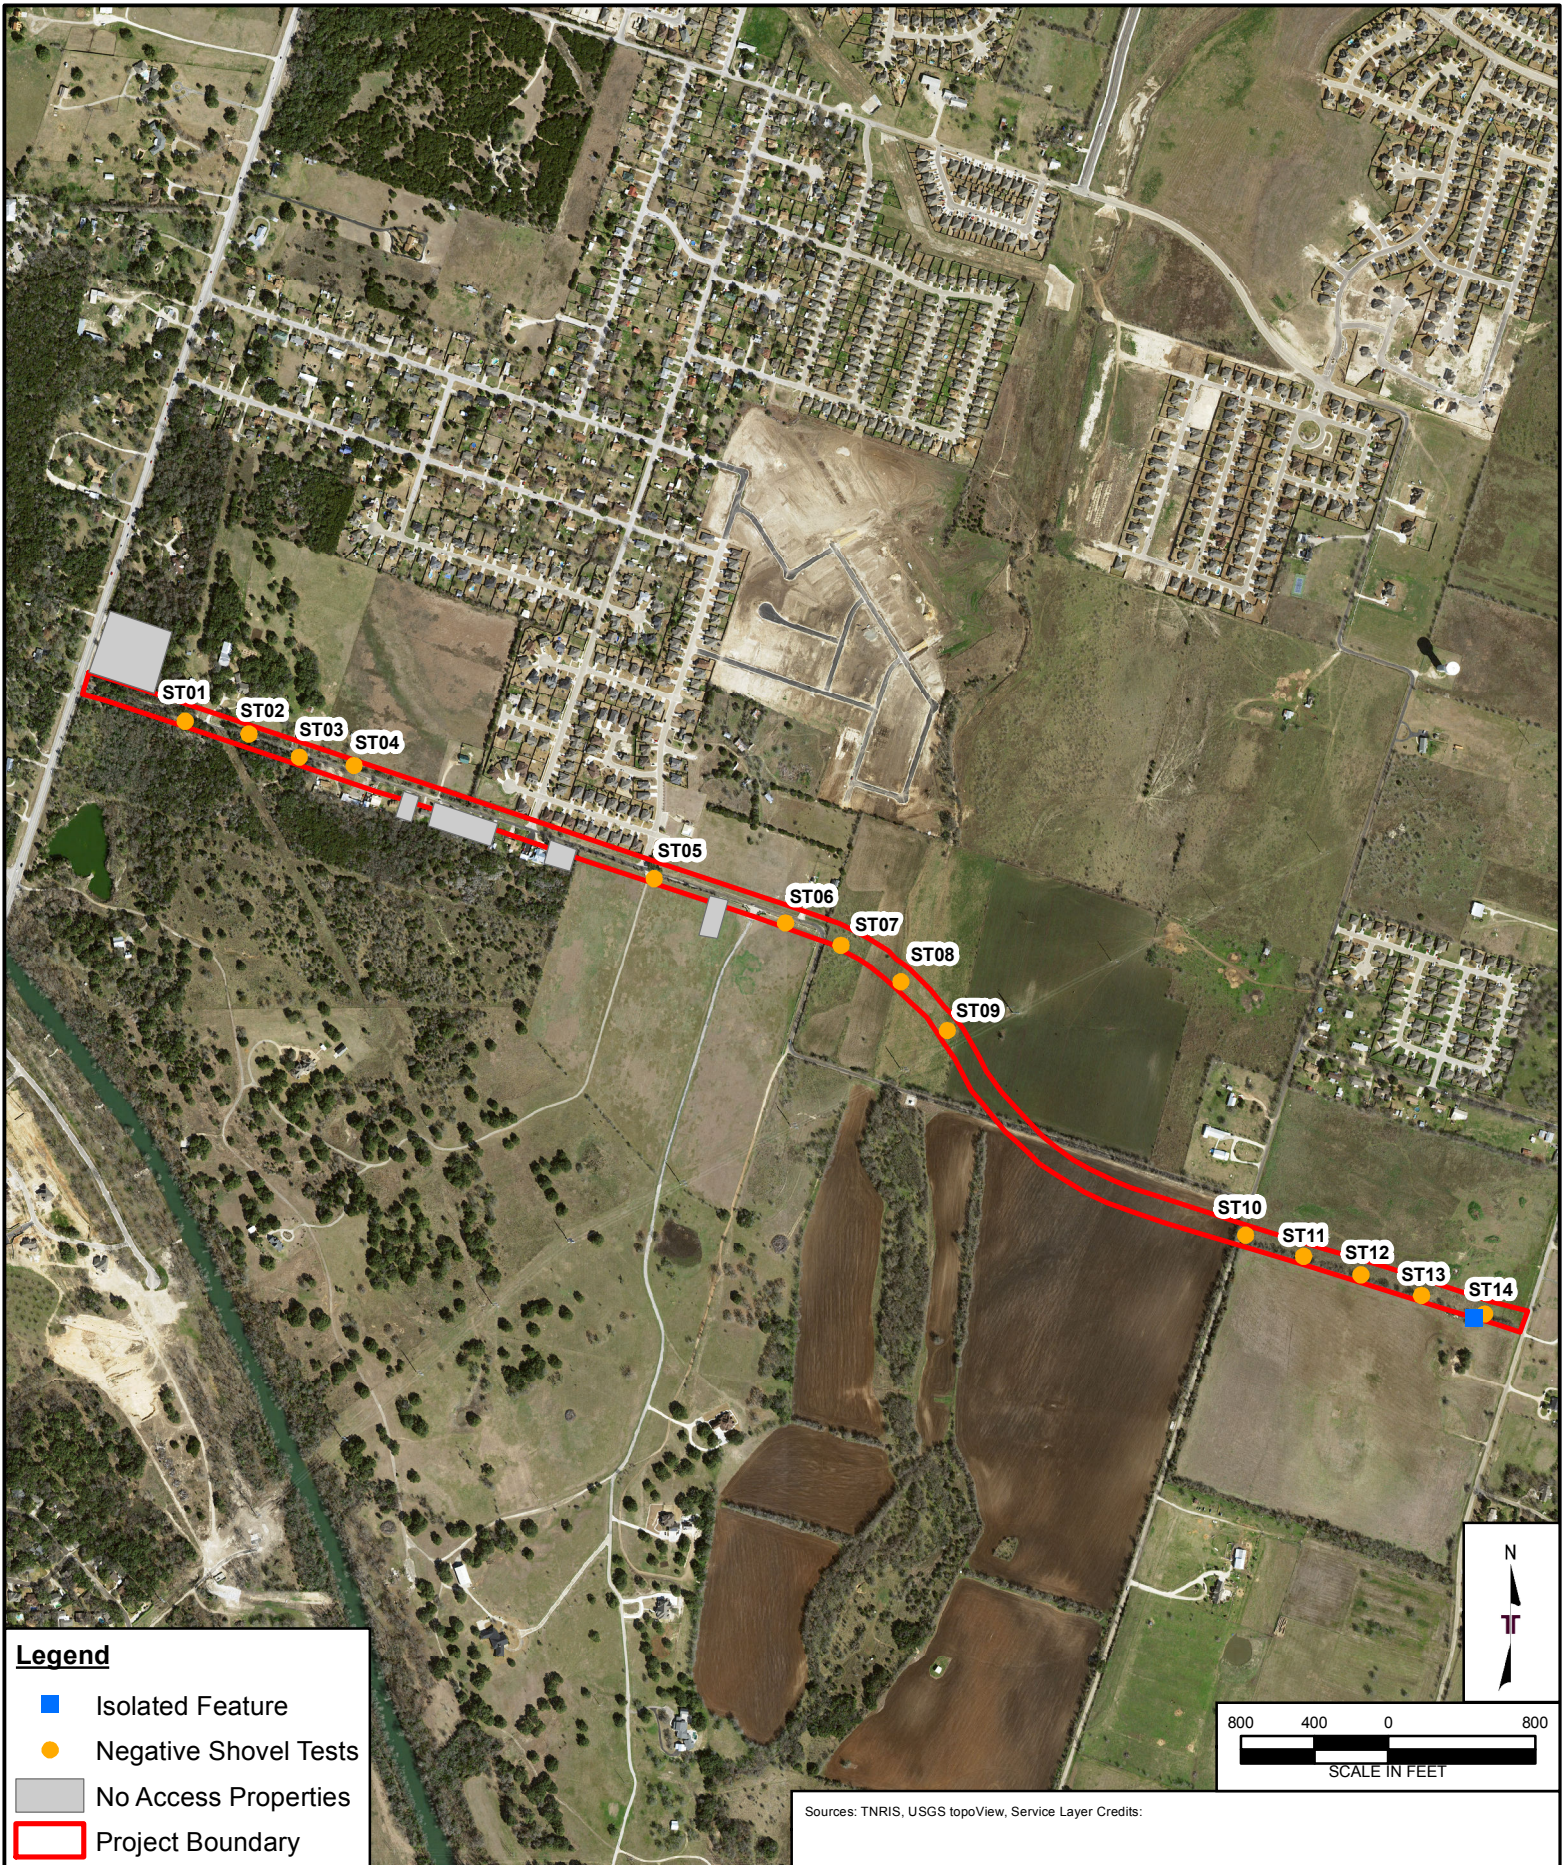
EXHIBIT
4

The intensive pedestrian survey of the APE resulted in thorough coverage of the alignment and the excavation of fourteen shovel tests (Appendix A, Exhibit 4). The project APE from the intersection of Poison Oak Road and FM 317 to Old Waco Road and was relatively flat to gently sloping in topography. The APE was covered in short, local grasses. The eastern and western portions of the project APE had generally poor ground surface visibility, ranging between 2 to 20 percent (Appendix B, Photos 1 and 2). The central portion of the project area was located in agricultural fields with generally good ground surface visibility, ranging from 80 to 95 percent (Appendix B, Photo 3). The western portion of the project alignment was heavily disturbed from existing Poison Oak Road and buried utilities such as water lines, sewer lines, and fiber optic cables (Appendix B, Photos 4, 5, and 6). The central portion of the project area was located in agricultural fields with good ground visibility. Natural chert cobbles were observed in these plowed fields, but no cultural lithic materials were observed (Appendix B, Photo 7). The eastern portion of the project alignment had generally poor ground visibility, and was less disturbed than the western portion of the alignment (Appendix B, Photo 8). Fourteen shovel tests were placed in areas that appeared undisturbed and had less than 30 percent visibility (Appendix B, Photo 9) (see Appendix C for shovel test log). No cultural materials were observed during shovel testing.

One isolated feature was observed during the course of the survey (see Appendix A, Exhibit 4). This feature consists of an outbuilding structure located on the southern edge of the project APE. The structure is roughly 15 feet by 30 feet, and made from wood and sheet metal (Appendix B, Photos 12 and 13). Historic aerial photographs indicate that this outbuilding was built between 1952 and 1964. No historic-age cultural materials were observed in the vicinity of the outbuilding. Given the isolated nature of the structure, its recent age, and the lack of associated artifacts, it was not recorded as an archaeological site.

In the western portion of the project alignment, several parcels could not be surveyed due to lack of Right of Entry (ROE) (see Appendix A, Exhibit 4). In total, the parcels which could not be surveyed added up to 1,070 linear feet. However, this was not deemed to be detrimental to the survey as the parcels are not entirely adjoining and do not constitute the entire width of the alignment. When the parcels without ROE were examined from adjoining parcels with ROE, it was observed that they had been heavily disturbed by utilities and landscaping activities (Appendix B, Photos 14 and 15). It is unlikely that the parcels without ROE contain intact cultural resources.

Results Map
Poison Oak Road Realignment
 Poison Oak Road
 Temple, Bell County, Texas

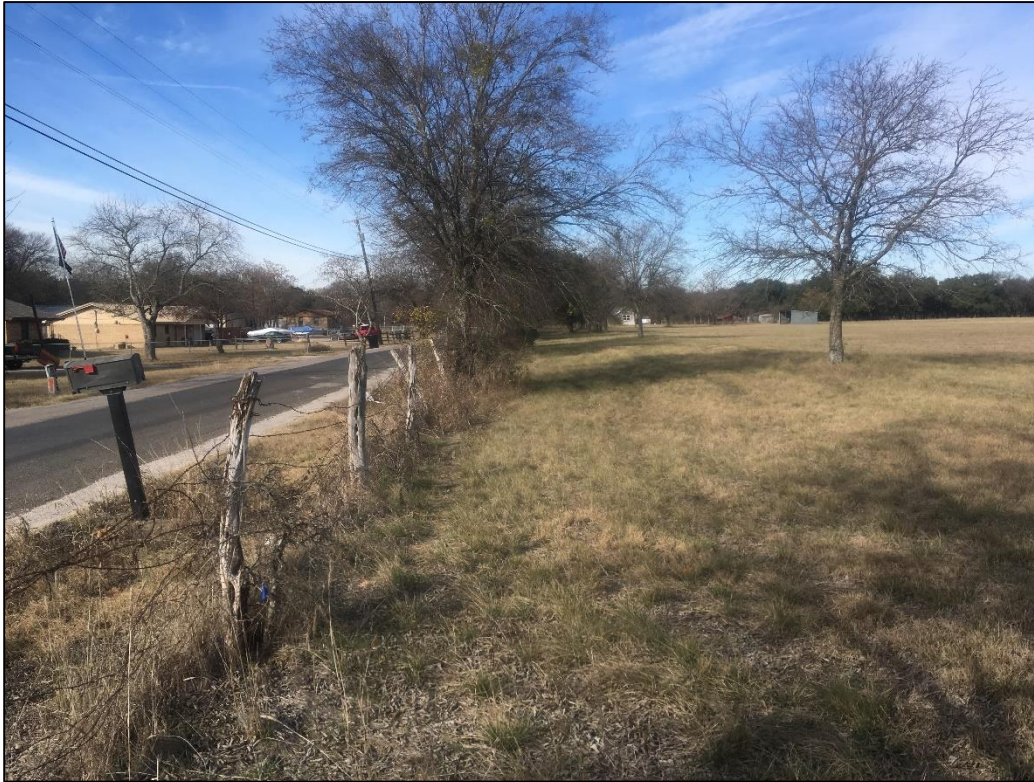
Photo 1. Poor ground surface visibility in the western portion of the project area. View to the west.

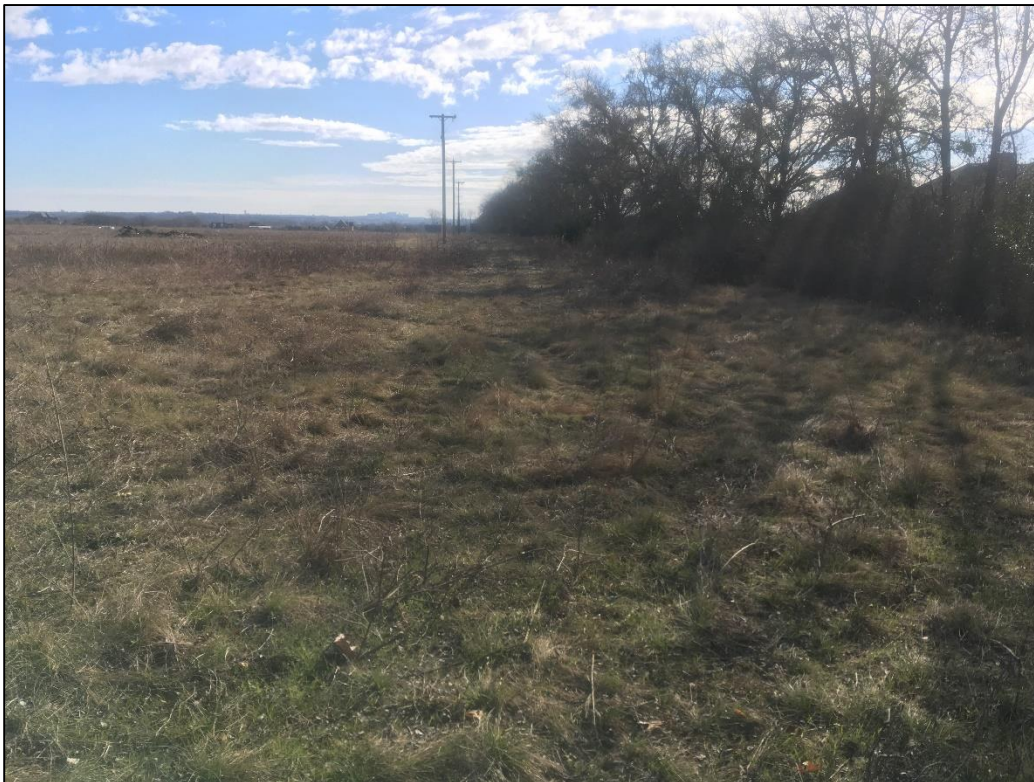
Photo 2. Poor ground surface visibility in the eastern portion of the project area. View to the east.

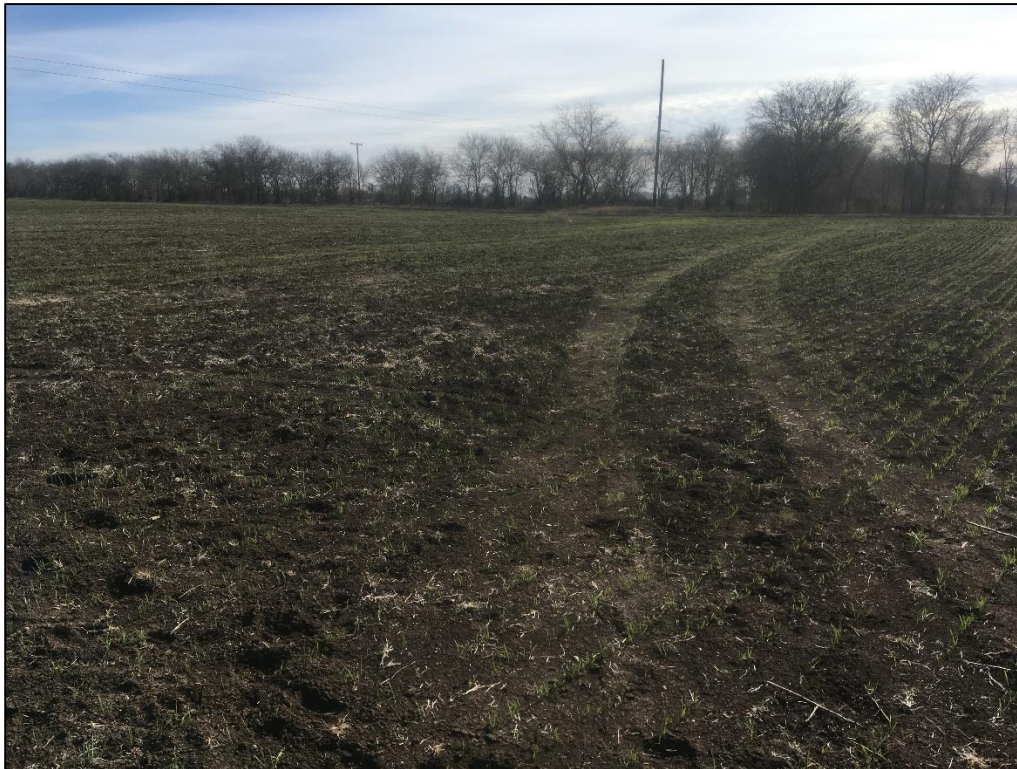
Photo 3. Good ground surface visibility in the central portion of the project area. View to the southeast.

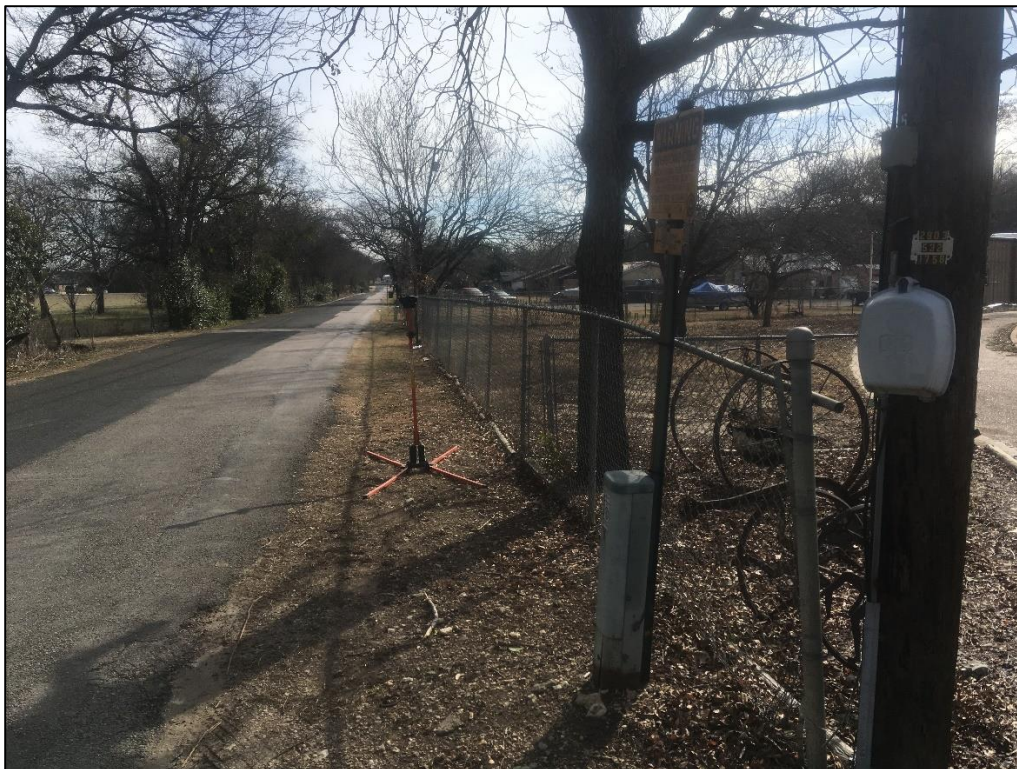
Photo 4. Western portion of project alignment, on south side of Poison Oak Road. Note disturbances from existing road, utilities, and landscaping in yards. View to the east.

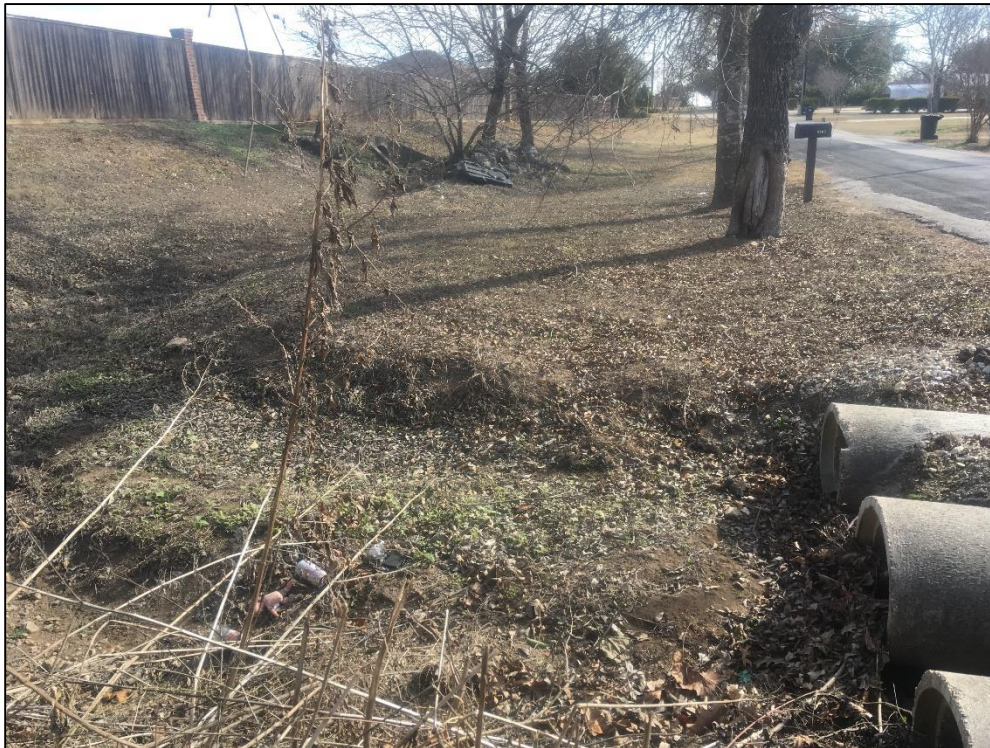
Photo 5. Western portion of project area, on north side of Poison Oak Road. Note disturbances from existing road and landscaping. View to the east.

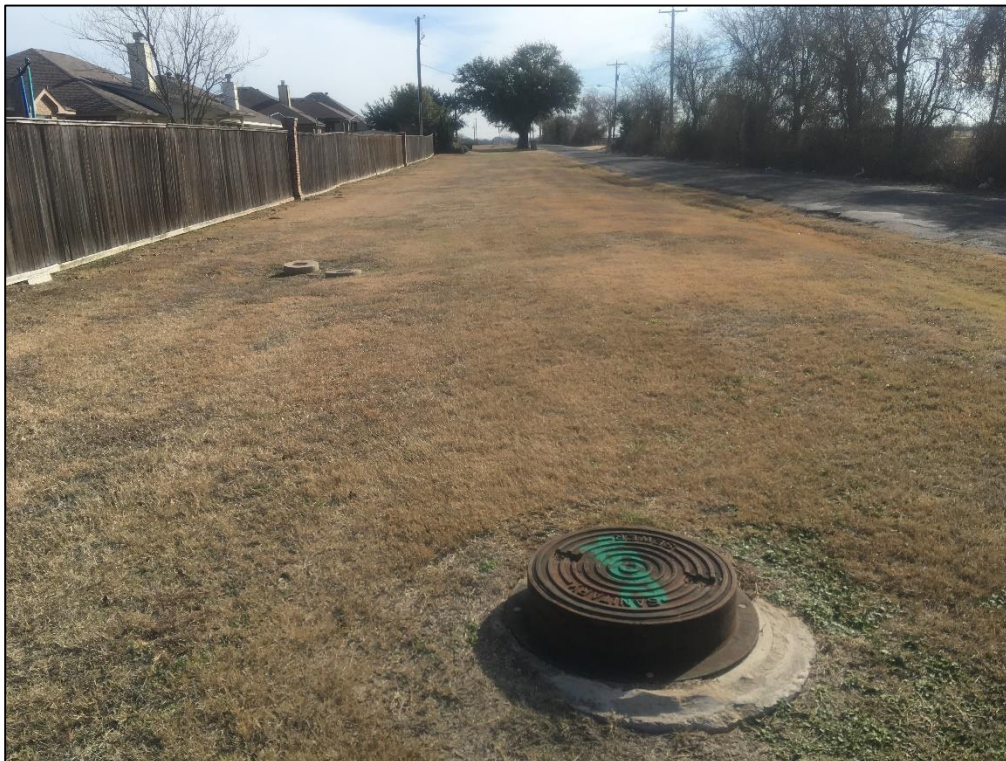
Photo 6. Western portion of project area, on north side of Poison Oak Road. Note disturbances from road and utilities. View to the east.

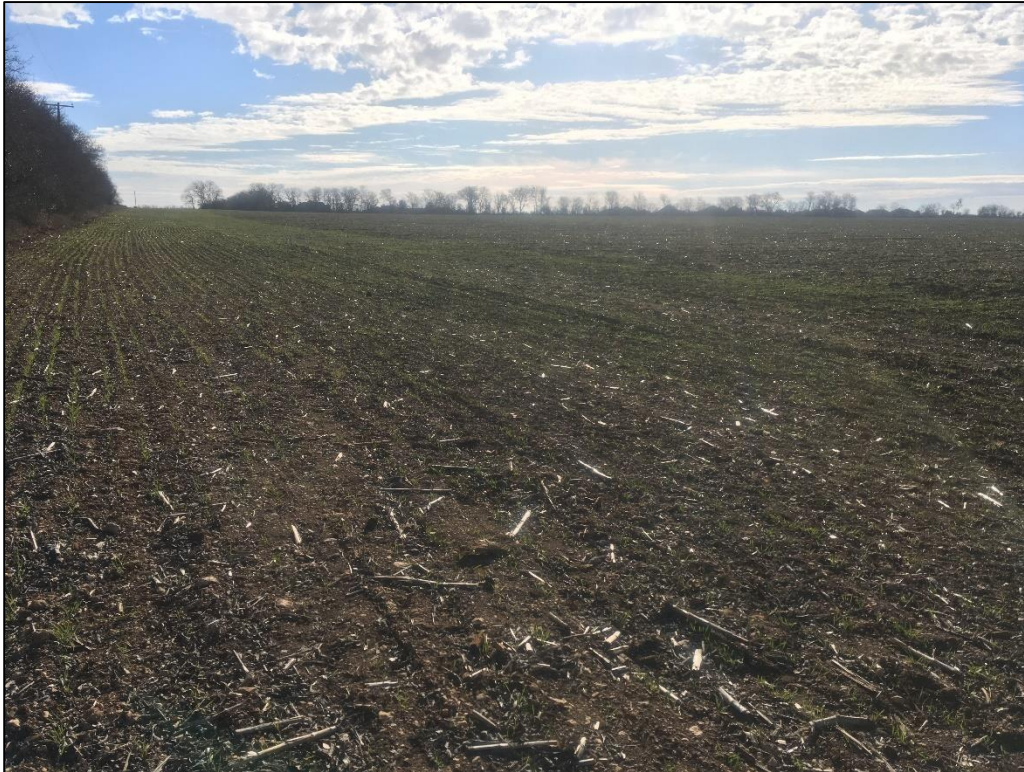
Photo 7. Central portion of project area. Note good ground surface visibility and natural chert cobbles. View to the southeast.

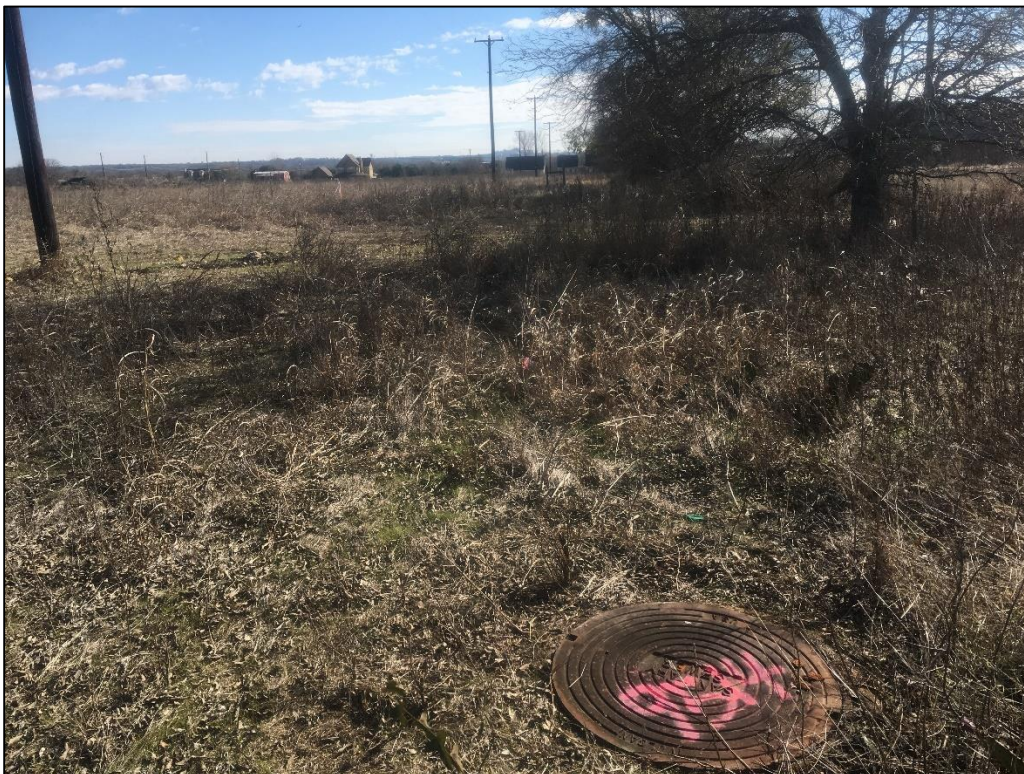
Photo 8. Eastern portion of project area. Note poor ground visibility and utilities. View to the east.

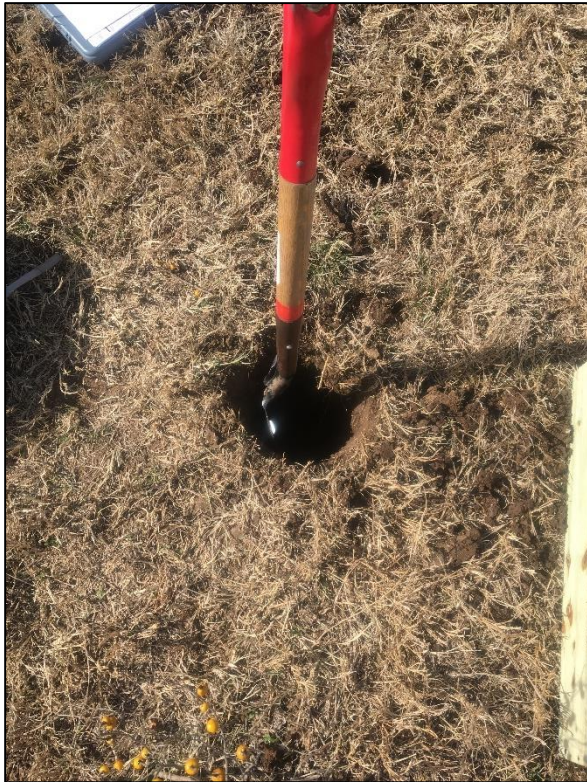
Photo 9. Shovel Test 08.

ST ID #	Depth cmbs	+/-	Ground cover	Munsell & Color	Texture	% Gravels	Comments
ST08	0-45	-	40%	10YR 2/2 Very dark brown	Clay loam	0-5%	Compact due to livestock trample. Rootlets near surface. Calcium carbonate nodules starting at 40cmbs. Terminated due to carbonates.
ST09	0-40	-	95%	10YR 2/1 Black	Loamy clay	0-5%	Very compact. Rootlets near surface. Some small calcium carbonates with depth. Terminated due to compactness of soil.
ST10	0-30	-	80%	10YR 2/1 Black	Loamy clay	0-5%	Rootlets near surface. Very compact. Gravels/decomposing bedrock start at 25cmbs.
ST11	0-25	-	70%	10YR 2/1 Black	Loamy clay	0-5%	Rootlets near surface. Large gravels starting at 15cmbs. Terminated due to bedrock.
ST12	0-20	-	90%	10YR 2/2 Very dark brown	Loamy clay	0-5%	Rootlets near surface. Terminated due to bedrock.
ST13	0-25	-	100%	10YR 2/2 Very dark brown	Loamy clay	5-10%	Rootlet near surface. Large gravels starting at 20cmbs. Terminated due to bedrock.

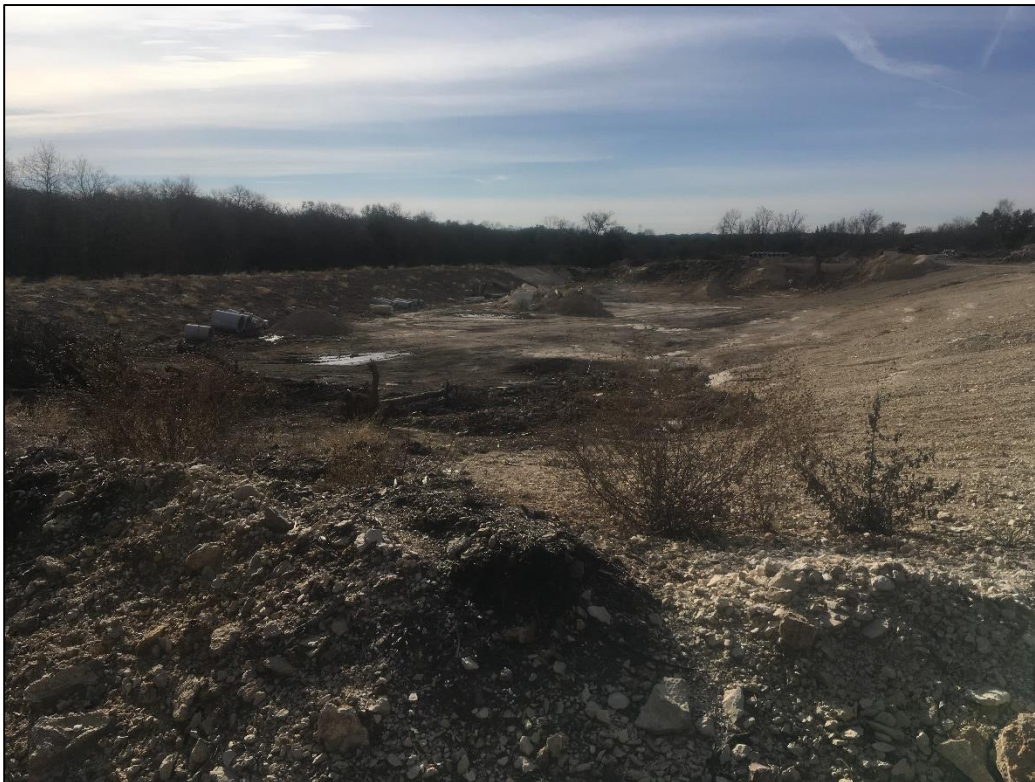
Site 41BL1379, located near the intersection of FM 317 and Poison Oak Road, is mapped immediately south of the project area. Recorded in 2015 by Texas Department of Transportation (TXDOT) archaeologists as a historic-age homestead, no standing structures were observed when the site was recorded (Oksanen 2015). When the portion of the APE closest to 41BL1379 was inspected, it was very disturbed from construction activities (Appendix B, Photos 10 and 11). It is likely that the portion of 41BL1379 closest to the current project APE, if not the entire site, has been destroyed from construction activities.

Photo 10. Construction/gravel pit near location of 41BL1379. View to the southeast.

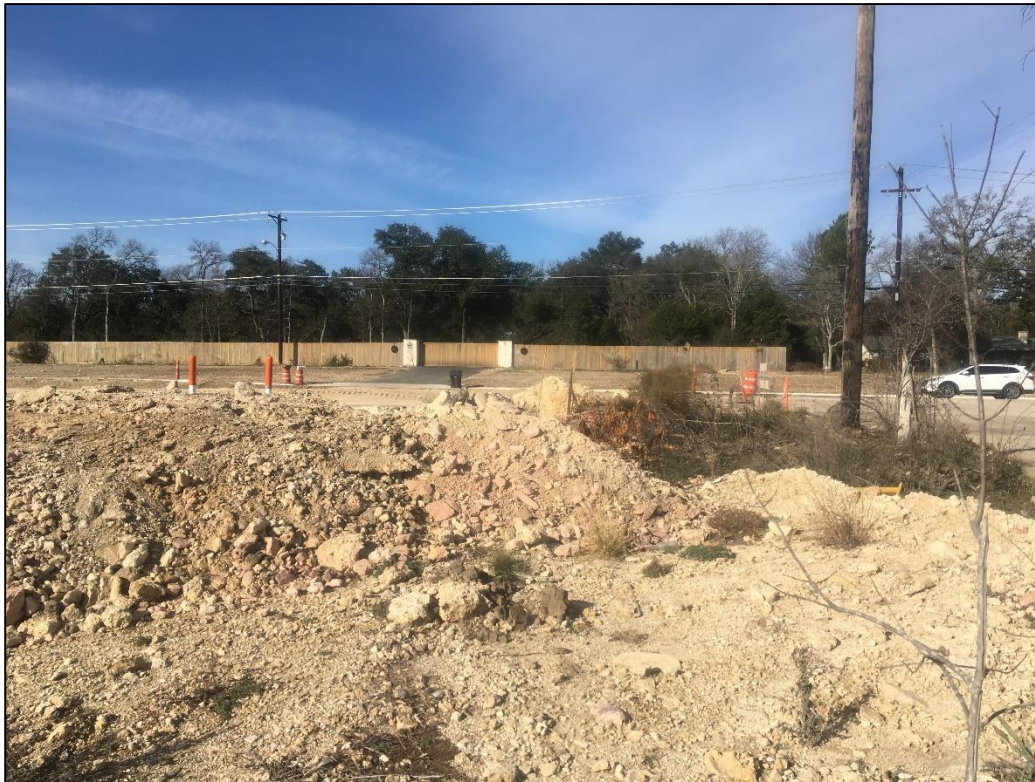
Photo 11. Project APE near 41BL1379. Note disturbances from construction. View to the west.

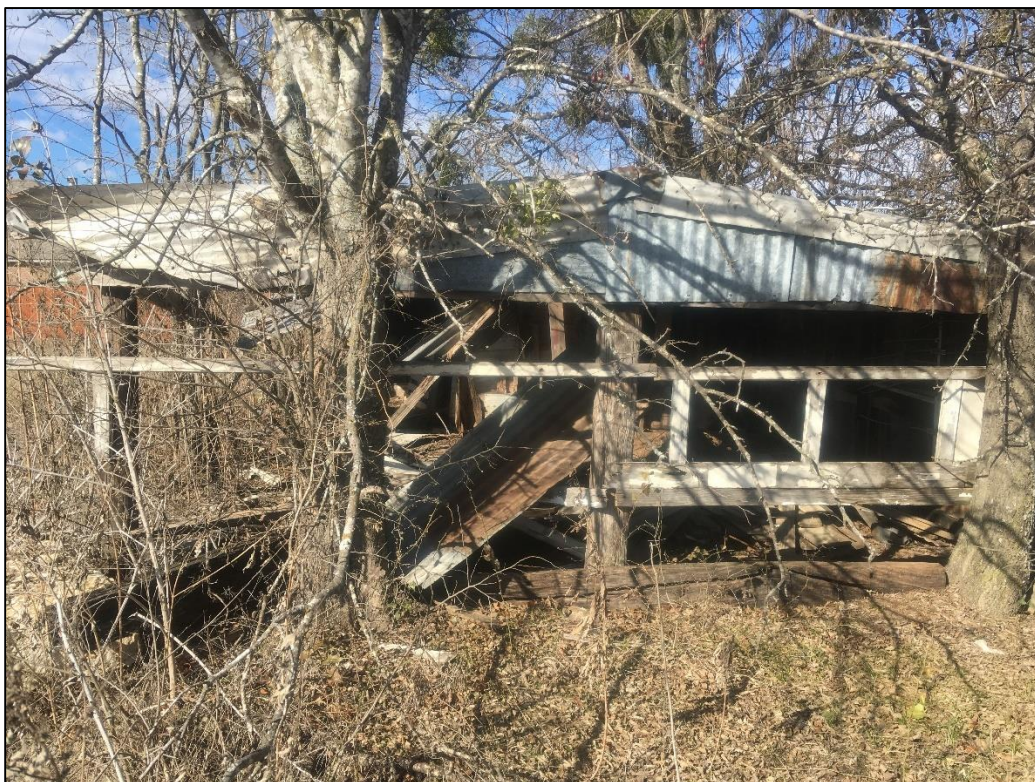
Photo 12. Historic-age outbuilding in the eastern portion of the project APE. View to the west.

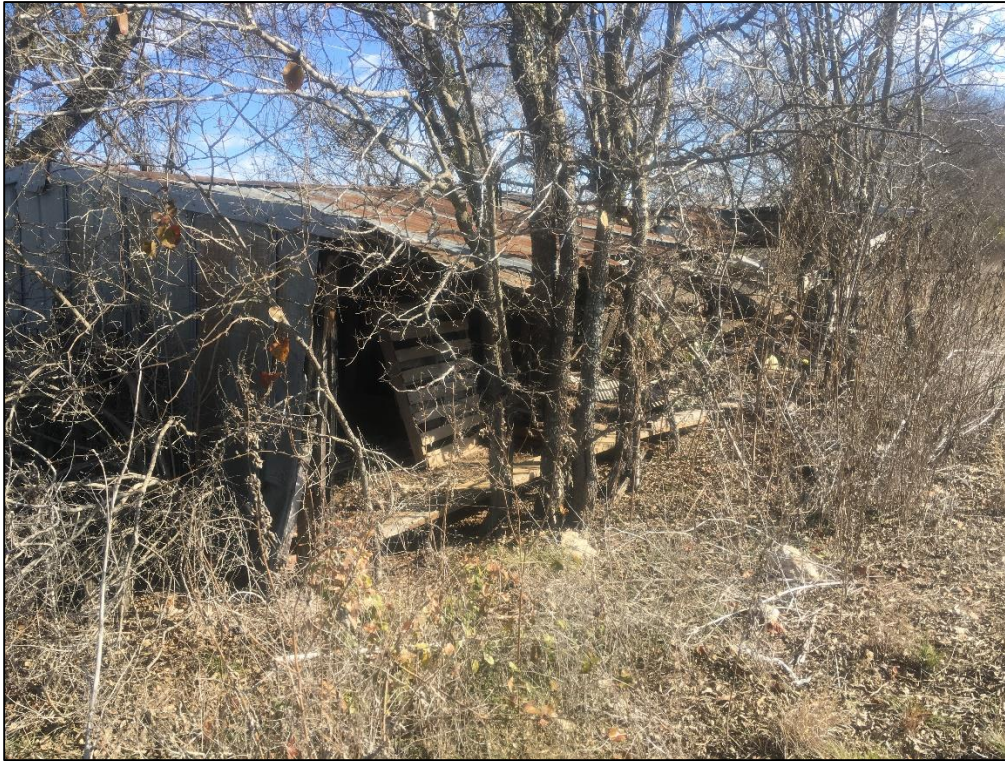
Photo 13. Historic-age outbuilding in the eastern portion of the project area APE. View to the northeast.

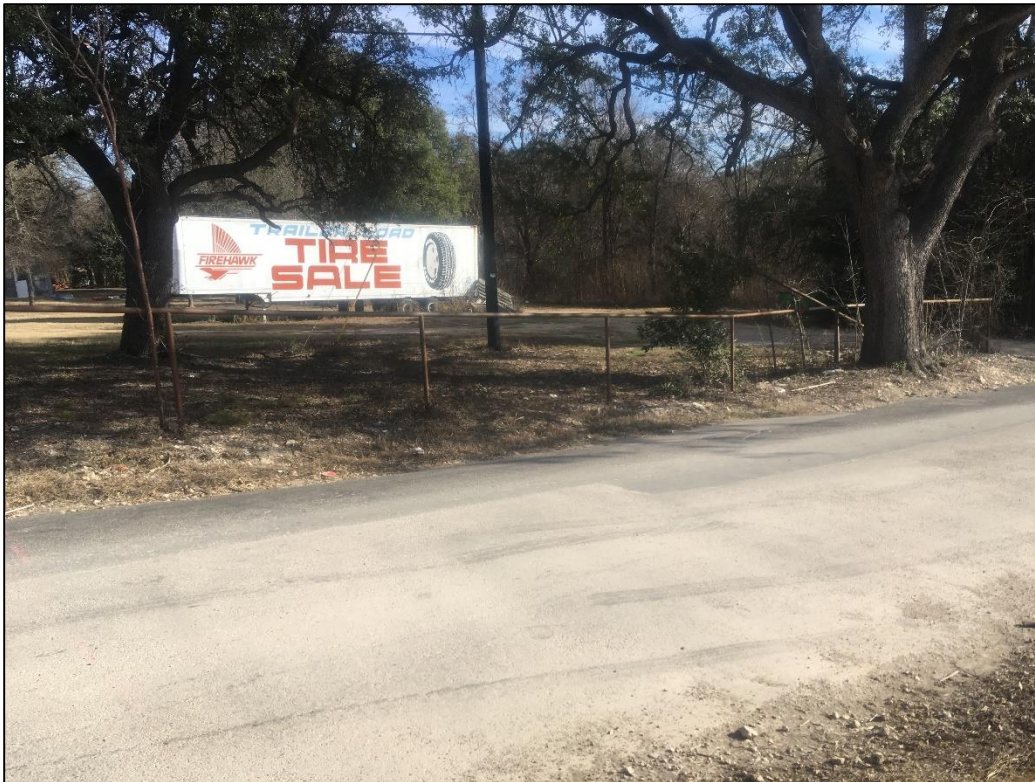
Photo 14. Parcel without ROE near intersection of FM 317 and Poison Oak Road. Note landscaping disturbances. View to the northeast.

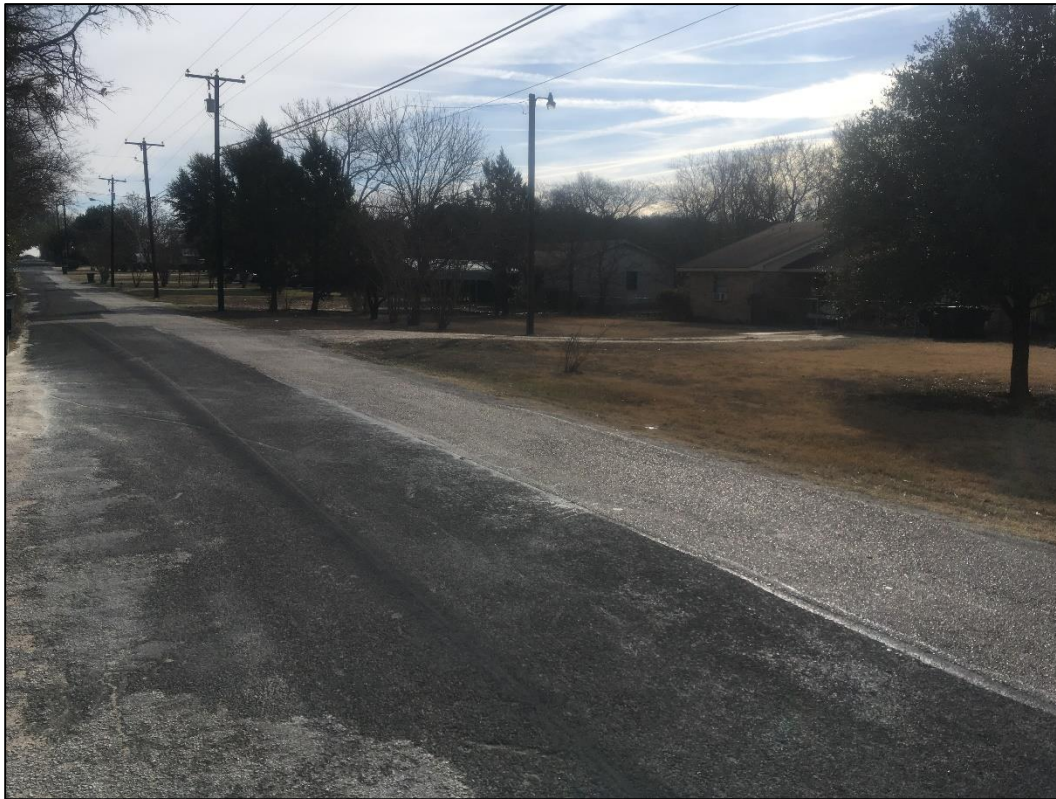
Photo 15. Parcels without ROE west of intersection of Poison Oak Road and Ridgeway Drive. Note disturbances from utilities and landscaping. View to the southeast.
