Article

Effect of Chases with Renovation Techniques on the Load Carrying Capacity of Masonry Walls

Citation: Al-Sibahy, A.; Edwards, R. Effect of Chases with Renovation Techniques on the Load Carrying Capacity of Masonry Walls. *Infrastructures* **2021**, *6*, 160. <https://doi.org/10.3390/infrastructures6110160>

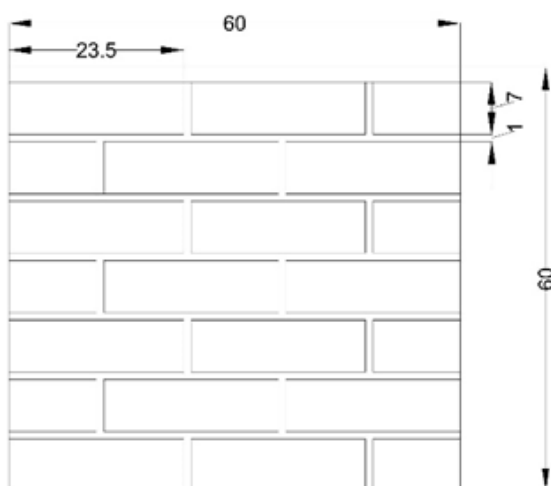
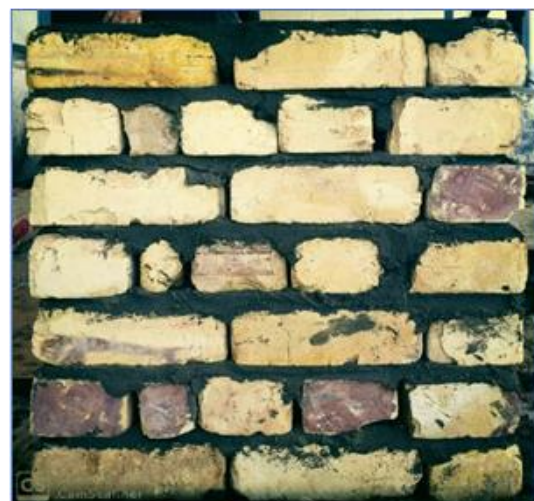
Figure 2. Construction of the masonry wallettes.

For practical considerations, BS EN 1052-1 [17] mentions the possibility of using small scale walls (wallettes) in the experimental investigation in order to evaluate the structural behaviour under the effect of different loading conditions. The aforementioned standard stated also that more than 0.04 m² are needed for reasonable replication of the large-scale masonry walls. Thus, more than 0.04 m² was provided throughout the construction of one leaf wallettes. The latter has 60 cm width (two and a half brick length), 60 cm height (7 brick courses) and 24 cm thick (one brick length), as shown in Figure 2. In all wallette samples, the thickness of the cement mortar was kept constant at 1 cm. For ease of lifting, the wallettes samples were built upon a thick steel plate and the upper surface was finished with cement mortar to have one level in order to avoid the concentration of loading and to achieve a uniform distributed load, as shown in Figure 3.

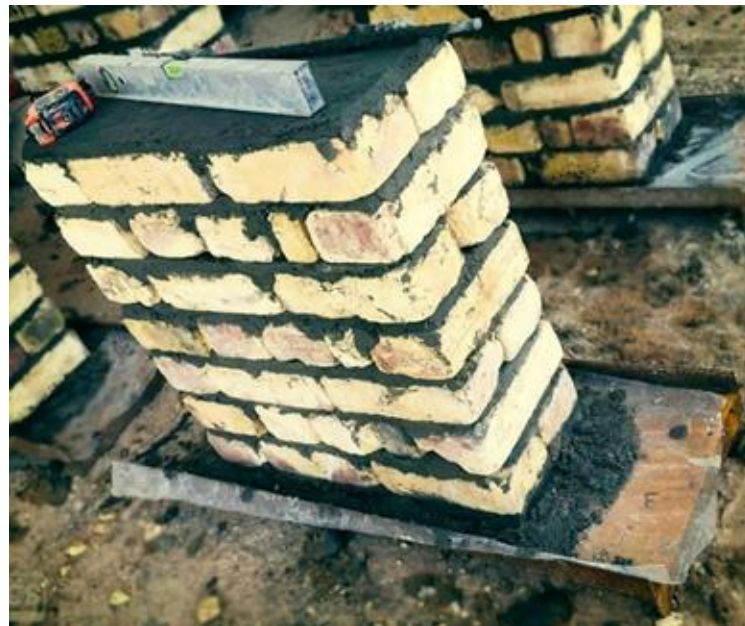
Figure 3. Finalizing the top surface of the wallettes and using underneath steel plate for lifting.

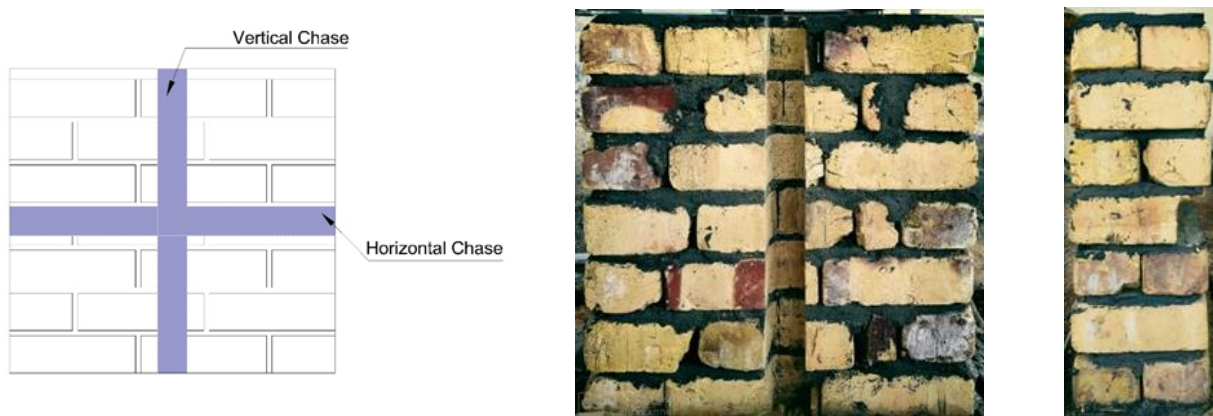
Figure 4. Creation of the vertical and horizontal chases.

After 28 days, vertical and horizontal chases were created in the front face of the wallettes using a special clipper-diamond tipped cutting wheel. The chases have width and depth of 5.5–6 cm and they were continued along the width or height of the wallettes. For the purpose of comparison, a reference wallettes sample without chases was also formulated. Before the time of the test, all of the investigated samples were rendered with a 1 cm cement mortar layer. For the renovated wallettes samples, plastic pipes were firstly inserted in the formulated chases to simulate the infrastructure of plumbing or electrical works. Plastic wire mesh with cement layer or galvanized steel channel followed by plastic wire mesh with cement layer was then applied to cover the whole chases with an offset distance of 5 cm from the outer edges of the chases, as shown in Figure 4.

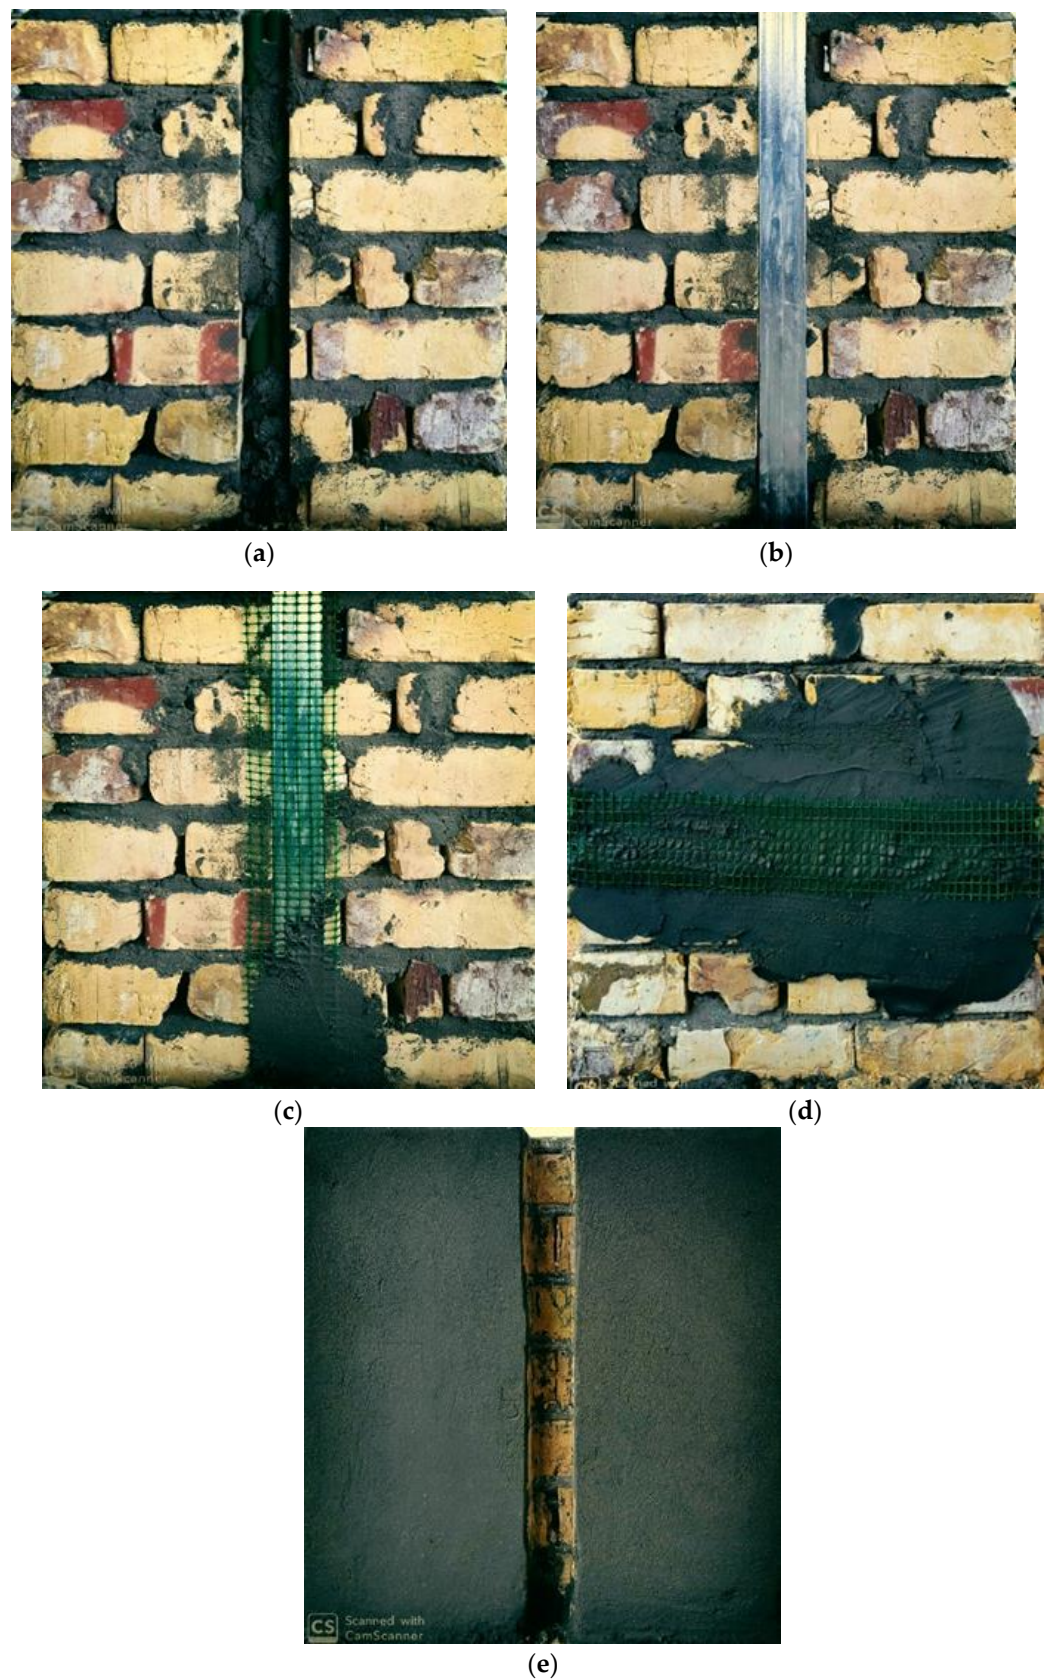
Figure 5. Renovation of the chases and cement rendering of the wallettes: (a) insertion of the service pipes; (b) fixing the galvanized steel channel; (c) galvanized steel channel with plastic wire mesh and mortar; (d) plastic wire mesh and mortar; and (e) rendering the wallettes with cement mortar.

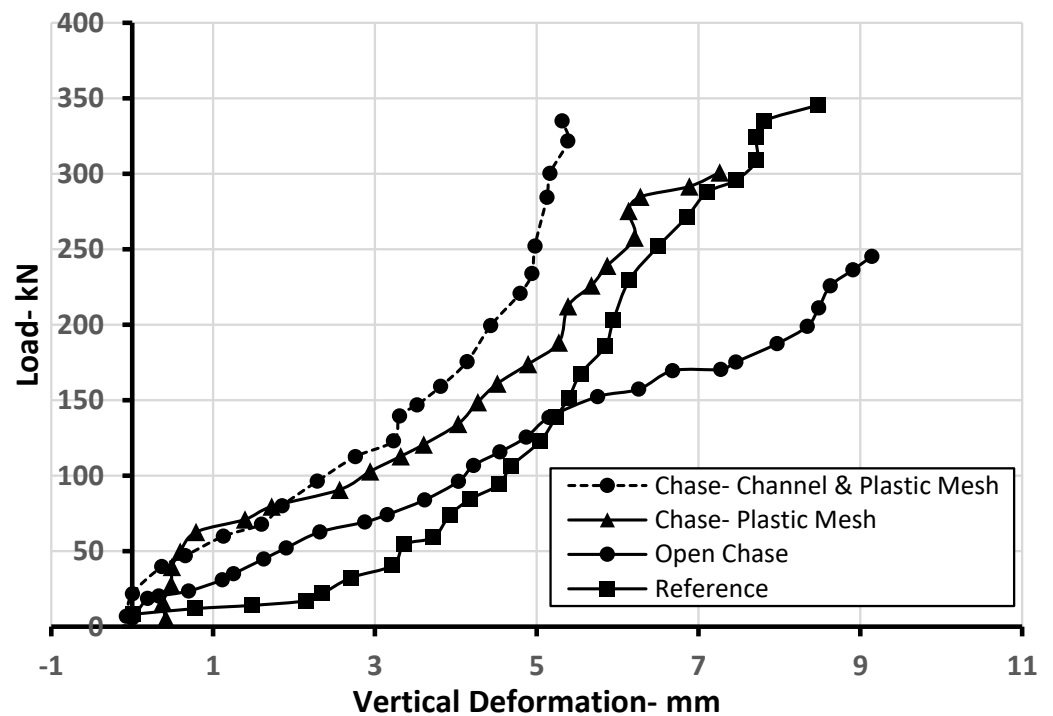
Figure 7. Load–vertical deformation for the masonry wallettes containing horizontal chases and masonry wallette without chase.

Figures 7–10 clearly show the effect of the created chases in both directions on the ultimate failure load of the wallettes. The recorded ultimate load for the reference sample was 345 kN. This level of load capacity reduced sharply to reach 250 kN (i.e., percentage reduction of 29%) due to the present of open horizontal chase at the middle height of wallette. Such reduction was associated with more deformation characteristics in both vertical and lateral directions, as shown in Figures 7 and 8. This was expected as the horizontal chase represents the weakness region which accommodates more stresses than the other regions of the wallette elements. Consequently, stresses concentration will take place at this zone result in a triaxial action exceeding the load carrying capacity of the wallette. Such attitude promises for more deformations in the available spaces. However, at a load level lower than one-third of the ultimate load, less vertical deformation was noted for the wallette samples containing open chase compared with the reference sample. Such behaviour may be attributed to the redistribution of load flow over the subjected area which is mainly governed by the depth of the chase. After the former strength level,

The use of plastic mesh and cement mortar as a renovation technique for the chases recovered the reduction in the load carrying capacity of the wallettes. As can be seen, the ultimate load at failure reached 306 kN with the use of the former technique. This forms 86% of the original load capacity of the reference wallette sample, meaning that 55% of the lost bearing capacity due to the open chase was recovered. This can be explained by the filling role of the plastic mesh and cement mortar and their adhesion to the chase surfaces. Such filling techniques provide more rigidity to the wallette system and works as disconnector for the tension lines of the inclined trusses. Thus, it was expected to have lower vertical deformation and the de-bonded failure will govern the structure behaviour under compression loading, as shown in Figure 7.

Using galvanized steel channel together with plastic wire mesh and mortar was an active renovation technique for counteracting the adverse effect of the horizontal chase. It was found that 98% of the ultimate failure load can be achieved and the value of load carrying capacity reached 340 kN. High stiffness and more ductile characteristics were the reasons for the final behaviour of this kind of renovation. In addition to the filling role, such composite material will support overall load bearing capacity and restrain the vertical deformation, as shown in Figure 7, where only 5 mm vertical displacement was recorded. Basically, the aforementioned behaviour is defined as a reinforcement action that enhances the tensile strength of the wallettes. Based on the adhesion capacity at the interfacial surfaces between the galvanized steel, plastic wire mesh and cement mortar with the interior surfaces of the chase, the failure will propagate as a debond phenomenon.

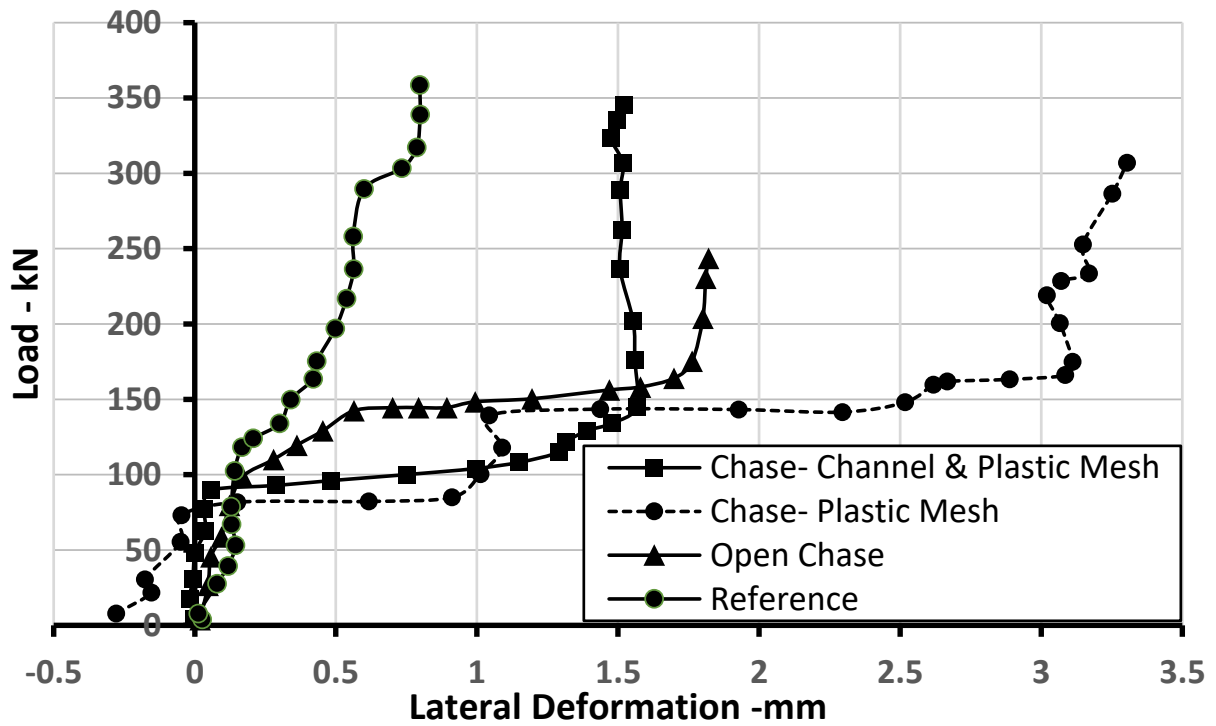
Figure 8. Load–lateral deformation for the masonry wallettes containing horizontal chases and masonry wallette without chase.

For the case of the lateral deformation shown in Figure 8, all of the tested samples revealed more lateral displacement than that of the reference wallette. The largest deformation was noted for the wallettes renovated with plastic wire mesh and cement mortar at 3 mm out of plane. This behaviour may be attributed to the nature of vertical confinement of the compression load which tends to produce lateral pushing for the regions far away for the constrained ends, i.e., mid height of the wallette. Due to the discontinuity of the wallette system, the less ductile filler of the chase shows more de-bonded behaviour and skip away out of the wallette plane. Such justification is acceptable for the case of galvanized steel channel together with plastic wire mesh filler where more ductility is available and less lateral deboned is expected. However, due to the heterogenous nature associated with the renovation technique, all of the measured cases exhibited higher lateral deformation than the reference sample which seem to be more homogenous than the others

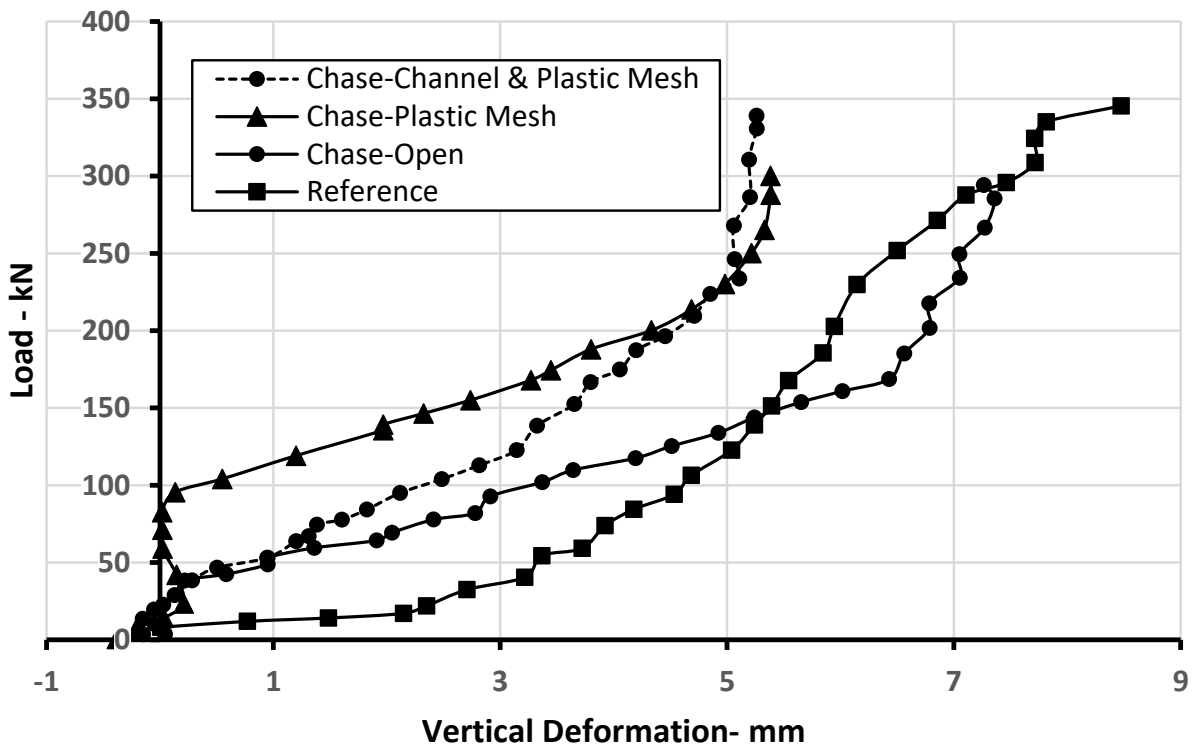
Figure 9. Load–vertical deformation for the masonry wallettes containing vertical chases and masonry wallette without chase.

A similar tendency for the wallettes with horizontal chases was noted for those containing vertical chases in terms of load-vertical and lateral deformations, as shown in Figures 9 and 10. However, a slight increase in the value of the load carrying capacity was observed for the samples tested with open chase. As the direction of the cavity located within the compression region, less reduction in the load carrying capacity occurs. The percentages decrease for the cases of open chase, chase containing plastic wire mesh and chase containing galvanized steel channel together with plastic wire mesh and mortar compared with the reference wallette sample were 15%, 13% and 2%, respectively. Similar results were also noted by Mojsilovic [11].

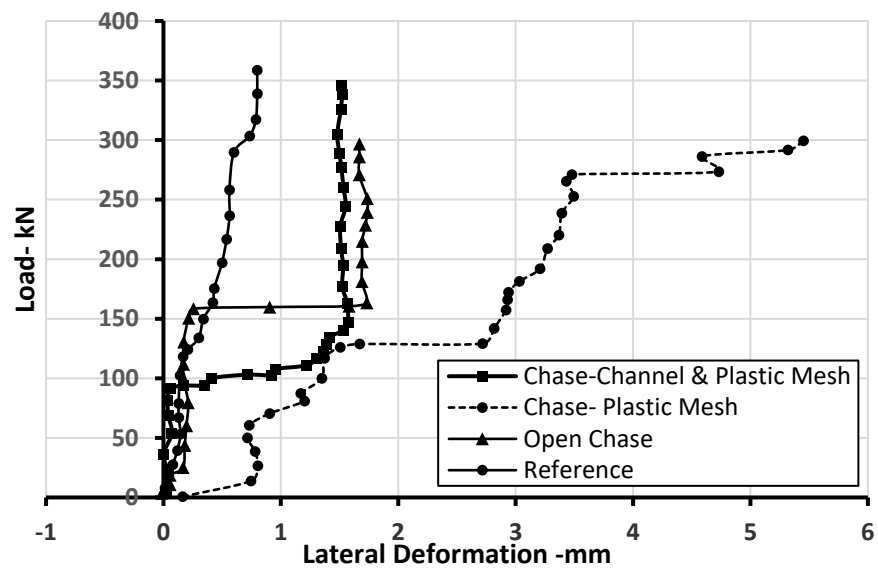
Figure 10. Load–lateral deformation for the masonry wallettes containing vertical chases and masonry wallette without chase.

Except for chase containing plastic wire mesh with cement mortar, the lateral deformation did not exceed 2 mm. The former case exhibited the highest lateral displacement at 5.5 mm, as shown in Figure 10. The justification presented for the horizontal chases is still valid and can be applied to explain the structural behaviour for the case of vertical chases.

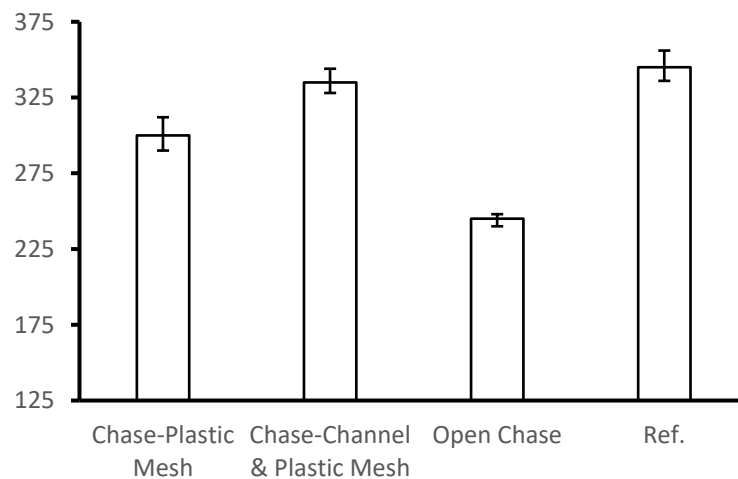
Figure 11. Statistical variation of the ultimate load for the wallette samples containing horizontal chases and masonry wallette without chase.

From a statistical point of view, Figure 11 gives an indication for the reasonable variation in the measured values of the ultimate strength, so they are valid for the comparison purposes.
