ERECTION OF A STAINLESS-STEEL TANK FOR STORING A PHOSPHORIC ACID

A storage tank for 93 % phosphoric acid was built in Luka Koper from 7 mm thick ground hot-rolled plates of 316L stainless steel. The capacity of the storage tank is of the 750 m³, diameter of 11 m and the height of 8,2 m. The shell plates were welded manually using the shielded metal-arc and gas-metal-arc processes. Before the erection, welding procedure tests according to EN 288-3 were carried out. During the construction several non-destructive examination methods were used, such as radiographic testing and visual and liquid penetrant examination. After the entire tank and roof structure were completed, a hydrostatic leak test was carried out. The surfaces of all the welds on the internal surface of the vessel were ground and the roughness was checked on site. The surfaces of the base material and the ground welds were passivated and tested for resistance to corrosion with electrochemical measurements.

J. Vojvodič Tuma, R. Celin, Institute of Metals and Technology, Ljubljana, Slovenia

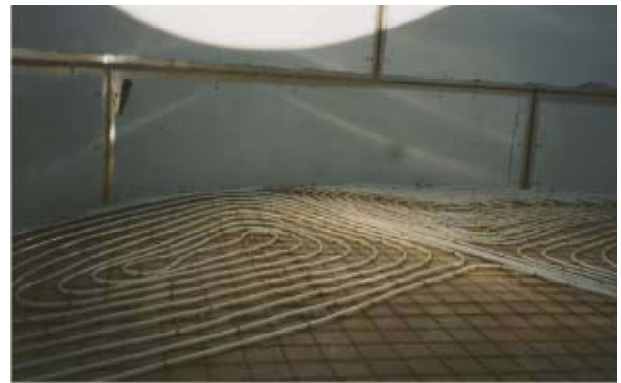
Figure 9. Heating coil on the bottom of the tank
 Slika 9. Sustav zagrijavanja dna rezervoara

foundation, following the slope layer of the concrete. The heating coil (Figure 9.) was completely covered with a second layer of concrete. The stainless-steel bottom was fitted to the last layer of concrete. Stainless-steel bottom plates with dimensions 7×1500×6000 mm were welded together with full-penetration butt welds and a backup

The storage tank shell has five 1500 mm wide courses, while the upper one is 700 mm wide. Each course consisted of five 6000 mm long sheets and an insert for the final diameter adjustment. An insulation layer and a mesh with a 730 m long heating coil were laid on the storage tank's

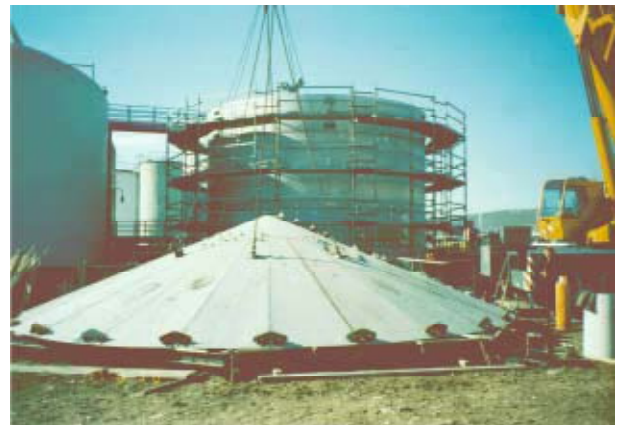
Figure 10. The storage tank's roof
 Slika 10. Krov rezervoara

bar. The incline of the storage tank stainless steel bottom is 1 %. The storage tank roof (Figure 10.) is designed as a self-supporting of membrane type.

The tank is equipped with a bottom- and shell-heating coil and the whole of the tank is covered with heat insulation of a 100 mm thick material, with a protective aluminium foil and 0.6-mm-thick steel plates covered with a paint resistant in marine environment. The bottom annular ring has a width of 200 mm and it is 7 mm thick [2]. The whole of the steel structure is anchored to a reinforced concrete foundation with twenty M16 bolts. The shell consists of a five 1,5 m high courses and with upper course of 0,7 m high. The roof of the tank is designed as a self-supporting cone of membrane type.

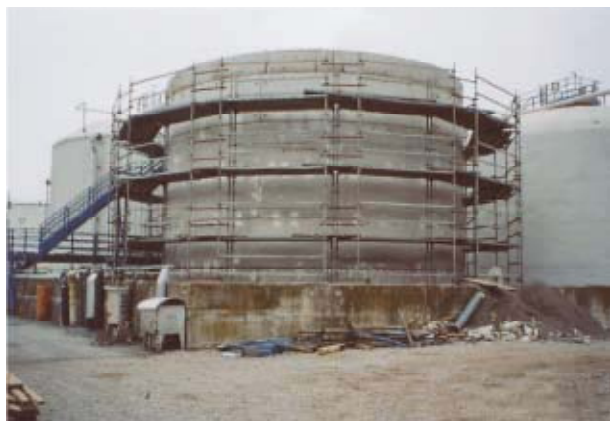
Figure 11. Erection of the storage-tank shell
Slika 11. Montaža plašta rezervoara

Figure 11. shows the storage-tank shell during the erection.

The on-site quality control consisted of control of the shell erection, retesting of the welding procedure, visual checks, liquid penetrant and the radiographic examination of the welded joints. A leak test of all the welded joints on the bottom and on the roof was carried out using the vacuum-box technique.
