THESIS FOR THE DEGREE OF DOCTOR OF PHILOSOPHY

Natural corrosion in reinforced concrete
structures

SAMANTA ROBUSCHI

CHALMERS
UNIVERSITY OF TECHNOLOGY

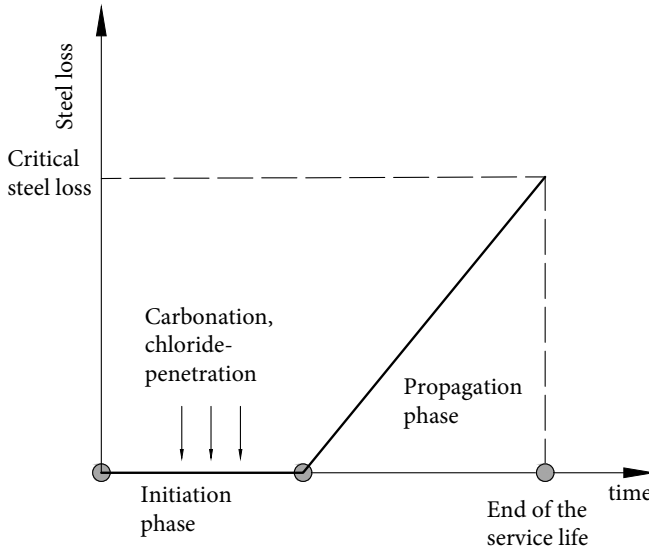
Figure 2.1: Tuutti's model for reinforcement corrosion, adapted from [5]

The time frame in which carbonation or/and chloride contamination take place is generally known as the initiation phase of the corrosion process, according to Tuutti's model [5]. Tuutti's model describes the service life of concrete with respect to degradation due to corrosion and has been commonly used since first published in 1982. The model divides the corrosion process in two phases: initiation and propagation, see Fig. 2.1.

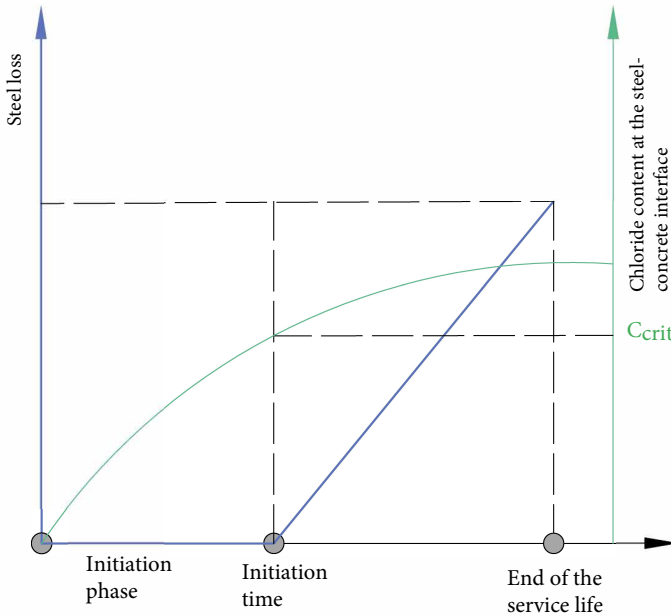
Figure 2.2: Generally assumed relationship between the chloride content at the steel-concrete interface and the corrosion initiation phase, adapted from [16]

interface and comparing it against a known threshold (see Fig. 2.2). However, both these predictions involve large uncertainties, and particularly no agreement on threshold values is found in literature [16], [35].

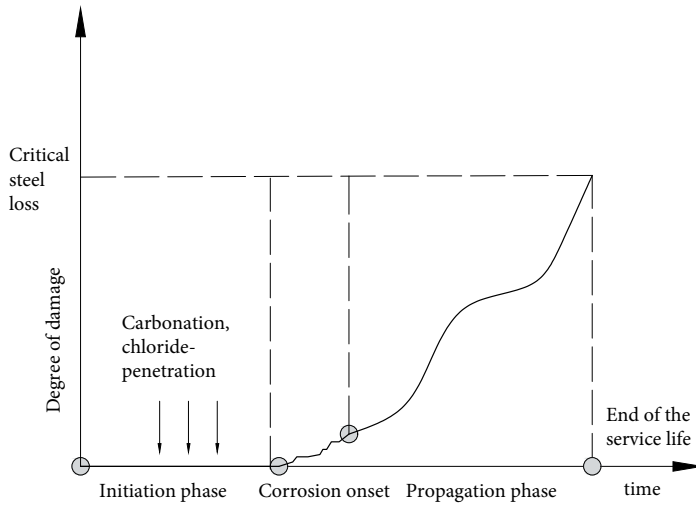
Figure 2.3: Adaptation of Tuutti’s diagram, including corrosion onset and changes in the corrosion rate through the service life of the structure [16]

The actual initiation point of the corrosion process is nowadays acknowledged not to be an instantaneous event [36]. In Fig. 2.3, Tuutti’s diagram is re-proposed, as adapted by Angst [16]. The initiation phase is now followed by a corrosion onset phase: during the onset phase, the corrosion rate of chloride-induced corrosion is highly dependent from the supply of chloride ions at the anode, and the steel may re-passivate when the supply of chlorides is not sufficient [37].

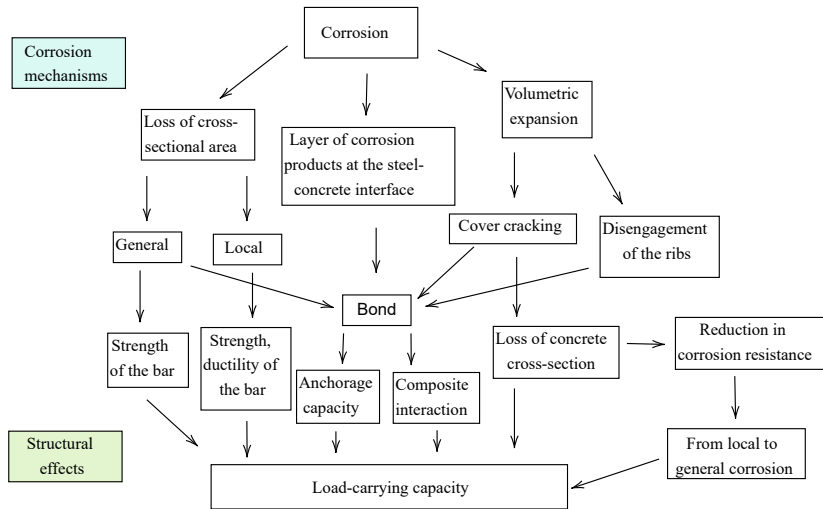
Figure 2.5: Corrosion process and its structural consequences, adapted from [25] and [56].

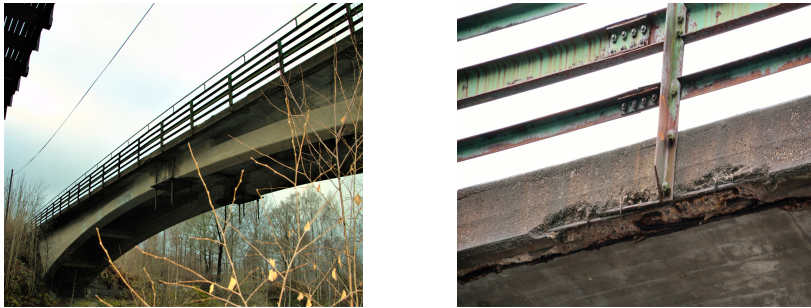
Figure 3.1: Gullspång bridge: view of the bridge before demolition (left) and exposed tensile reinforcement bars and spalling in an edge beam (right). Photos courtesy of Ignasi Fernandez

Gullspång bridge (Fig.3.1) was built in 1935 and torn down in 2016 due to heavy corrosion damages. The edge beams were carefully taken out, cut in segments and designated to be used for research. Having been exposed for 81 years to weather conditions that include snow, freezing-thawing cycles and wind, as well as to de-icing salts and traffic loads, the beams presented different cracks on their surface, and spalling strongly affected the geometry in some locations (Fig.3.1). Signs of corrosion were clearly visible, but not uniformly distributed.

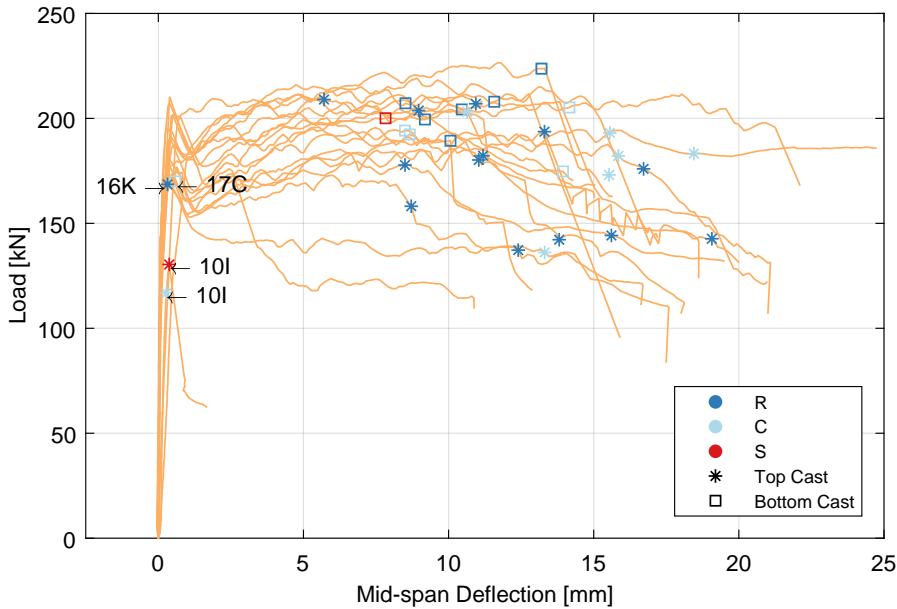
Figure 3.6: Load-mid-span deflection curves for the three-point bending tests. The markers show where each bar started to slip; colours indicate the level of damage in the anchorage zone. The impact of the cast position is shown by an asterisk for the top-cast bars and by a square for the bottom-cast bars. The labels of the beams where end-slip of one or more bars took place without yielding are marked.

The tests were characterized by the opening of one or two major bending cracks, that was closely followed by yielding of the tensile reinforcements. In most of the tested beams, their load-carrying capacity was limited by yielding of the bars. Slipping of the tensile reinforcement took place after yielding of the tensile reinforcements. The beams failed in bending: slipping of the bars occurred at a point where the bending cracks had already reached an opening width of several centimetres. In Fig. 3.6 load-displacements curves for each tested specimen are presented. In Fig.3.7, the typical crack patterns exhibited by the specimens are shown.

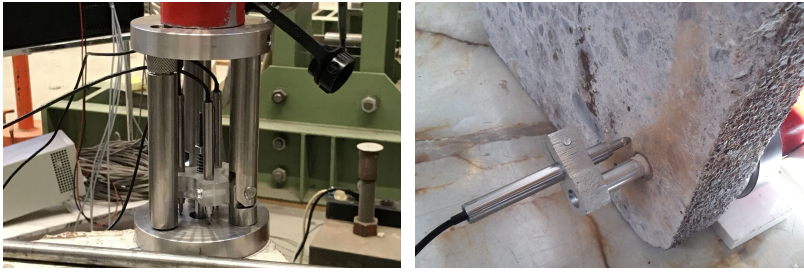
Figure 3.9: Photographs of pull-out rig and slip measurement devices. Note that specimen to the right is tilted with respect to normal testing position to better show the measurement device.

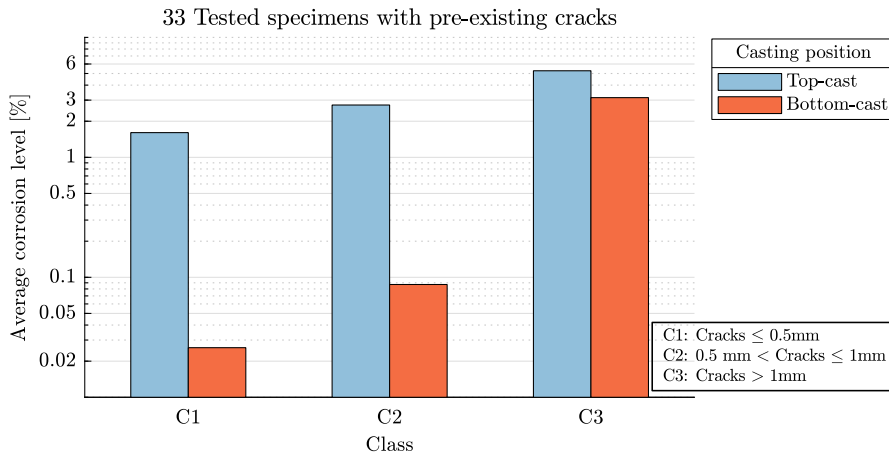
Figure 3.10: Average corrosion level of specimens with cracks in the surrounding concrete, sorted by crack width. Note that the y-axis is in logarithmic scale.

as observed as well in the previous tests. Additionally, as shown in Fig. 3.10, the corrosion level necessary to damage the surrounding concrete was observed to be smaller for bottom-cast bars than for top-cast bars. This is likely a consequence of the concrete density variation.
