Impacts of environmental and hydrologic factors on urban stream water quality.

IMPACTS OF ENVIRONMENTAL AND HYDROLOGIC FACTORS ON URBAN
STREAM WATER QUALITY

Master of Science of Civil Engineering

Civil and Environmental Engineering
University of Louisville
Louisville, Kentucky

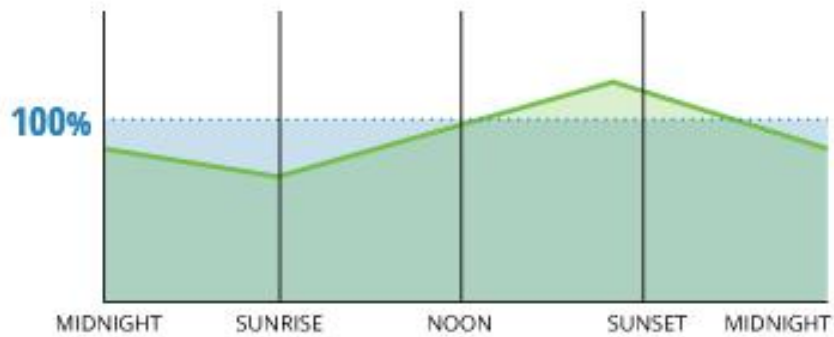
Figure 4.7 Dissolved Oxygen concentrations in a stream over one day (Fondriest, 2019)

The use of solar radiation changes the oxygen produced and used throughout a day. When the sun rises, plants begin to produce oxygen, meaning the dissolved oxygen concentration is at its lowest levels at dawn (Allan, 2007). As the day progresses, the

oxygen will increase until species become active and begin to consume the oxygen produced, causing it to reduce again. Once the sun sets, the oxygen will reduce to low levels, again. Figure 4.7 illustrates these changes in dissolved oxygen concentrations of a stream throughout a day.

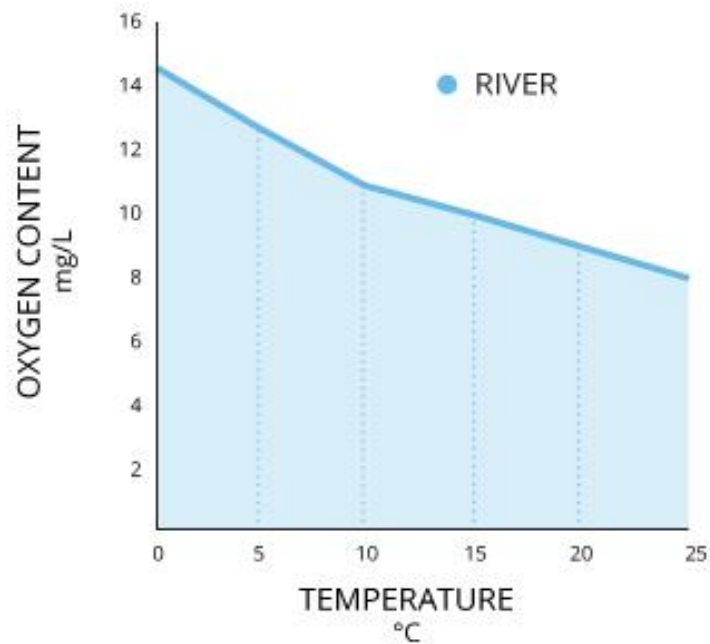
Figure 4.8 Dissolved Oxygen Concentration vs Temperature in a river system (Fondriest, 2019)

Rises in temperature have an effect on the oxygen concentration in the water. Dissolved oxygen is lower in concentration in warmer waters because of the faster speeds of the excited molecules of water that allow oxygen to escape (Allan, 2007). In colder water, the molecules are slower allowing for more of a concentration of oxygen in the water (Allan, 2007). Figure 4.8 below shows the effect of temperature on the DO concentration in a river.

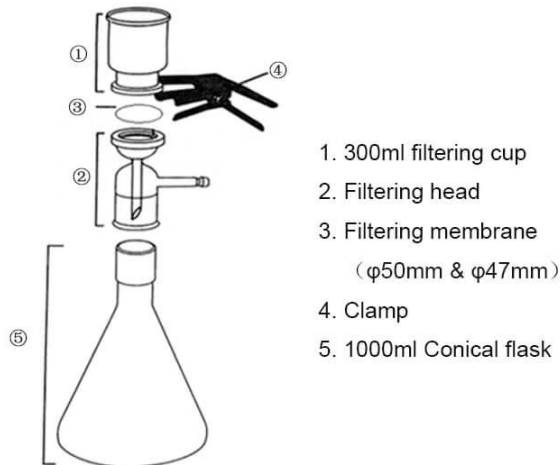
Figure 4.9 Filtration Apparatus Diagram (toptionlab.com, 2020)

This test was completed in the Deborah Yoder-Himes Biology Laboratory at the University of Louisville. This lab provided items for the apparatus that contained the filtration. A diagram of the filtering apparatus is in figure 4.9 below. The apparatus parts used were a filtering cup to funnel the sample water through the filter head. The filter head had a piece of sterile 47 mm filter membrane on top of it for the sample water to filter through. When the water went through the membrane the e. coli colonies would remain on the filter paper because they are too large for the 0.45 μm pores. These pieces were held by a clamp to a conical flask to store the wastewater of the filtration. The flask also came equipped with an outlet to attach a rubber hose to the vacuum spout in the lab to create a vacuum within the apparatus.

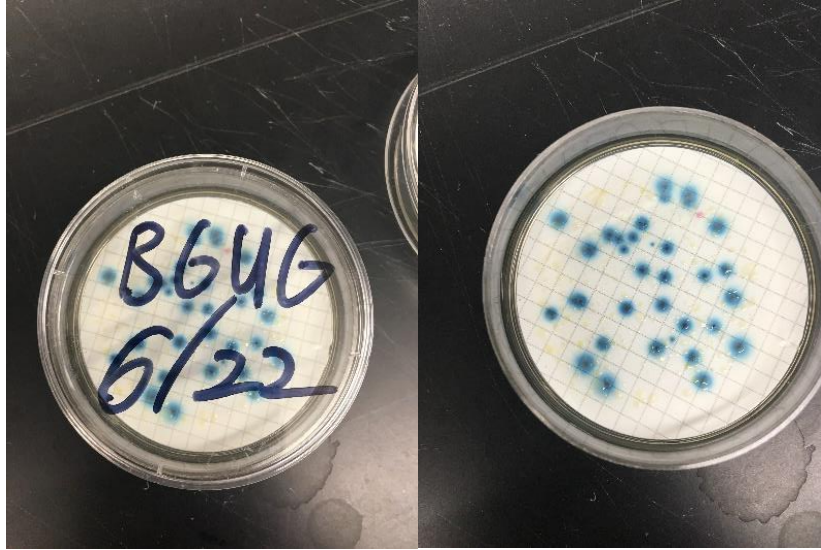
Figure 4.10 (a) Beargrass Creek Upstream Grab sample (BGUG) example results
(6/22/19)

Once the samples were diluted and filtered through the vacuumed sterile filter membrane, the funnel was unclamped to remove the funnel cup. Once removed, the filter membrane could be removed and placed on the MI agar medium at room temperature. MI agar is a “chromogenic/fluorogenic medium” (Oshiro, 2002). The reason the filter membrane with the e. coli colonies were placed on this medium was because it contained enzymes that allowed the colonies to survive, but not grow. The MI agar used in this experiment was Difco™ MI Agar, which contained a variety of ingredients including yeast extract and required an antibiotic to be used to ensure no outside contamination of the mediums. Another useful property of the medium was that it caused the e. coli colonies to appear as blue when the membrane was placed on it after filtration. This color contrast of blue colonies on the tan medium allowed for easy counting. The colonies would only change into this blue shade 24 hours after filtration when left in an incubation. For this study, an incubation room was used at 35 °C. The results were petri dishes with blue colonies scattered throughout that could be counted before properly being disposed of. All equipment was washed and sterilized after each membrane filtration. Figures 4.10 a, b, and c below are a few examples of the results.

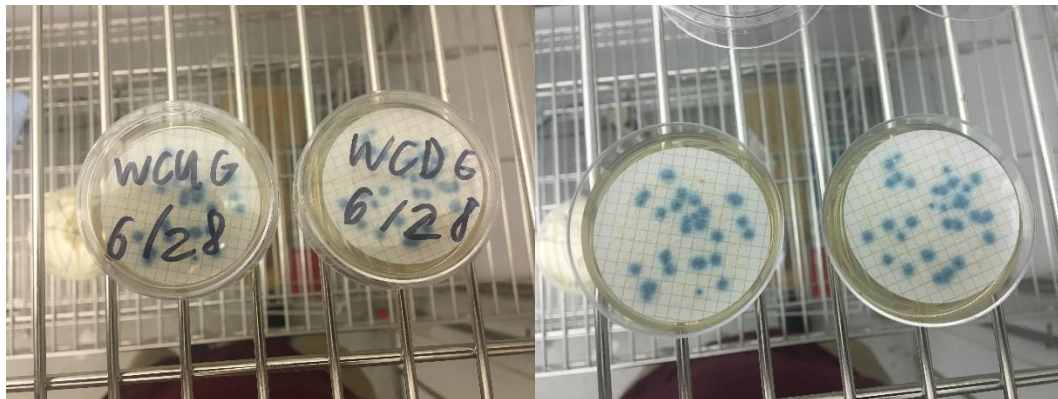
Figure 4.10 (b) Wilson Creek Upstream & Downstream Grab sample example results
(6/28/19)

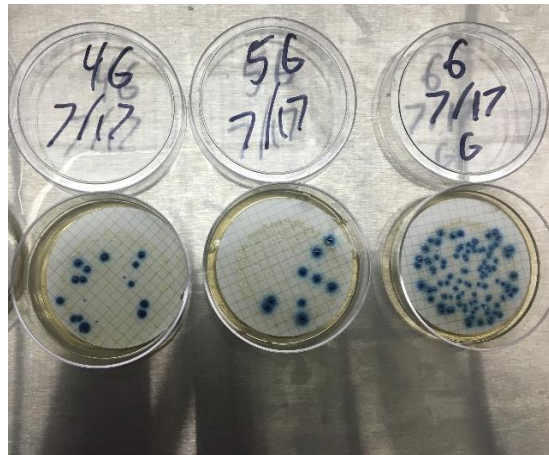
Figure 4.10 (c) Mill Creek example grab (G) sample results for sites 4, 5, 6 (7/17/19)

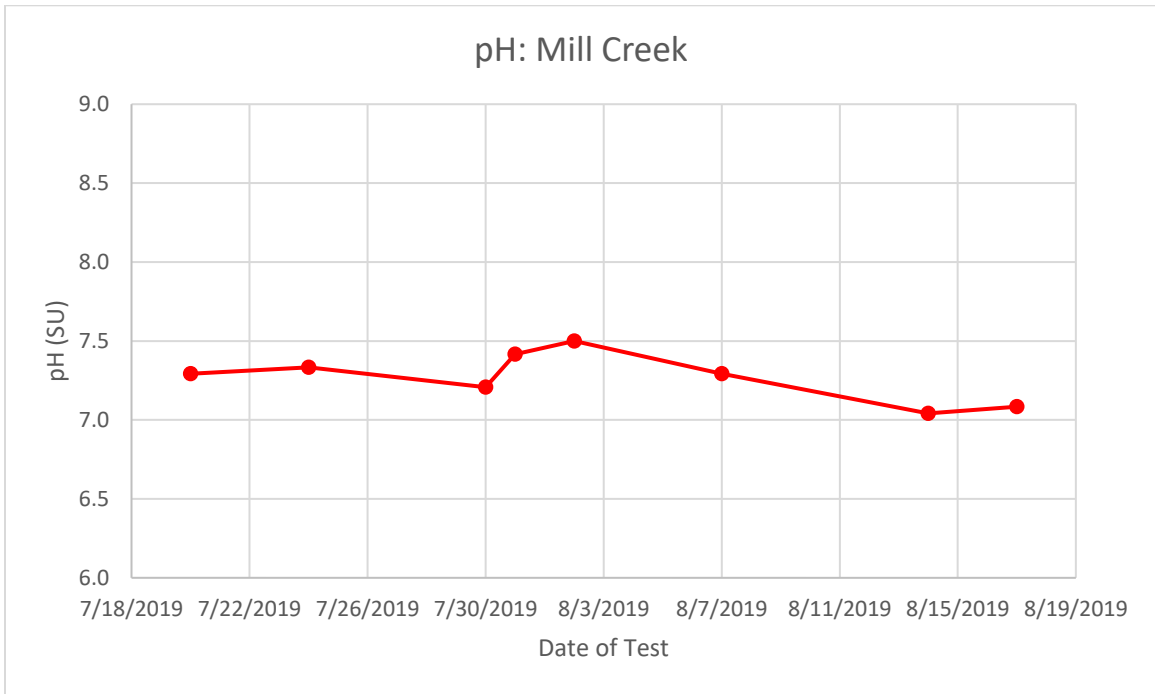
Figure 5.1 pH Average for the 6 gaging sites for Mill Creek

For both July and August there were zero days with violations to the KAR standards of surface water quality in the categories of pH and water temperature. The conductivity levels were also in the recommended zone to sustain fish populations. These three parameters are graphed as the average of the six sites below in figure 5.1 for pH, figure 5.2 for water temperature, and figure 5.3 for conductivity.

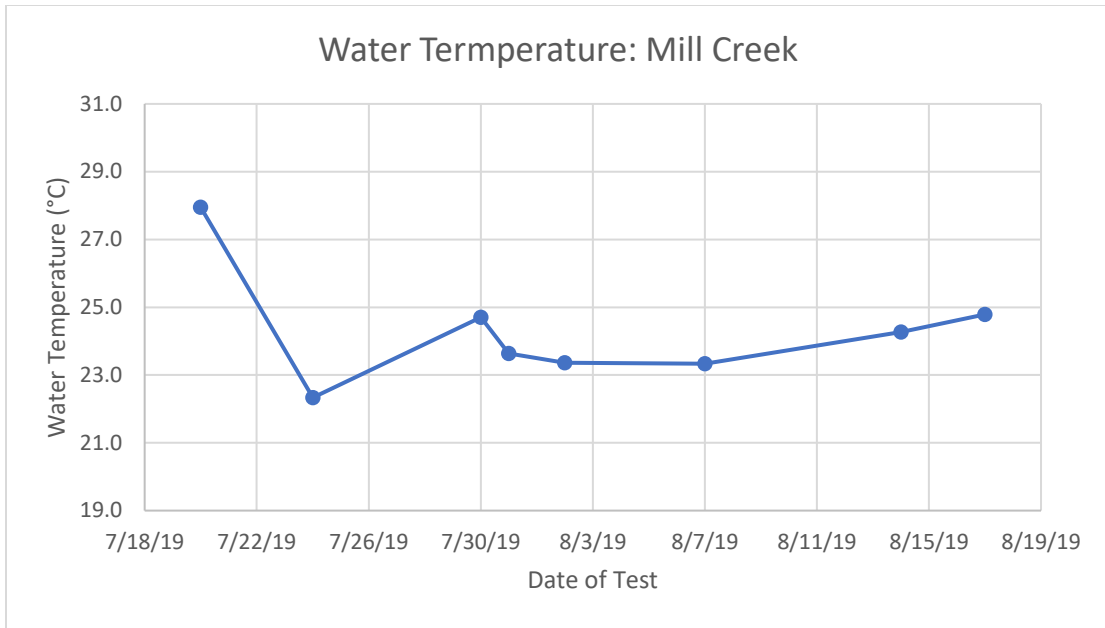
Figure 5.2 Water Temperature Average for the 6 gaging sites for Mill Creek

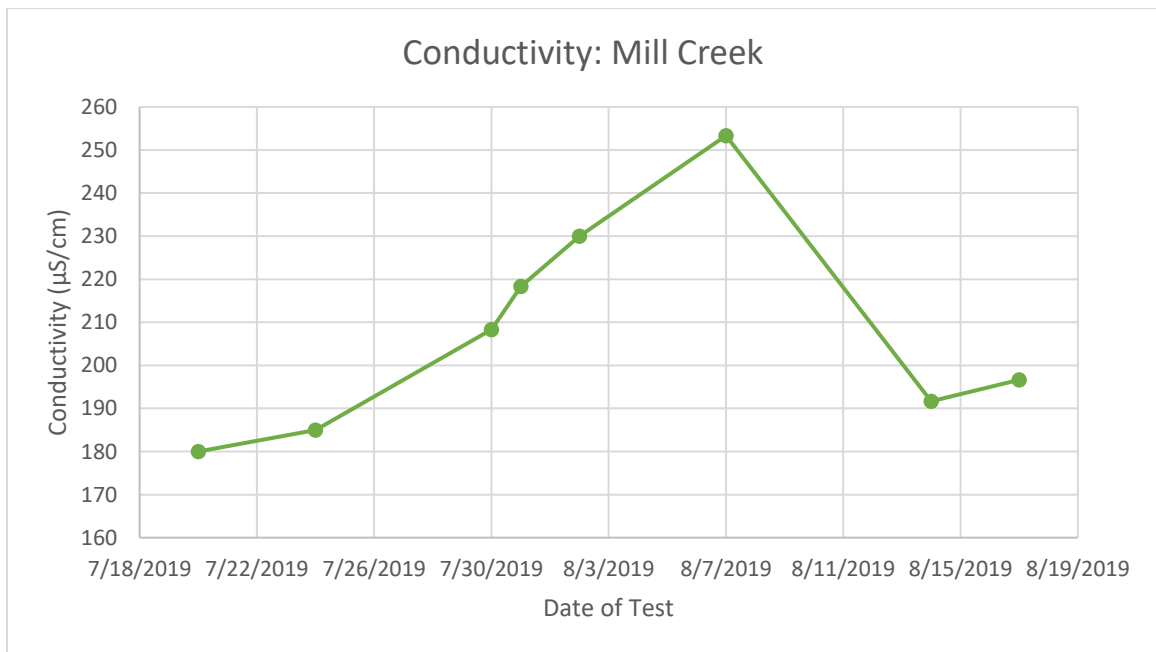
Figure 5.3 Conductivity Average for the 6 gaging sites for Mill Creek

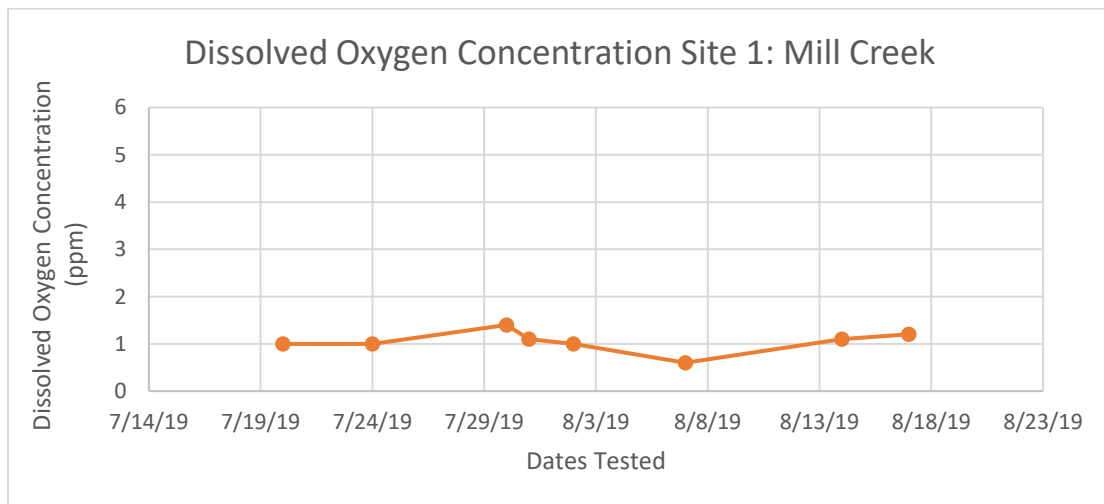
Figure 5.4 (a) Mill Creek Dissolved Oxygen (DO) Concentrations for site 1

The dissolved oxygen has been found to be lower in warmer waters due to the faster motion of the water molecules (Allan, 2007). The decrease from a DO concentration rating of fair to poor (from the 2016 report to these 2019 results) is a result of the regions high temperatures without precipitation as seen with the NOAA data. Rainfall in the summer increases the average dissolved oxygen concentration in water body by mixing and cooling the water (Allan, 2007). In this study, the average DO for each site on days without rain was less than the DO on the days with rain. From July 3rd to July 16th and from July 31st to August 12th of 2019 there were zero days with precipitation, but temperatures reached highs up to 35 °C. In this time, the water only

reached above Kentucky standards for DO the first day of the period without rainfall at one site. During the period of time without precipitation in the Mill Creek study, 5 of the 6 sites decreased in DO concentration over time while temperatures rose from 30.6 °C to a high of 35.6° C on the August 10th. Temperatures dropped on August 13th and precipitation was recorded for two days straight after. After this rainless period, during the rainfall testing day of August 14th, 2019, half of the sites increased in DO levels with one location's concentration moving above regulations for Kentucky.

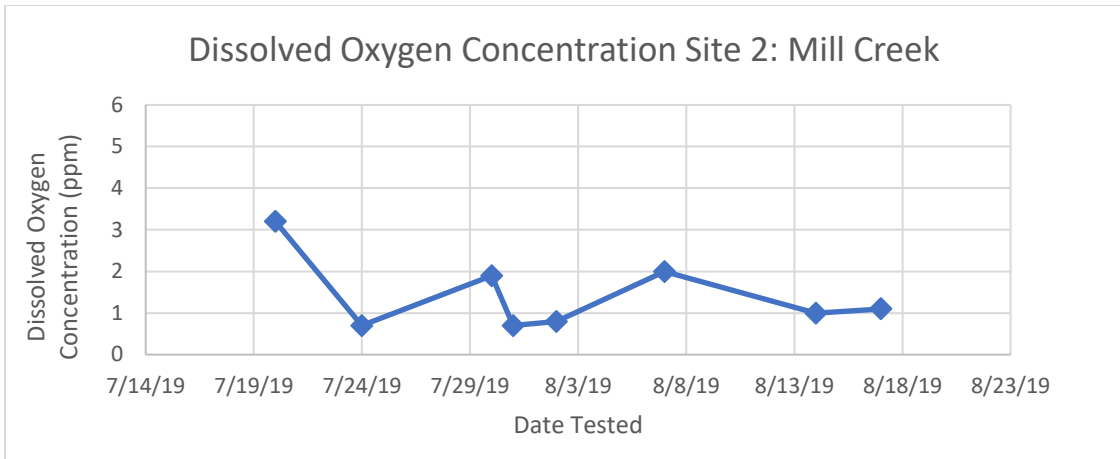
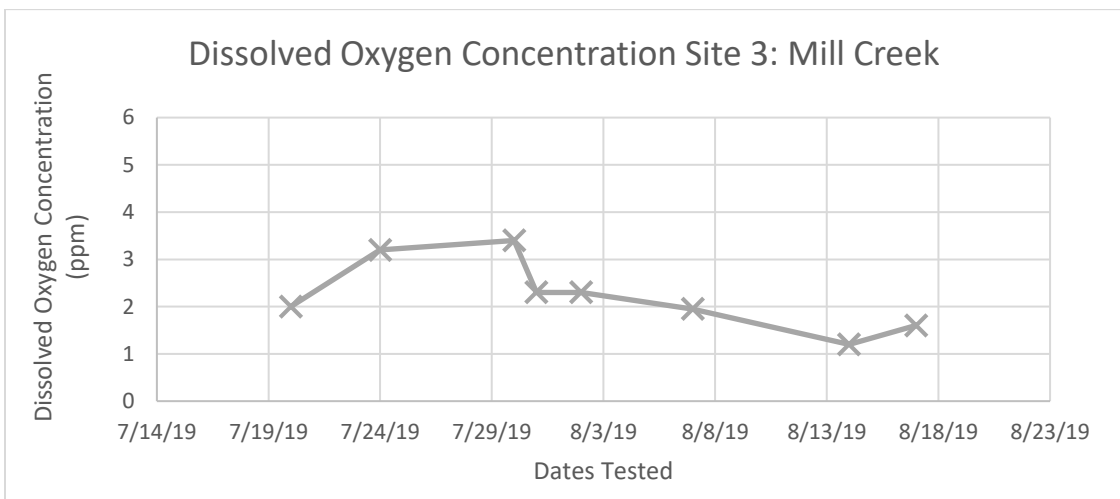
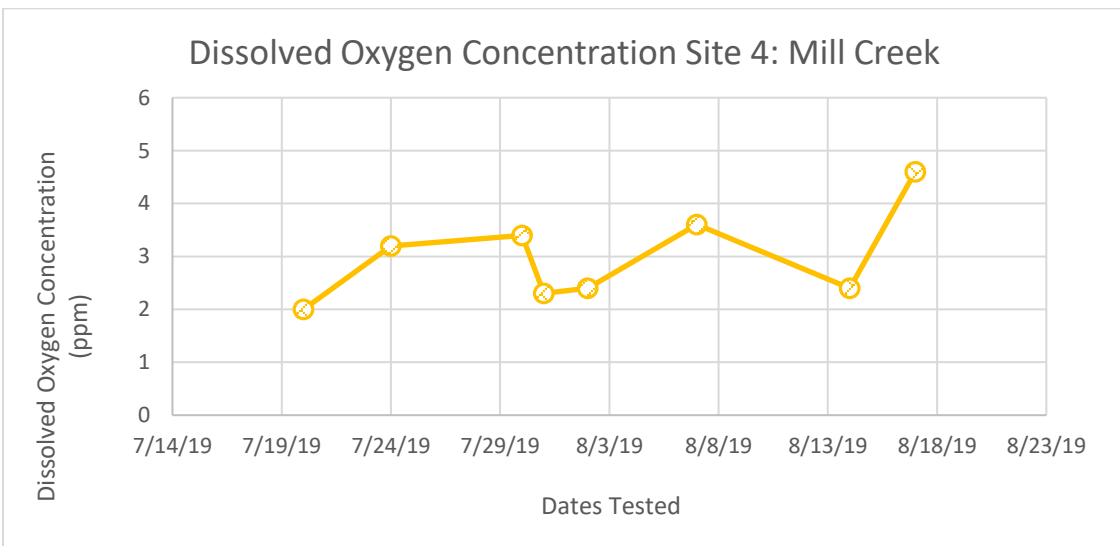
Figure 5.4 (b-d) Mill Creek Dissolved Oxygen (DO) Concentrations for sites 2-4

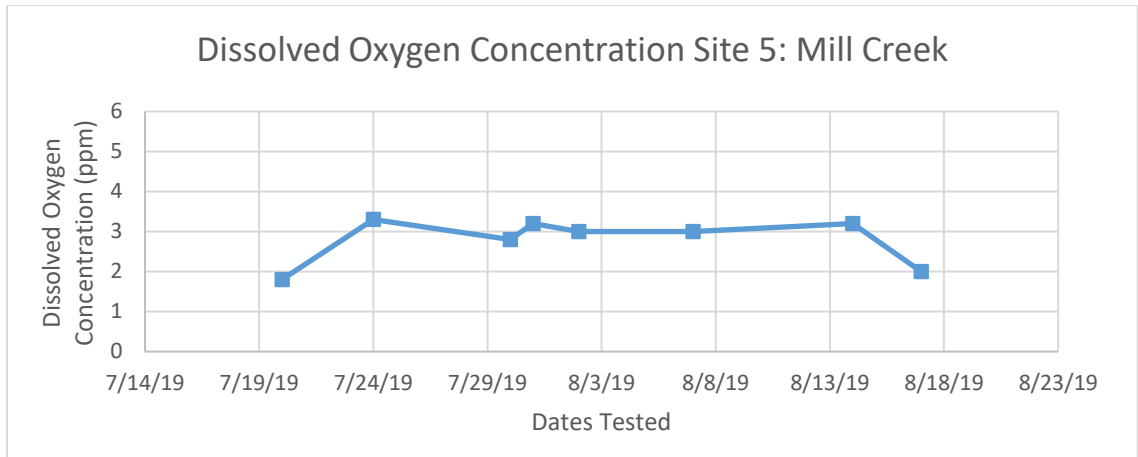
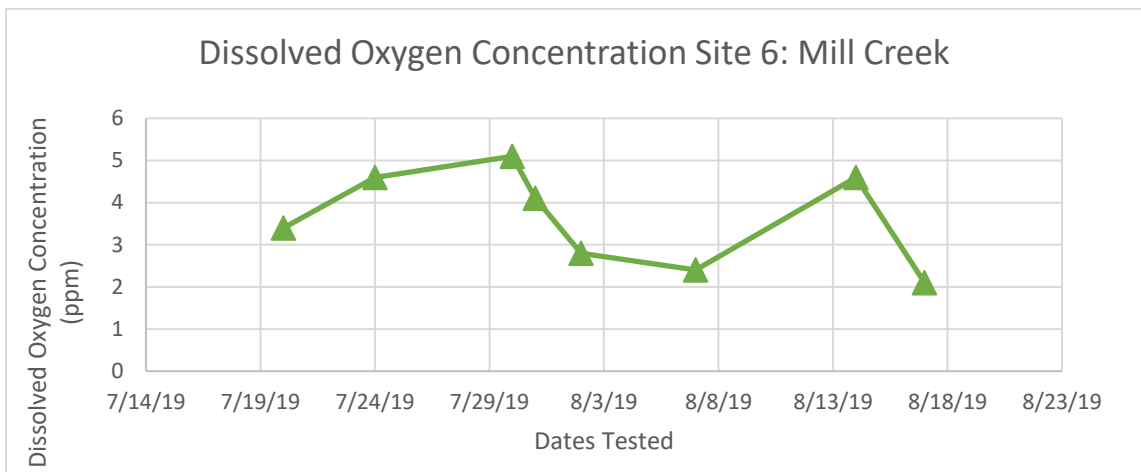
Figure 5.4 (e-f) Mill Creek Dissolved Oxygen (DO) Concentrations for sites 5-6

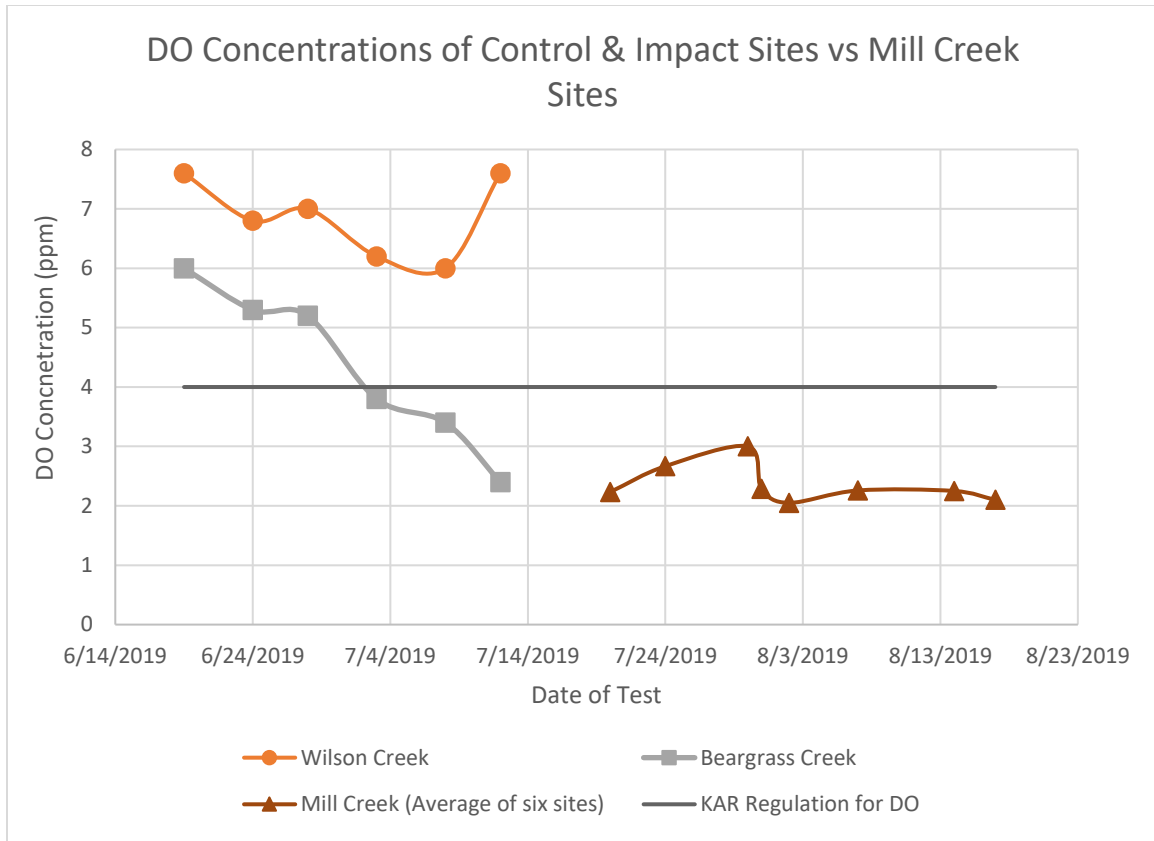
Figure 5.5 DO Concentrations of Control & Impact sites vs Mill Creek sites

The severity of the deterioration in the water quality of Mill Creek is illustrated when compared to other local streams using the Before-After-Control-Impact (BACI) method. A comparison of DO concentrations for Mill Creek to the control and impacted sites are in the following graph, in figure 5.5.

The control creek (C) in BACI was Wilson Creek, which always contained acceptable levels of dissolved oxygen. This is the result of the canopy coverage of vegetation in the wooded area keeping water temperatures down with shading. Shading can keep water temperatures down, reduce greenhouse gases like carbon dioxide that absorb heat, and reduce evaporation allowing higher volume for flow rates in the creek to maintain movement for oxygen to be captured from the atmosphere. This is compared to the urban stream with removed canopy coverage for urban expansion, Mill Creek, where DO concentrations were always below standard. This result indicates that replanting canopy coverage removed during construction of urban and suburban areas could be a solution for urban streams to combat high temperatures. Mill Creek contained foliage on either

side of the stream, but for large stretches not within the riparian zone directly along the creeks bank. Therefore, the stream was exposed to the solar radiation and carbon dioxide from human activity in the region. The Creek was noticeably pooled in parts during times of low rainfall, leading to less reoxygenation. This is similar to Beargrass Creek, the impacted creek (I). DO was found to be below standard at this location with values closer to Mill Creek than Wilson Creek. Beargrass Creek is an urban stream with similar conditions of less foliage for shading and low water levels. This requires Beargrass Creek and Mill Creek to depend on precipitation for mixing the waters to restore DO levels, but without physical characteristics to maintain restored levels. Therefore, DO will be a problem for the quality of these urban streams during the high temperatures of the summer.

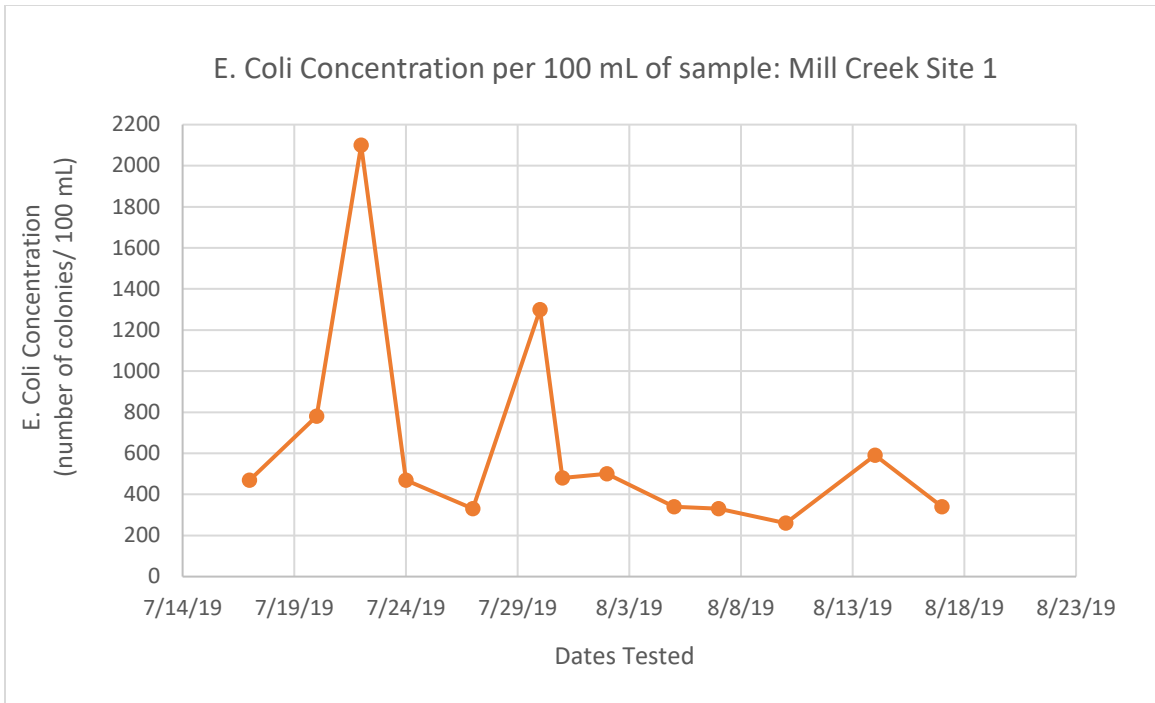
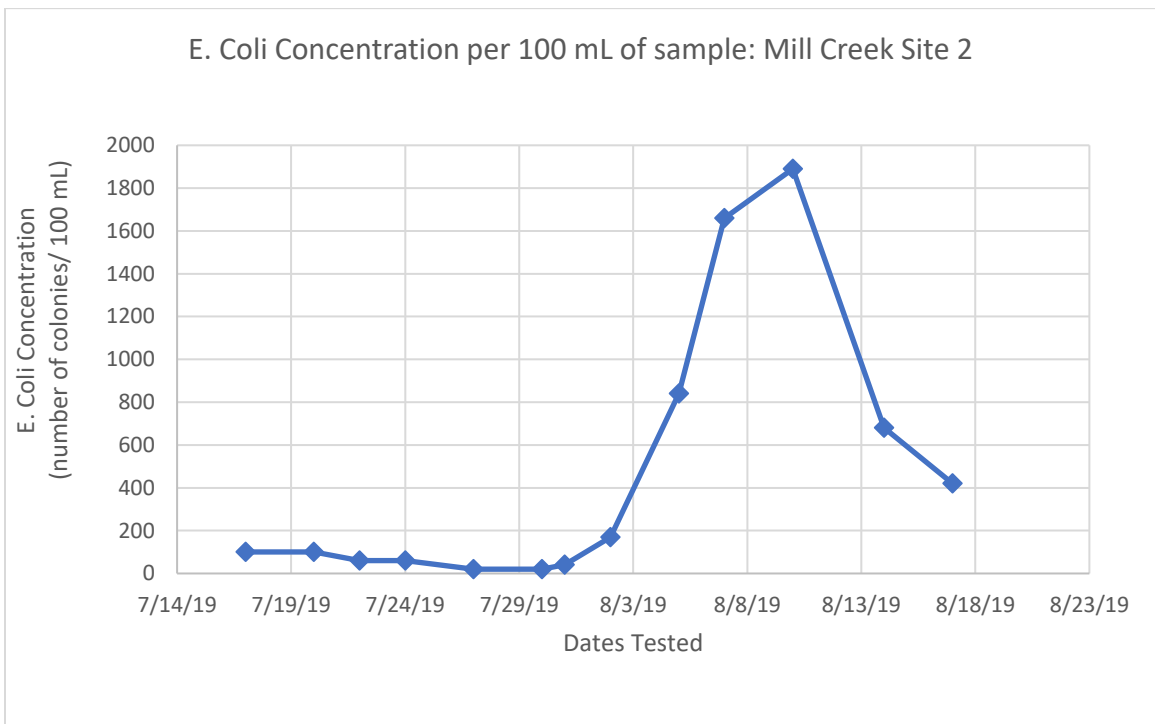
Figure 5.6 (a-b) Mill Creek E. Coli Concentrations for sites 1-2

E. coli concentrations of grab samples were tested in the biology lab after proper storage and transportation from the field. Graphs of the concentration for each site are below in figure 5.6 (a-f). These individual graphs for unique data points at each site illustrate increases or decreases of e. coli concentrations. The concentrations for each site then is analyzed with the unique environmental and hydrologic factors of the creek, including the climate of that day. This will allow for trends to be discovered for locations along the stream with more data points.

One site was up to standard for acceptable e. coli levels in both July and August. This location on Mill Creek was site 4. Site 2 resulted in acceptable e. coli concentrations in July, but not August. Inversely, site 3 contained acceptable e. coli concentrations in August, but not July. The five sample geometric means are how the KAR standards determine the quality of the water instead of an instantaneous single sample result. The geometric means for each site in the July and August testing periods are below in Table 5.6.

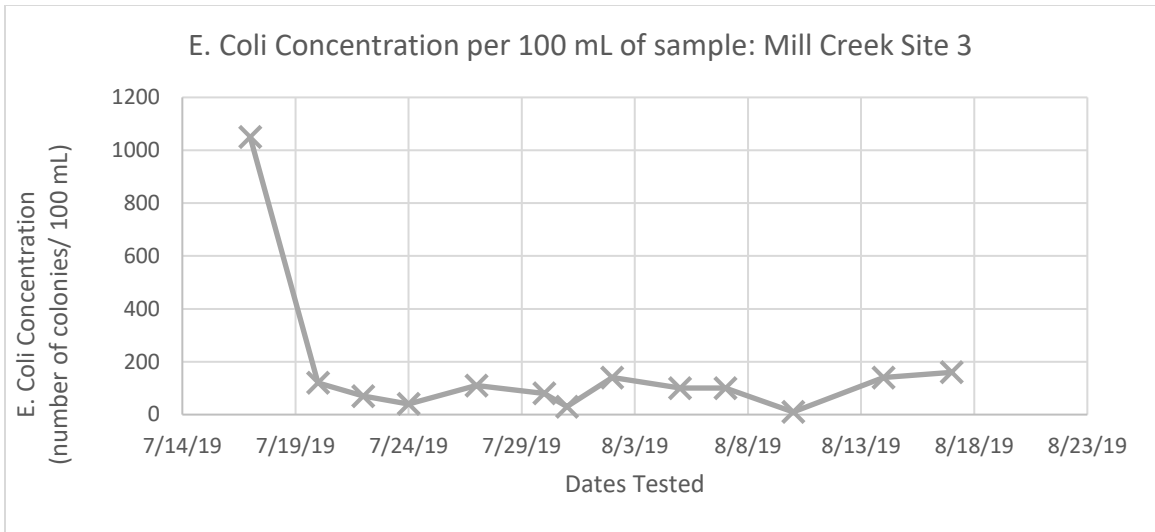
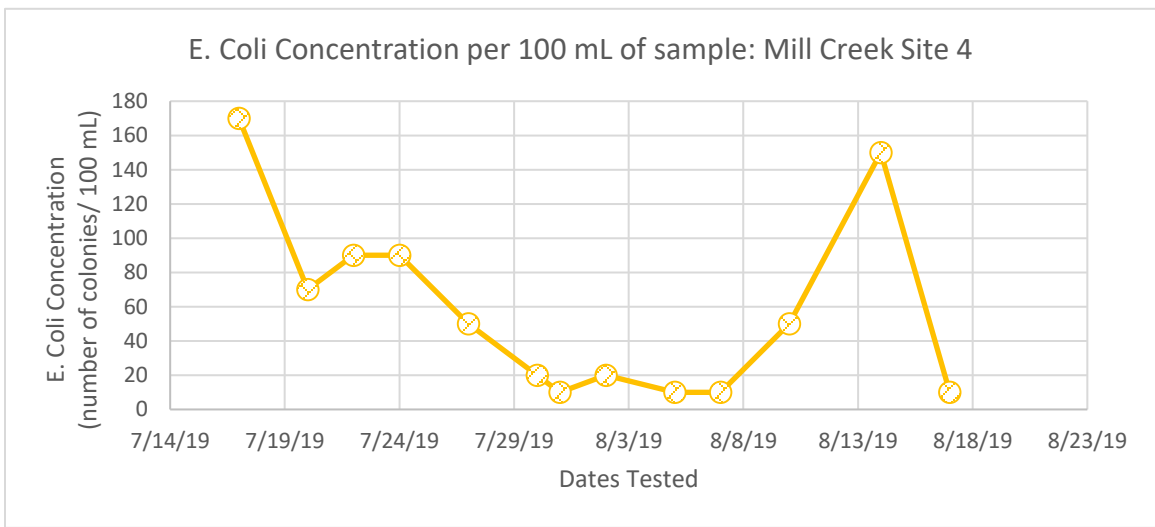
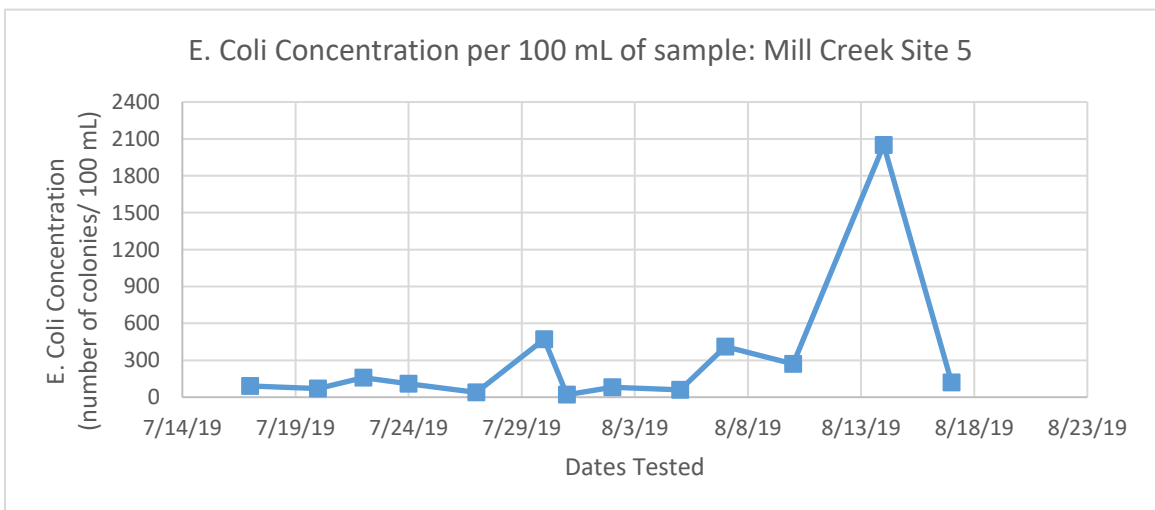
Figure 5.6 (c-e) Mill Creek E. Coli Concentrations for sites 3-5

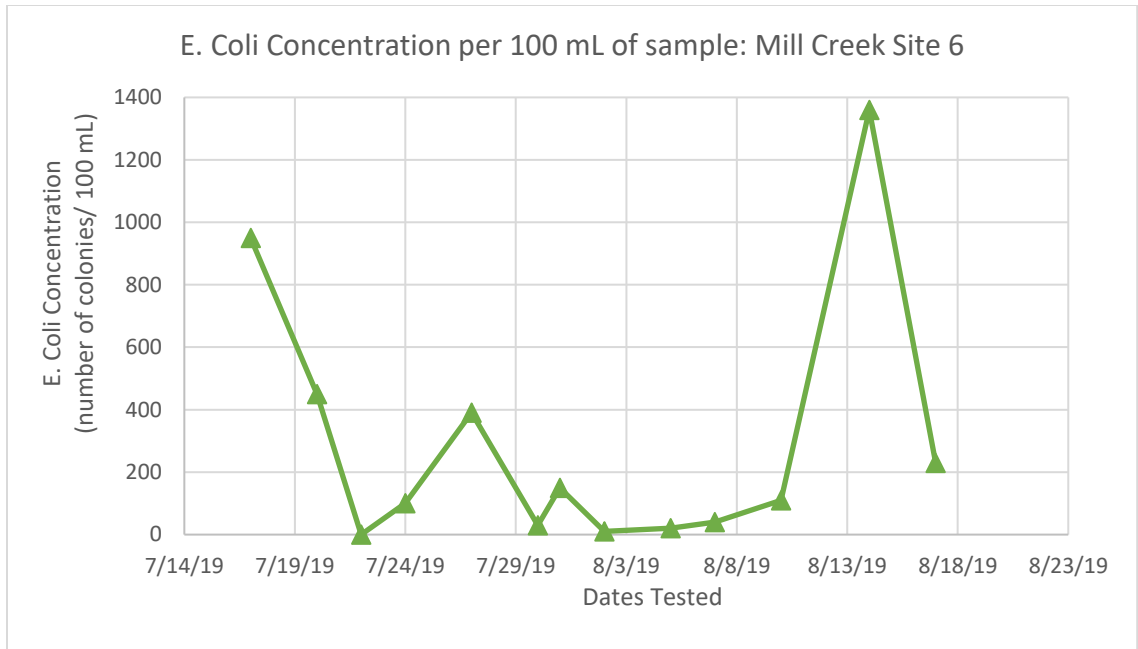
Figure 5.6 (f) Mill Creek E. Coli Concentrations for site 6

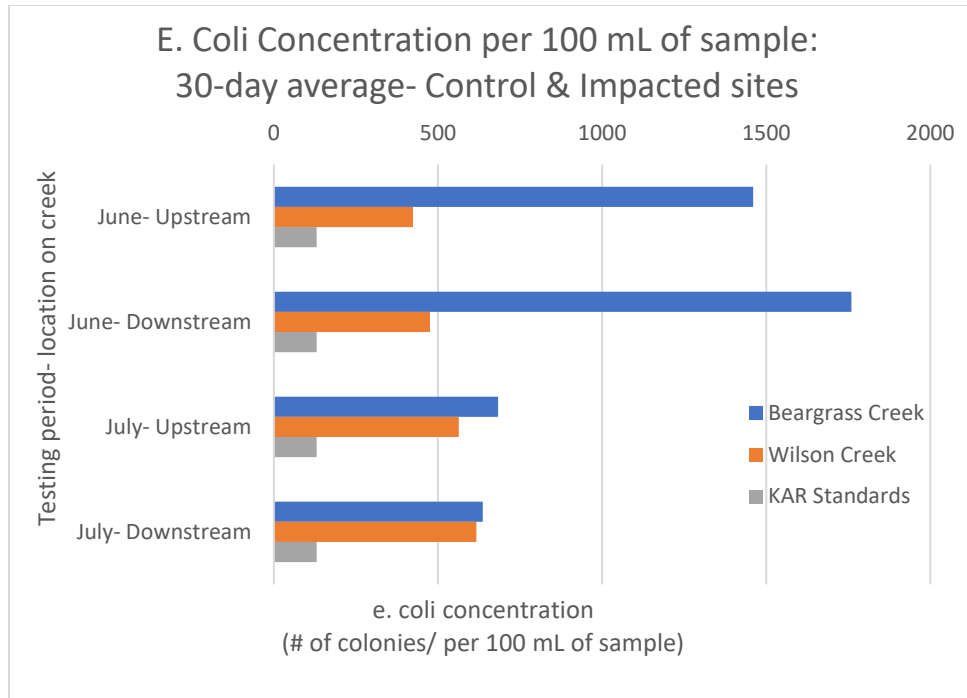
Figure 5.7 (a) E. Coli Concentration per 100 mL of sample: 30-day average: Beargrass Creek & Wilson Creek

Creek) were not within Kentucky regulations either and on average worse than most of Mill Creek (5 of 6 sites each month). Figure 5.7 (a) illustrates the geometric mean of e. coli concentrations for each testing period for the control and impacted sites tested. Figure 5.7 (b) illustrates the geometric mean of e. coli concentration as the average of each site in the July and August testing period.

Mill Creek was closer in values for e. coli concentration to Wilson Creek than Beargrass Creek. The reason is that Mill Creek and Wilson Creek do not contain CSOs, but Beargrass Creek does. CSOs by design discharges domestic wastewater with fecal contamination mixing with storm water directly into Beargrass Creek whenever the storm sewers cannot handle the surface runoff. In comparison, other streams receive concentrations of e. coli from surface runoff. Surface runoff is a non-point source pollutant whereas CSOs are point-source pollutants, therefore the e. coli concentrations would be expected to be closer to Wilson Creek than Beargrass Creek (Basic, 2018) (Nonpoint, 2017). The values seen on Wilson Creek for e. coli could be the result of a non-point source pollution upstream that this study could not identify. Possibilities include fertilizer and animal waste in runoff from small farms, sediment runoff, or illegal discharge of wastewater of a resident in the region (Basic, 2018). This differs from Mill Creek pollution sources because Mill Creek is in an urban watershed with urban runoff polluting the stream, for instance oil, grease and toxic chemicals from motor vehicles, pesticides and nutrients from lawns and gardens (Nonpoint, 2017). Overall, the impacts of urbanization found in this study on urban streams is a rise in concentration of e. coli and a decrease in the DO. Urban growth will continue to exacerbate the issues experienced in urban streams if the trends in land use and climate data continues as shown.

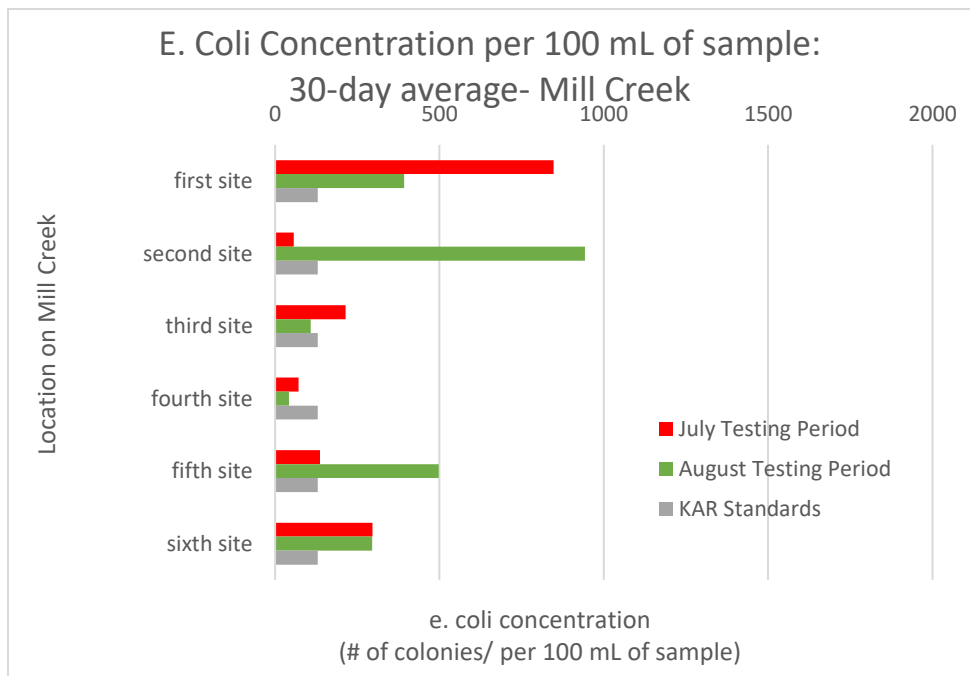
Figure 5.7 (b) E. Coli Concentration per 100 mL of sample: 30-day average: Mill Creek

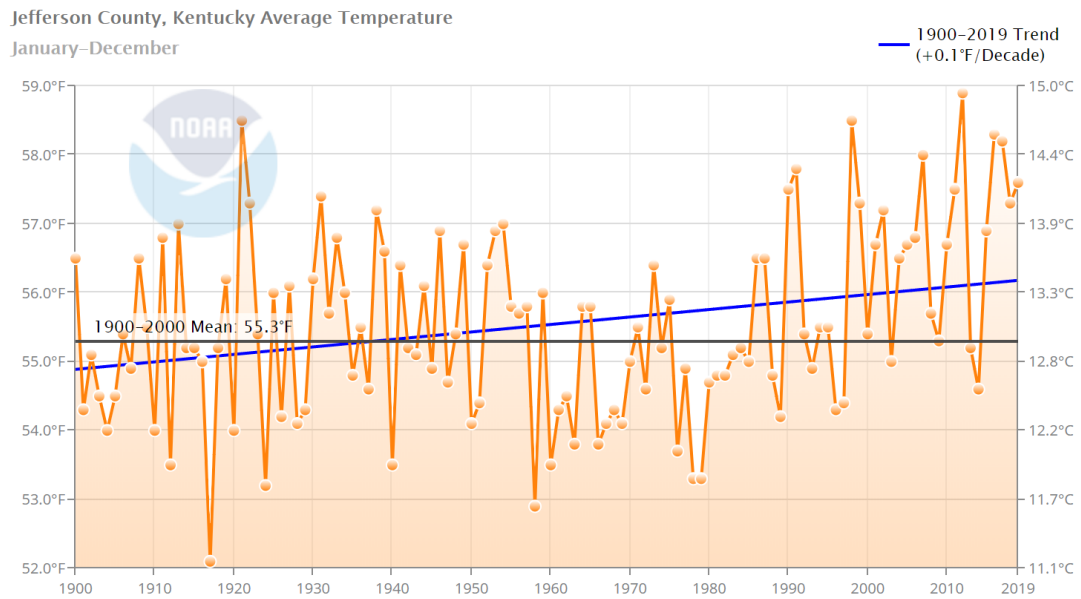
Jefferson County Average Annual Atmospheric Temperature (1900-2019) (NOAA, 2020)

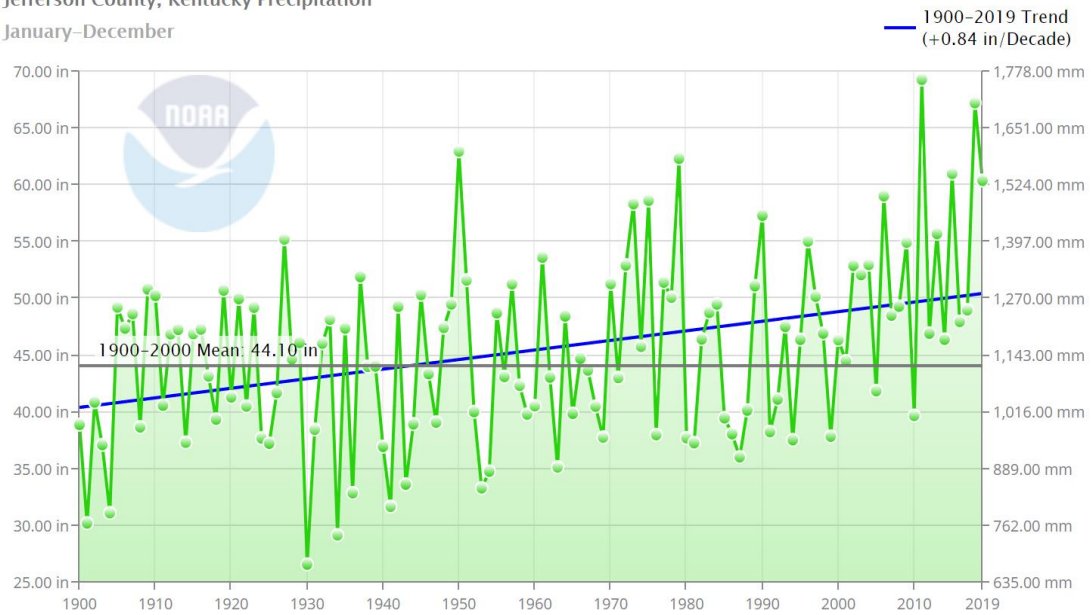
Jefferson County Annual Precipitation levels (1900-2019) (NOAA, 2020)

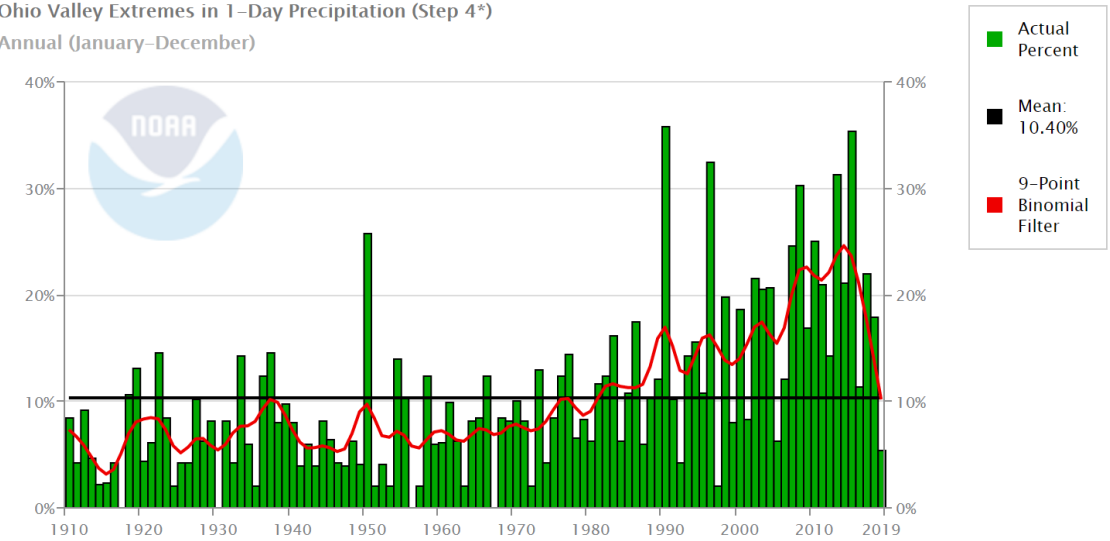
Ohio River Valley Extremes in 1-Day Precipitation (1910-2019) (NOAA, 2020)

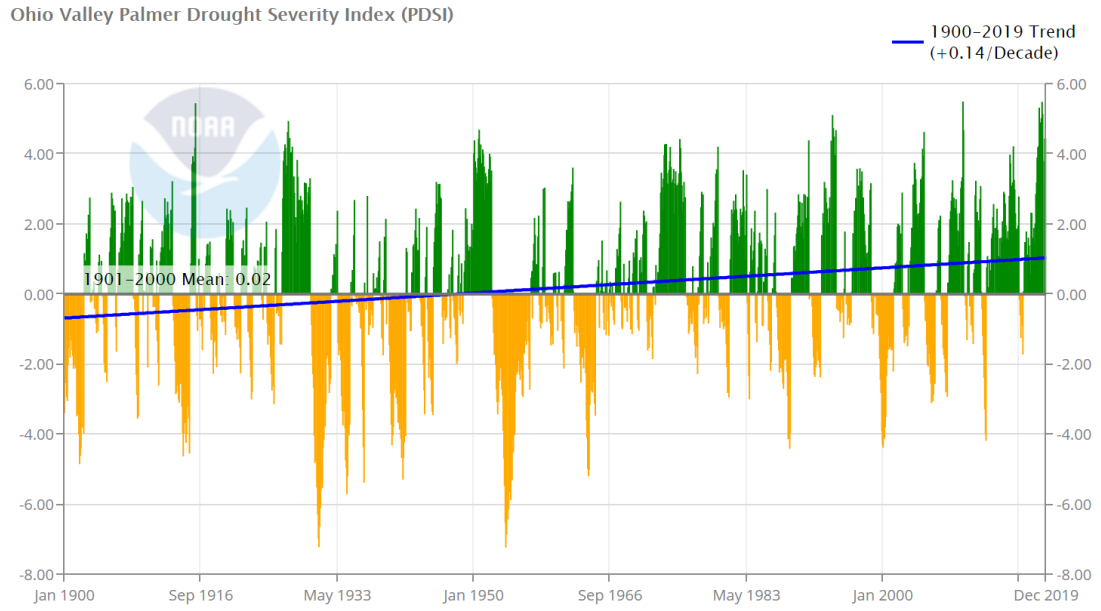
Ohio River Valley PDSI (1900-2019) (NOAA, 2020)
