## **Significance of Cracks in Durability Design and Assessment of Hydraulic Concrete Structures due to Reinforcement Corrosion**

# **SIGNIFICANCE OF CRACKS IN DURABILITY DESIGN AND ASSESSMENT OF HYDRAULIC CONCRETE STRUCTURES DUE TO REINFORCEMENT CORROSION**

Amir Rahimi

Federal Waterways Engineering and Research Institute, Karlsruhe, Germany

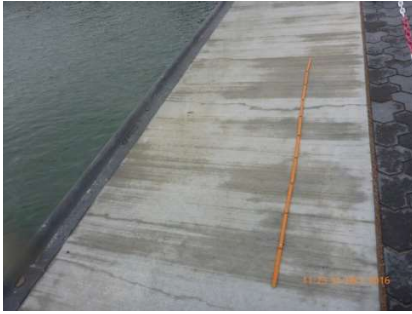
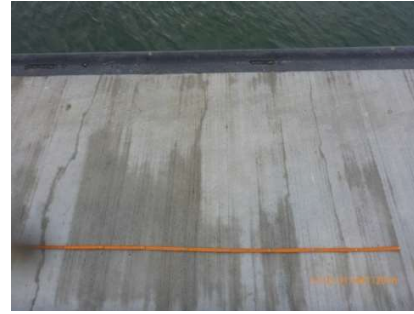
Figure 1: Transverse cracks running across the entire width of the top surface of a newly constructed quay; general view (left); typical crack spacing between 30 and 60 cm (right)

Cracking must always be expected in solid hydraulic engineering structures on account of the early restraint forces caused by the tensile stresses due to the heat of hydration. Figures 1 and 2 show cracking that occurred in a quay on the North Sea coast shortly after placement of the concrete. Cracks with widths ranging from  $\leq 0.1$  mm to around 0.3 mm with a spacing of between approximately 25 to 120 cm (on average around 60 cm) were detected along the inspected section of the structure which was around 500 m in length (total length of the quay: 950 m). The detected crack widths were mostly less than 0.2 mm, with isolated crack widths of up to 0.3 mm. The cracks detected on the top surface of the quay also continued on the waterside face and can thus be characterised as separation cracks. Vertical coring revealed that the cracks extended down to a depth of 400 mm. Tapering of the cracks was only detected in a few cases. The quay has a length of 950 m and was constructed without joints. Figure 2, right, shows the standard cross-section of the quay. To ensure durability, the quay was designed with a design crack width of 0.25 mm in accordance with [DIN 19702:2013]. Wider cracks are generally grouted. The cracking pattern described above was observed while the quay was drying out (a few hours after it had rained). The cracks were not visible when the quay was dry and only barely visible when the quay was wet.

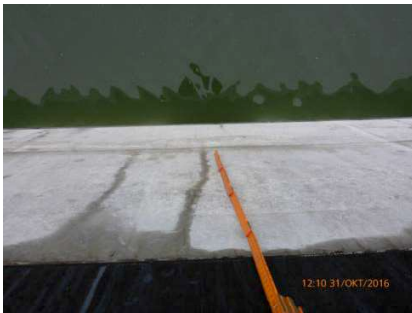
Figure 2: Cracking pattern on the face of the quay (left); cross-section of the quay superstructure (right)

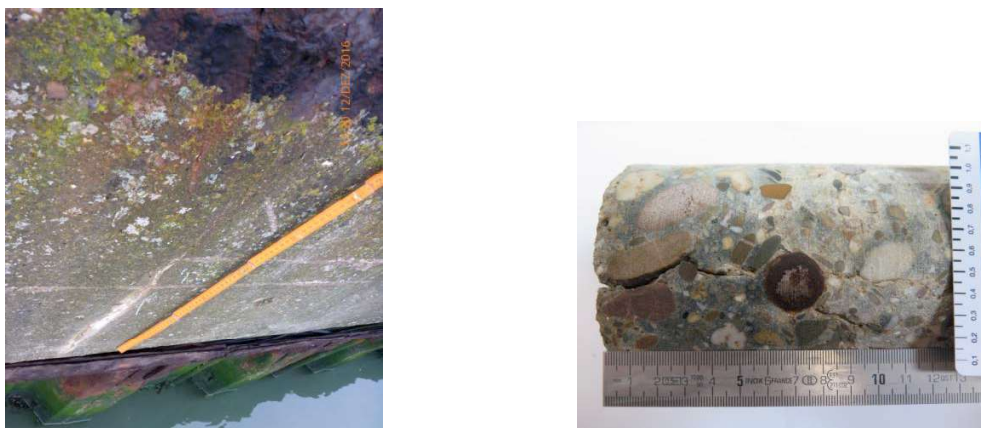
Figure 3: Continuous crack on the face of the quay with calcium carbonate deposits near to where drilled core no. 4 was taken on the top surface (left); drilled core no. 4, 1st layer of rebars, concrete cover approx. 60 mm (right)

An approximately 40-year-old quay on the North Sea coast (similar to the structure shown in the diagram in Figure 2) was examined in order to address the first issue described in Section i. Five drilled cores were taken from the top surface of the capping of the quay ( $\varnothing/L=100/\sim 350$  mm) (cores no. 1 to 5). There was at least one pronounced crack (width 0.1 to  $> 0.5$  mm) in each of the selected sections; the cracks extended into the face of the capping and can thus be considered as separation cracks. Calcium carbonate deposits could be seen on the sides of all five cracks in the face of the capping, indicating water exchange through the cracks. The drilled cores were taken perpendicular to the cracks. After the cores had been split it could be seen that each crack had extended across at least one rebar. The rebar fragments in the cores were all exposed and a pickling solution was subsequently used to remove the hardened cement paste and rust products, thus enabling the surface of the rebars to be visually examined for erosive corrosion. Partial or extensive erosive corrosion had occurred on each fragment of the rebars that had crossed a crack, resulting in a reduction in the cross-section of the steel. The greatest reduction in the cross-section was detected on the rebar fragments in cracked sections nos. 4 and 5 in which cracking of the structure appeared to be particularly pronounced (wide cracks, no tapering over long stretches of the cracks), see Figures 3 to 5. The few rebar fragments next to the cracks in the drilled cores did not exhibit any reduction in cross-section due to erosive corrosion, Figure 5, right.

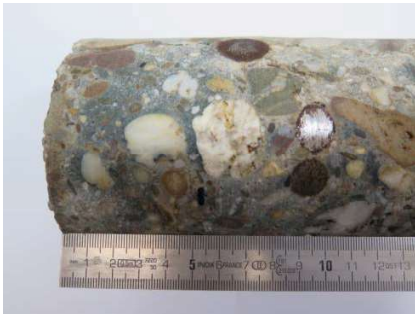
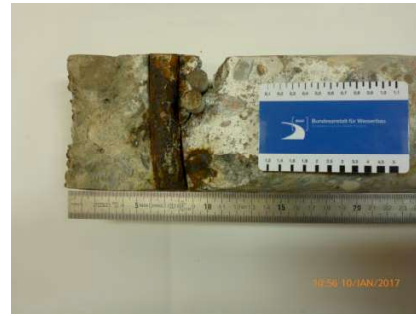
Figure 4: Drilled core no. 4, 1st and 2nd layer of rebars (left); drilled core no. 4, split, 1st and 2nd layer of rebars (right)

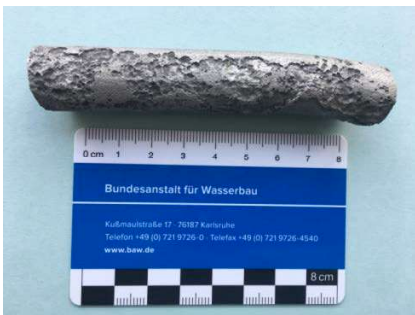
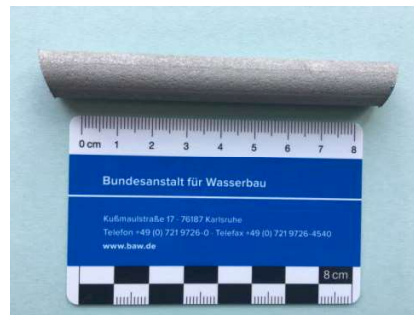
Figure 5: Drilled core no 4, rebar in 1st layer after application of the pickling solution, extensive erosion (left); rebar in 2nd layer after application of the pickling solution, no reduction in the cross-section (right)

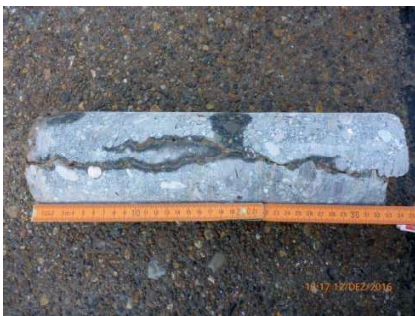
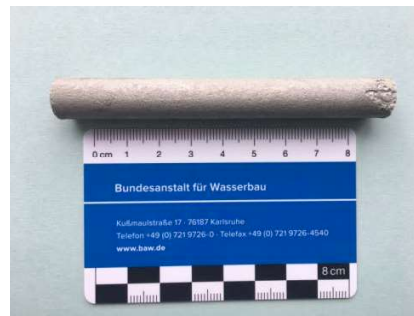
Figure 6: Drilled core no. 1, after sampling, 1st layer of rebars, width of crack at surface approx. 0.25 mm, concrete cover approx. 60 mm (left); drilled core no. 1, rebar in first layer after application of the pickling solution, minor reduction in the cross-section at the right-hand edge (right)

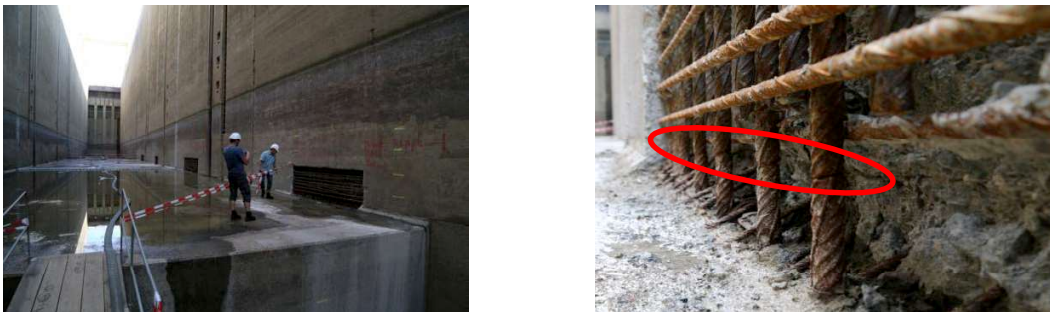
Figure 8: Lock chamber wall with the exposed section directly above the bottom of the lock (left); fractured rebars in the construction joint (right)

Figure 8 shows a chamber wall of one of the locks (around 40 years old). Extensive rust streaks can be seen in the construction joint above the bottom of the lock. The outer layers of reinforcement in a small section of the chamber wall were therefore exposed with a high-pressure water jet to permit inspection. It was discovered that six parallel vertical rebars ( $\text{Ø} 25 \text{ mm}$ ) in the exposed section had fractured at the level of the construction joint. The likely cause is a marked reduction in the cross-section of the rebars owing to corrosion in conjunction with high cyclic tensile stresses due to lockage operations. Water leaks through the open construction joint owing to the difference between the water level in the chamber and the groundwater level (behind the chamber wall). Depassivation of the reinforcing steel therefore occurs as a result of leaching from the concrete (portlandite). The affected section of the wall is relatively thin and only has a little secondary reinforcement. There was no reduction in the cross-section of the neighbouring rebars outside the construction joint.

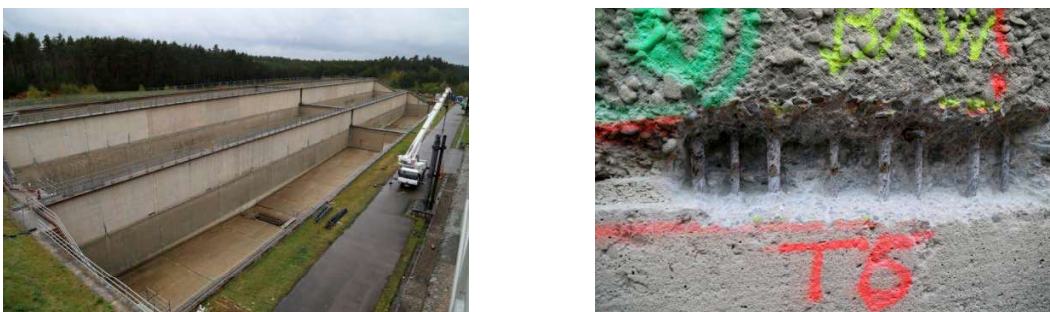
Figure 9: View of the side ponds of the lock (left); exposed rebars in the leaking horizontal construction joint of the wall between the two side ponds (right)

Tests on another lock are shown in Figures 9 to 12. Rebars close to the surface of the structure near pronounced cracks and construction joints were exposed in two different sections of the lock. In one case, the reinforcement (Figure 9, right, and Figure 10) was exposed in a horizontal construction joint in the wall separating two side ponds (Figure 9, left). Extensive corrosion with development of red rust and loss of material was detected at this point. The construction joint is located in the zone of fluctuating water levels and water leaks through it. There is an almost constant water pressure gradient in the construction joint owing to the different water levels in the two locks.

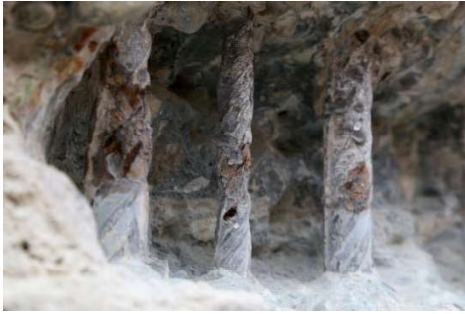
Figure 10: Corroded rebars in the construction joint

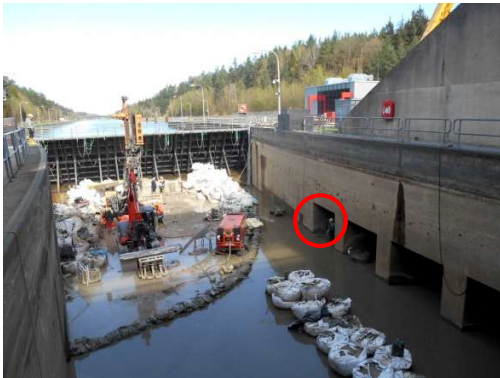
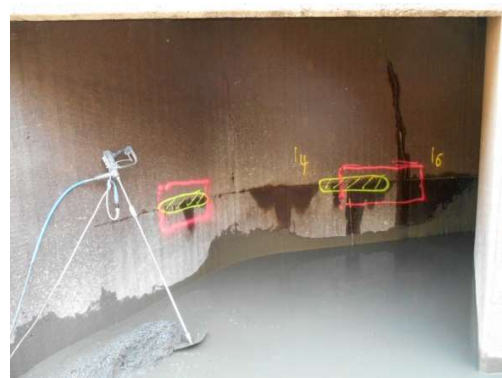
Figure 11: View of the lock, bottom gate, drainage area (left); horizontal construction joint and vertical crack prior to exposure of rebars (right)

In the second case, rebars were exposed near a horizontal construction joint and a vertical crack in the drainage zone of the bottom gate of the lock (Figures 11 and 12). The construction joint and the vertical crack are both leaking as calcium carbonate deposits have developed in the crack and in the construction joint. The lock-side concrete surfaces in this section of the lock are constantly under water and the groundwater level behind the wall is several metres above the water level in the drainage zone of the lock, resulting in a water pressure gradient. Rebars crossing the vertical crack exhibited superficial corrosion without any apparent reduction in their cross-section. The exposed rebars next to the crack did not exhibit any corrosion. Compared with the two previous examples, there appears to be cathodic inhibition of the corrosion at this point owing to the lack of oxygen as the structural element (drainage area) is almost constantly submerged. In addition, the structural element is not exposed to high levels of tensile stress.

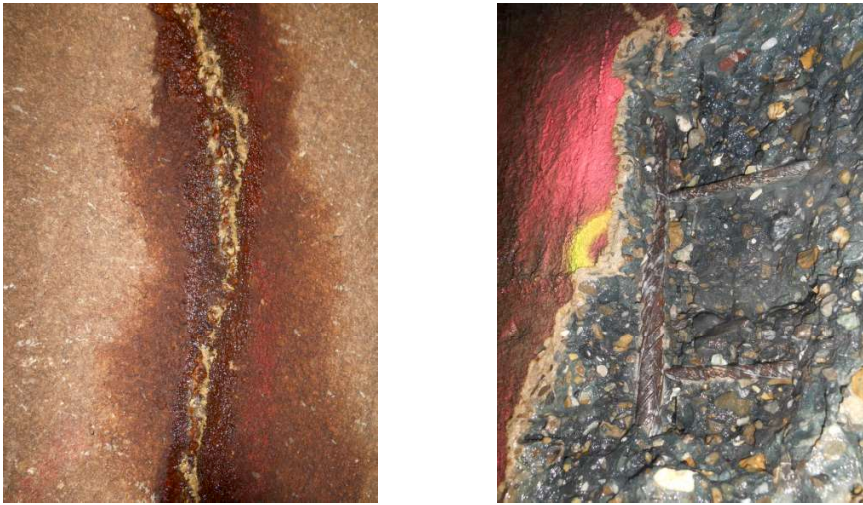
Figure 12: Calcium carbonate deposits at the leaking vertical crack (left); rebars exposed near the vertical crack (right)
