Hydrographische Nachrichten

Coastal cliff monitoring using UAS photogrammetry and TLS

A peer-reviewed paper by THOMAS P. KERSTEN, MAREN LINDSTAEDT and KLAUS MECHELKE

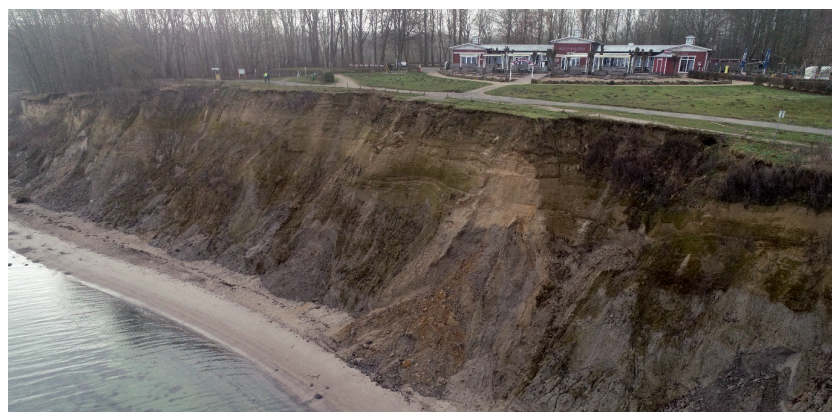
Fig. 1: The coastal cliff at Brodten with the Hermannshöhe restaurant in the background, photographed from the DJI UAS on 20 January 2020

outline of the current Baltic Sea coast (Schmidtke 1992). The coastline, in places up to 20 m high, is in large sections still an active cliff. It recedes on average up to one metre per year due to the erosive action of waves generated by east-northeast winter storms, heavy rainfall with the accompanying softening and washing out of sediment layers, as well as freezing seepage water spreading in volume. In the immediate vicinity of the steep bank is the restaurant Hermannshöhe, built before the First World War and replaced by a new building in May 2012, which is a popular destination for tourists. The HCU Hamburg carried out coastal cliff monitoring with terrestrial laser scanners in Hermannshöhe section (Fig. 1) between 2004 and 2016 in order to document the changes and landslides. In 2016 the steep coast was surveyed with a UAS for the first time (Kersten and Lindstaedt 2017) followed by a second survey with the same UAS in 2018 (Kersten et al. 2019). Fig. 1 shows the investigation area at the Brodten cliff with the restaurant building in the background, located some 52 m from the edge of the cliff (status January 2020).

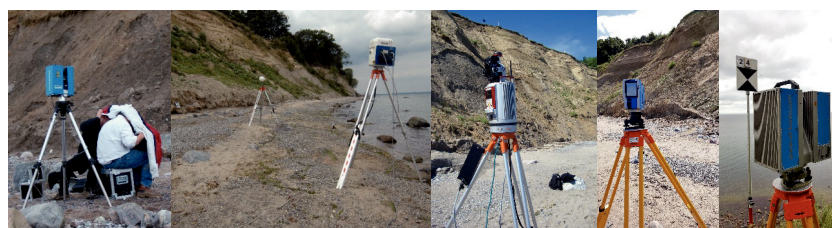
Fig. 2: Terrestrial laser scanning at the coastal cliff of Brodten – Z+F IMAGER 5003 (2004), Mensi GS100 (2005), Riegl VZ-400 (2010) and Faro Focus3D X330 and Z+F IMAGER 5010 (2016)

Different terrestrial laser scanning systems were used for the documentation and monitoring of the Brodten cliff section over twelve years (Fig. 2 and Table 1).

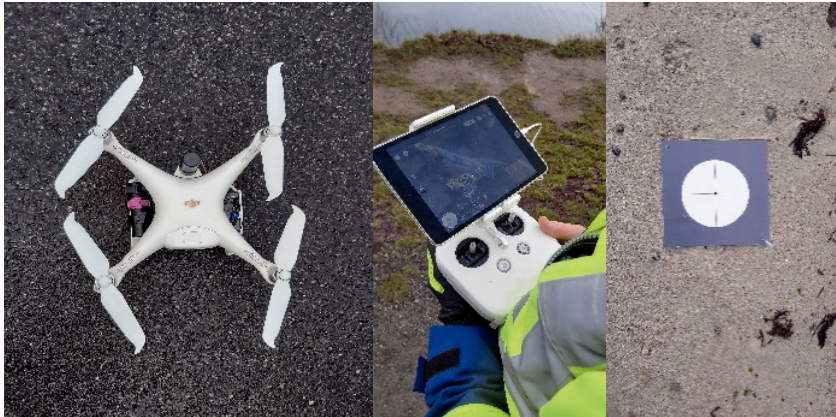
Fig. 3: DJI Phantom 4 Pro KlauPPK (left), remote control with Apple iPad (centre) and signalised ground control point (right)

including remote control and signalised ground control points, is illustrated in Fig. 3. The central component of the KlauPPK hardware is the multi-channel multi-frequency GNSS receiver of NovAtel. The KlauPPK software provides sophisticated PPK data processing to determine the precise coordinates of the projection centre of each image taken in the requested coordinate system.

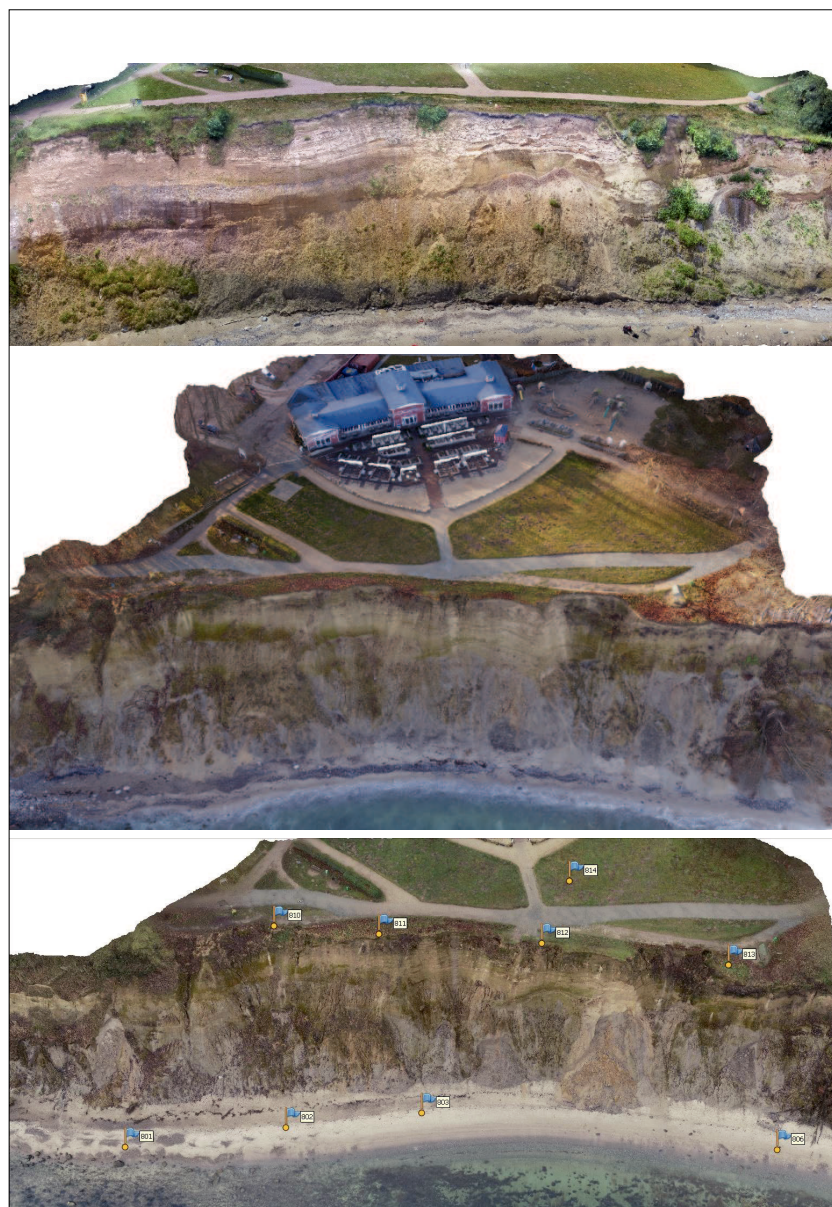
Fig. 4: 3D meshed models of the Brodten Cliff derived from UAS-based aerial imagery – June 2016 (top), December 2018 (centre) and January 2020 (bottom) including the configuration of nine ground control points (yellow dots with blue flags)

signalised control points in the respective images of each aerial flight. The configuration of nine GCP for the aerial flight in 2020 is illustrated in Fig. 4 (bottom). During each aerial UAS flight, a very high overlap of more than nine images per area could be achieved for all photogrammetric blocks.

segmented. For the reduced point cloud, PhotoScan/Metashape calculated a triangular mesh in high resolution, which represents a digital surface model (DSM). Fig. 4 shows the three generated 3D surface models of the cliff after texture mapping using the colour images.

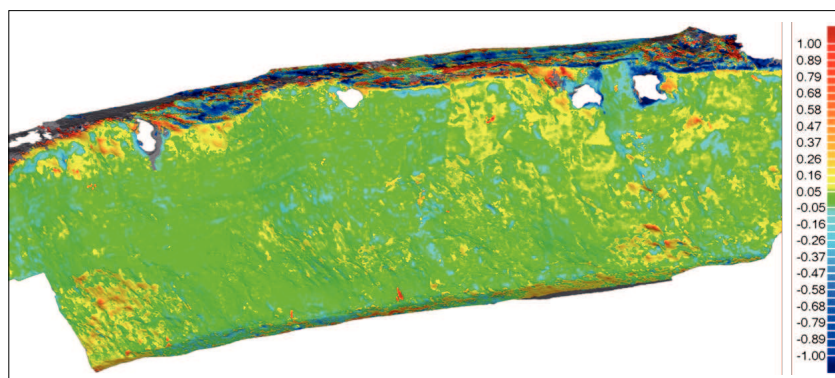
Fig. 5: 3D comparison of 3D meshed models derived from TLS and UAS-based aerial imagery in the year 2016 – differences higher than ± 5 cm (green) are indicated in different colour (reddish or bluish)

The 3D point clouds from different periods generated from TLS and UAS photogrammetry data were then used to document the changes in Geomagic Control. To evaluate the quality of the UAS data, a 3D comparison between the 3D models from terrestrial laser scanning and from the UAS image flight, both from the same day in 2016, was also calculated. The deviations between the two 3D models are visualised as colour-coded in Fig. 5. Most of the deviations between TLS and UAS are in the range of ± 5 cm (green), so that the results from UAS image data are comparable with the TLS data. The achieved accuracy for the digital surface model of a few centimetres is therefore more than sufficient for the evaluation of the cliff monitoring, i.e. both methods meet the requirements for cliff monitoring, since the deviations are on average up to one metre per year. Especially in the areas of vegetation, higher deviations are visible between both data sets, since TLS is mostly able to penetrate the vegetation, while all automatic image
