## **Tribology of Protective Hard Coatings for Oil-Less Compressors**

T. A. Solzak and A. A. Polycarpou

ACRC TR-243

June 2006

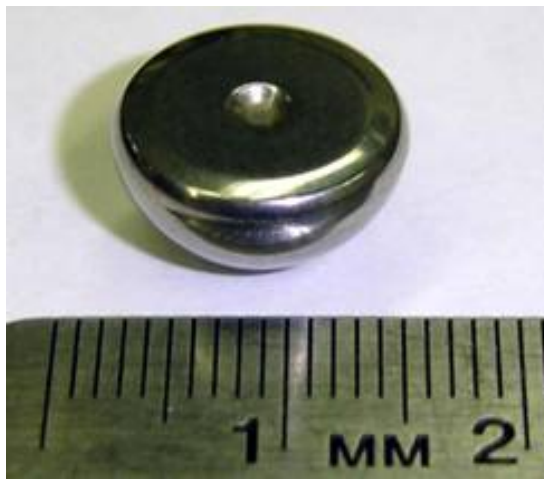
Figure 2.3: 52100 Steel Shoe

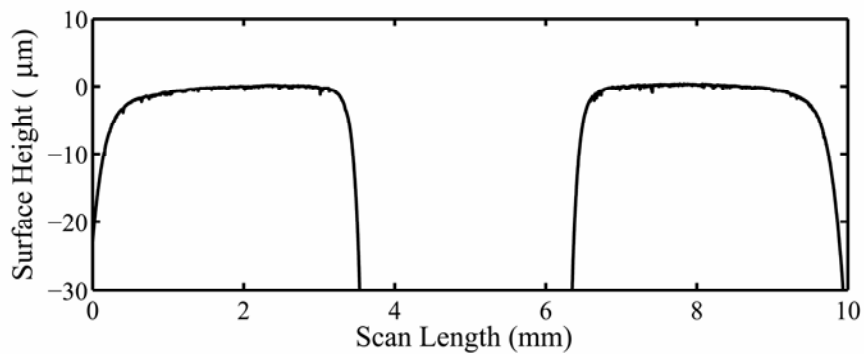
Figure 2.7: Cross section profile of 52100 steel shoe

The contact geometries used in this study were shoe-on-disk and pin-on-disk configurations. Shoe-on-disk testing has been conducted extensively in past ACRC projects for swashplate compressor simulation and consists of a 52100 steel shoe (Figure 2.3) that is allowed to self-align to form a flat contact with the disk (Figure 2.4). The self-aligning holder is depicted in Figure 2.5 and shows where the temperature and ECR measurements were made. An illustration of the contact is also displayed in Figure 2.6 while wear on an actual disk is exhibited in Figure 2.4 with a wear track diameter of 1.75" (44.5 mm). Although it appears that the shoe is flat, it is actually crowned with a dimple in the center causing higher contact pressure and wear initiation to occur where the central region of the shoe meets the disk. A cross section profile of the shoe is depicted in Figure 2.7.

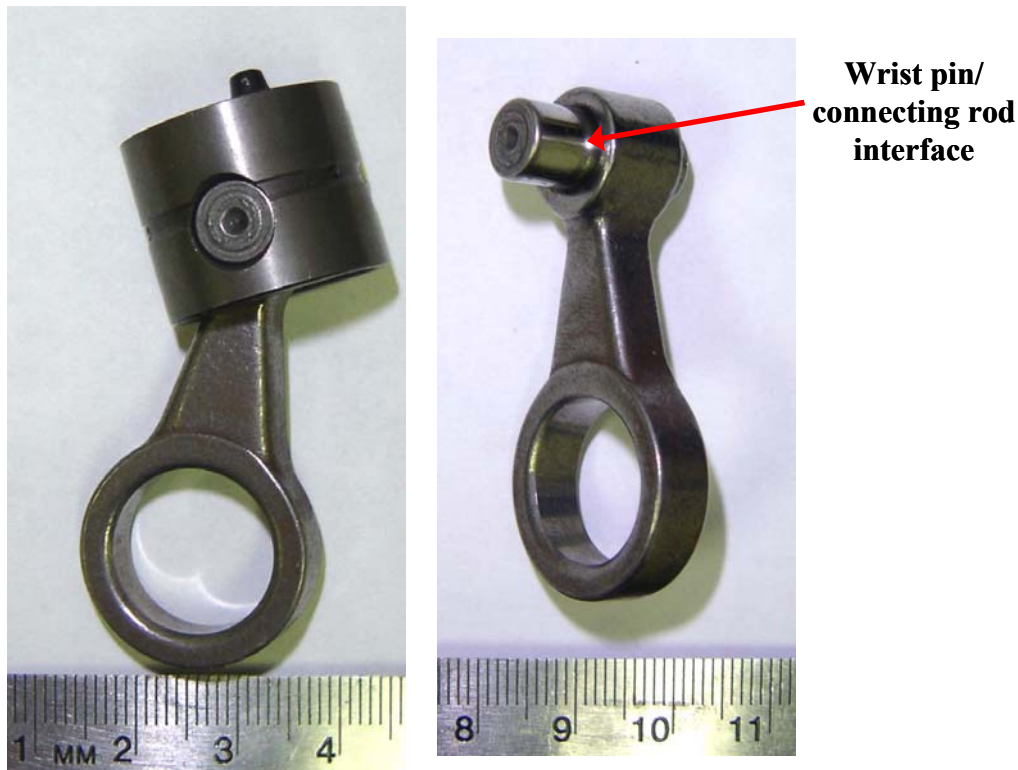
Figure 2.8: Piston assembly for a piston-type compressor indicating the wrist pin-connecting rod interface of interest.

The emulation of the wrist pin/connecting rod interface (Figure 2.8) of a piston-type compressor was performed based on the equivalent contact pressure occurring on an actual connecting rod journal. Traditional pin-on-disk testing utilizes a cylindrical pin with a spherical top, usually a ball bearing, in contact with a flat disk. However, to achieve contact pressures relevant to piston-type compressors, relatively large contact radii on the order of 50 mm for the same load are needed necessitating custom pins. It proved difficult to attain a perfectly spherical surface due to manufacturing limitations, and many times a sharp point remained on the pin tip causing immediate severe wear. In this research, a new method was developed that used actual cylindrical wrist pins oriented to create a line contact as illustrated in Figure 2.9. Using this configuration, desired contact pressures were easily applied, and it is felt that test results were more applicable to piston-type compressors due to the similarity of the line contact. Pins were 8 mm in diameter and 8 mm long with a 1 mm diameter hole for miniature thermocouple insertion. They were produced from actual wrist pins that were cut to length and machined to have a flat seat (Figure 2.10). To accommodate this pin orientation, a special holder was designed which allows the pin to self-align (Figure 2.9(b)) to the disk surface ensuring a uniform contact pressure. The holder was similar to the shoe holder and is shown with provisions for temperature and ECR measurements in Figure 2.11. It was mounted such that a wear track diameter of 1.75" (44.5 mm) was attained, as depicted on the disk in Figure 2.12 that contains four tests. The disks for both piston-type and swashplate configurations are 3" (75 mm) in diameter and either 0.267" (6.8 mm) thick (cast iron) or 0.5" (12.7 mm) thick (aluminum). The exact dimensions of the pin and disks are given in Figures 2.13 and 2.14.

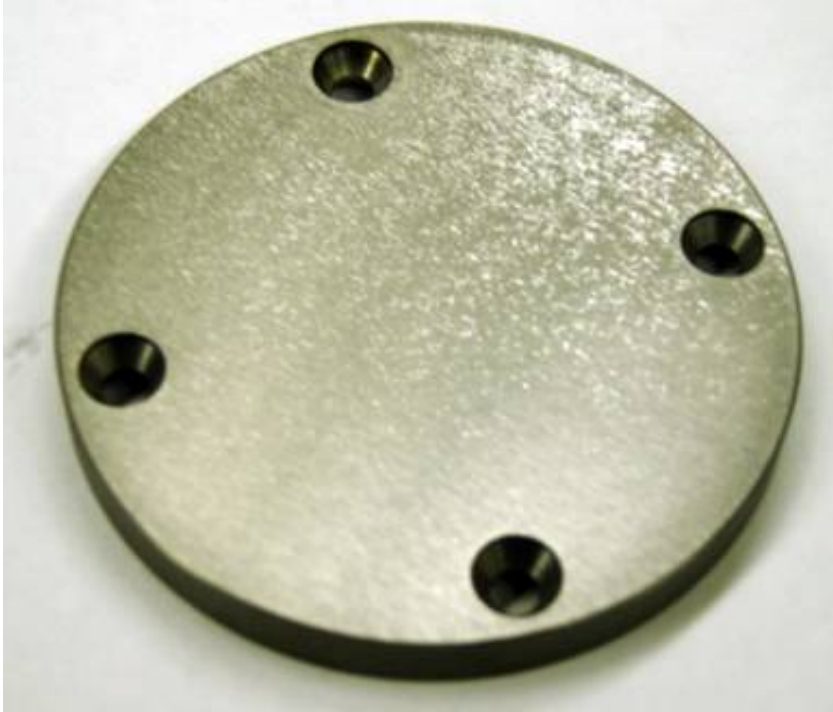
Figure 2.25: Cast iron disk with poor WC/C(A) coating adhesion

Unlike the shoe-on-disk testing, the harder 52100 steel pins were coated due to poor coating adhesion to gray cast iron as shown in Figure 2.25. Initially, the effects of coating one or both substrates were to be investigated, but poor adhesion dictated meant that only uncoated disks could be tested. Poor adhesion in gray cast iron stems from the soft, graphitic nature of the carbon content [18]. The same coatings were applied to the wrist pins as the aluminum disks, except without the CrN underlayer. A list of the coatings, substrates, and roughness of coated and uncoated samples used in this portion of testing is provided in Table 2.4 with their respective profiles scans in Figures 2.26-2.31. All coated samples have a ~0.5 µm thick Cr interlayer to promote adhesion, and the separate layers and thicknesses are displayed in Figure 2.32. TiAlN + WC/C is not shown due to poor performance, explained in later sections.

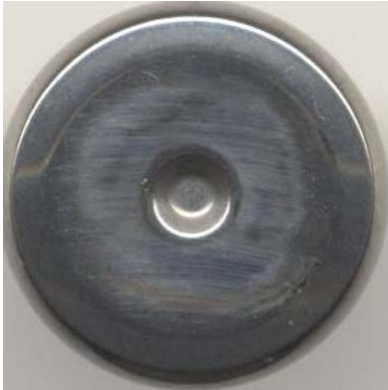
Figure 3.8: WC/C(A) transfer film formed on 52100 steel shoe

films. After each test, only polishing was observed on the coating surface while the softer WC/C(A) (versus 52100 steel) formed a transfer film on the shoe, displayed in Figure 3.8. Transfer films have been shown to be a key ingredient to low friction in the literature [9-12], but seemed to have little or no effect in these tests. Table 3.1 lists the friction coefficients obtained with each load showing little variation except that it decreased slightly with higher loads. It became apparent through these tests and those explained next, that without extremely long tests, no measurable wear will be obtained. In general, with coated aluminum, the scuffing occurs due to the soft substrate and poor load support causing coating fracture.

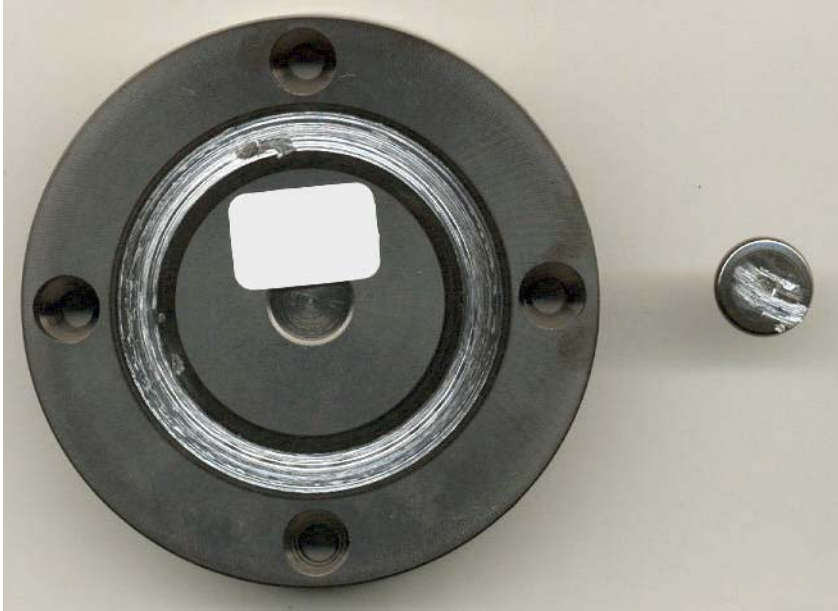
Figure 3.11: Worn CrN + WC/C(B) coated disk and shoe

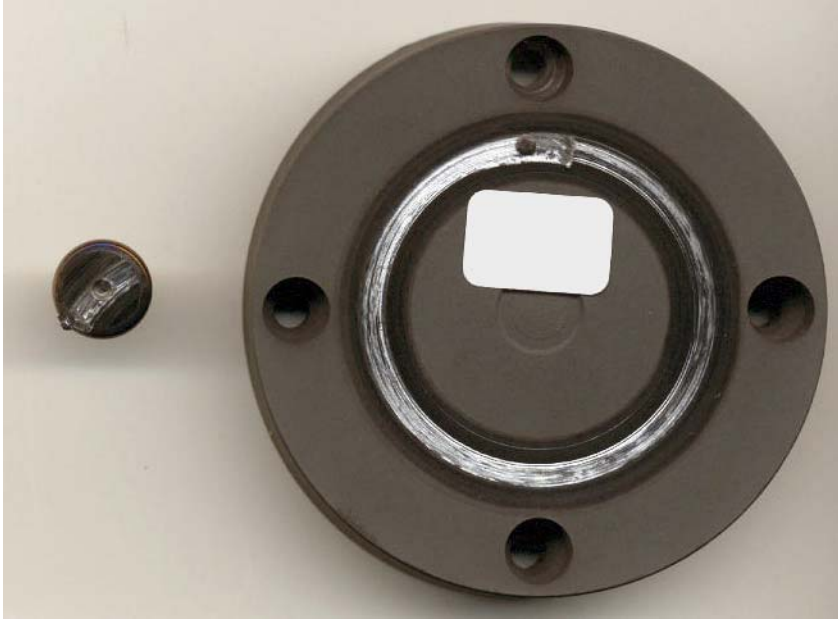
Figure 3.13: Worn CrN + WC/C(A) coated disk and shoe

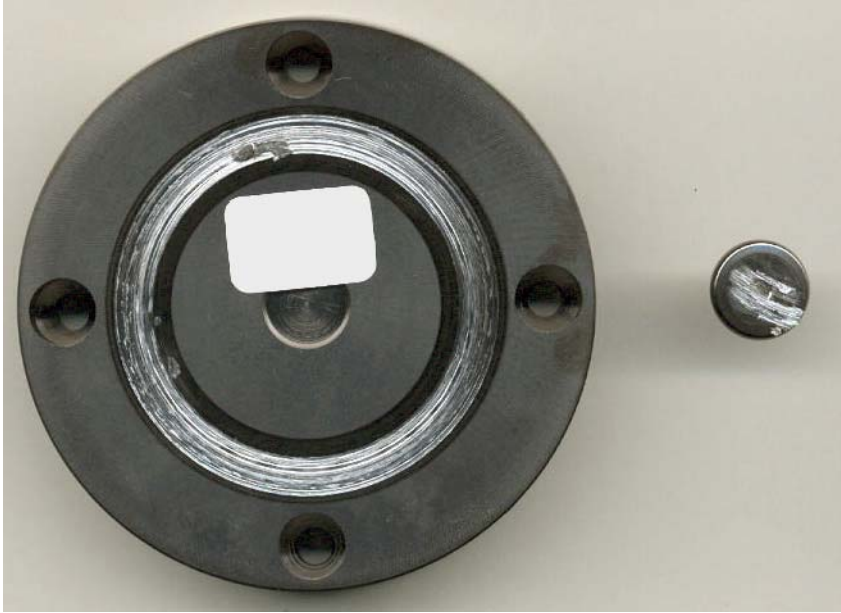
Figure 3.17: Worn CrN + WC/C + DLC coated disk and shoe

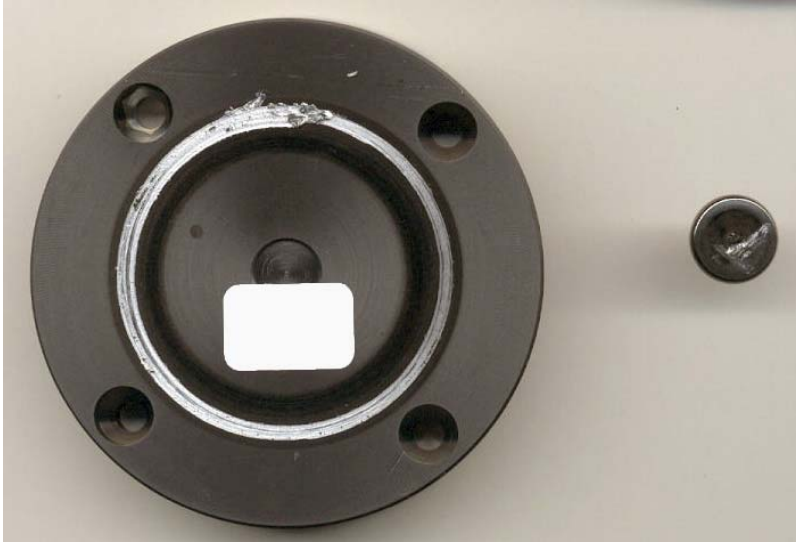
Figure 3.19: Worn WC/C(A) coated disk and shoe

The final test in this series of scuffing experiments was performed with WC/C(A). As the HPT data in Figure 3.18 shows, the scuffing load of 245 lbf (1091 N) is much lower than that of the previous tests due to the load bearing capability of the CrN underlayer. As a result of the lower roughness, though, it produces a friction coefficient of 0.09, about half of that produced with a CrN underlayer, but was still higher than CrN + WC/C(B). The worn disk and shoe are displayed in Figure 3.19.

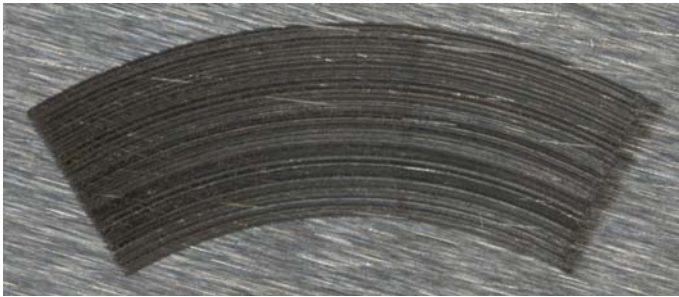
Figure 3.23: Worn cast iron disk used in uncoated test

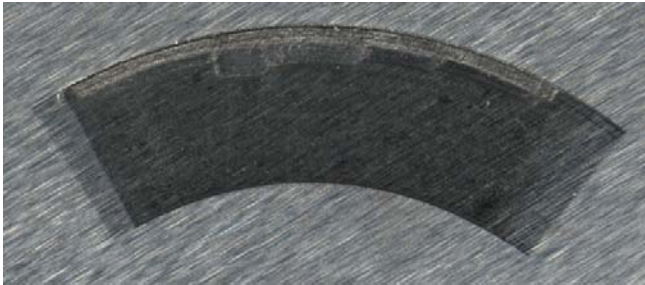
Figure 3.26: Image of worn cast iron disk showing plastic deformation in step-loading test

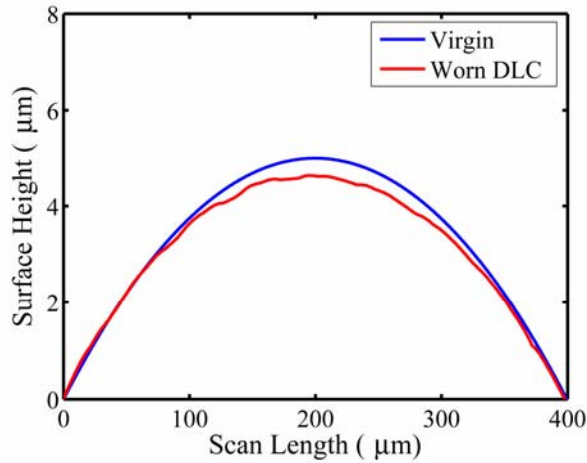
Figure 3.28: Pin wear scan performed parallel to sliding direction

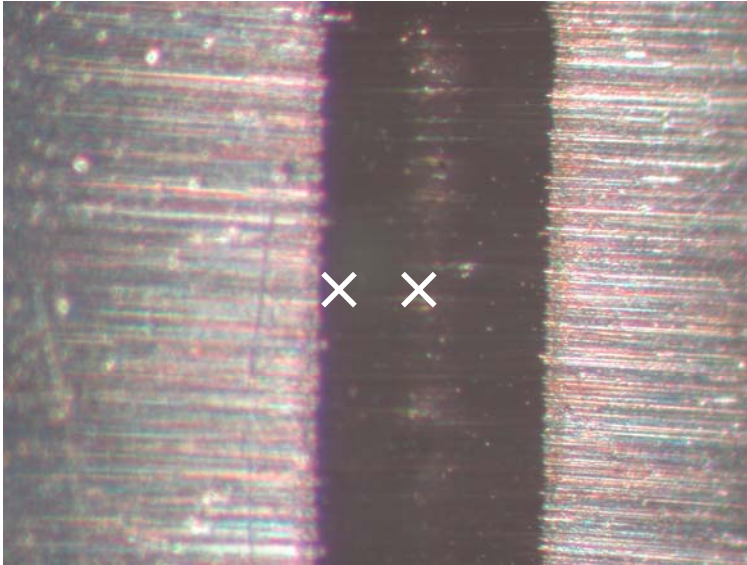
Figure A.6: Nanoindentation locations
