REVIEW ON PERFORMANCE OF EXISTING COOLING TOWER FAN BLADE IN THE PRODUCTION INDUSTRY

Cooling towers are the major industrial part for heat rejection in petrochemical industry, oil refineries, chemical plants, thermal power plants and HVAC systems for cooling structures. The fan is a mechanically forced-draft used to extract the heat accumulated in the flowing cooling water components and the fan blade is a very important part of the towers. Failure of fan blade leads to low productivity, high cost of replacement and maintenance of cooling tower fan blade in service. This paper presents a review on failure mode and material availability of cooling tower fan blade.

Cite this Article: Nduka Ekene Udoye, Ojo Sunday Isaac Fayomi and Anthony Omieraokholen Inegbenebor, Review on Performance of Existing Cooling Tower Fan Blade in the Production Industry, International Journal of Mechanical Engineering and Technology, 10(01), 2019, pp.1833–1839

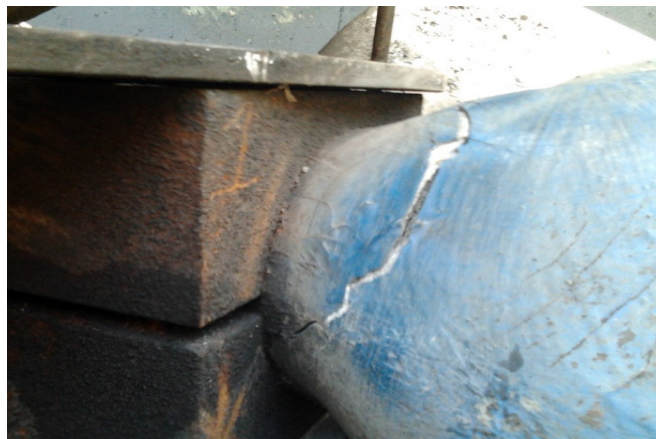
Figure 1: Failed fan blade at the neck portion [12]

According to Kushwaha (2017) “The failure of one blade also damage other blades, drive shaft and other components and hence causes huge financial impact as well as fan availability”. The author studied fatigue failure analysis of the fan blade used in a 500MW unit of a thermal power plant. The author developed a 3D modelling of the blade by using Pro-Engineer based on dimensions of the actual blade used at site and FEM analysis was carried out by Ansys software. Concurrence between FEM results and observations of failing pattern at site has been found. The result of the experiments shows that fan blade failure was due to excessive deflection caused by crack initiation at its root. The hitting of other deflected blade with other fan components such as drive shaft and failure of any one blade becomes primary reason of failure of other fan components. The analysis of failed blade by visual inspection and finite element analysis shown that the blade is failing repeatedly at mainly two point one at its shank/neck portion and second near 1/3 of the blade length from its tip side. Figure 1 shows the failed fan blade at the neck portion and figure 2 shows the failed fan blade at 1/3 of the blade length [12].

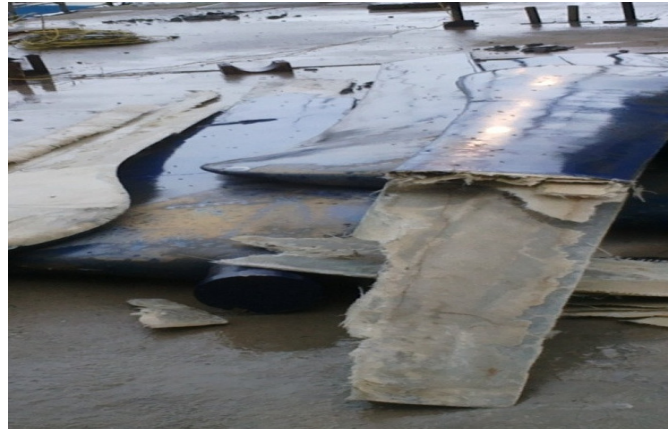
Figure 2. Failed fan blade at 1/3 of the blade length [12]

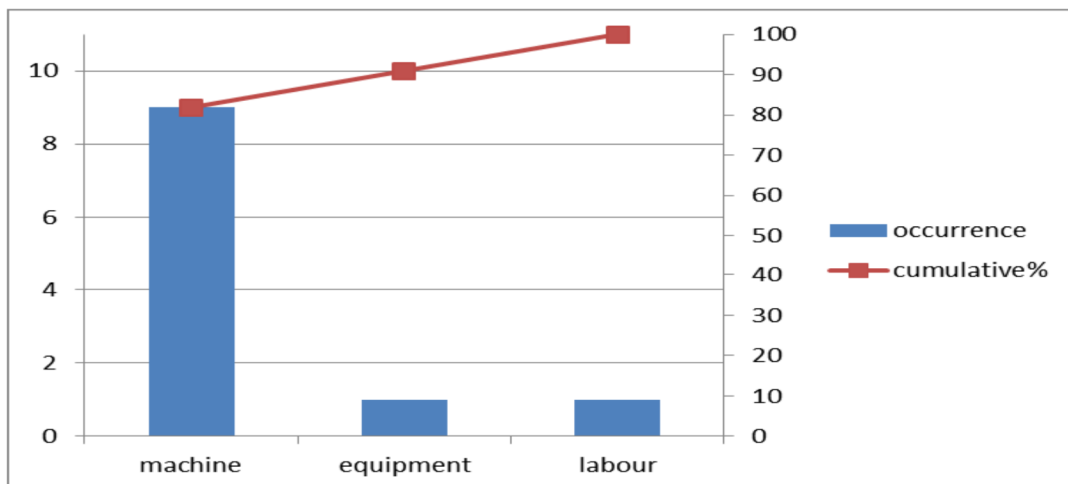
Figure 4 depicts plotted graph on a Pareto chart using maintenance log sheet. The result shows that 80% of the problem is due to machine errors.

Figure 4: Pareto chart [13]

It can be shown from figure 4 that 80% of the vibration is due to unstable impeller and lopsided base and fastener failure. The authors affirmed that erosion on the blades is instigated by suspended particles in the air. Furthermore, erosion and corrosion cannot be measured as the industrial environment is polluted. Therefore, the authors concluded that forced draft fan catastrophe was caused by bearing damage and it can be avoided by eliminating disruption in the impeller and misalignment of base and fastener failure [13].
