NSEL Report Series
Report No. NSEL-016
August 2009

Seismic Performance of Anchored Brick Veneer

**Dziugas Reneckis
and
James M. LaFave**

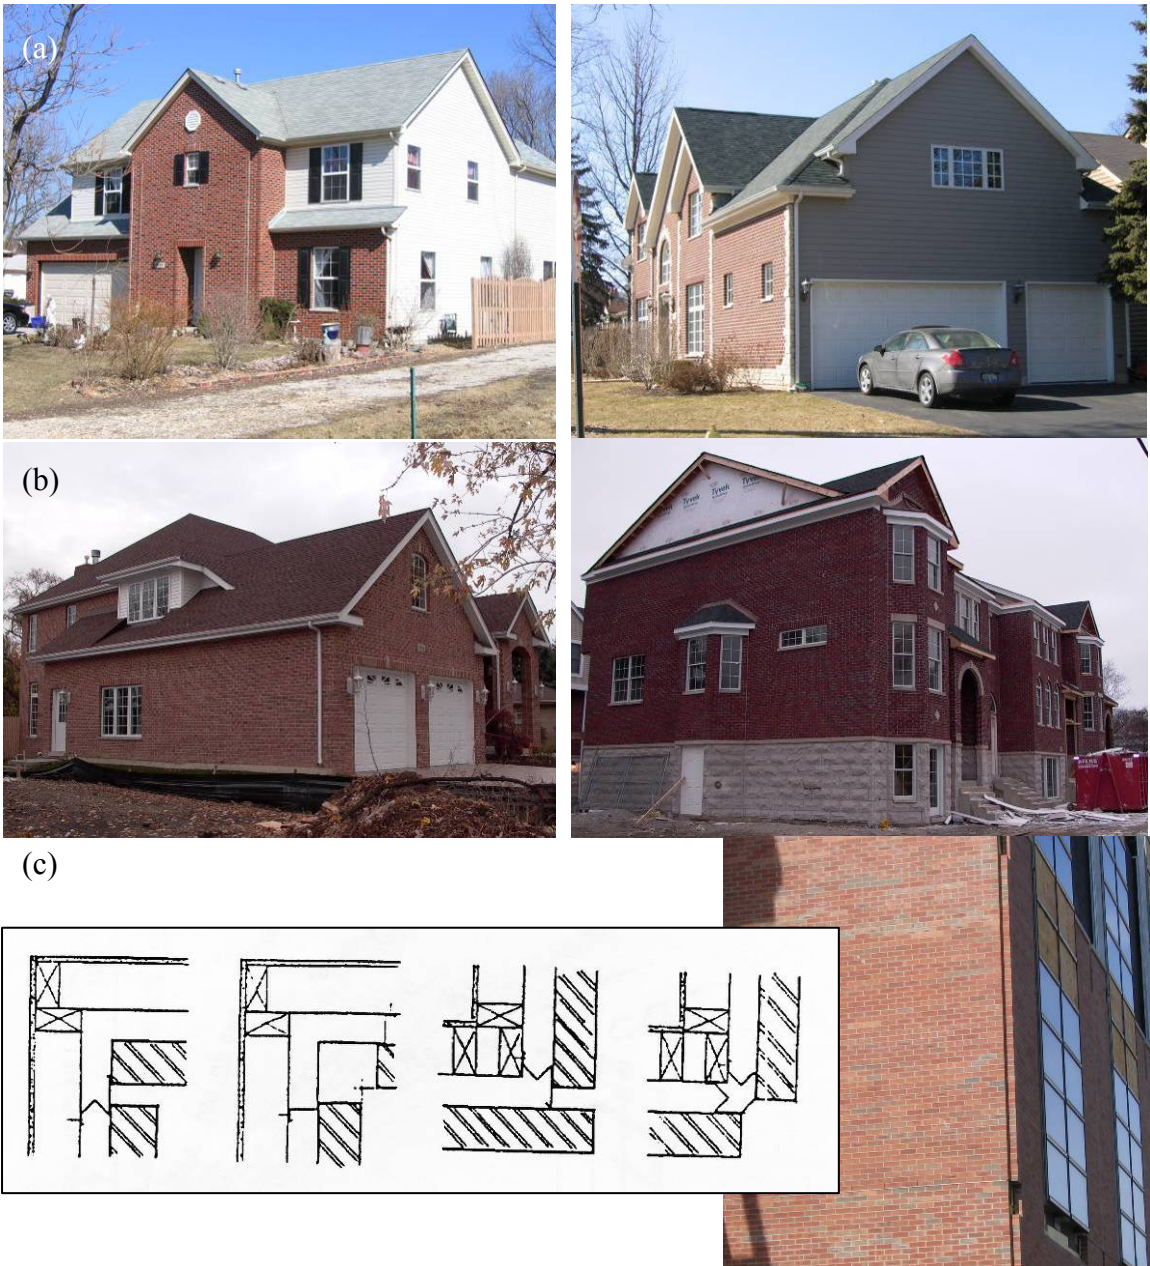
Figure 1.3 – Typical architectural styles for brick veneer construction: (a) front wall only brick veneer, (b) continuous around corners and multi-story brick veneer, and (c) expansion joint (open) wall corner details (corner detail sketches from Lapish (1988)).

Residential wood frame home structures with exterior brick masonry veneer are typically built in one or two story configurations, as shown earlier in Figure 1.3. The wood frame structure and the brick veneer must be supported by a noncombustible foundation, usually made of concrete or masonry. The wood backup structure typically comprises floor framing, walls built of 2x4 (1-1/2 in. x 3-1/2 in. [38 mm x 89 mm]) studs spaced at 16 in. (406 mm) on center (with exterior sheathing and interior gypsum wallboard), and roof/ceiling framing (Figure 1.1). The IRC (ICC 2003) provides design and construction requirements for all structural components of a home. On the other hand, MSJC (2008) simply recommends that such designs comply with the ACI 318 Building Code Requirements for Structural Concrete (ACI 2005) for the concrete foundation, and with the National Design Specification (NDS) for Wood Construction (NDS 2001) for the wood frame structure; MSJC would be referenced for the case of designing a masonry foundation.

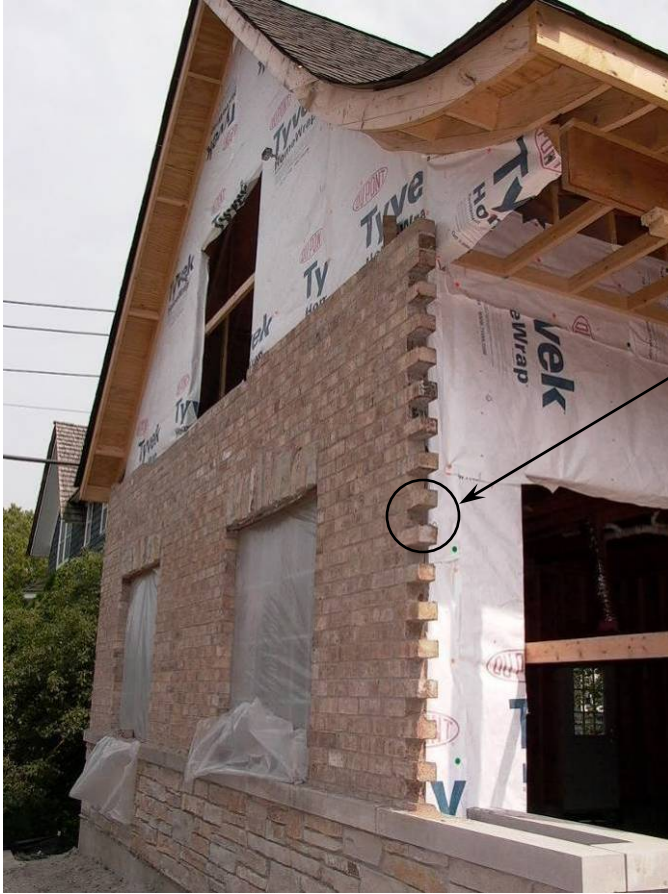
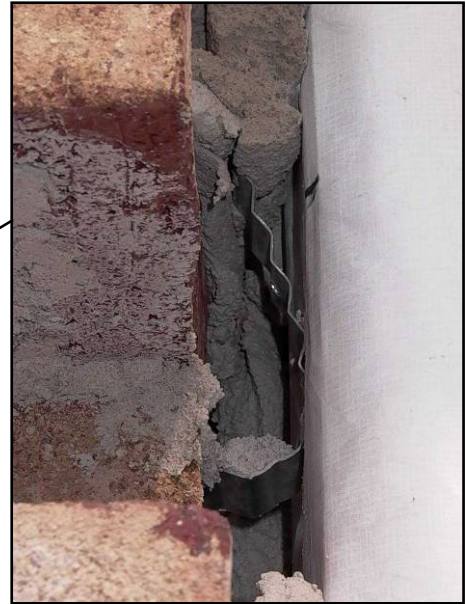
Figure 2.1 – Residential brick veneer home during construction, with excessive mortar droppings in the wall cavity.

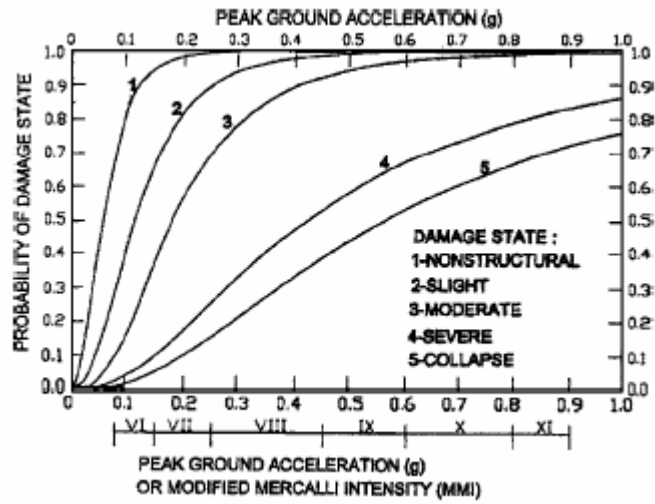
Figure 2.16 – Fragility curves for low-rise unreinforced masonry buildings (FEMA 1985).

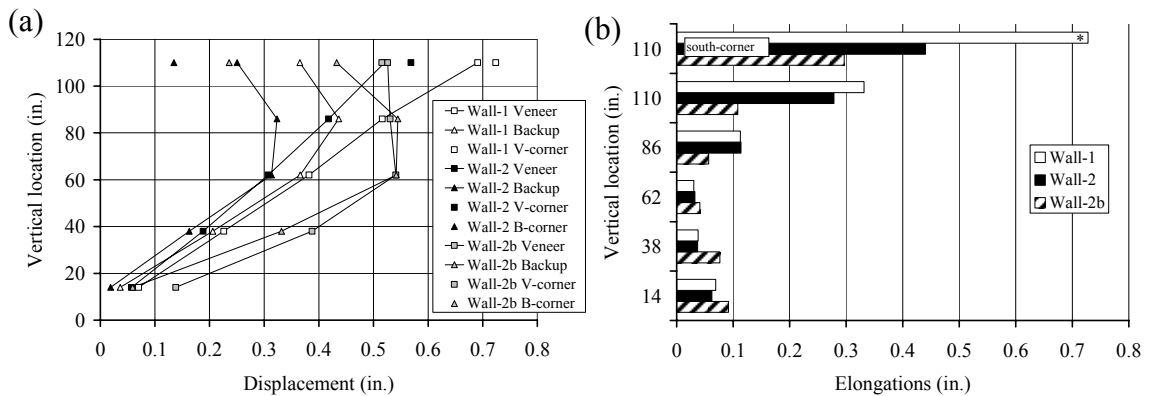
Figure 4.16 – (a) Peak positive displacements in Walls-1 and -2 during the highest dynamic runs prior to collapse (M10-0.66g and M10-0.41g, respectively), and in Wall-2b during the maximum dynamic test (M10-0.80g); and (b) peak relative displacements for those same tests (* – net brick displacement).
