BEHAVIOR OF WELDED BUILD-UP BEAMS UNDER REPEATED LOADS

March 1958

BEHAVIOR OF WELDED BUILT-UP BEAMS
UNDER REPEATED LOADS

A Technical Report
for the
Bureau of Public Roads, Department of Commerce
Association of American Railroads
Welding Research Council Fatigue Committee

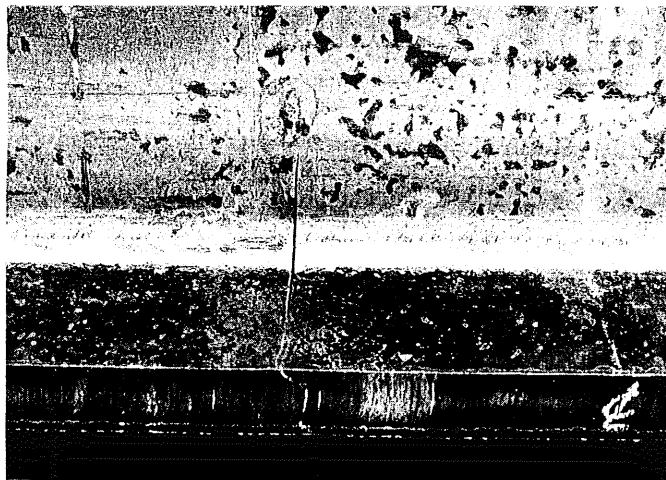
a. SPECIMEN P-1: FAILURE AT CHANGE OF ELECTRODE

b. SPECIMEN P-1: FRACTURED SURFACE

c. SPECIMEN P-7: FAILURE AT CHANGE OF ELECTRODE

d. SPECIMEN P-5: FAILURE AT EDGE OF TENSION FLANGE

FIG. 5 TYPICAL FRACTURES OF PRELIMINARY SERIES

All specimens failed in the pure moment region except P-7, which failed 15 in. from the center line. All specimens except P-6 failed in the tension flange. Photographs of typical fractures are shown in Figs. 5 and 6.

Specimen P-5 with splice type "C" failed at a notch cut by the torch due to a blow-out during cutting. This notch acted as a stress concentration and transferred the location of fracture to the edge of the flange. The reported life of the specimen is probably somewhat lower than it would have been without the notch.

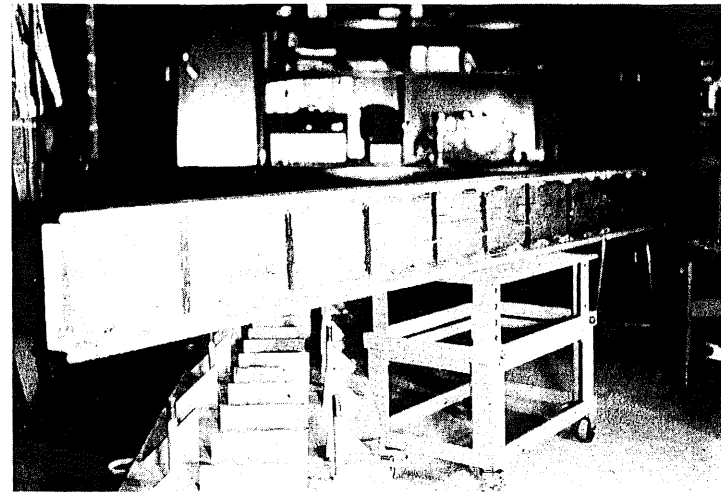
a. SPECIMEN IN TACKING JIG

b. SPECIMEN AFTER TACKING

c. SPECIMEN IN WELDING STANDS FOR DEPOSITION OF FILLET WELDS

d. CLOSE-UP OF WELDING STAND

FIG. II FABRICATION OF TYPICAL SPECIMEN

More recently, the H-beam has been replaced by a jig in which both of the flanges and the web are aligned at the same time and secured in position. The tack welds are then made in accordance with the previous fabrication procedure. Positioning equipment has also been fabricated which permits the beam to be put in any position. This equipment was designed for use with the submerged arc process but works extremely well for the manual procedure also.

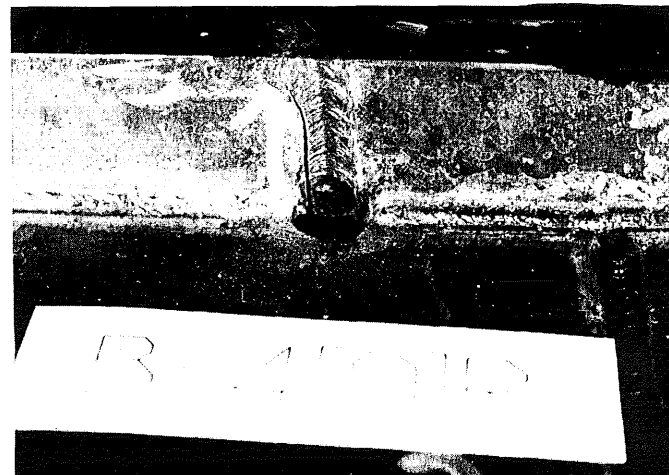
a. SPECIMEN B-3(O)R : FAILURE AT TOE OF FILLET WELD

b. SPECIMEN B-4(O)R : FAILURE IN BUTT WELD

c. SPECIMEN B-4(O)R : FRACTURED SURFACE

d. SPECIMEN B-5(O)R : FAILURE IN BASE METAL

FIG.18 TYPICAL FATIGUE FRACTURES OF SPLICE TYPE "B"

In splice type B all failures, with one exception, occurred at the toe of the fillet weld around the cope hole. One of these specimens, B-6(0)R,

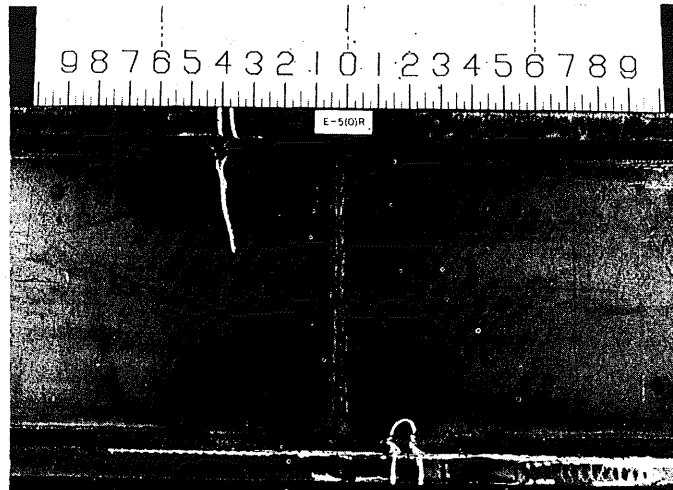
a. SPECIMEN E-5(O)R : FAILURE IN TENSION FLANGE AND COMPRESSION BUTT SPLICE

b. SPECIMEN E-3(B-3)R : FAILURE IN WELD METAL OF TENSION BUTT SPLICE

c. SPECIMEN E-7(AA-9)R : FAILURE IN BASE METAL OF TENSION FLANGE

d. SPECIMEN E-7(AA-9)R : FRACTURED SURFACE

FIG. 22 TYPICAL FATIGUE FRACTURES OF SPLICE TYPE "E"
