STRUCTURAL RESEARCH SERIES NO. 172

EFFECT OF WELDING ON THE AXIAL FATIGUE PROPERTIES OF HIGH STRENGTH STRUCTURAL STEELS

UNIVERSITY OF ILLINOIS
URBANA, ILLINOIS
MARCH, 1963

A TECHNICAL REPORT OF AN INVESTIGATION CONDUCTED
in
THE CIVIL ENGINEERING DEPARTMENT
UNIVERSITY OF ILLINOIS ENGINEERING EXPERIMENT STATION

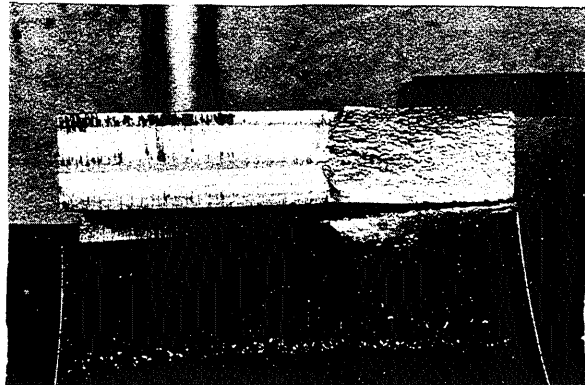
FIG. 6 TYPICAL FRACTURE SURFACES OF AS-ROLLED PLATE SPECIMENS OF QUENCHED AND TEMPERED STEEL

a. FRACTURE SURFACES

b. LOCATION OF FRACTURES

The fatigue failures of all but one as-rolled plate specimen initiated at the end of the fillet radius (at the end of the test section), due to the discontinuity in the section at that point. The exception to this type of failure was specimen FTT-33 in which fracture initiated in the test section. All fatigue cracks initiated at the surface. Photographs of typical fracture locations and fracture surfaces are shown in Fig. 6.

from that of the as-welded specimens (Fig. 8) is noticeable. Also noteworthy is the marked resemblance of the texture of the fracture surface to that of the plain plate specimens shown in Fig. 6.

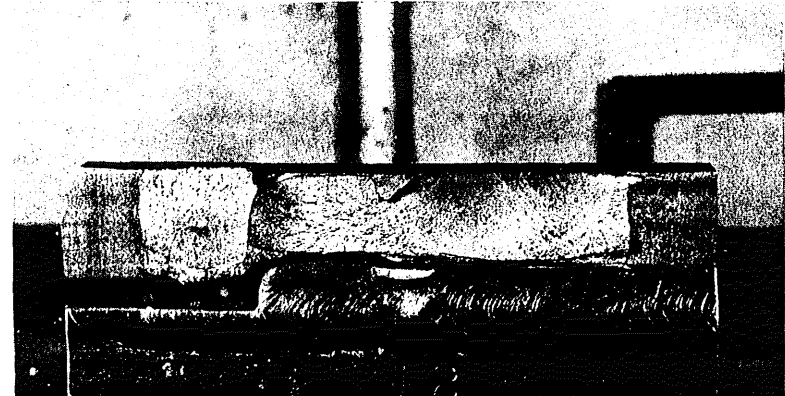
FIG. 20 TYPICAL FRACTURE SURFACES OF AS-WELDED TRANSVERSE BUTT WELDS IN A-242 STEEL

a. PARENT METAL IN THE AS RECEIVED CONDITION

b. PARENT METAL HEATED TO 1400° F.

Failure surfaces of the specimens in the two different conditions are shown in Fig. 20.
