STRUCTURAL RESEARCH SERIES NO. 173

THE BEHAVIOR OF STIFFENED BEAMS UNDER REPEATED LOADS

A Technical Report
for the
Bureau of Public Roads, Department of Commerce
Welding Research Council Fatigue Committee

1 April 1959

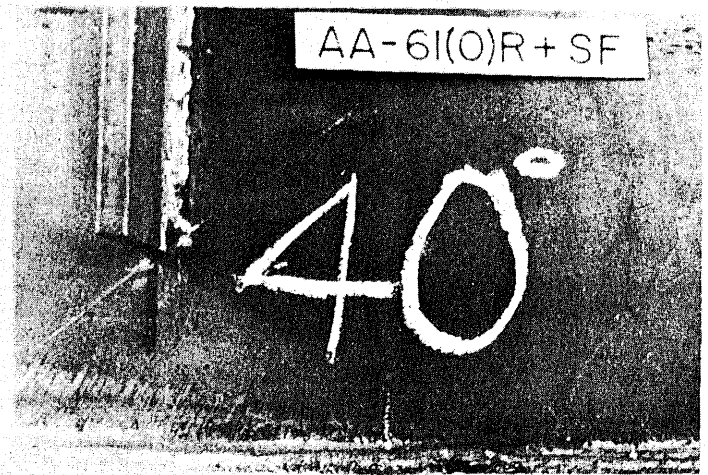
(d)

The last specimen was designated AA-61(O)B + SF₂. The stiffeners were cut off square two inches short of the tension flange and welded only to the web continuously for their entire length of 8 in. Figure 17d shows a close-up of the only fracture which was located at Stiffener 5. The crack initiated at the lower end of the fillet weld connecting the stiffener to the web on the centerline side of the stiffener. The crack propagated diagonally at an angle of 40 deg.

FIG. 17 TYPICAL FATIGUE FRACTURES OF STIFFENER SPECIMENS

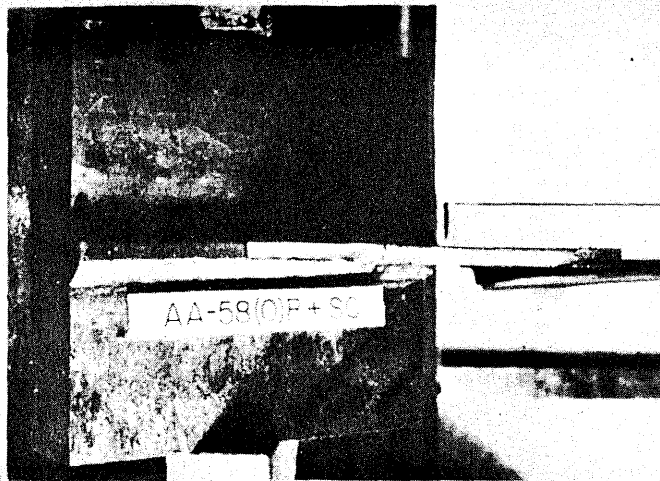
(a)

FIG. 18 TYPICAL FATIGUE FRACTURES OF STIFFENER SPECIMENS

Specimen 58 ran for 4,608,200 cycles and the only fracture was identical to the primary fracture of Specimen 57 with regard to point of initiation, location of stiffener and direction of crack. Figure 18a shows a cross-sectional view of the fracture. Although the stiffener is not shown, the point of initiation can easily be noted from the crescent shape formed where the lowest point of the intermittent weld was fastened to the web.

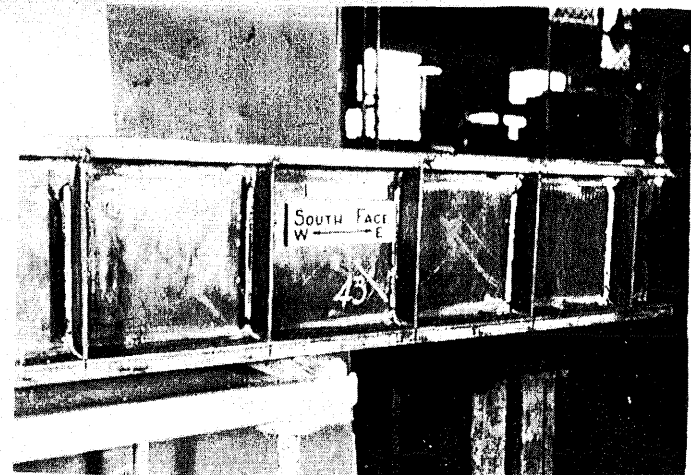
(b)

FIG. 19 TYPICAL FATIGUE FRACTURES OF STIFFENER SPECIMENS

Specimen 49 displayed only one fracture which occurred at Stiffener 4 (see Fig. 19b). A close-up view of Fig. 18d indicates that the fracture initiated in a manner similar to the majority of the fractures of the A and D-type specimens. A cross-sectional view confirmed the fact that the crack initiated at the bottom of the fillet weld which joined the stiffener on the south side of the beam to the web on the centerline side of the stiffener. The crack propagated diagonally upward at an angle of 43 deg. into panel 4-3. It should also be noted that the stiffener on the south side of the beam had been welded about 1/2 in. further down than the stiffener on the north side.

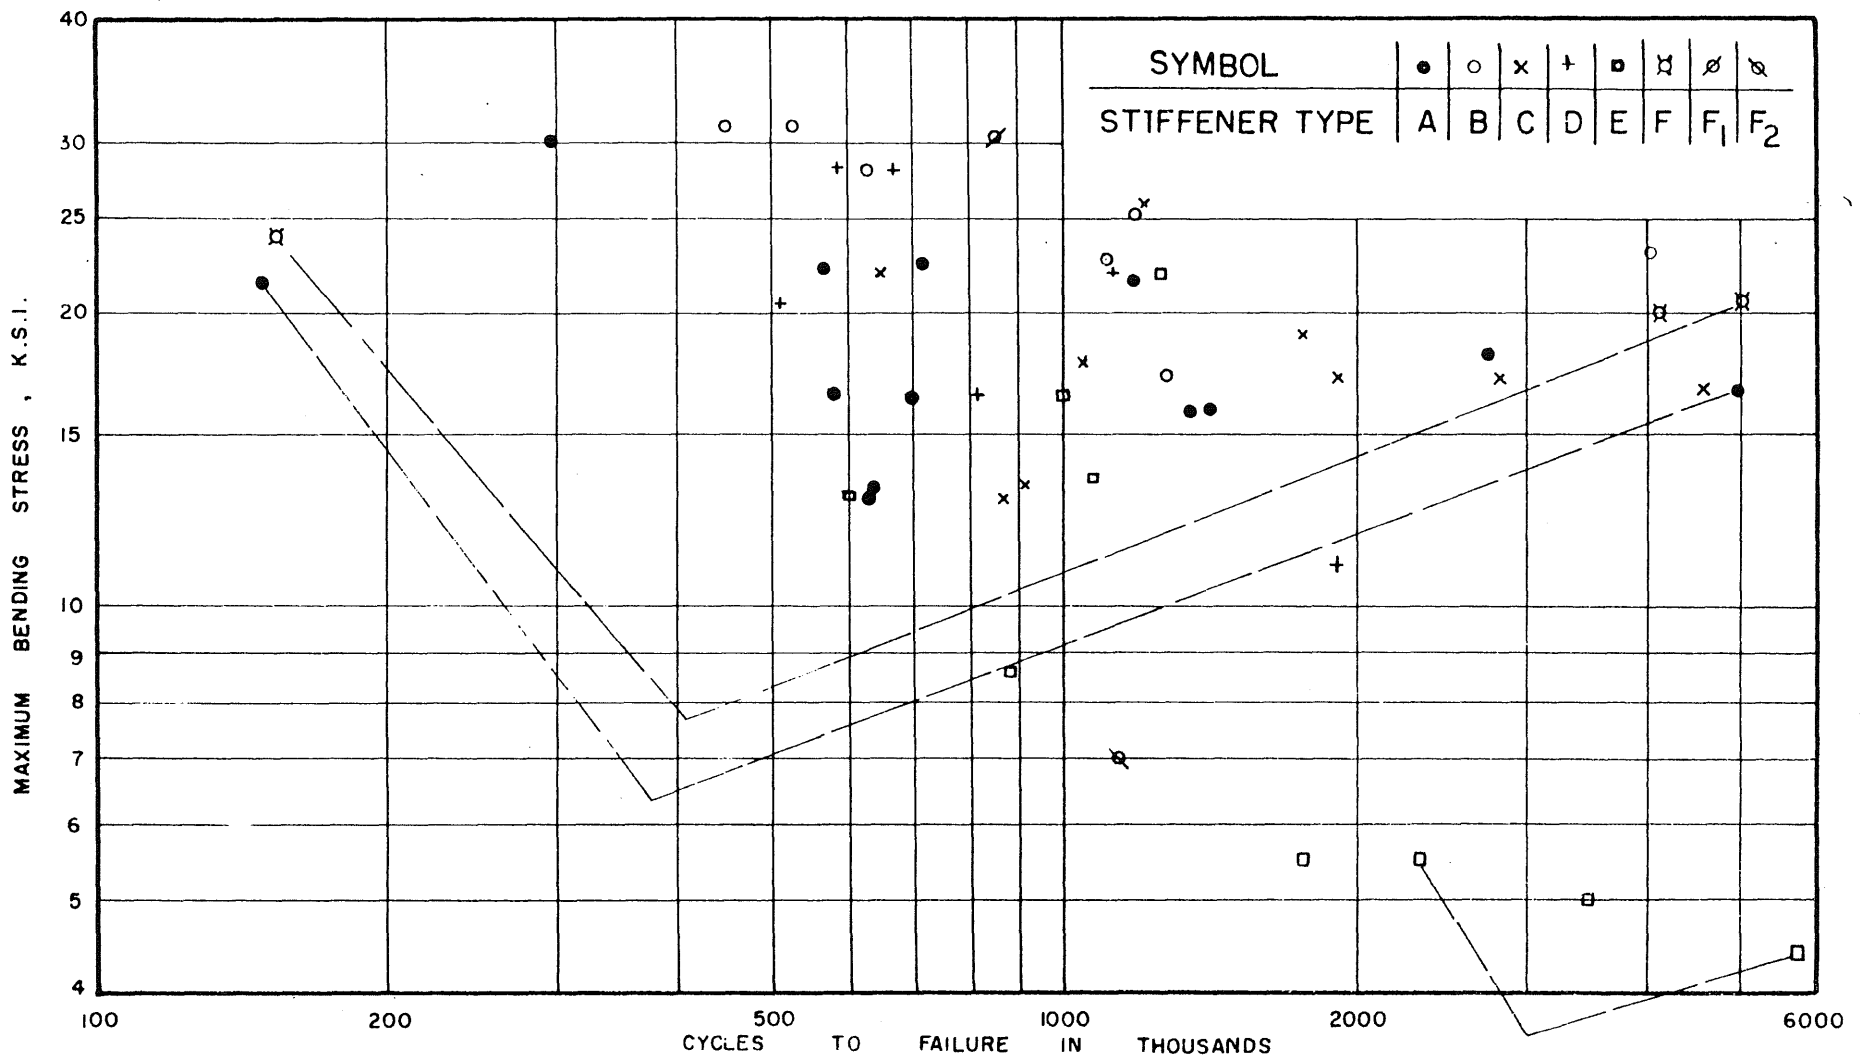
FIG. 20 S-N DIAGRAM FOR MAXIMUM BENDING STRESS AT THE FAILURE SECTION
