# **FORENSIC COLLAPSE INVESTIGATION OF A CONCRETE BRIDGE WITH TIMBER PIERS**

Research Report ICT-09-042

A report of the findings of  
**ICT-R27-SP12**  
**DeKalb County Bridge Collapse Investigation (Special Project)**

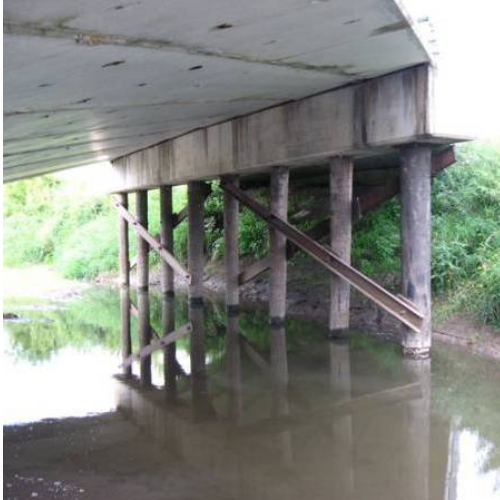
Figure 3. Midspan bent 2 timber pile foundation.

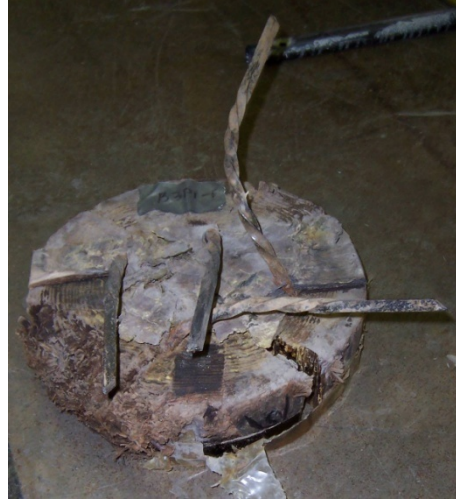
Figure 4. Damaged "post" connection.

The bridge was inspected in 2000 by Osmose. The top six feet of piles 1 and 7 (numbered from north to south) of bent 3 were removed and replaced by new round timber (termed "posting"). In 2004, Osmose posted pile 1 of bent 2 due to slight brooming. These replacement posts were connected to the existing pile by four embedded steel dowels (Figure 4). These connections were capable of transmitting axial compression through bearing, but provide insignificant transfer of moment. The "post" connection was wrapped with plastic sheeting and steel bands to protect the connection from corrosion and decay.

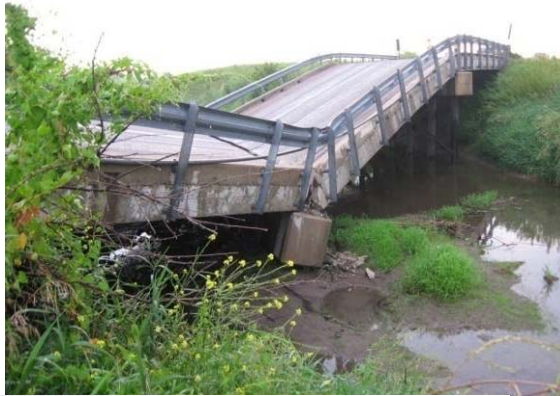
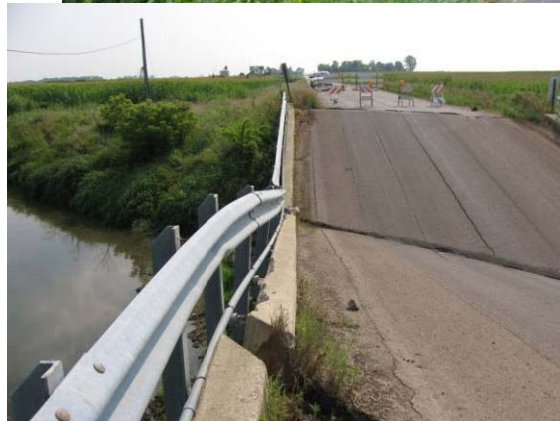
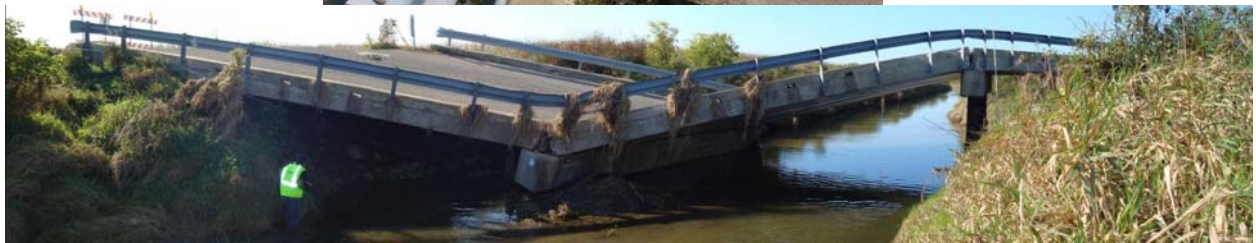
The bridge collapsed on the afternoon of August 19, 2008 (Figure 5). Bent 3 failed, collapsing the east and middle spans. The pile cap of bent 3 rested in the riverbed, obscuring the pile foundation. The bent 4 abutment pile cap rotated with the collapsed deck. The west span between bents 1 and 2 remained standing. The pile to pile cap connection of bent 3 remained intact after the collapse, maintaining its connection capable of transferring axial force and moment (Figure 6). Since the deck was not continuous at the pile cap there was a large rotation between the two deck segments, cracking the asphalt surface (Figure 5). The deck-to-pile cap connection consisted of steel dowels that were ductile enough to remain connected and likely retained some of their shear strength despite the excessive relative rotation of the deck to the pile cap.

Figure 5. Illinois Dekalb County Bridge No. SN019-5010 after collapse.

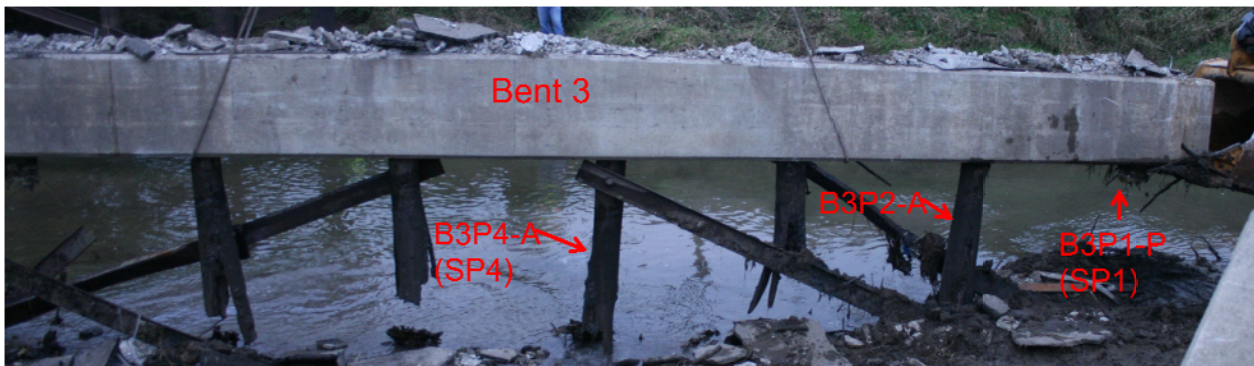
Figure 7. Bent 3 extracted from riverbed.

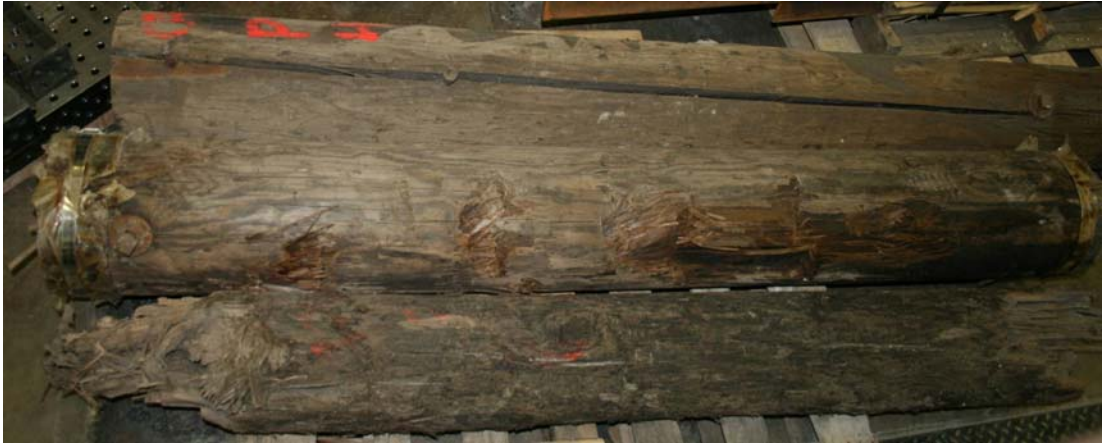
The origin and condition of each of the retrieved samples is described in Table 1. Sample names are based on the bent, pile, and location where the samples were extracted. The first number is the bent number, increasing to the east. The second number is the pile number, increasing to the south (see Figure 2). The trailing letter denotes the elevation of the sample as typically above the water line (-A), typically below the water line (-B), or a post from an Osmose repair (-P). The intact length describes the length of sample adequate for structural testing. Figure 8 shows three of the cleaned, retrieved samples.

Figure 8. Retrieved pile samples.

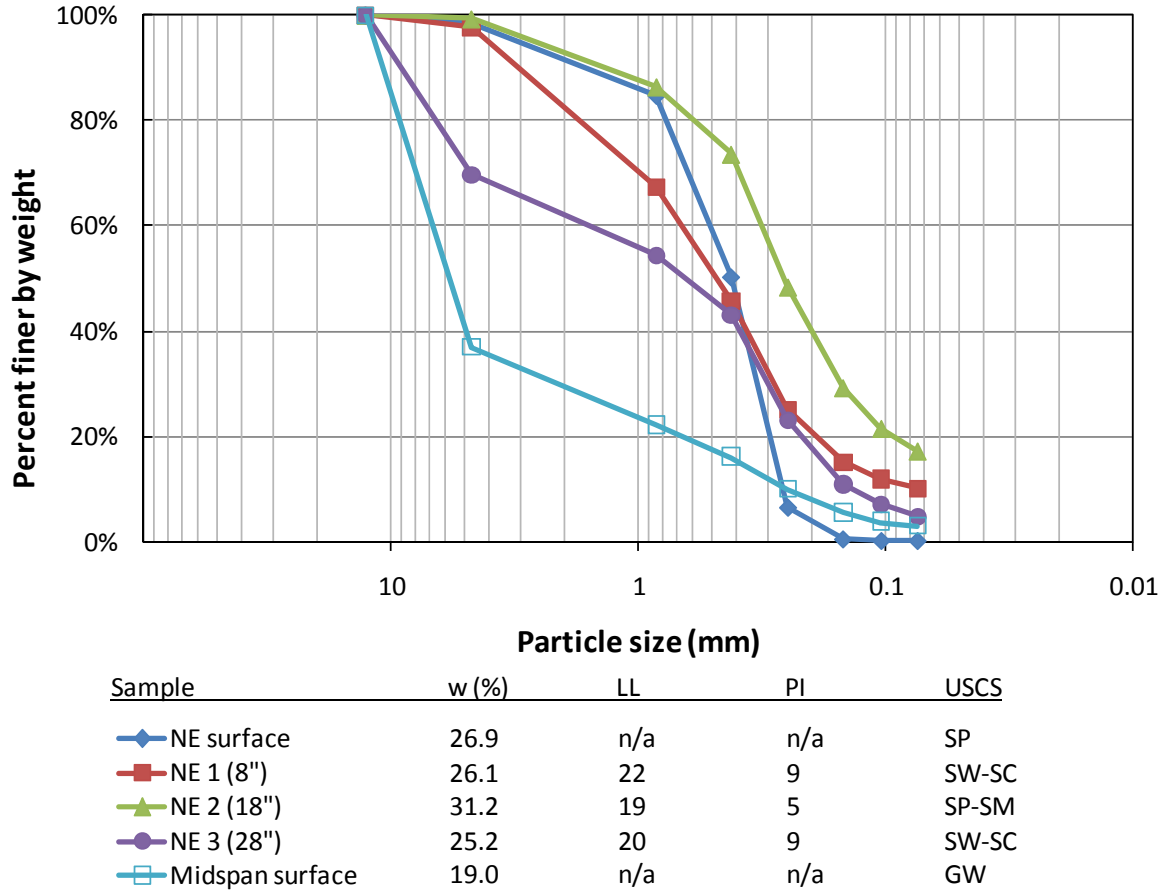
Index tests on the samples were performed, including water content (ASTM 2216), grain size distribution (ASTM D422), and Atterberg limits (ASTM D4318) where appropriate and sufficient fines were available. Figure 11 presents the grain size distributions, Atterberg limits, and USCS classification (ASTM D2487) for the samples.

Figure 11. Retrieved soil samples grain size distributions, Atterberg limits and USCS classification.

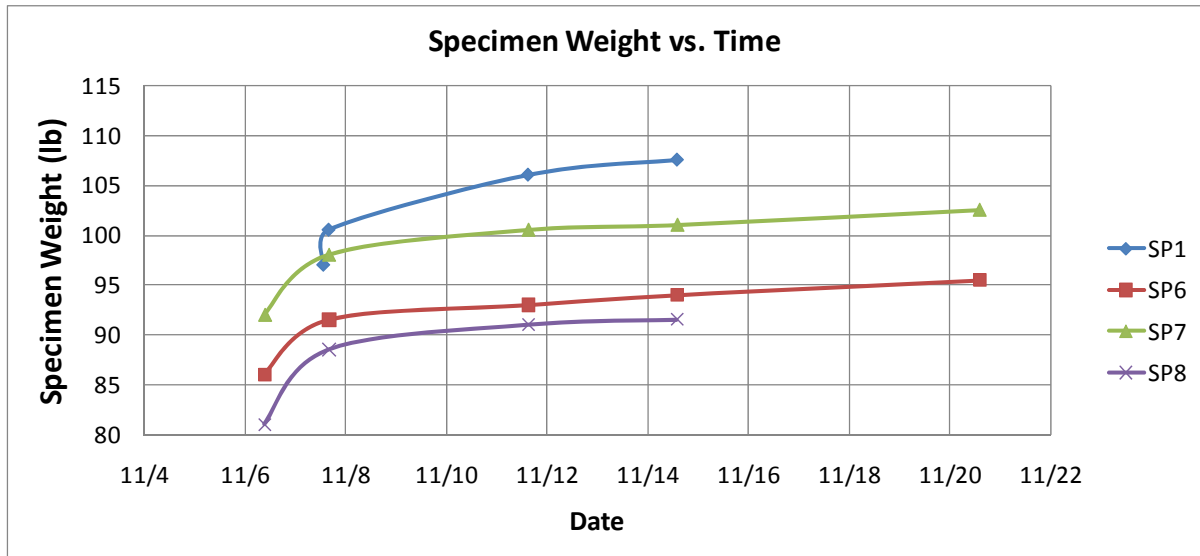
The specimens were tested at two moisture content levels to replicate field conditions: air-dried and submerged. The air-dried specimens were dried for 36 days under laboratory conditions. The saturated specimens were submerged in water and weighed periodically until their weight stabilized (Figure 12).

Figure 12. Specimen saturation curves.

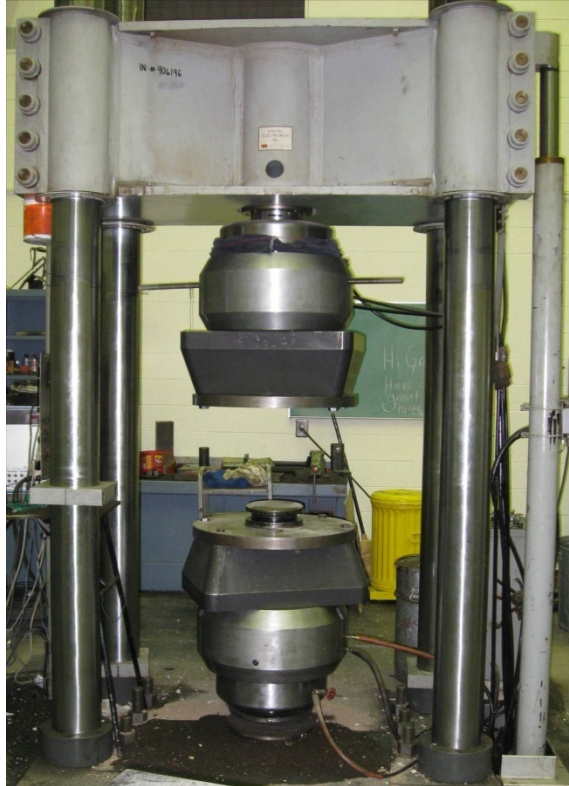
The tests were conducted in Newmark Structural Engineering Laboratory using a 600 kip MTS uniaxial servo-controlled testing frame (Figure 13). A 28 inch circular bearing plate was attached to the top and bottom grips. A spherical head with a 10 inch diameter plate was placed on the bottom bearing plate to avoid unintentional eccentricities. A 1-5/8 inch thick plate (not shown) was placed on the spherical head to provide a large bearing surface for the specimens. The actuator was controlled using an INSTRON 8800 controller.

Figure 13. 600 kip MTS testing machine.

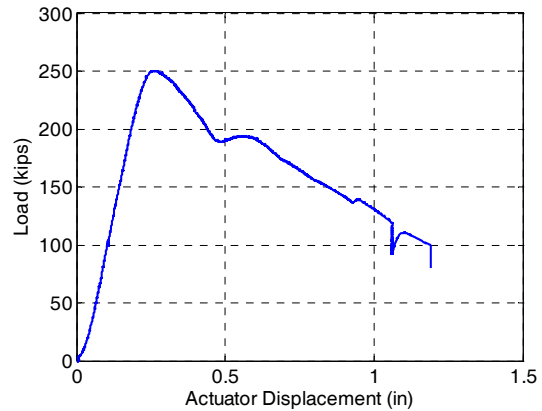
The typical response of the specimen during the test is shown in Figure 17. Below 10 kips the specimen had a softer response, likely due to localized crushing caused by uneven loading. Subsequently the specimen behaves linearly up to the peak load, 250 kips in this case. The post-peak softening response is also nearly linear. A brief strength increase can be observed around 0.9 inches when the strain rate was increased (Figure 16). When the cross-head position was held at 1.05 inches the load decreased as the specimen relaxed, as demonstrated by the vertical line in Figure 17.

Figure 17. Typical monotonic load vs. displacement response.

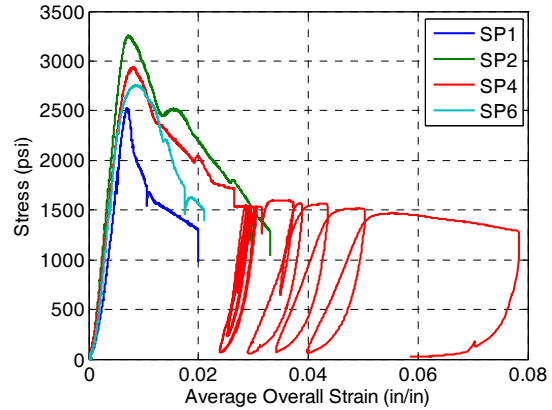
Figure 19. Monotonic test stress vs. strain.

The stress-strain response of the monotonic compression tests is summarized in Figure 19. The initial stiffness is similar between the tests but the peak stress has some scatter (Table 5). Specimen SP4 was subjected to several cycles post peak designated by the red loops. The tests were halted after the load dropped below half of the peak.

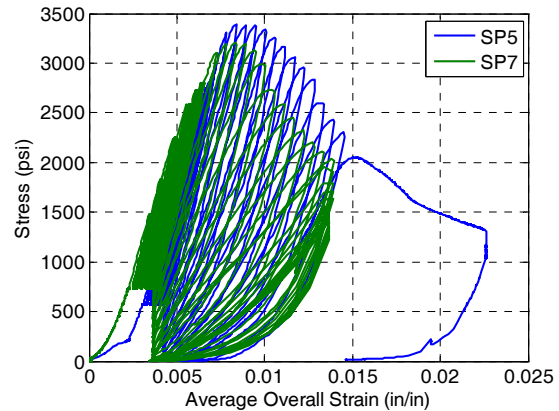
Figure 23. Cyclic test stress vs. strain.

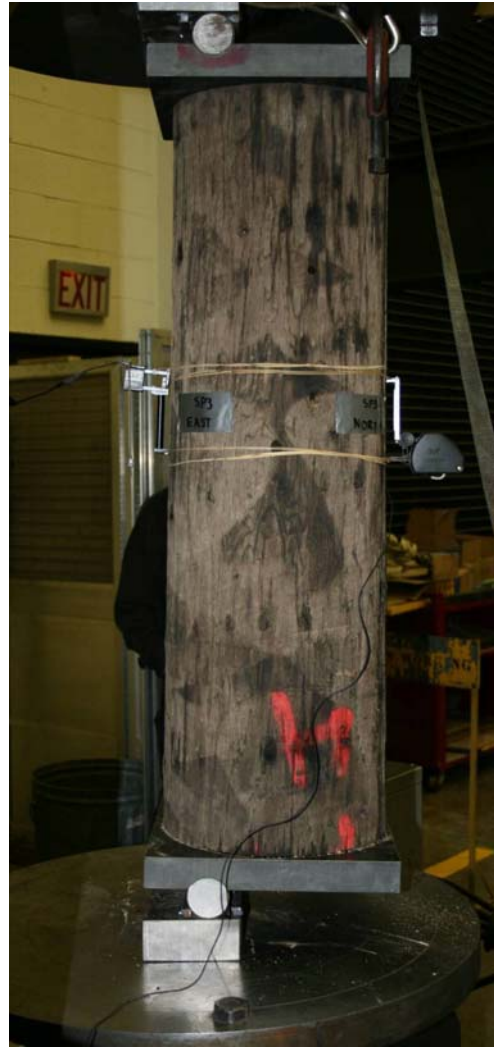
Figure 25. Loading end plate in testing frame.

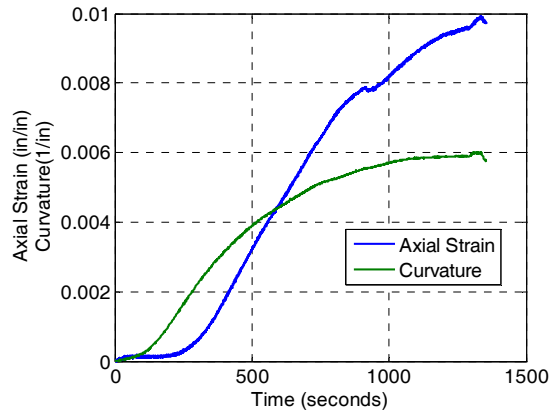
Figure 29. Typical compression-flexure test axial strain and curvature.

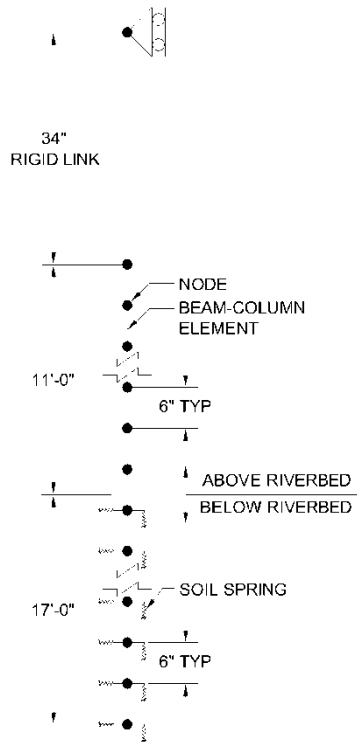
The pile was broken into two regions, above the riverbed, and below the riverbed. A length of 11 feet was used above the riverbed, and 17 feet below the riverbed. For simplicity, the moisture content was assumed to be air-dried above the riverbed and saturated below. The top of the pile was connected to a 34-inch rigid link to represent the concrete pile cap (Figure 31). The pile was modeled as perfectly vertical. The pile was divided into fiber beam elements, each 6 inches long. Below the riverbed, vertical and lateral springs were applied at the nodes (Figure 31) using properties outlined in Section 4.1.6 and determined based on the geotechnical investigation outlined in Chapter 2.

Figure 31. Analytical full-scale model of single pile.

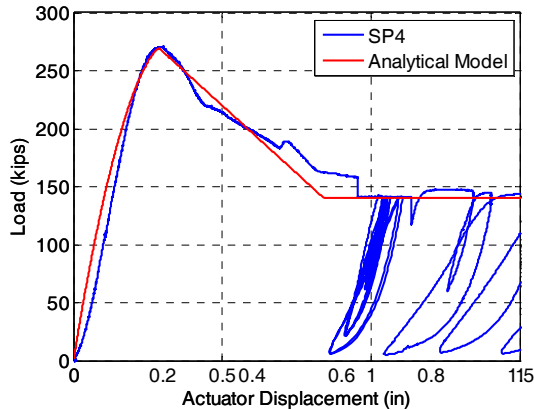
Experimental tests were modeled using the same elements and materials as the full-scale model. The geometry of the compression tests was modeled using six 6-inch-long elements with pinned-fixed boundary conditions (Figure 32). The material model compression parameters were then calibrated to replicate the compression experimental response. Figure 35 and Figure 36 compare the observed response of the specimen with the analytical prediction with good agreement of peak stress and nature of response.

Figure 35. Experimental vs. computational load-deformation response of pile above riverbed: compression.

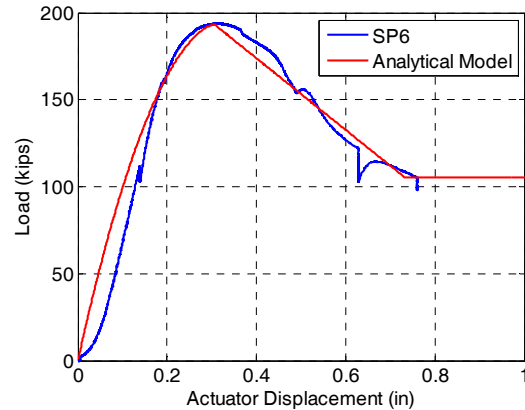
Figure 36. Experimental vs. computational load-deformation response of pile below riverbed: compression.

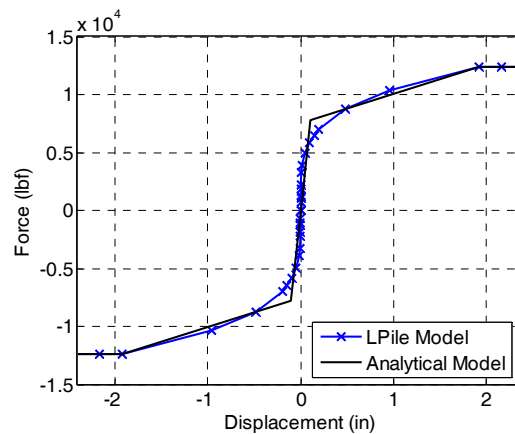
Lateral (transverse) springs were used to represent the resistance of the soil against the pile buckling (see Section 2). Each node (i.e., every 6 inches) below the riverbed was stabilized transverse to the length of the pile with a lateral spring. The lateral springs were connected between stationary (fixed) nodes and the nodes on the pile. The lateral springs only resisted lateral translation and were not influenced by vertical displacement. The nonlinear geotechnical soil springs from LPILE were modeled with a tri-linear constitutive formulation using the OpenSees Hysteretic material model (Figure 40). The computer model is a simplified constitutive relationship of the soil response predicted by the geotechnical analysis. As only one lateral spring was attached to each node, rather than a spring on both sides, the lateral springs were modeled to give the provided behavior in compression and tension.

Figure 40. Typical geotechnical and computer model load-deformation response of lateral soil spring.

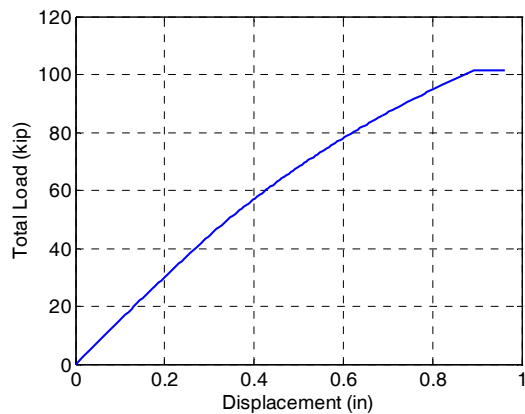
Figure 45 and Figure 46. The results are summarized in Table 9. Under increasing loading thereafter, the pile begins to soften, and it experiences a peak strength at which failure of the pile group would be predicted to occur, thus leading to collapse of the structure.

Figure 45. Computational load vs. displacement results of concentrically-loaded pile.

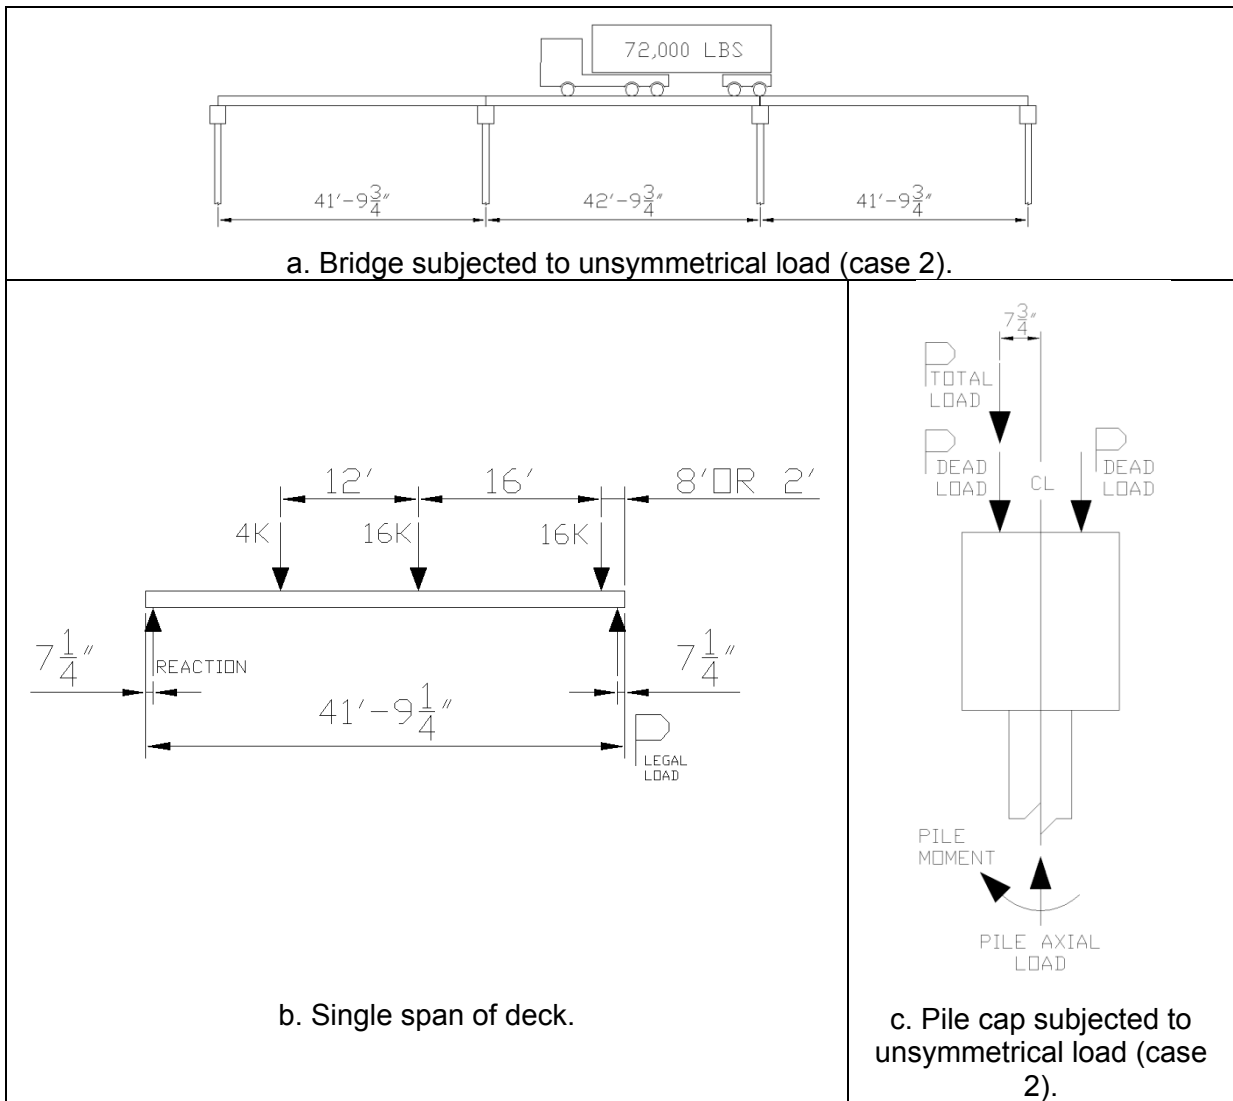
Figure 56. Free body diagram of bridge subjected to Illinois legal load Type 3-S2.

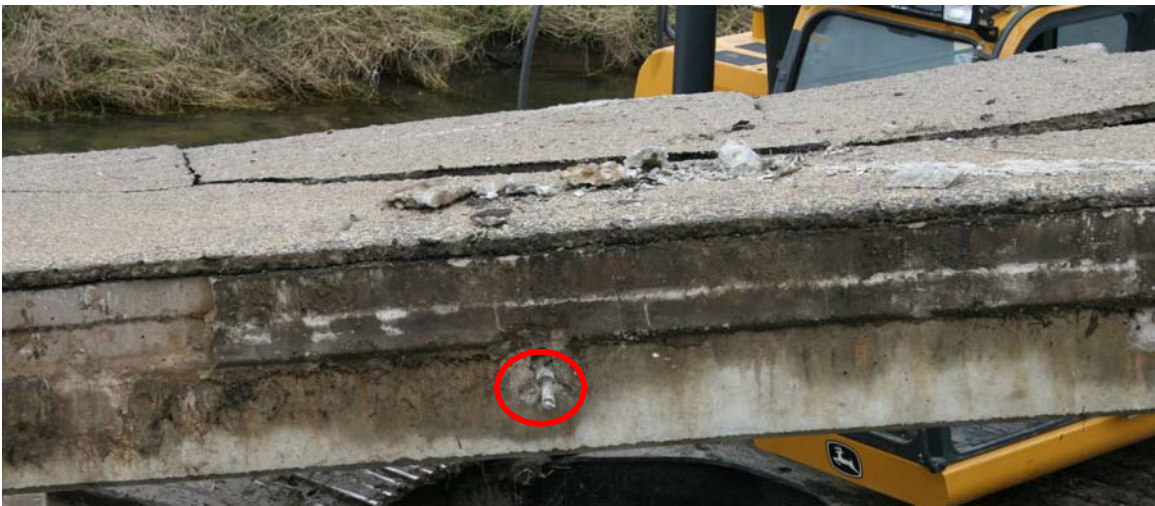
The deck beams did not show any signs of damage. The beams were cambered upward when placed on a flat surface due to the initial pretension. The photos below show the removal of the deck beams.

Figure A-1. Deck beam with transverse ties cut.

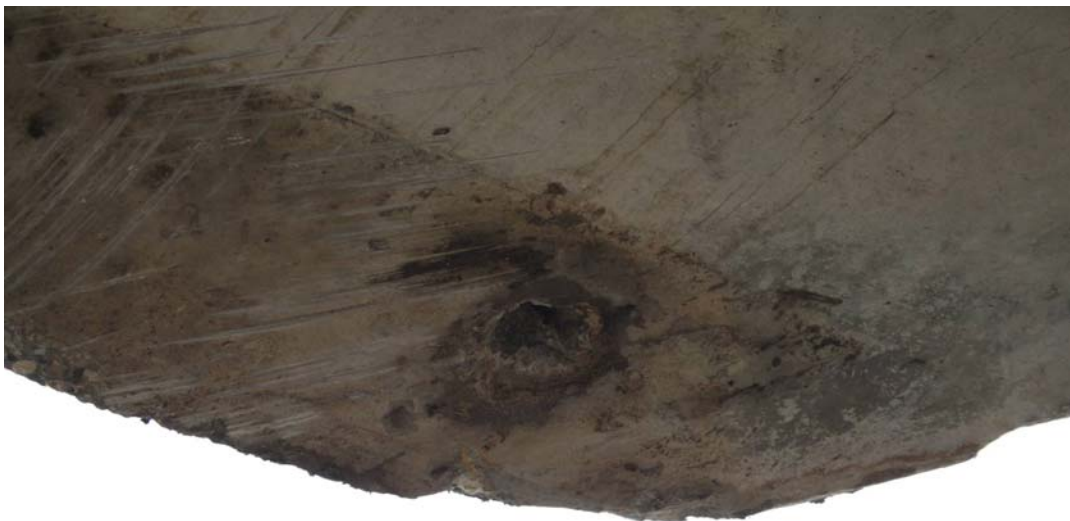
Figure A-2. Two inch tubes precast into deck beams.

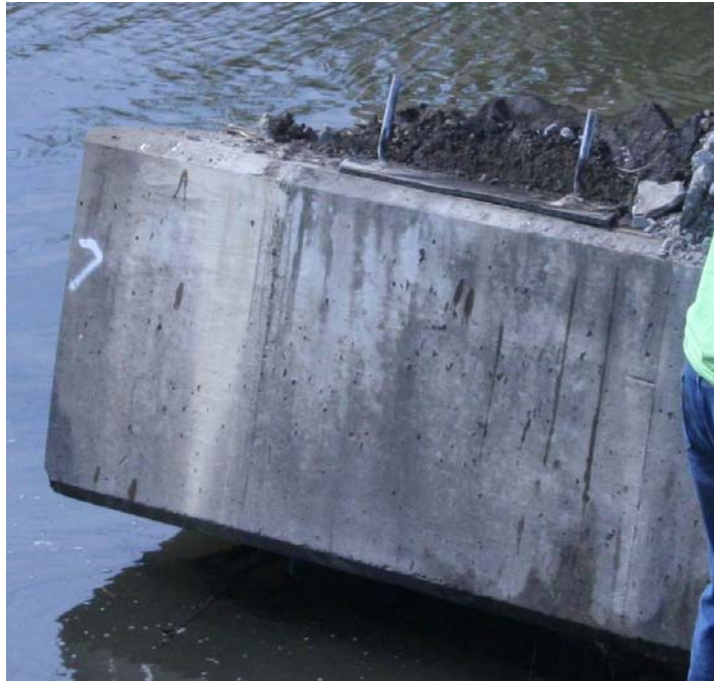
Figure A-3. 3/4 inch steel dowels.

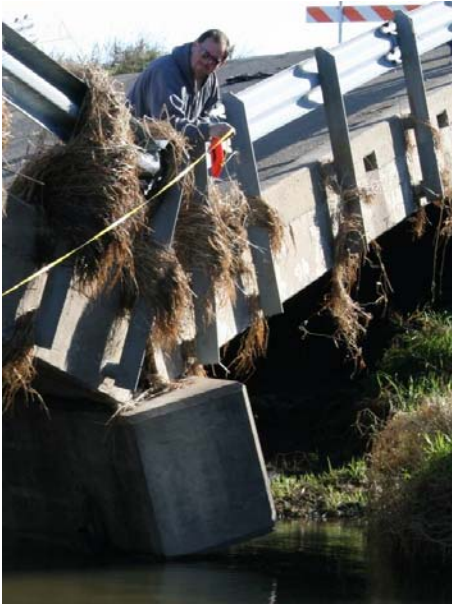
The bent 3 pile cap rested in the riverbed on top of the remaining piles, tilted away from the bank (Figure A-5). The pile cap was removed after the deck removal on October 7, 2008. The pile cap was attached by a large crane and pulled from the riverbed with the assistance of two excavators (Figure A-6). Six of the eight piles remained connected to the pile cap, fractured a few feet from the bottom of the pile cap (Figure A-7, Figure A-8 and Figure A-9). The connection between the piles and the pile cap was sound, even after the collapse (Figure A-10). The post connections failed during the collapse (Figure A-11). Additional length of pile remained embedded below the riverbed (Figure A-12). The pile cap did not show any structural damage.

Figure A-5. Collapsed bent 3 pile cap.

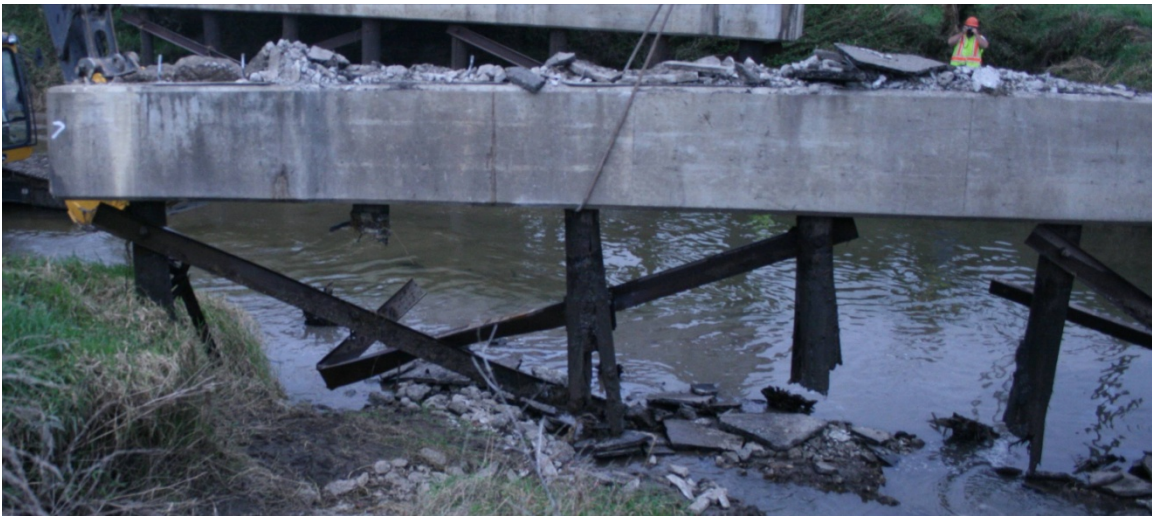
Figure A-8. Fractured piles and failed post connection.

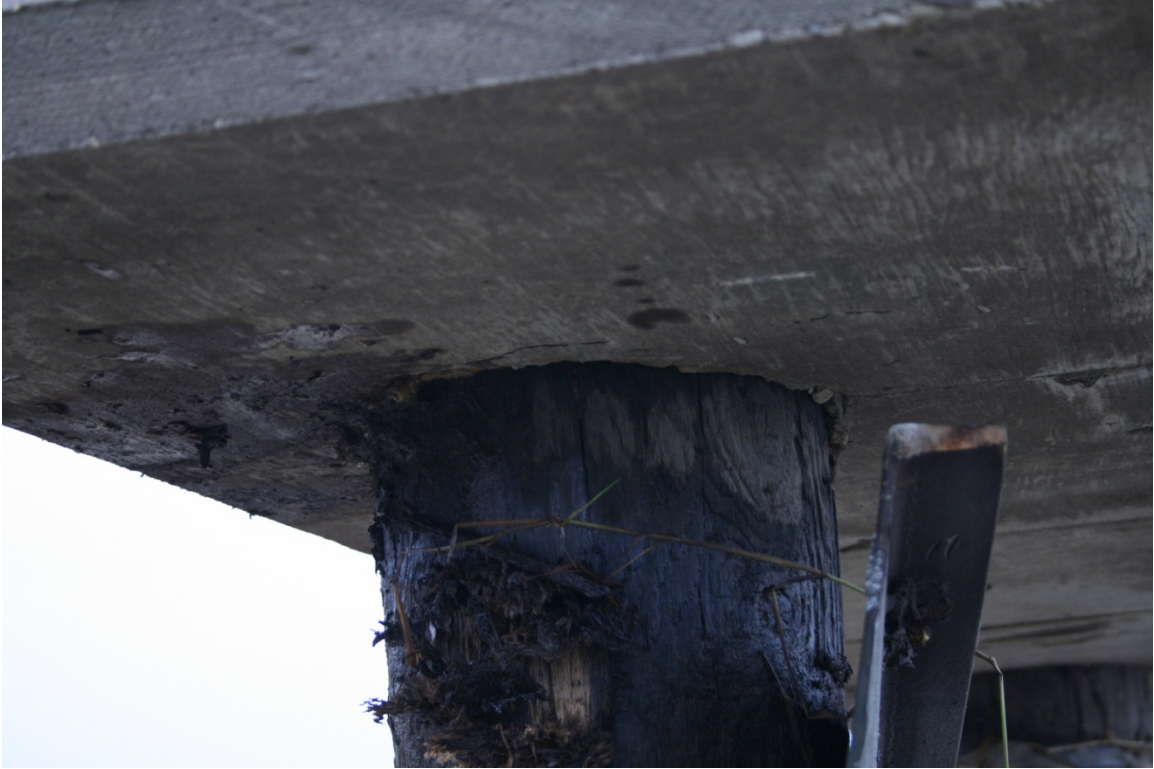
Figure A-10. Intact pile to pile cap connection after collapse.

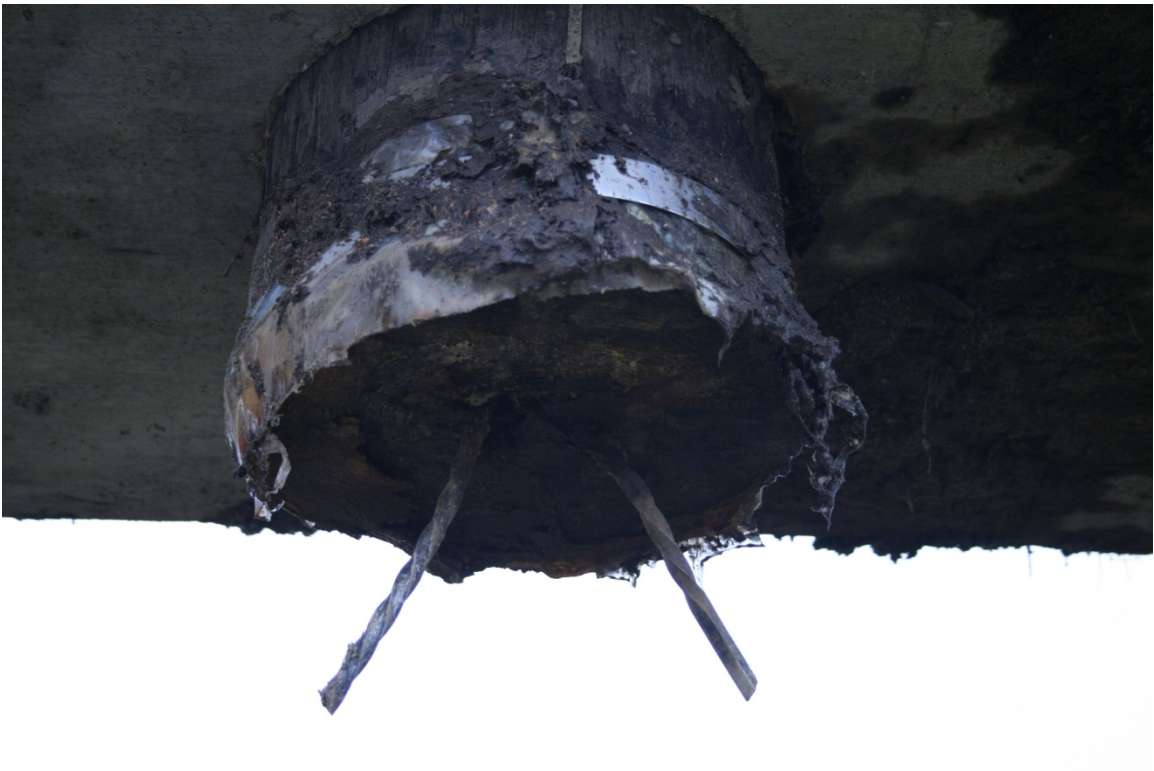
Figure A-11. Failed post connection.

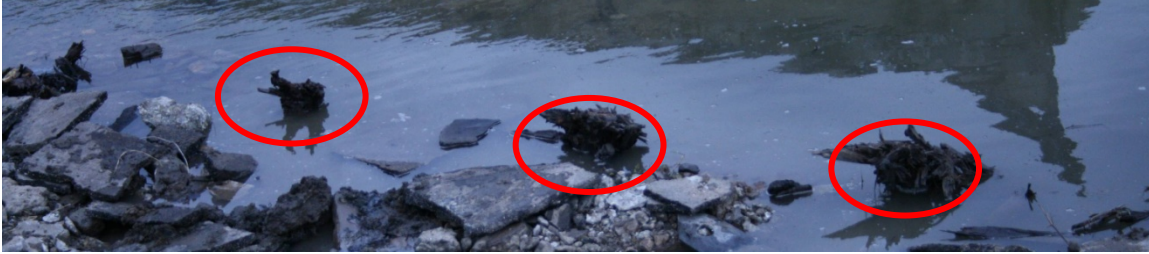
Figure A-12. Piles remaining in riverbed.

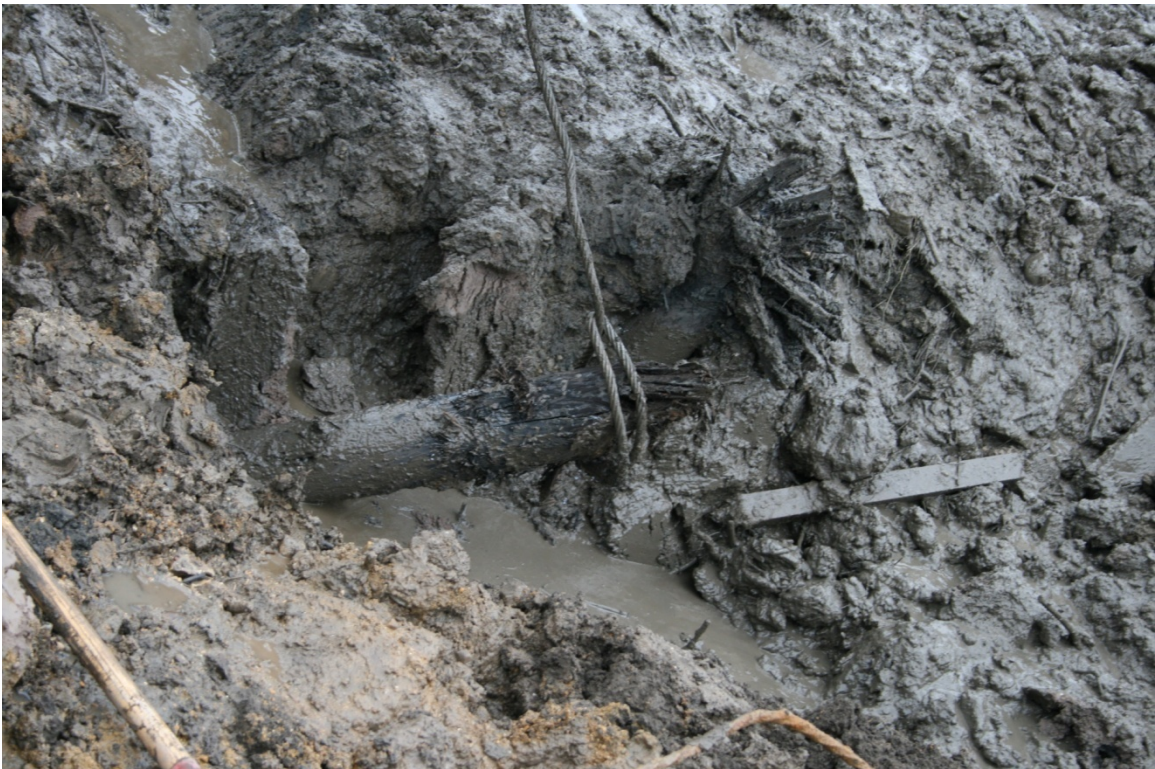
Figure A-15. Failure of embedded pile 1 under applied lateral load.
