# THE EFFECT OF INTERNAL WELD DEFECTS ON THE FATIGUE BEHAVIOR OF WELDED CONNECTIONS

By  
DAVID H. EKSTROM  
W. H. MUNSE

Report on Phase 2.3  
Investigation of Welded Highway Bridges  
Project IHR-64

UNIVERSITY OF ILLINOIS  
URBANA, ILLINOIS  
FEBRUARY 1973

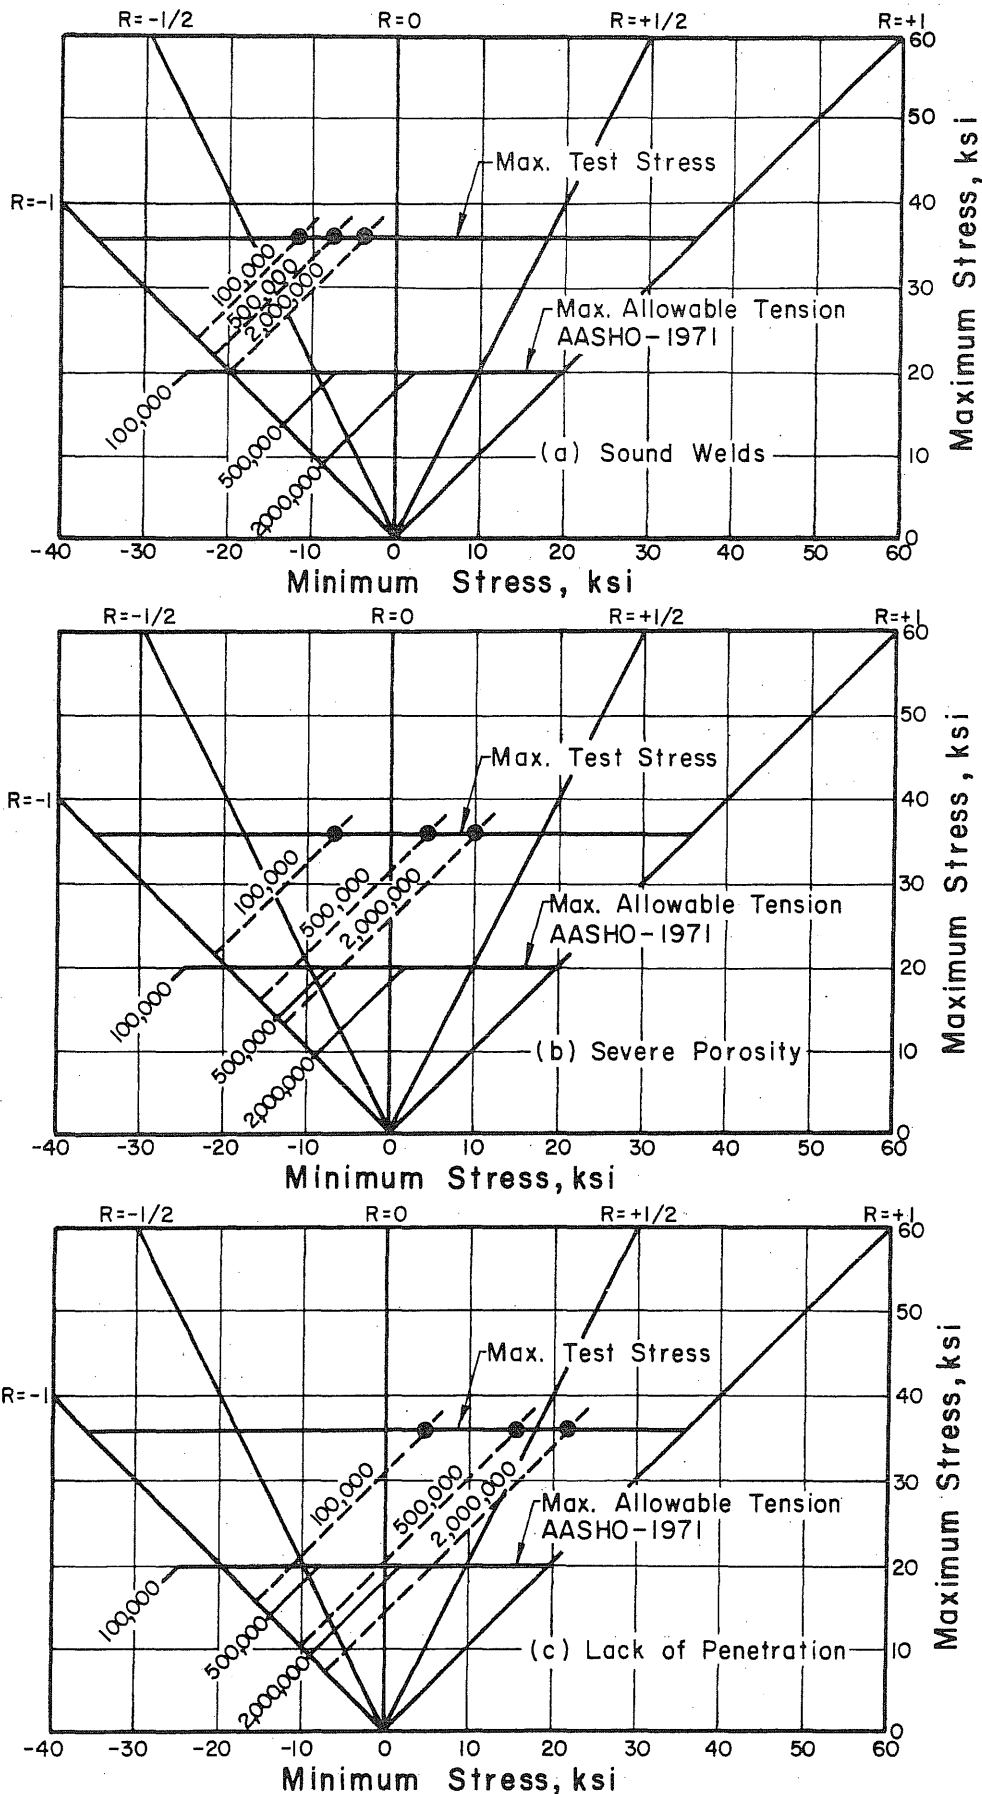
FIG. 5.8 MODIFIED GOODMAN FATIGUE DIAGRAM. COMPARISON OF TEST RESULTS WITH AASHTO-1971 DESIGN REQUIREMENTS

If the specimens behave as shown by the dotted lines in Figure 5.8 (fatigue resistance is assumed to be a function only of the range of stress--for these members the assumption is believed to be relatively good), the only defect that would cause serious concern if in a connection designed for 2,000,000 cycles according to the AASHO 1971 Specifications<sup>2</sup> would be those with large amounts of lack of penetration. Taking  $F_{2,000,000}$  as an example, the AASHO Specification allows a range of 18 ksi with a 20 ksi maximum for a sound butt weld prepared in the general manner in which the specimens of this investigation were prepared. In the test results of this study the only type of defect that has a  $F_{2,000,000}$  stress range (average fatigue strength) less than 18 ksi is the lack of penetration with a stress range of 14 ksi. Even the specimens with severe porosity had an average stress range of approximately 25 ksi at 2,000,000 cycles. The specimens with sound welds had a fatigue strength at 2,000,000 cycles of approximately 39.9 ksi. (This is somewhat higher than most data reported in the literature for connections with the reinforcement removed. The reason for this is not known.)

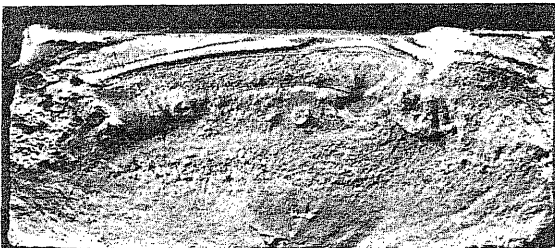
FIG. B.2 FRACTURE SURFACES OF SOUND WELDED JOINTS

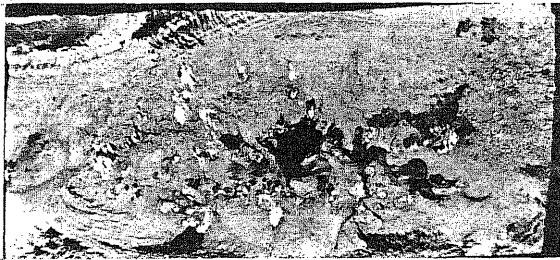
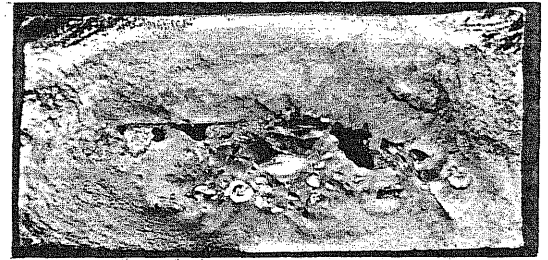
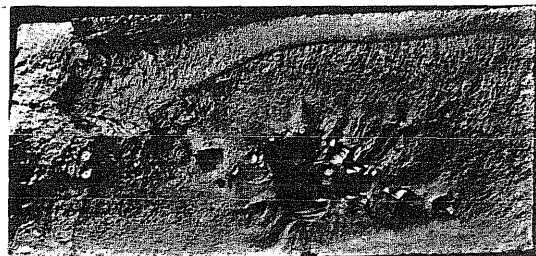
**FIG. B.4 FRACTURE SURFACES OF JOINTS WITH SEVERE CLUSTERS OF POROSITY**

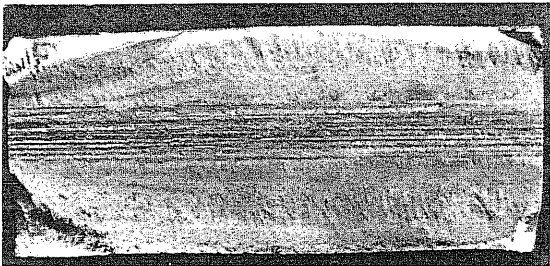
FIG. B.5 FRACTURE SURFACES OF JOINTS WITH LACK OF PENETRATION
