LABORATORY TESTS OF TWO-SPAN PRESTRESSED REINFORCED CONCRETE BRIDGE GIRDERS CONSTRUCTED FROM THREE LONG SEGMENTS

by
W. L. GAMBLE
R. G. DREW

Issued as the Final Report on an
Investigation of Field-Made Joints in
Prestressed Reinforced Concrete
Highway Bridge Girders
Project IHR-303

UNIVERSITY OF ILLINOIS
AT URBANA-CHAMPAIGN
URBANA, ILLINOIS
FEBRUARY 1979

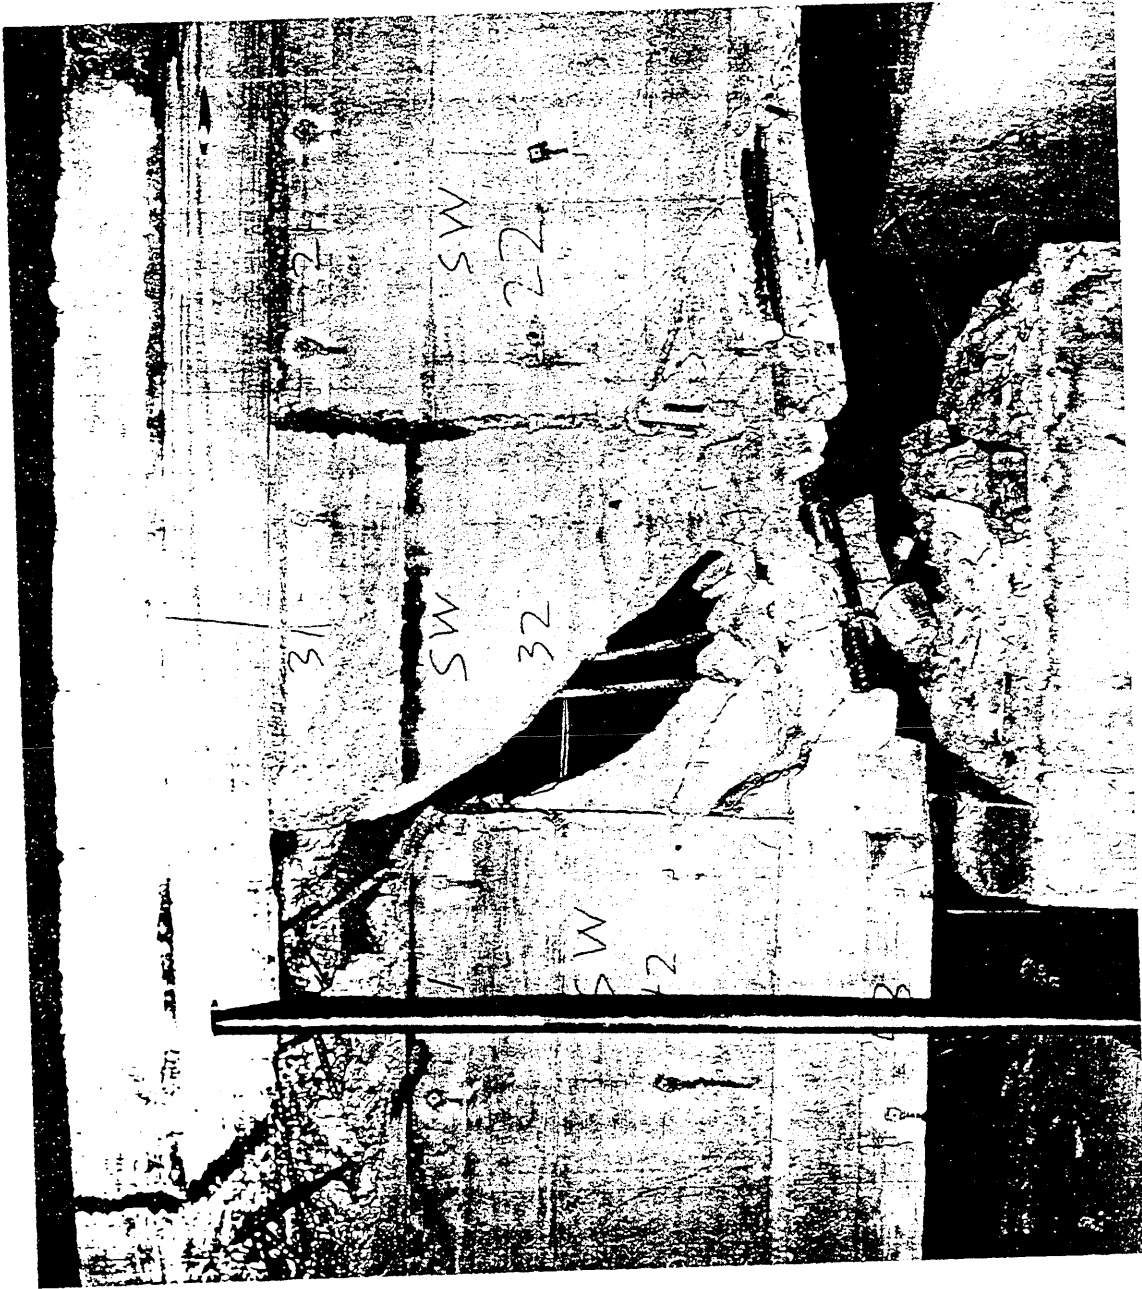
FIG. 5.36 PHOTO OF SOUTH SIDE OF WEST SPLICE OF MODEL 2 AFTER FAILURE
