EFFECTS OF REPEATED LOADINGS ON STRUCTURAL CONNECTIONS WITH HIGH-STRENGTH BOLTS

A Progress Report of An Investigation

Project IV

January 1955

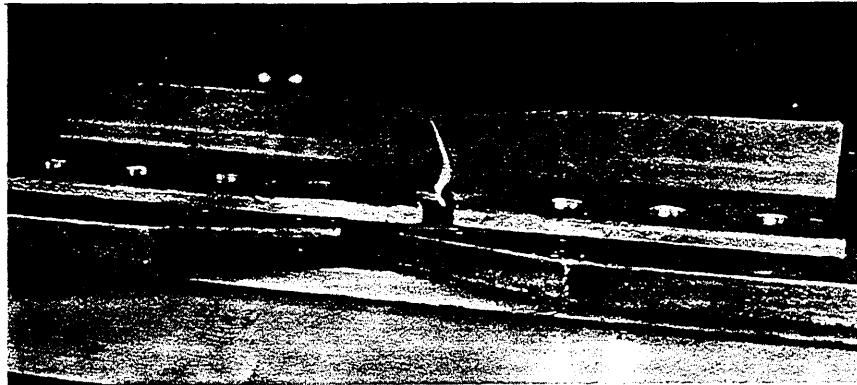
(a) NECK-DOWN IN WEB AT NET SECTION
AFTER FAILURE, SPECIMEN P18-4

(b) NECK-DOWN IN FLANGE TOE BEFORE
FAILURE, SPECIMEN B18-5

FIG. 14 CRITICAL SECTION OF T-SECTIONS
(STATIC TESTS)

The T-sections all fractured at a section through the first transverse row of fasteners of one of the two joints at loads varying from 390,000 to 458,000 lb. Views of the fractures of B18-5 and P18-5 are shown in Figs. 13a and 13b, respectively. Figure 14a is a longitudinal view of one of the T-sections of specimen P18-4 after fracture and shows the "neck down" of the web.

In the process of withstanding the maximum loads, the flange toes at the critical sections in nearly all of the specimens ruptured. This was probably a result of the notch effect of the bolt holes and the fatigue cracks. At least half of the specimens exhibited broken flange toes just before or at maximum load. The remainder of the specimens developed breaks in the toes after the maximum load had been reached but before rupture took place. Figure 14b shows the highly localized necking-down which was typical of a flange toe at a first transverse row of fasteners just before the flange toe fractured.

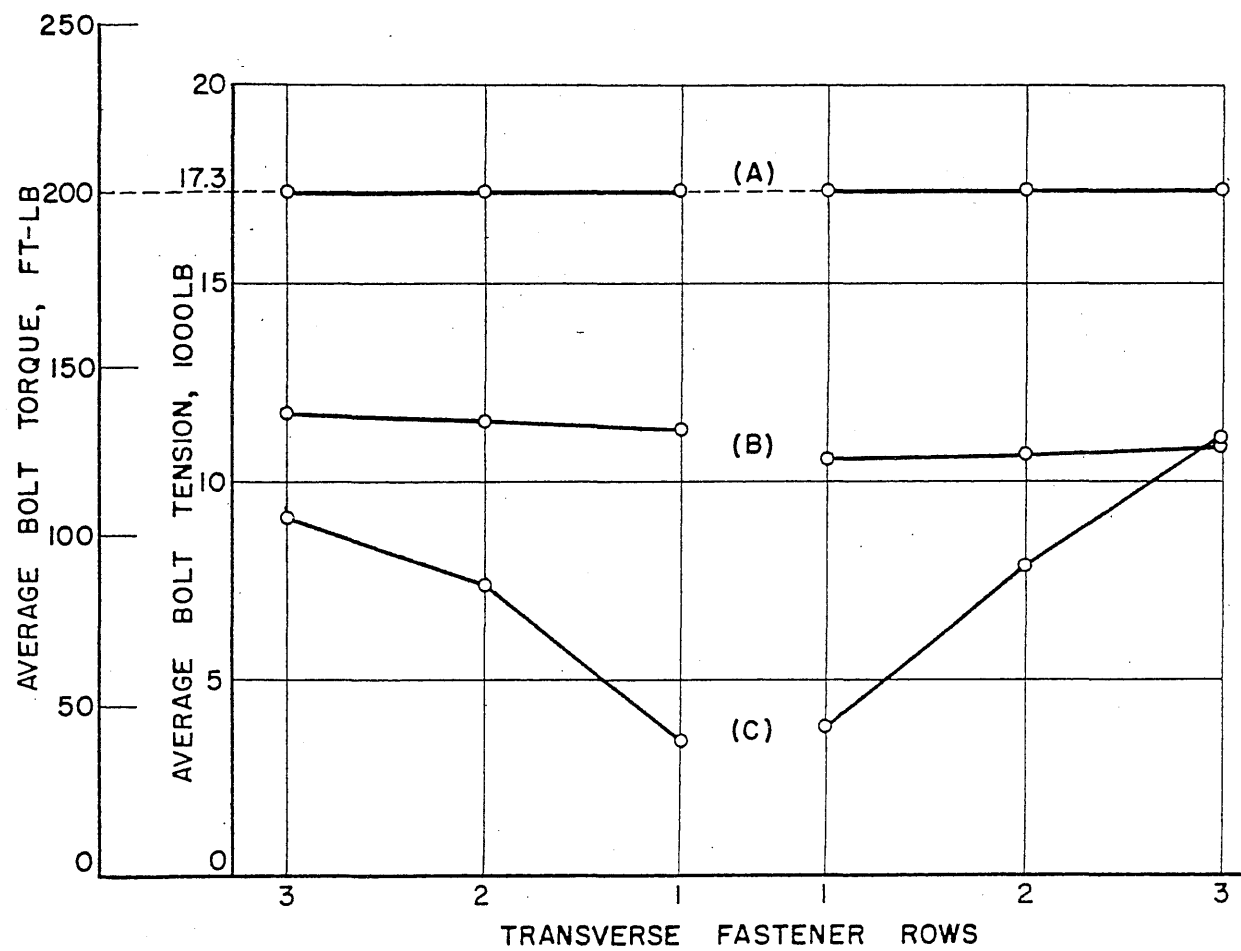
(A) INITIAL BOLT TENSION, STATIC & FATIGUE TESTS
 (B) BOLT TENSION AFTER FATIGUE TESTS
 (C) BOLT TENSION AFTER STATIC TEST OF P6-5

FIG. 17 BOLT TENSIONS AT VARIOUS STAGES DURING TESTING OF SPECIMENS OF SERIES P6

The tension remaining in the bolts after the static testing was also measured in terms of the torque required to loosen the nuts. Figures 16 and 17 show the residual bolt tensions for specimens B6-5 and P6-5; Fig. 18 shows the bolt tension remaining in the specimens of series B18 and P18.

The bolts in the first transverse rows of specimens B6-5 and P6-5 lost 80 to 90 per cent of their initial tension while those in the third transverse rows lost 40 to 60 per cent. The bolts in the T-section specimens had a 95 to 100 per cent loss in tension at the first transverse rows and a 50 to 60 per cent loss in the third rows. This extreme loss in tension at the first rows was due, of course, to the necking-down and fracture of the connected parts.

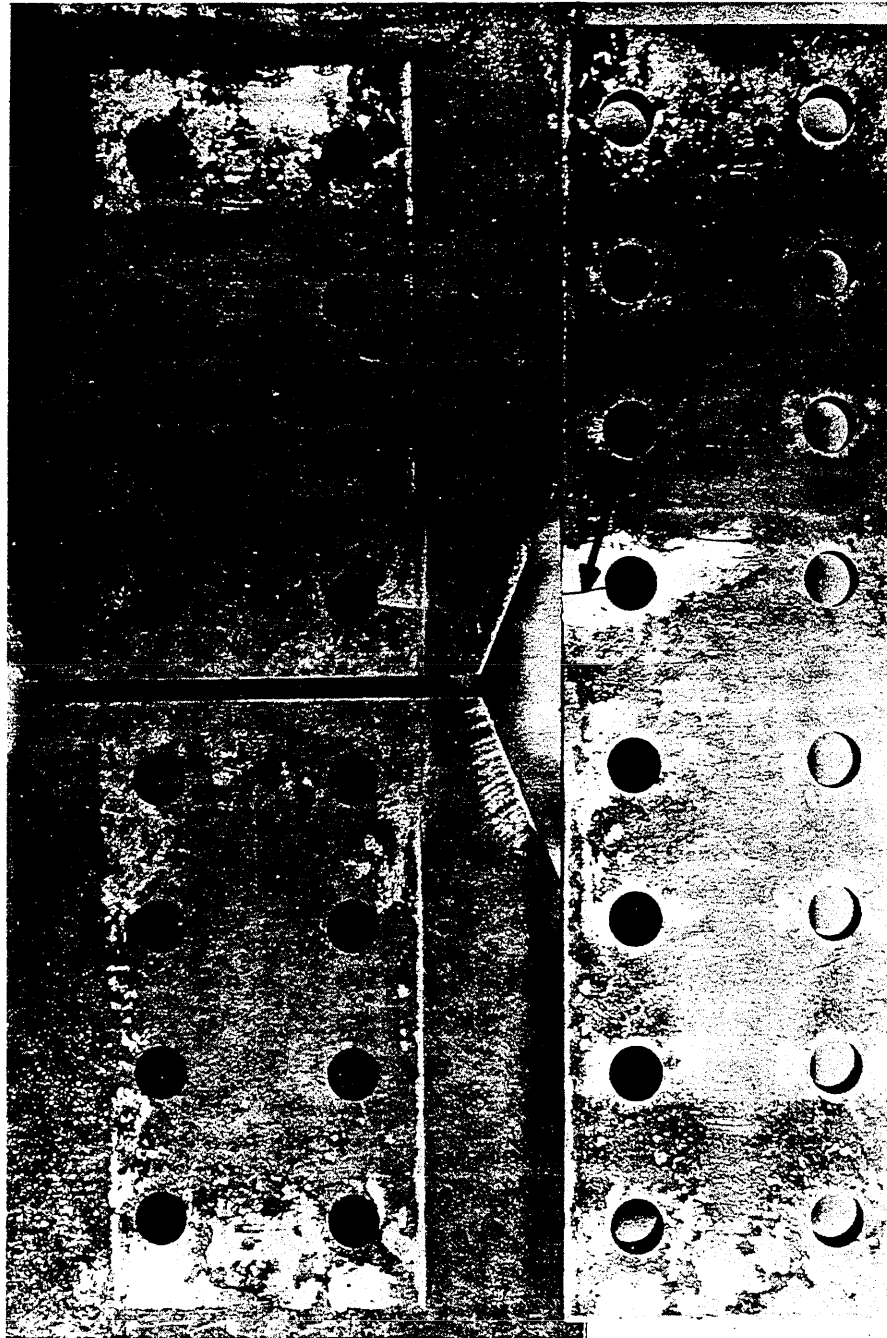
FIG. 19 GRINDING ACTION ON JOINT CONTACT SURFACES OF SPECIMEN P18-2

Table 5 lists the stress cycle, number of cycles applied, and the slip of the joint per cycle for the tests of the T-sections. All of the T-sections withstood about 2,000,000 or more cycles without any visible signs of failure. Specimen P18-2, the second T-section specimen tested, ran 2,400,000 cycles at an average stress on the net section of $\pm 12,000$ psi without any sign of failure. The stress level was then changed to a completely reversed stress cycle of 17,200 psi to hasten failure. After an additional 200,000 cycles, a crack became visible and had progressed through one of the first row flange toes. The arrow in Fig. 19 indicates the location of this crack.

A Grinding action took place on the contact surfaces of the specimens during the fatigue tests. Although this grinding existed at many points on the surfaces, it was predominant at the first and fourth transverse rows of fasteners. The grinding pulverized the rust and mill scale, and caused a reseating of the contact surfaces. This action is believed to have reduced the original grip of the bolt slightly and may have been responsible for the loss in tension being largest at the first and fourth rows of fasteners. An example of the areas polished by this grinding action may be seen in Fig. 19.
