AN EXPERIMENTAL STUDY OF A FLAT SLAB FLOOR
REINFORCED WITH WELDED WIRE FABRIC

J. O. JIRSA

JUNE 1962

CIVIL ENGINEERING DEPARTMENT
UNIVERSITY OF ILLINOIS

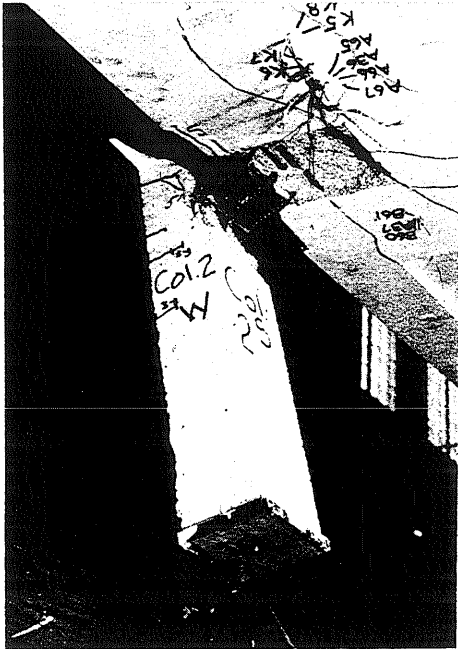
(a) Column 2 After Failure

(b) Bottom View at Column 3

(d) Bottom View of Column 14

FIG. 7.30 PHOTOGRAPHS OF BEAM-COLUMN CONNECTIONS AFTER FAILURE

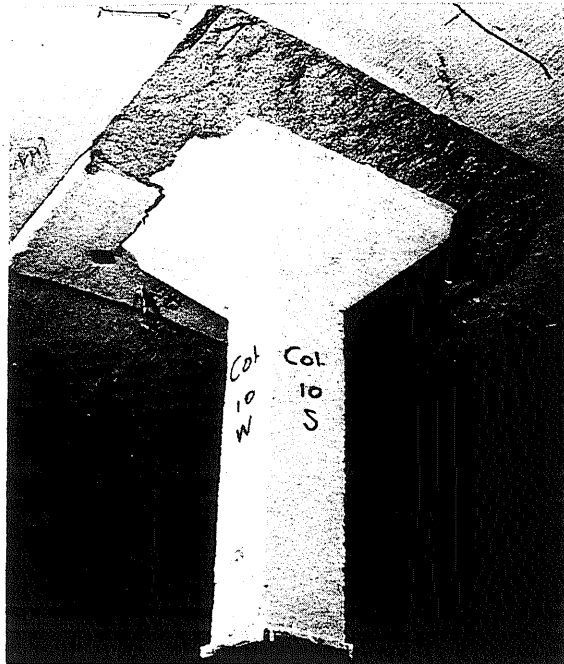
FIG. 7.31 PHOTOGRAPHS OF DROP PANEL AFTER TEST TO FAILURE
