CIVIL ENGINEERING STUDIES

STRUCTURAL RESEARCH SERIES NO. 493

**INFLUENCE OF STIRRUP-TIE SHAPE ON INELASTIC
CYCLIC RESPONSE OF FLANGED REINFORCED
CONCRETE FLEXURAL MEMBERS**

UNIVERSITY OF ILLINOIS
at URBANA-CHAMPAIGN
URBANA, ILLINOIS
AUGUST 1981

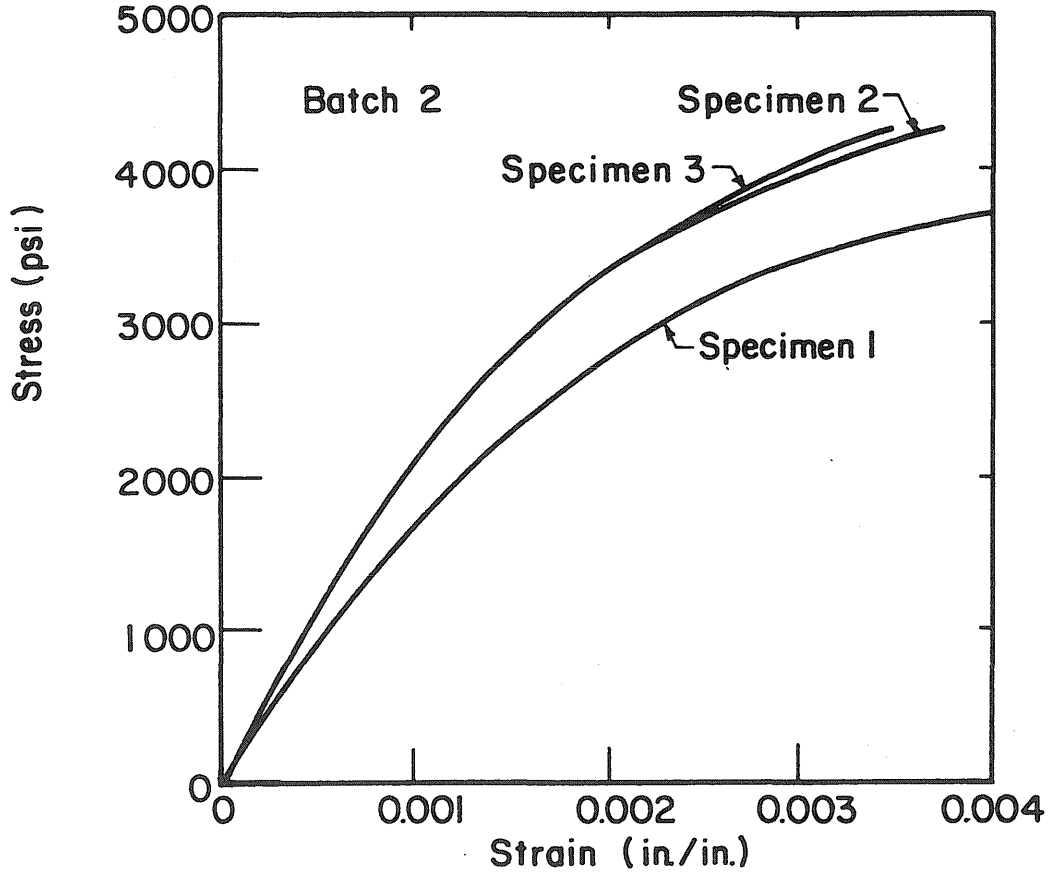
Fig. 2.9 Concrete Stress-Strain Relationships

(a) Batch 1

(b) Batch 2

Two batches of concrete were required for each specimen cast. All concrete was mixed in a Koehring Model 170 Cyclo-Mixer 1/2 cubic yard (0.38 m³) capacity mixer. The first batch was placed in the region near the crossbeam section. The second batch was placed in the regions near the end supports. Measured compressive strengths, splitting strengths, and cylinder ages at the time of testing are presented in Table 2.2. Stress-strain relationships were measured for all concrete batches. Typical stress-strain curves are shown in Fig. 2.9.

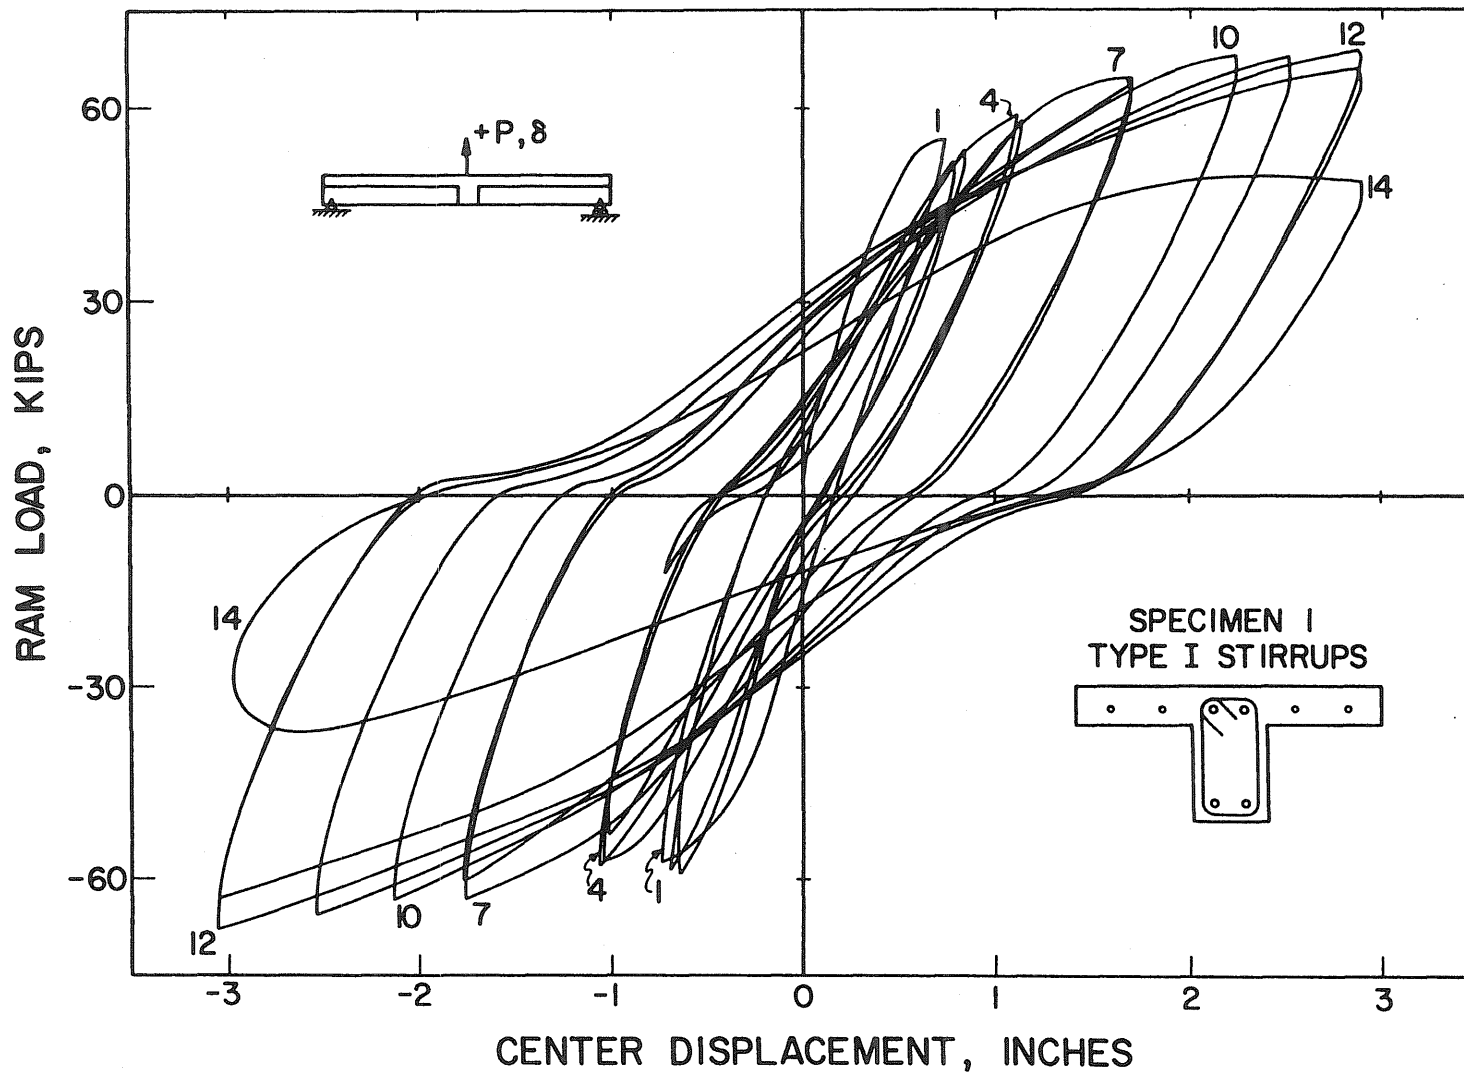
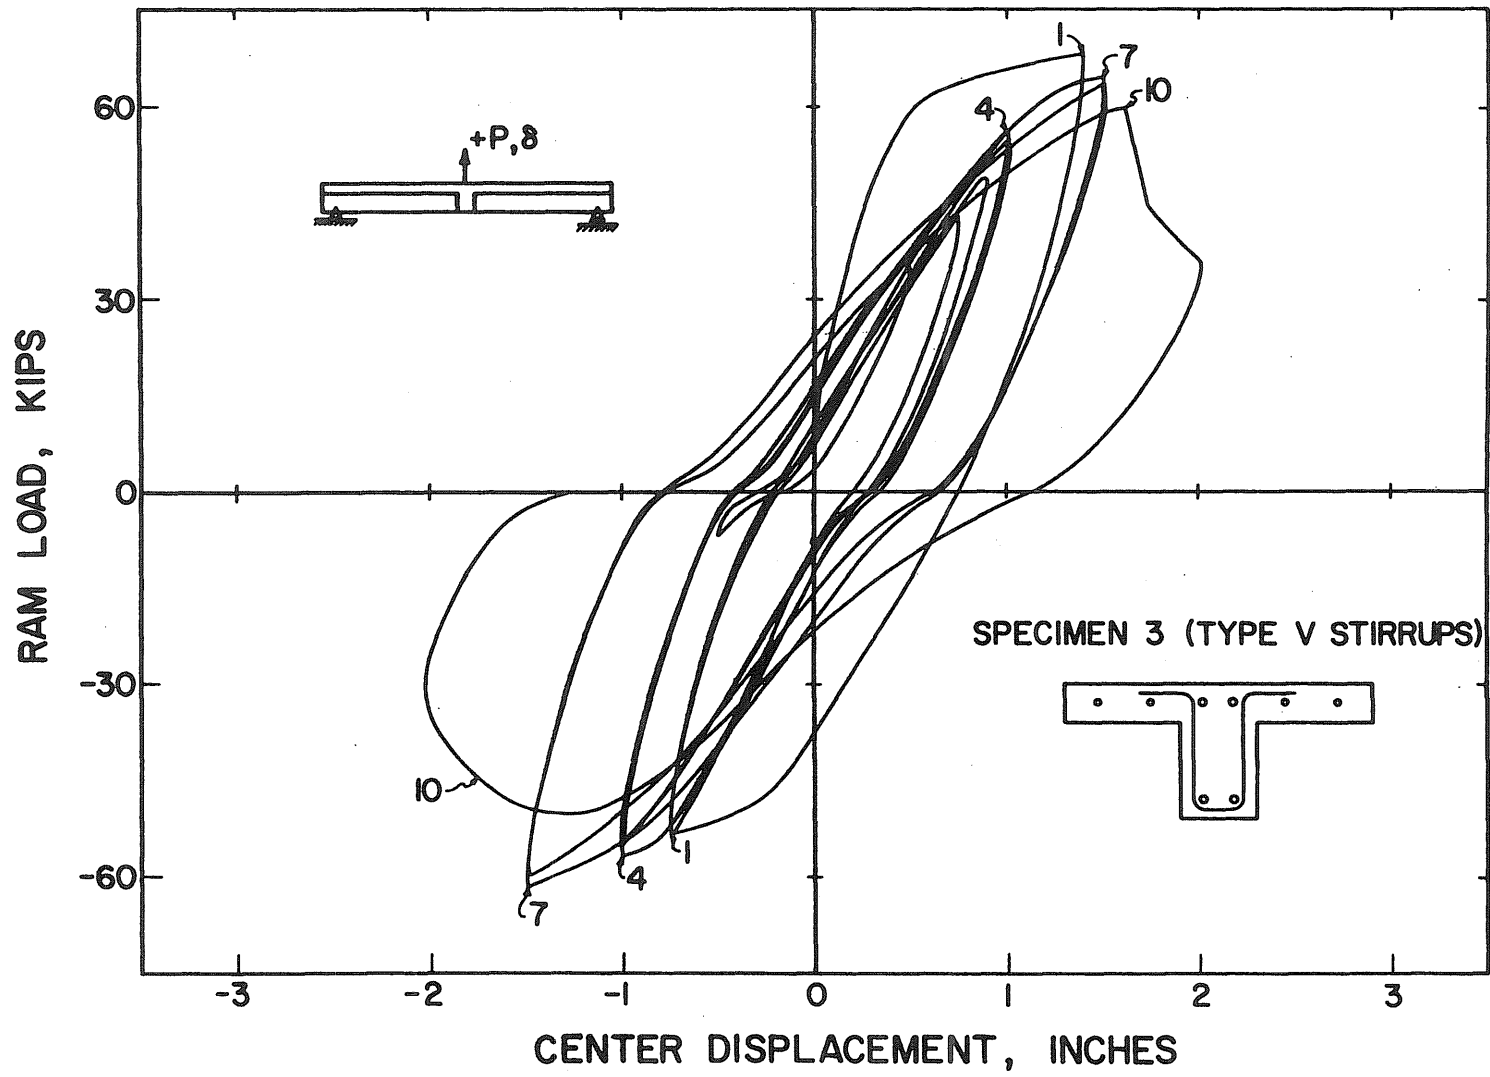
3.1a Load vs. Displacement Relationship--Specimen 1

3.1b Load vs. Displacement Relationship--Specimen 2

3.1c Load vs. Displacement Relationship--Specimen 3

3) During all load cycles except the first, each specimen suffered loss of shear stiffness at small displacements from the original unloaded beam position, shown as "pinching" of the load-displacement curves. The pinching became more pronounced as loading progressed, indicating that beam cracking and deterioration were resulting in progressive loss of shear strength.

The ability of the beams to dissipate energy during cyclic loading was considered to be a good indication of the durability of the specimens. Areas enclosed by the load-displacement curves (Fig. 3.1) were measured to determine the energy dissipation capacities of the members. Energy dissipation values for the three specimens, including total energy dissipation during the first eight load cycles and total energy dissipated by each specimen prior to failure, are presented in Table 3.1.

An overall view of individual member behavior and differences in behavior among the three members tested may be obtained by examining the member load vs. displacement curves (Fig. 3.1). It must be noted that, although it had been intended that displacement history be uniform for the three specimens, actual displacement history for each specimen was unique due to differences in measurement of displacement at the point of loading and to difficulties in controlling load ram position.

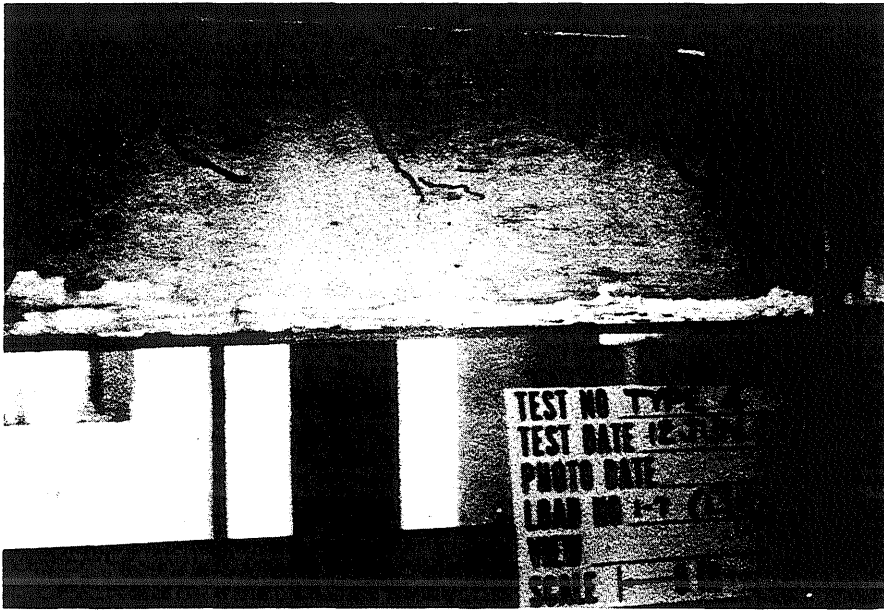
Fig. 3.9 Crack Patterns in Specimen 2

(a) During First Half-Cycle

(b) During Second Half-Cycle

The pattern of cracks which developed during the first cycle of loading of Specimen 2, shown in Fig. 3.9, may be considered typical for all specimens tested. During the first half-cycle of loading, flexural and flexure-shear cracks formed at uniform intervals and at varying slopes along the beam. A vertical crack formed at the face of the crossbeam in all specimens. During the second half-cycle of loading, cracks extended from the bottom face of the beam stem and intersected the cracks formed previously.

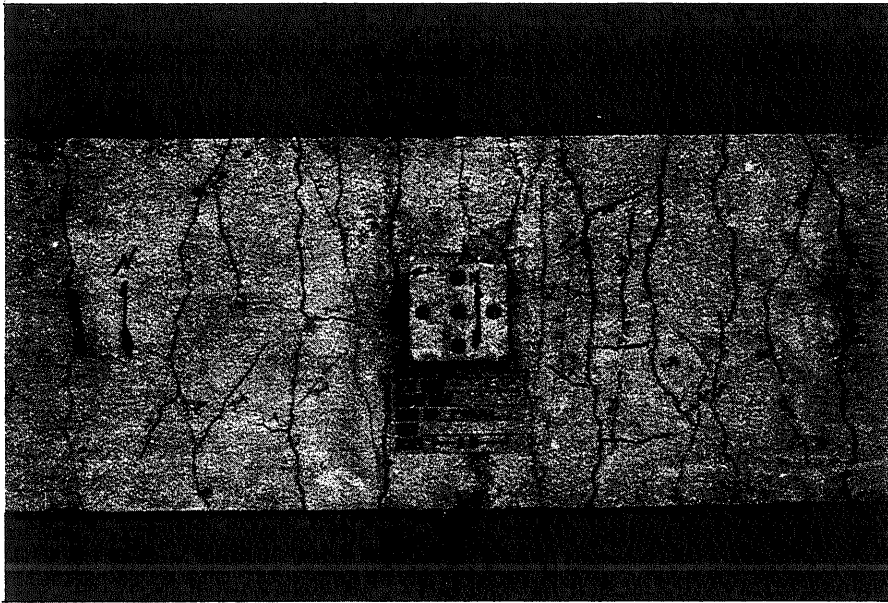
Fig. 3.11 Flange Crack Patterns at Failure

(a) Specimen 2

(b) Specimen 3

Crack patterns in the flanges of the specimens were indicative of the ability of shear reinforcement to confine the beam and flange laterally. Fig. 3.11(a) illustrates the cracks which occurred in the flange of Specimen 2. Crack patterns which developed in Specimen 1 were essentially identical to those shown in this figure. The majority of cracks formed at right angles to the beam axis. Longitudinal cracks, indicative of flange and beam lateral expansion, were small and few in number.

Cracking in the flange of Specimen 3, shown in Fig. 3.11(b), was much more severe than in either of the other two specimens. Longitudinal cracking was extensive, particularly in the plastic hinging regions. It is clear that the reinforcement used in Specimen 3 did not provide lateral confinement as effectively as that used in Specimens 1 and 2.
