**CIVIL ENGINEERING STUDIES**  
STRUCTURAL RESEARCH SERIES NO. 361

# LOW CYCLE FATIGUE OF BUTT WELDMENTS OF HY-100(T) AND HY-130(T) STEEL

The Naval Ship Systems Command, U.S. Navy

JULY 1970

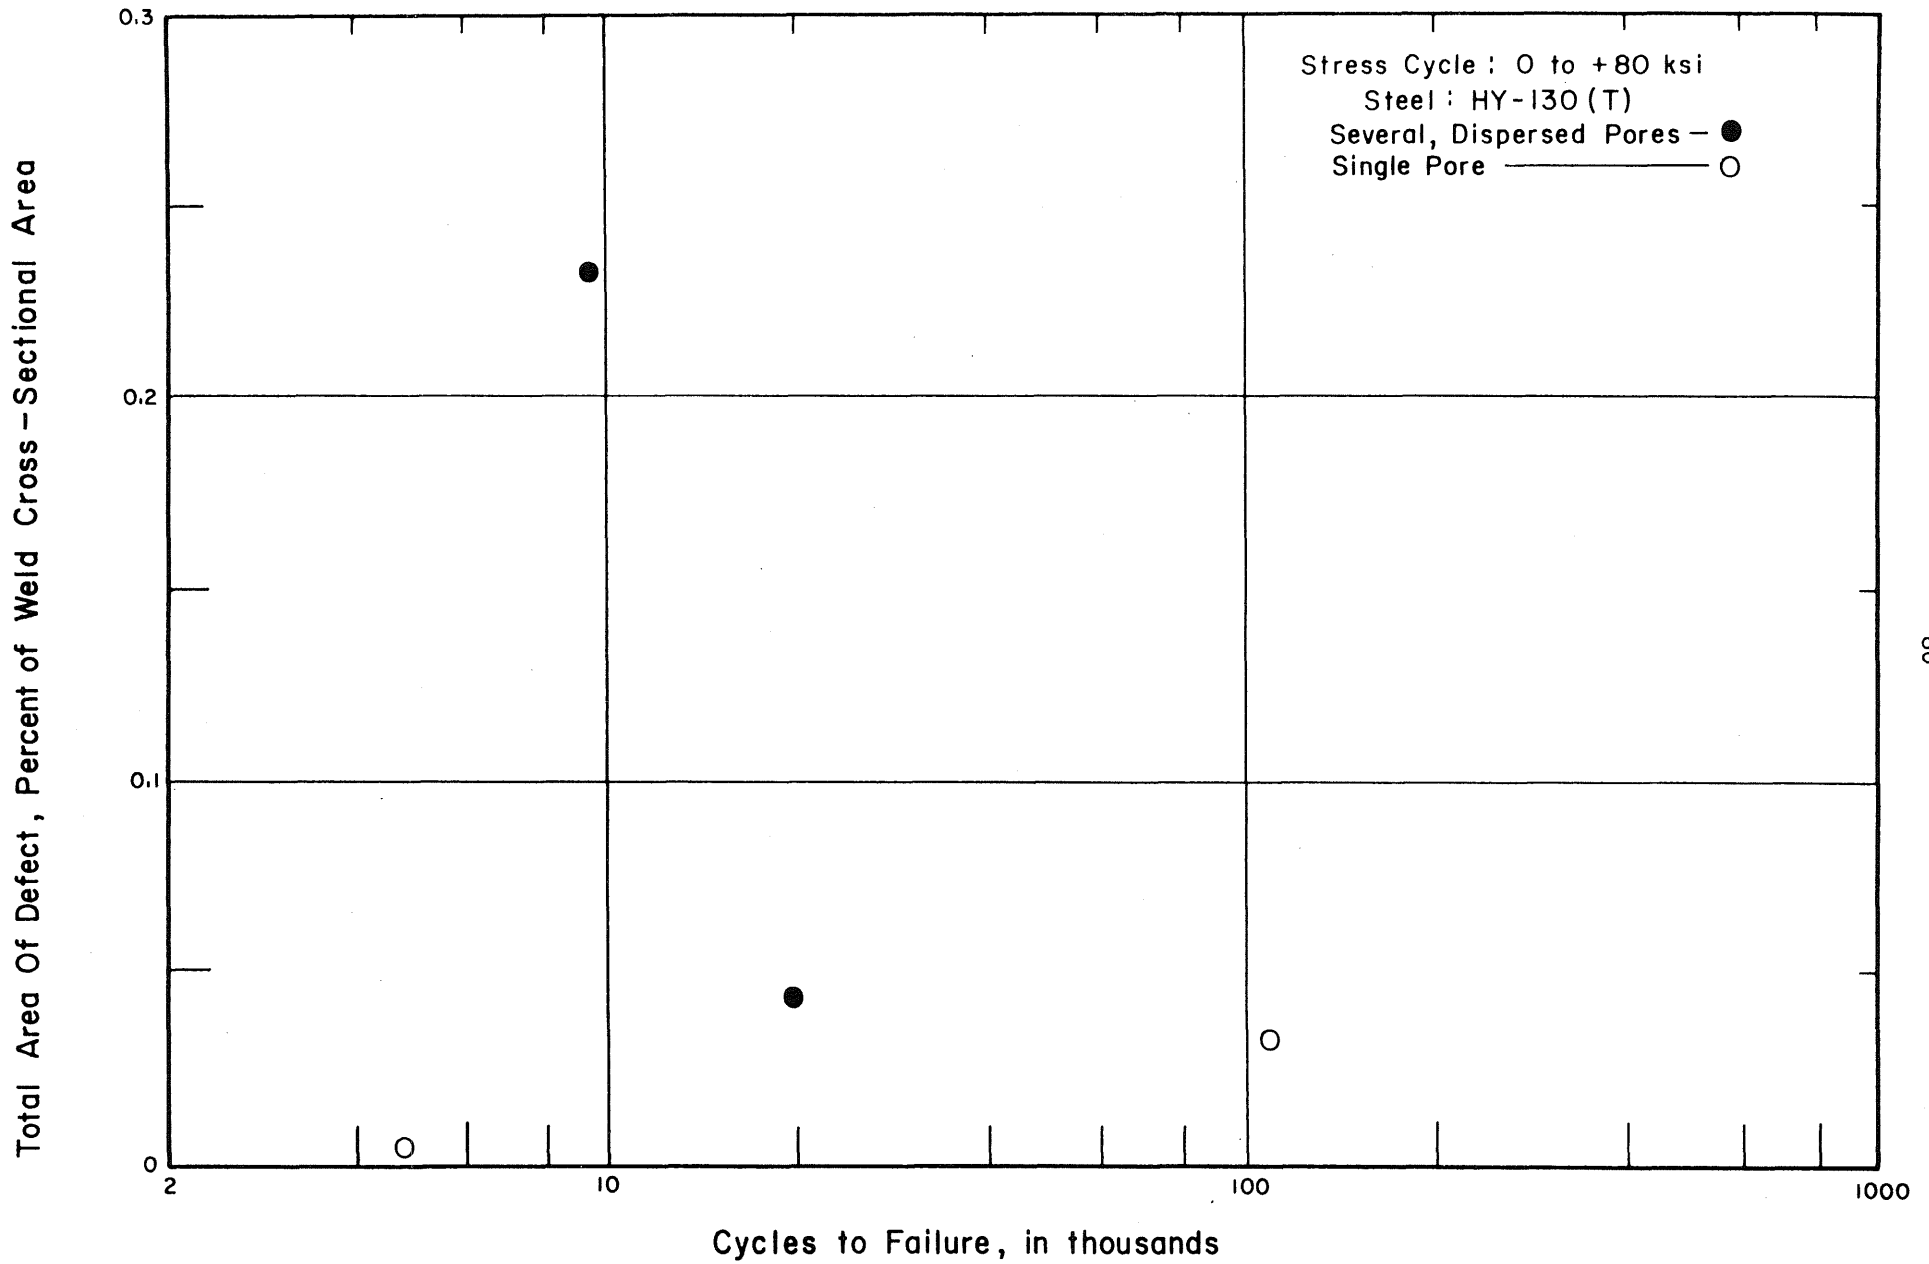
FIG. 3.12 VARIATION IN FATIGUE LIFE WITH TOTAL DEFECT AREA FOR SPECIMENS INITIATING FAILURE AT POROSITY—STRESS CYCLE : 0 TO +80 ksi

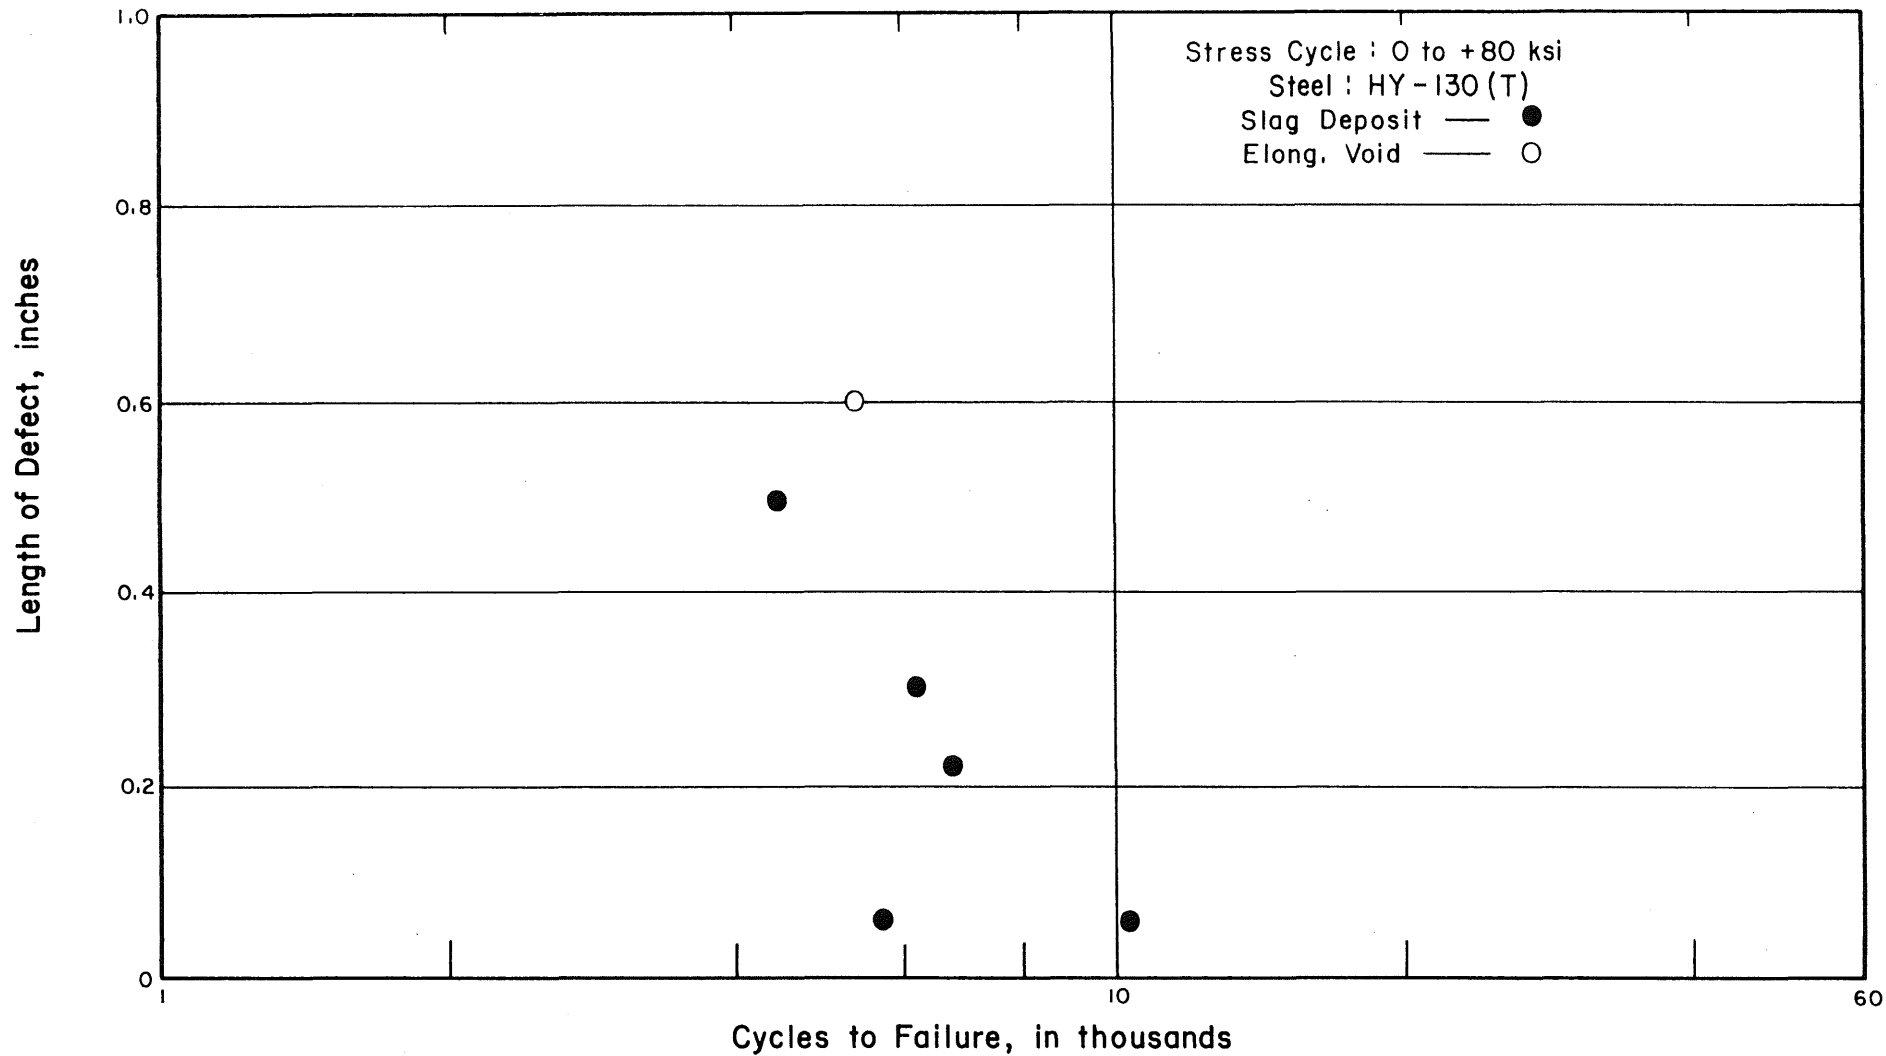
FIG. 3.15 VARIATION IN FATIGUE LIFE WITH DEFECT LENGTH FOR SPECIMENS INITIATING FAILURE AT SLAG OR ELONGATED VOIDS — STRESS CYCLE : 0 TO +80 ksi

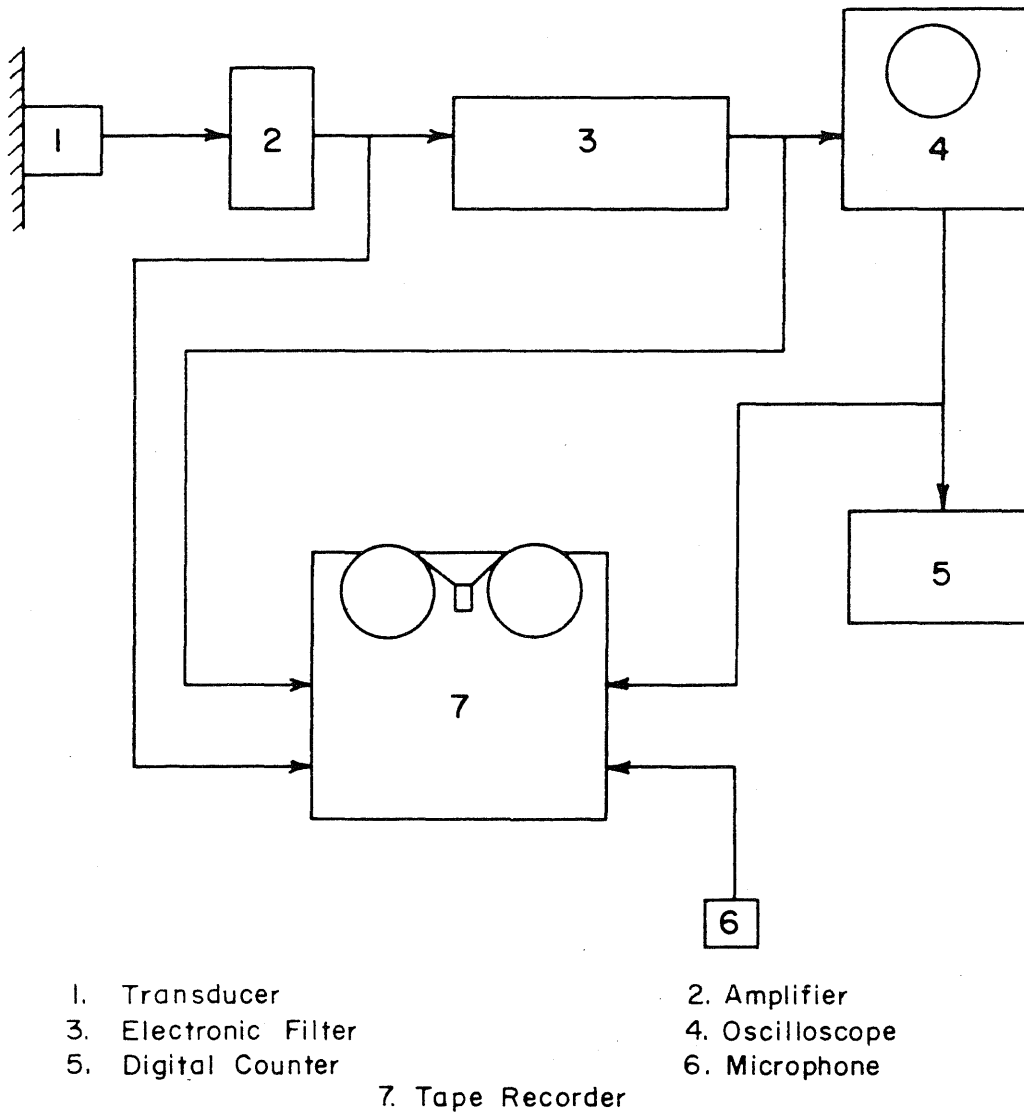
**FIG. 3.44 BLOCK DIAGRAM OF INSTRUMENTATION SETUP FOR ACOUSTIC EMISSION MEASUREMENTS**
