Analysis of the materials and state of conservation of the medieval rammed earth walls of Seville (Spain)

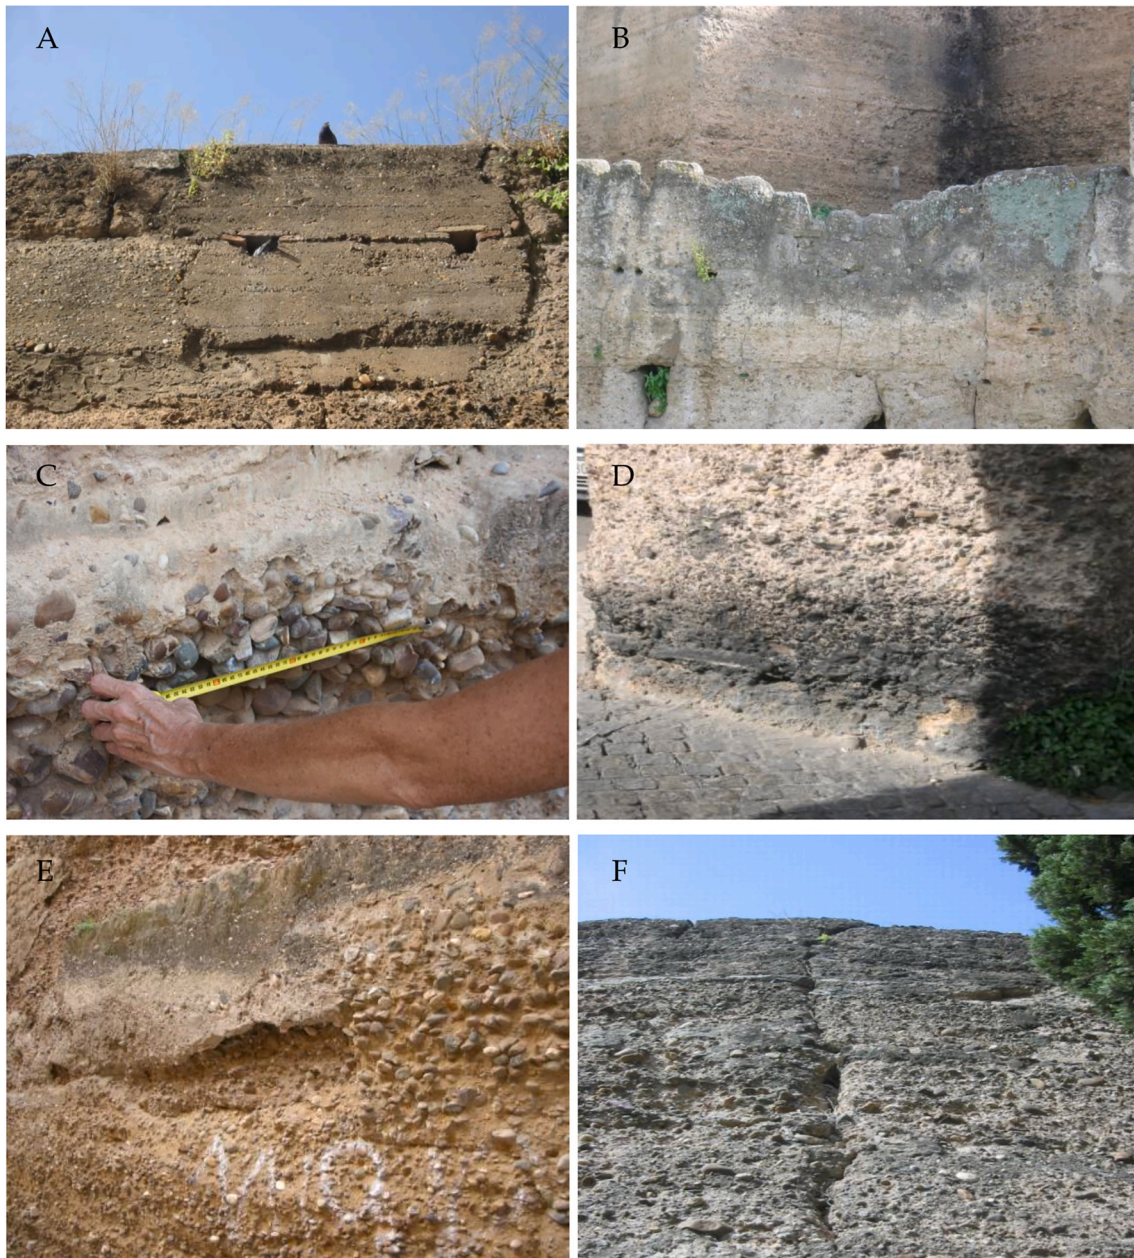
Fig. 3. Damages observed in the visual inspection: A: Biodeterioration, B: Erosion, dirt, C: lack of cohesion, D: Dirt in lower areas, E: Loss of mass, F: Cracks.

Precisely, considering the different overlapping of the construction stages and these restoration interventions, the study of materials is proposed to clarify the main degradation processes that currently affect rammed earth. The walls and towers of the Macarena Wall are suffering a progressive degradation process that mainly affects the materials' cohesion and leads to weathering and loss of mass (Fig. 3). The influence of water, either as an external weathering agent or as moisture content in the material, has been analysed for mechanical properties [46], durability [47] or within the cycles crystallization of salts [48] in rammed earth. The working hypothesis suggests that water plays an important role in weathering processes and mass loss, showing currently very evident symptoms on a significant part of the case study (Fig. 3).

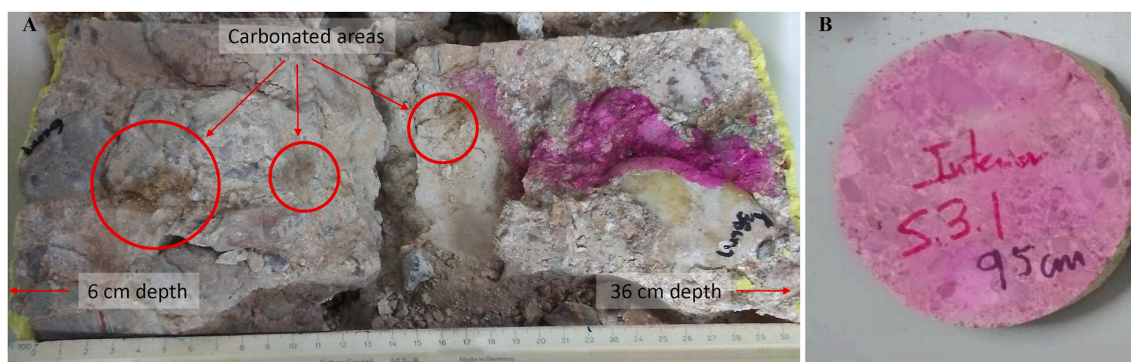
Fig. 10. Phenolphthalein test at different depths (cm) of drilled samples. A: inner core of the sample S-3.1 after the UCS test. B: Cross-section of sample S-3.1 at the innermost part.

In sample S-3.1a -a horizontal core-the inner section, located at 95 cm deep, is not yet carbonated (Fig. 10 B). That could be verified thanks to the phenolphthalein turnaround in contact with the basic pH of calcium hydroxide. In Fig. 10 it can be seen how the first 25 cm approximately show carbonation as there is no colour change in the deposited phenolphthalein. From these 25 cm onwards, the carbonation front is clearly visible first, followed by the non-carbonated sections (Fig. 10 A) up to the maximum depth reached by the sample at 95 cm (Fig. 10 B). Despite this circumstance, the mechanical strength of the internal sections of the wall has not been greatly reduced for this sample in relation to other samples (see section 4.5). In contrast to lime-crust rammed earth, where the lime is concentrated in the outer layer [30], in this type of rammed earth, lime is present throughout the thickness of the wall and in a considerable proportion of the wall. For these reasons, these types of rammed earth walls have been referred to as lime concretes by some authors [3,58].
