# DECONTAMINATION OF A HISTOPLASMA CAPSULATUM-INFESTED BLACKBIRD ROOST: USE OF A SPRINKLER SYSTEM TO APPLY FORMALIN

by A. R. Stickley, Jr.,<sup>1/4/</sup> J. R. Pruitt<sup>2/</sup>, C. E. Hume<sup>2/3/</sup>,  
T. Pass II,<sup>4/</sup> and C. H. Gayle<sup>5/</sup>

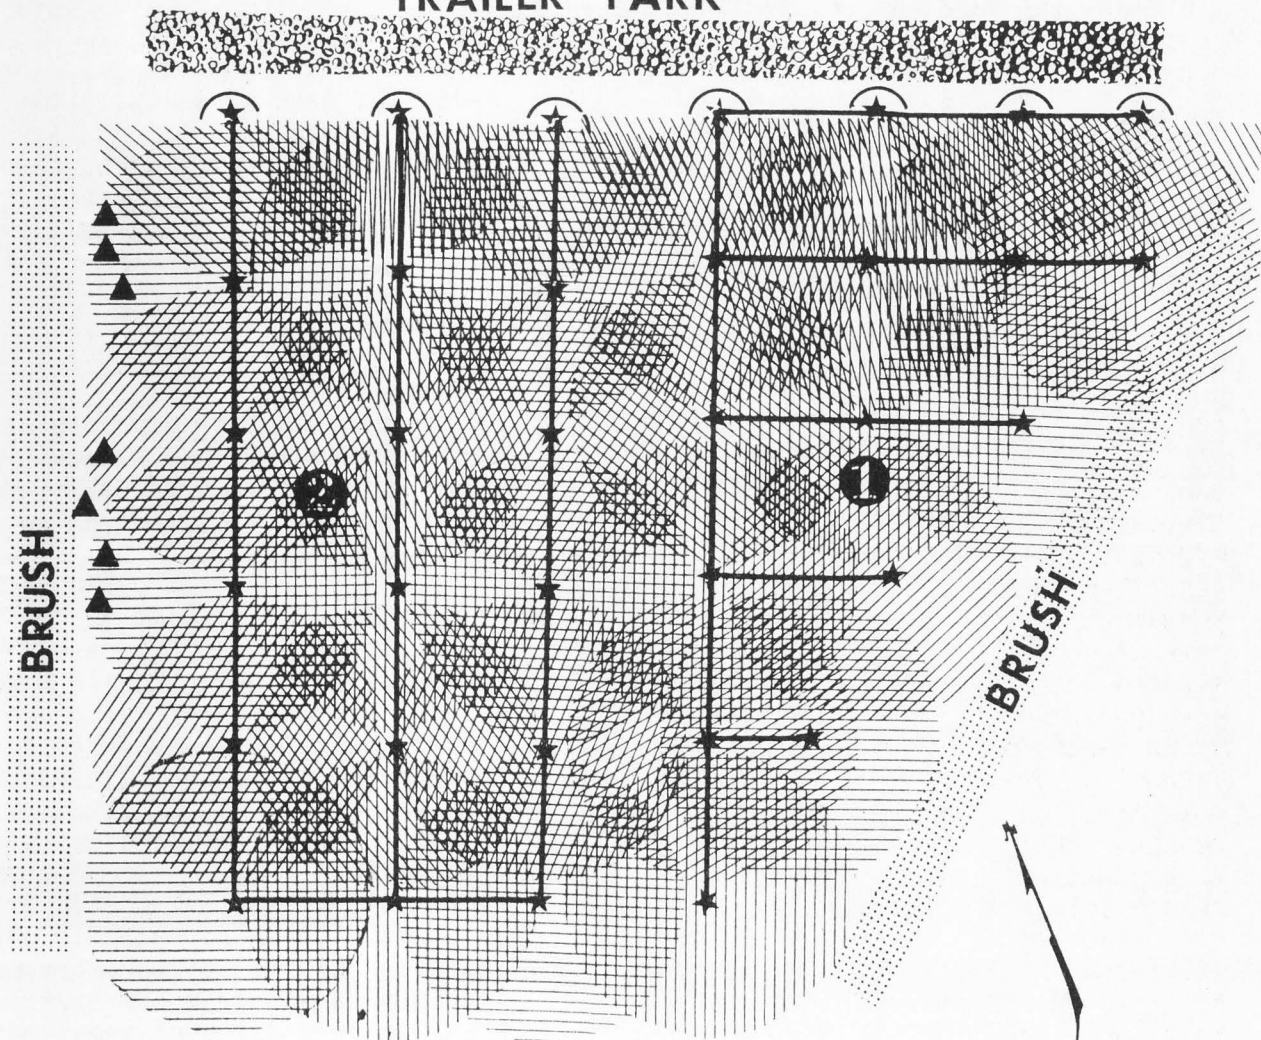
SCALE: 1cm = 9.6m

- PIPE
- ★ SPRINKLER
- ▲ TREE
- ⌒ BAFFLE

Figure 1. The two positions of the sprinkler system on *H. capsulatum*-infested site. Overlaid circular hatching indicates spray patterns for sprinklers.

In June 1981, on advice of the U.S. Public Health Service, the vegetation was removed by bulldozer from the H. capsulatum-infested area (at a time when the ground was damp) so that only weeds and forbs were left. Brush was piled up along the east and west sides of the target area (Fig. 1). Next, the sprinkler system was set up in an 18.3 m (60 ft) grid pattern (Figs. 1 & 2). It consisted of 9.1 m (30 ft) horizontal sections of 5.1-cm (2 in) and 7.6-cm (3 in) diameter irrigation pipe, and vertical 2.5-cm (1 in) diameter risers 1.6 m (5 ft) in height, with Toro Ag-2 Model 358 sprinklers each equipped with two 0.44-cm (11/64 in) diameter nozzles (Fig. 3). Because not enough pipe was available to spray the 1.3-ha area at one time, the site was treated in two stages (Fig. 1). Approximately 20 man-hours were required to put the system in place for the first application. In this position, where the spray from some sprinklers would likely reach the trailer park 30 m distant on the north side, baffles were installed on these sprinklers.

Despite the presence of strong formalin fumes, we shifted the sprinkler system to the second position (Fig. 1) in 16 man-hours on 10 July 1981 and again put baffles on the sprinklers nearest the trailer park. We pumped 6% formalin from another tank truck load of formalin for 4 hours beginning at 2000 hours. We applied 152,900 liters of 6% formalin to 5688 m<sup>2</sup> of land, or 26.9 liters

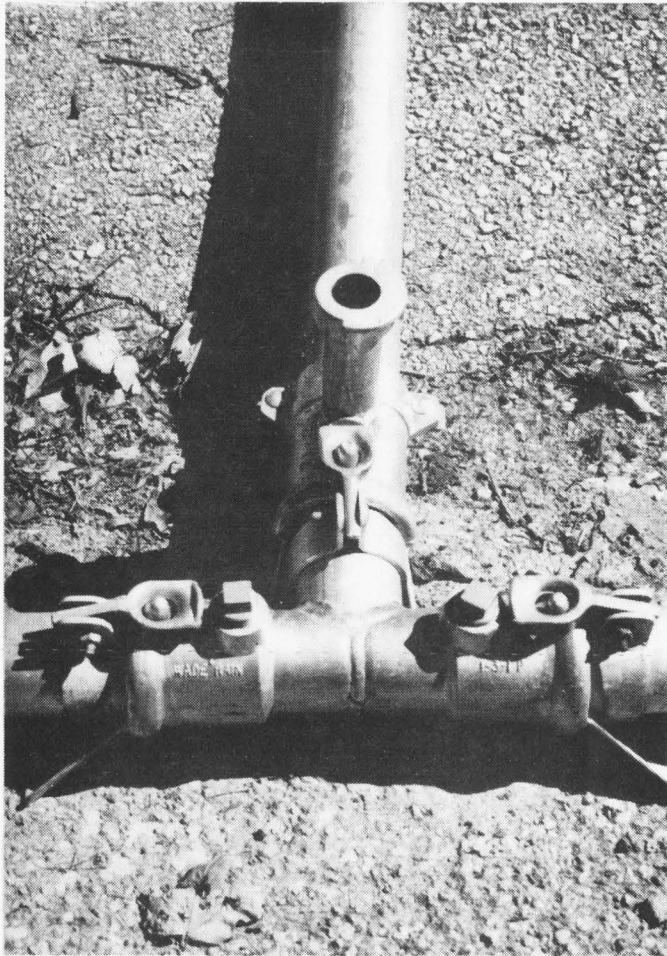
Figure 2. Close-up of irrigation pipe and connections used to spray formalin. A 5 ft riser is placed in the hole in the center of the upright connector.

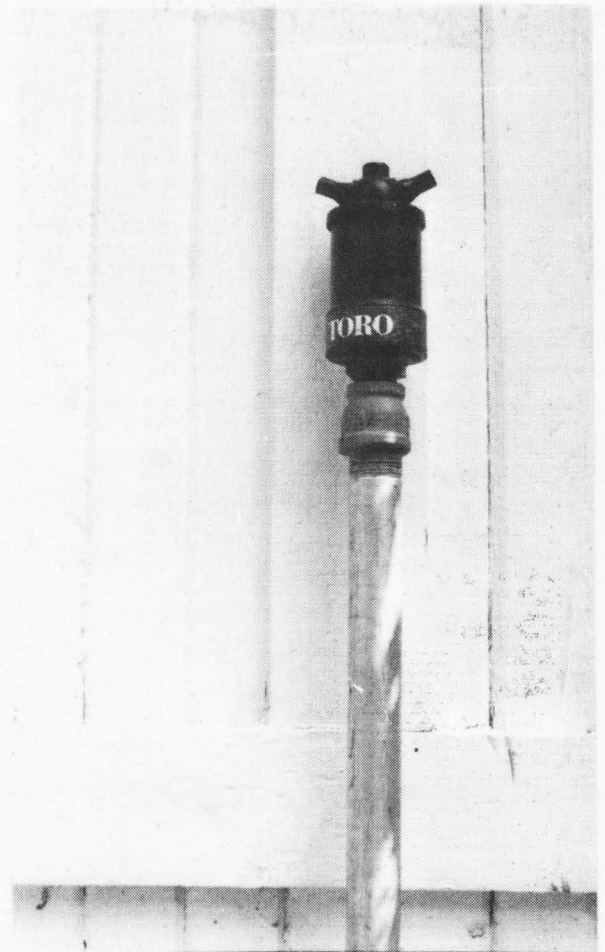
Figure 3. A Toro sprinkler on top of a 5 ft riser.
