Analysis of Conveyance Losses from Tertiary Irrigation Network

Naeem Shah Bukhari Syed ¹, Zhao Shuqi ^{1*}, Muhammad Munir Babar ²,
Rajesh Kumar Soothar ³

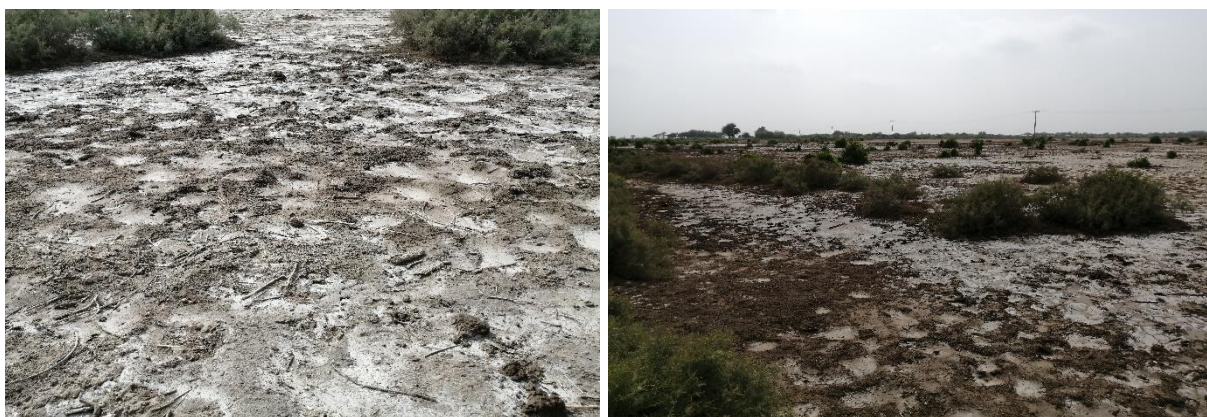
Figure 5. Waterlogging caused saline land in the study area

On an average, conveyance losses from the studied unlined tertiary water courses were observed to be 43% of the total water diverted to the tertiary irrigation network from distribution system. These conveyance losses raise groundwater table that results in waterlogging and hence negatively impacts fertile agricultural lands [15]. Our experimental study area is underlain by saline groundwater as reported by Aslam et al. (2015) [18] and according to them the surface salinity has increased due to waterlogging over the years in the Nara canal command area (command area where region of present study is situated). Besides, according to van Steenberg et al. (2015) [14] around 70% of the groundwater in the province of Sindh is too saline for irrigation purposes. The extent of waterlogging reported in these studies was validated through field reconnaissance survey. Figures 5 and 6 further portray the status of waterlogging and salinity affected lands in the study area. Thus, in the light of above stated facts, it is inferred that majority of these losses observed from the tertiary water channels under study result into non-beneficial losses. As reported by Marsden (2003) [13] conveyance losses become non-beneficial when water is lost to saline aquifers. Moreover, these losses become non-usable and results in disasters in the shape of return flows into freshwater bodies downstream.

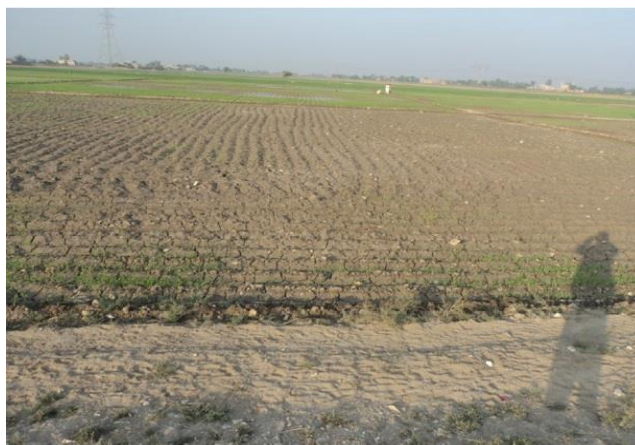
Figure 6. Patchy crop germination due to waterlogging and salinity in the Mirpurkhas irrigation district [14]
