Old British Breakwaters

How Have Engineering Developments Influenced Their Survival?

Nigel William Henry ALLSOP

Submitted for the degree of Doctor of Philosophy
at the University of Edinburgh
February 2021

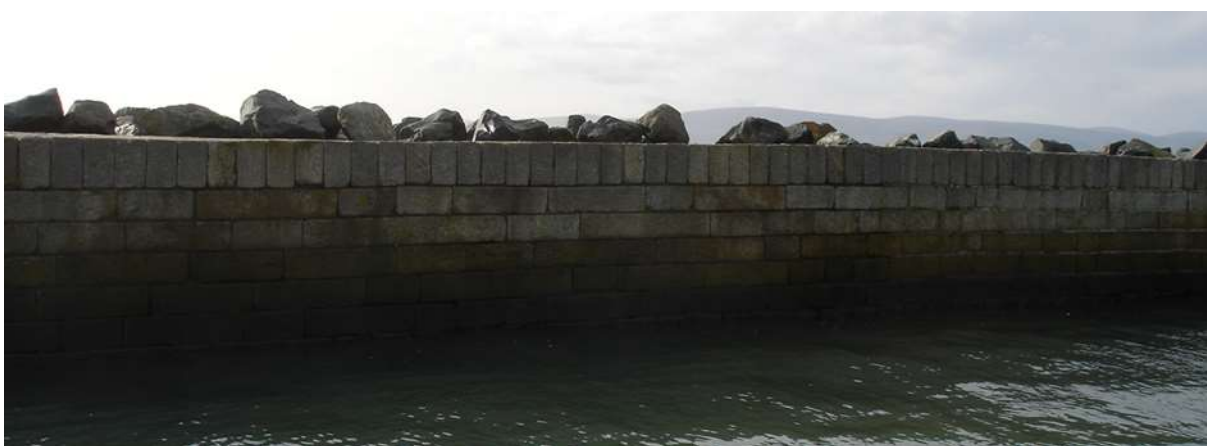
Figure 2.4 Inner face of Dublin Great South Wall

NB - The rock armour on the south face is a relatively recent addition.

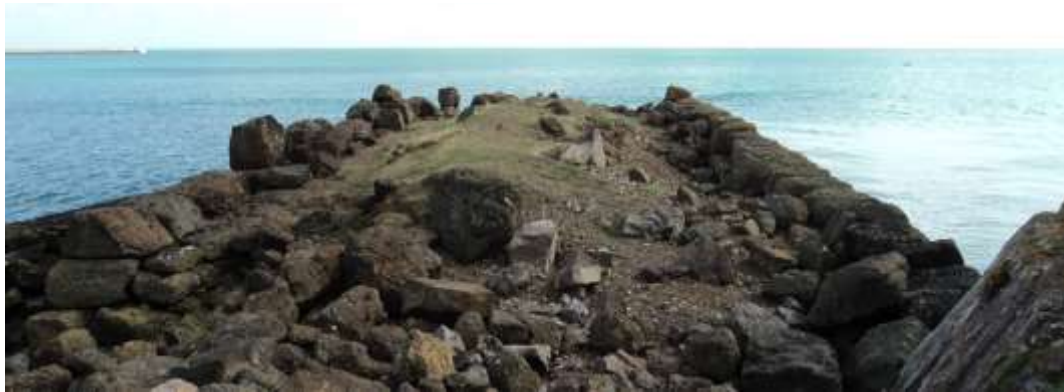
Figure 2.18 The Archirondel breakwater stub in 2014

Two issues affect the utility of any 'harbour of refuge' on Jersey: whether that is a useful location at all. If so, where on Jersey might a harbour be useful? The plan by Davies (Figure 2.17) shows two breakwaters, both of which were started in 1847: St Catherine's to the north; and Archirondel to the south. The St Catherine's breakwater exists to this day, and has recently been refurbished (Hold, 2013). The Archirondel breakwater was planned to be 2.5 times longer, protecting the harbour from southerly and south-east waves, and from the northerly running tidal currents. But in July 1849 Walker instructed the contractor to divert effort to completing the northern breakwater, perhaps as the putative harbour started to silt up as the breakwater trapped sediment in the northerly drift. A stub of the Archirondel breakwater exists today Figure 2.18, probably in similar state to when it was abandoned.

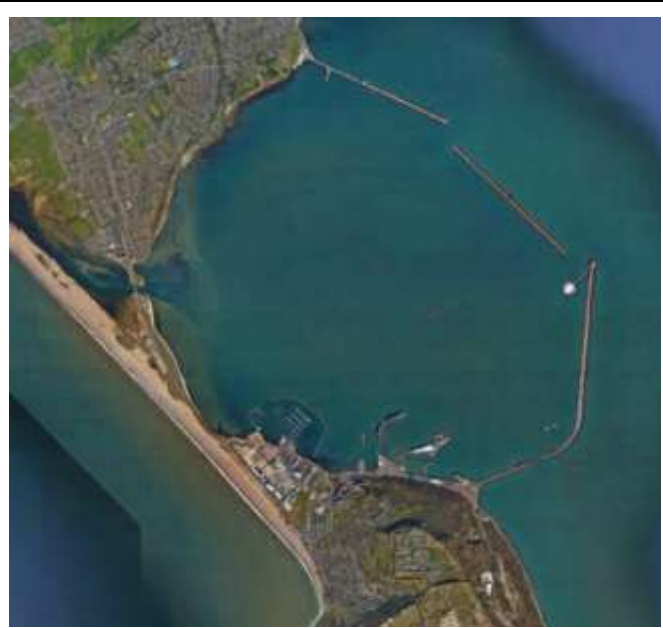
Figure 2.20 Portland harbour
Courtesy Google Earth

Portland Harbour is another 'roadstead' harbour like Cherbourg, formed in the shelter of Chesil Beach and the Isle of Portland, Figure 2.20. The harbour was created initially by two breakwaters: the short inner or southern breakwater connected to the island; and a detached breakwater to the north-east with a 120m wide entrance. Construction began in July 1849, designed by J.M. Rendel, supervised by John Coode as resident engineer.

The harbour was declared complete by the Prince of Wales in 1872. As part of works against torpedo attack, two further breakwaters were added between 1893-1906. The present layout is shown in Figure 2.20.

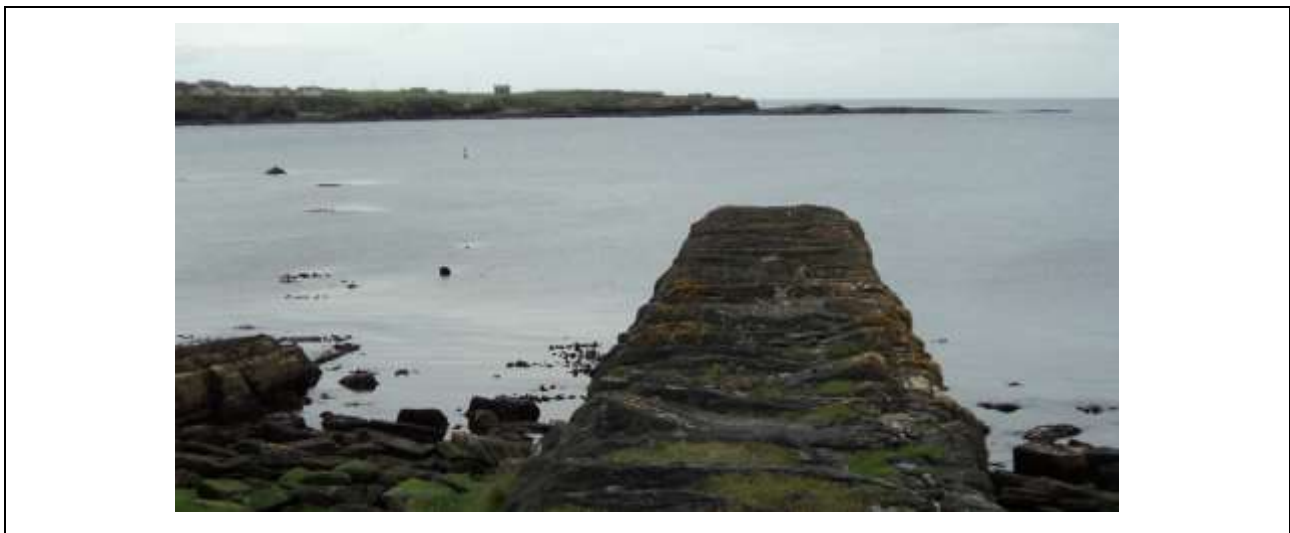
Figure 2.27 Remains of Stevenson's pier, May 2014

The failure history by Paxton (2009) suggests both impulsive and non-impulsive wave loads. Additional loads will have been imparted by overtopping down-fall pressures, see Bruce *et al* (2001), Wolters *et al* (2005). The Safety Factor analysis in Chapter 6 uses wave conditions, including wave breaking to derive momentum-driven or pulsating loads, then extending to include impulsive loads.

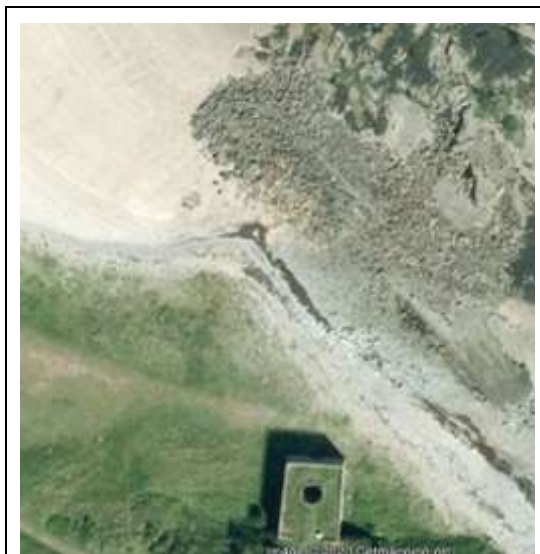
Figure 2.29 Collapsed breakwater and limekiln at Skateraw

Little now survives of the harbour structures. It is surmised by Graham (1971) that the breakwater collapsed and the harbour was overwhelmed at some time between the survey dates of Ordnance Surveys of 1853 and 1892. The harbour area is now filled with sand and shingle in a tombolo in the shelter of the mound of the collapsed breakwater, concealing any evidence of the quay in front of the kiln, Figure 2.29.

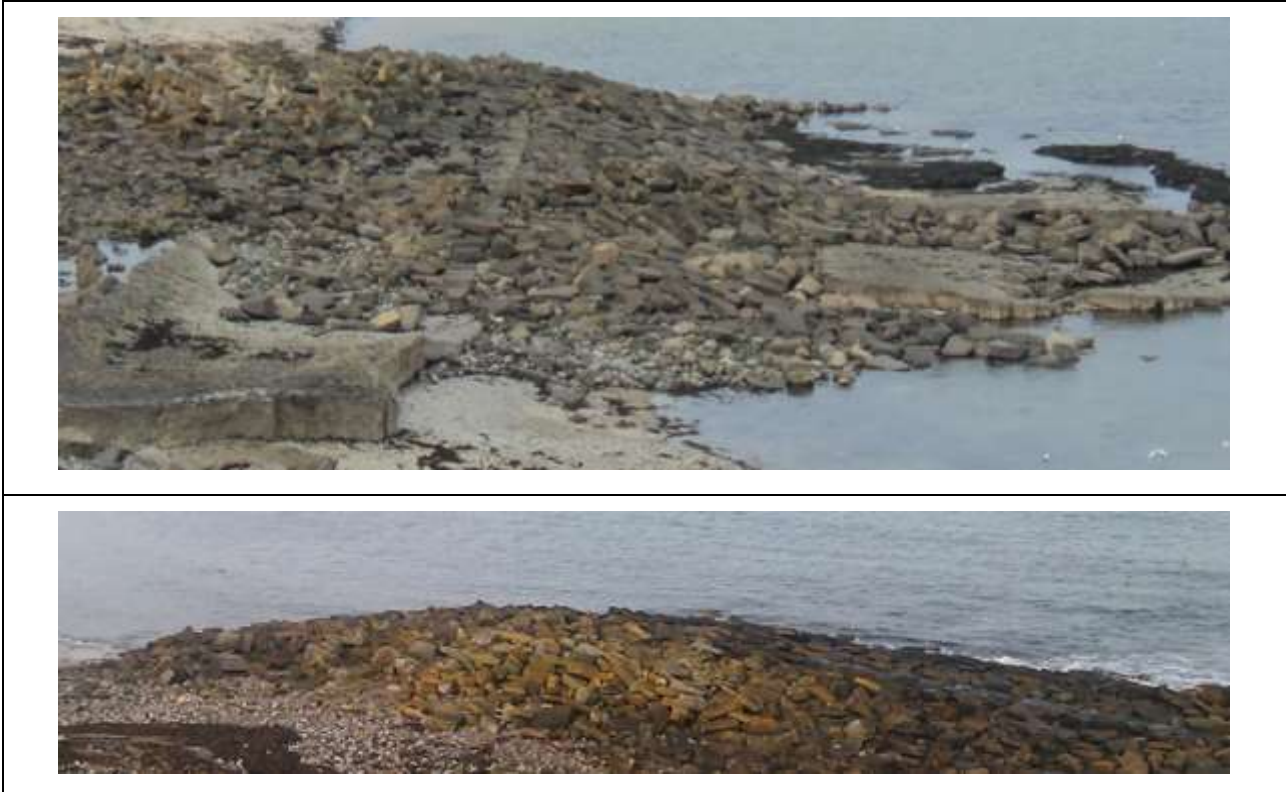
Figure 2.30 Collapsed breakwater at Skateraw (2014)

The breakwater is reduced in its NW portion to a rickety of debris, in which, however, the line of the outer wall may be traced (Figure 2.30). Chapter 7 of this thesis will report physical model tests of simple blockwork walls which will illustrate the propensity of such walls to fail above the toe blocks. From this it may be judged that the visible blocks are probably 2-3 courses above the original foundation blocks.

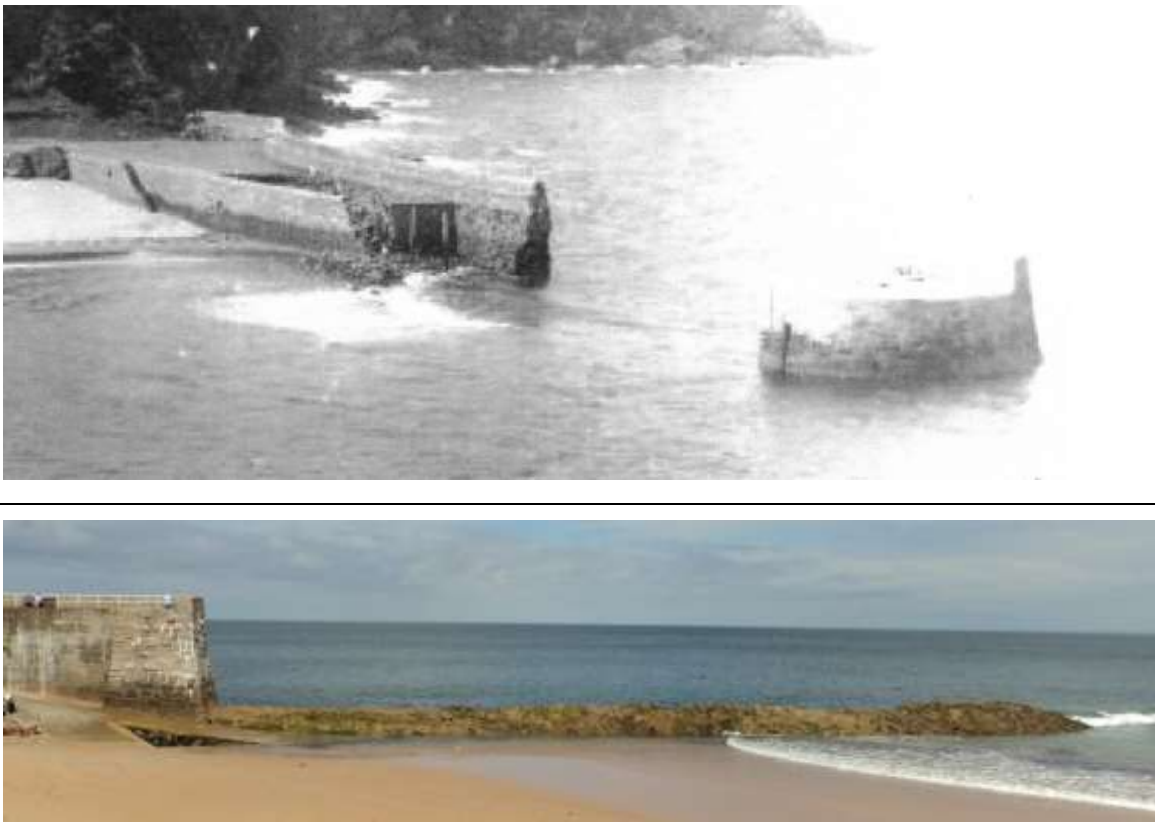
Figure 2.32 Failure at Greve du Lecq, Jersey, 1884

Hammond-Spencer had previously reported on an earlier failure of the pierhead in 1879 when he wrote: “It is not necessary to be an engineer in order to see that the quality of the masonry is altogether wretched and worthless, and that if once holes were formed in the face (thus affording a hole for the sea) the collapse of the wall would only be a question of time, longer or shorter according to the severity of the gales.” He also criticised the design of the pier, arguing that the plan layout “caused the force of waves to be concentrated on the section which collapsed”. He appears not to have approved of the outward curve of the pierhead.

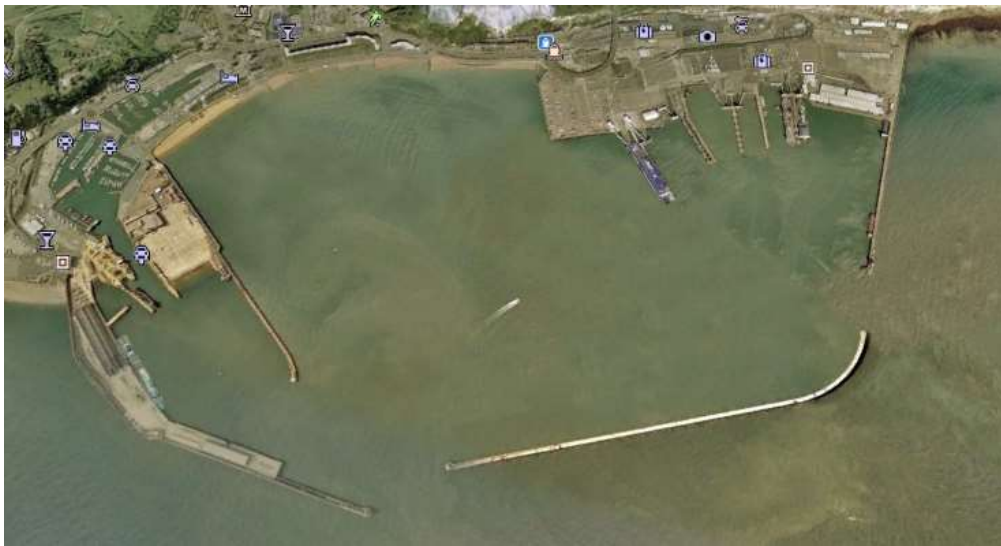
Figure 2.33 Dover Harbour layout

This single pier did not however give any significant shelter from easterlies, and a contract was let by Dover Harbour Board in 1892 to Sir John Jackson to construct the Prince of Wales Pier to enclose the Western Harbour. The Prince of Wales Pier was extended to some 500m supervised by Coode, Son & Matthews. Then in late 1895, Coode was requested to prepare drawings to facilitate expansion to the full Admiralty Harbour (Figure 2.33) by:

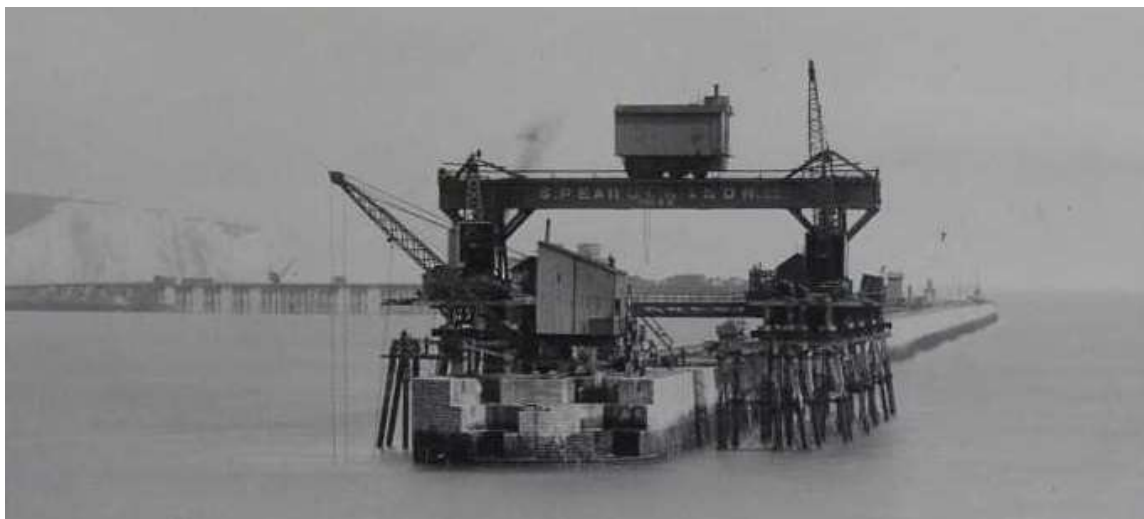
Figure 2.36 Construction of South Breakwater using Goliath crane on staging

Courtesy Dover Harbour Board. Note additional 'sway' bracing relative to Figure 2.35

Pearson eschewed the use of Titan block placing cranes that would run along the constructed works in favour of temporary staging above and beyond the works, supporting steam powered Goliath travelling cranes, Figure 2.35 and Figure 2.36. The rail level for these cranes was generally above +8.2m HWOST. Tasmanian Blue Gum piles were heavier than water, but Oregon pine required weighting by old iron rails to sink them. Staging piles were re-used as the work progressed, extracted by winch from a floating hulk. After use, piles were spliced to ensure availability of an undamaged head for driving.

Ahead of block placing, the seabed was prepared by excavating 1.5m of surface material, most by a 'Hone grab'. The final 0.3m of excavation was removed by four men using picks and shovels within a 35t diving bell which excavated a 4.6m wide strip across the running face, sufficient for two rows of blocks. The bell passed over each strip to give a coarse levelling, "*within a few inches*", and then a second pass for final levelling. Working under compressed air continued day and night in 3-hour shifts.

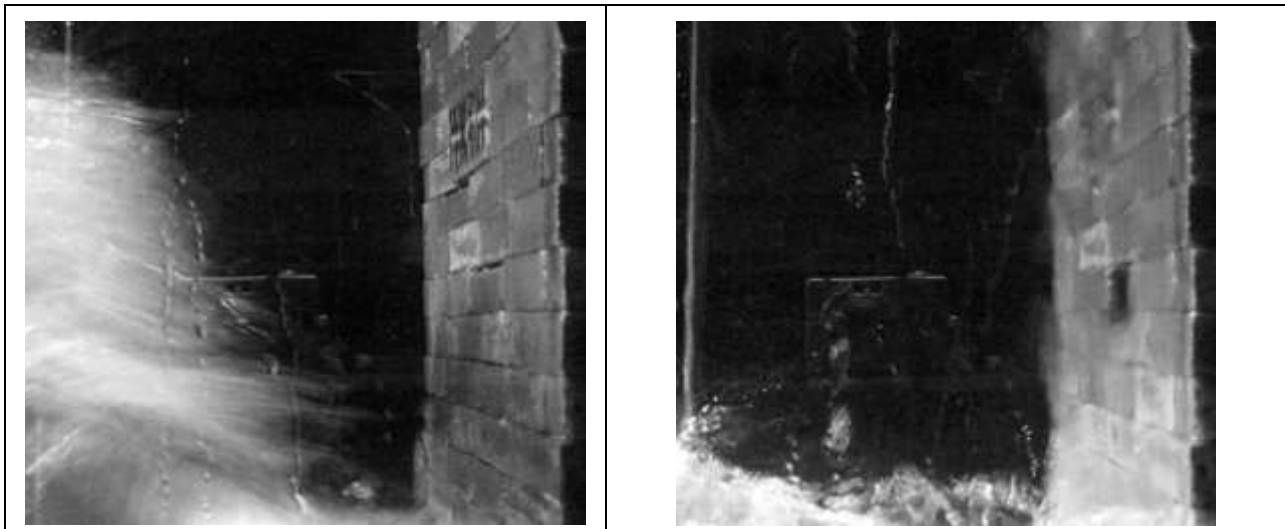
Figure 3.10 Extraction of a single block in a blockwork wall

From Marth et al (2004) Model tests at 1:20 scale.

This problem of block extraction was first analysed by Allsop & Bray (1994) who considered a single block in a wall, 2m deep x 1m across x 1m high, in the main wave impact zone slightly above water level attacked by breaking waves of $H_b=5m$. The analysis postulated a void behind the block, it being restrained only by its (buoyant) self-weight, and frictional resistance against the block below. In that paper, the magnitudes of impact pressures acting on the front face were estimated using formulae by Partensky (1988), discussed further in Chapter 5.

In their model tests loosely based on a cross-section of Alderney breakwater, Marth *et al* (2004) developed example pressures of 25kPa (equivalent to 500kPa at full scale) and quote an upper limit of 70kPa (1400kPa at full scale). They then show photographs of a single block in the process of being extracted from such a wall, claimed as by a single wave impact, see Figure 3.10.

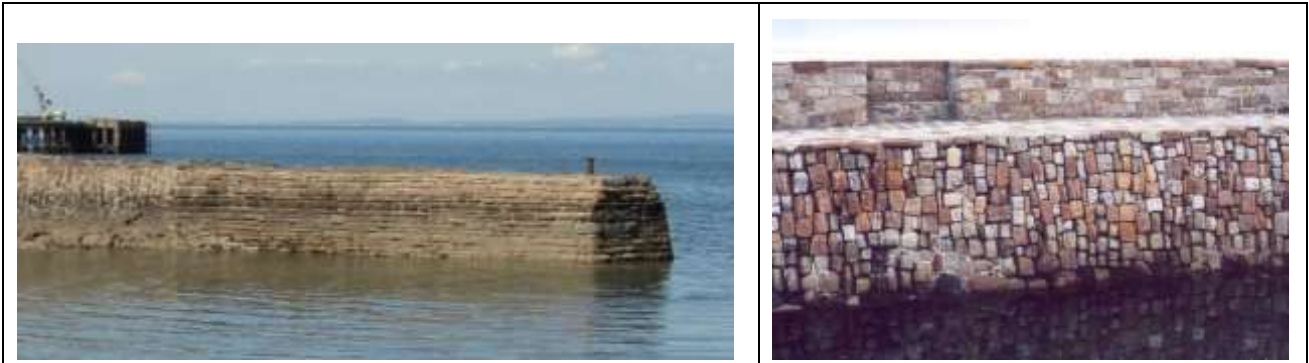
Figure 3.12 Variable blockwork placement at: a) Cockenzie; b) St Andrews

(examples in Figure 3.12). Apart from the strong recommendation by Stevenson (1874), see below, in favour of slice blockwork, other literature does not seem to suggest any particular reasons for preferring horizontal or vertical courses, perhaps local practice. Slice blockwork is often ascribed to Telford or to Smeaton (see Chapter 12).

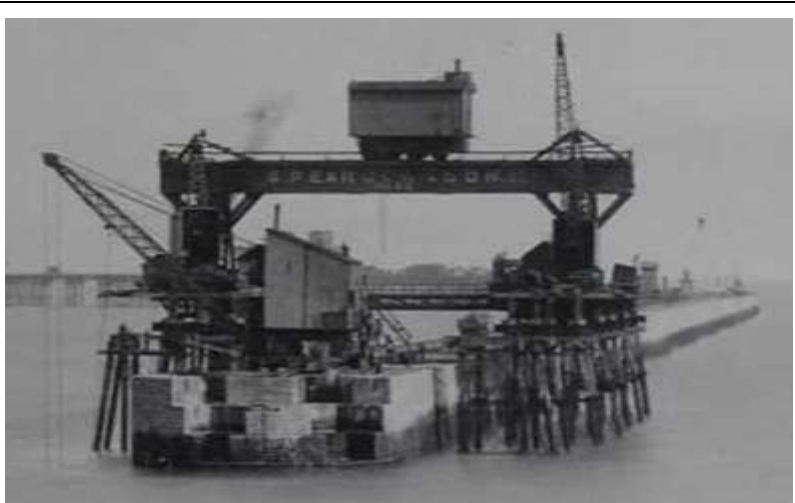
Figure 4.5 Dover - placing blockwork from travelling cranes
Courtesy Dover Harbour Board

The major advantage of good (robust) staging was the ability to accommodate steam-powered crainage. The largest machines are usually the block-setting machines, often known as Titans (originally non-revolving); Hercules (revolving or radiating); Mammoths (two very large machines used at Tynemouth. In reviewing the use of machinery to an ICE meeting in 1893, Pitt notes that the name Titan had been applied to all these, including revolving machines, see example for Peterhead in Figure 4.2 designed by W. Matthews for a working load of 50t, proved to 62.5t, and operated to a radius up to 30m. Most of those types of crane operated from the works being constructed. The travelling Goliaths used at Dover (see Figure 4.5) were essentially lighter and simpler using a small hoist to lift, and a traveller to move back and forth along the travelling beam. A smaller slewing crane is used to feed blocks to the Goliath. Similar Goliaths were using in the blockyard to produce and

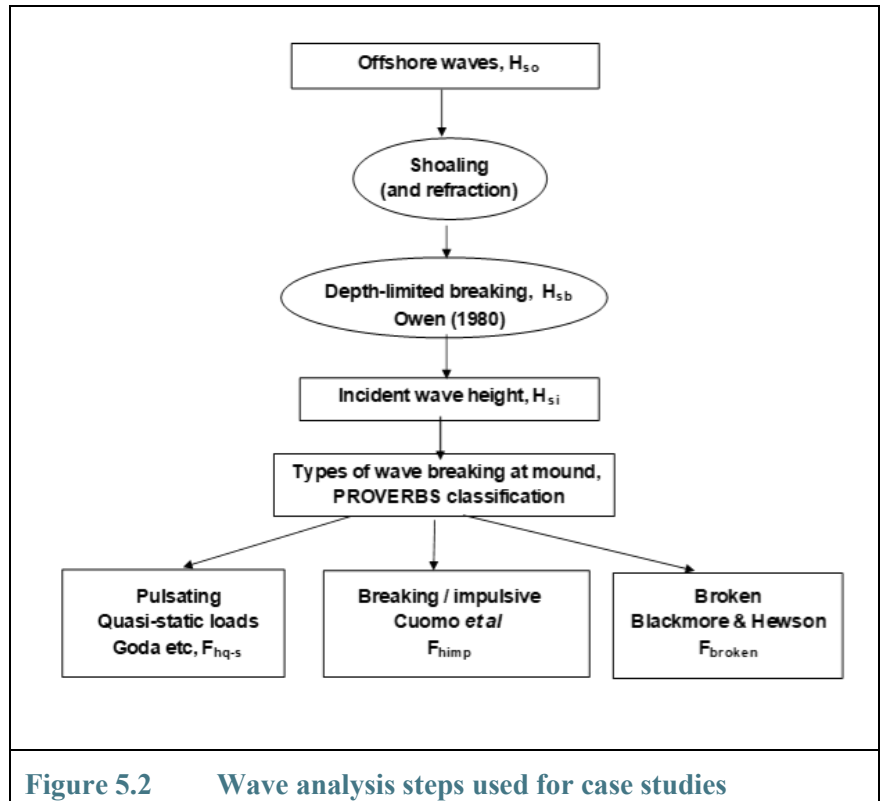
Figure 5.2 Wave analysis steps used for case studies

The intention of the stability analysis here is to calculate Factors of Safety against sliding or overturning for representative sections of each breakwater studied. The primary drivers for these actions / responses are wave loads onto the breakwater wall, Figure 5.1, so the first steps in each case study have been to determine appropriate wave conditions ‘offshore’, then at the structure, from which are then calculated the intensity (%) of wave breaking onto the breakwater wall. The disturbing loads are then contrasted with the structure weight, frictional resistance, and restraining moments about the wall heel giving the sliding or overturning strengths. The most important wave loads are quasi-static momentum-driven loads, taken as acting sufficiently slowly to generate ‘static’ responses. Where appropriate, impulsive loads due to waves breaking onto the wall are also calculated.

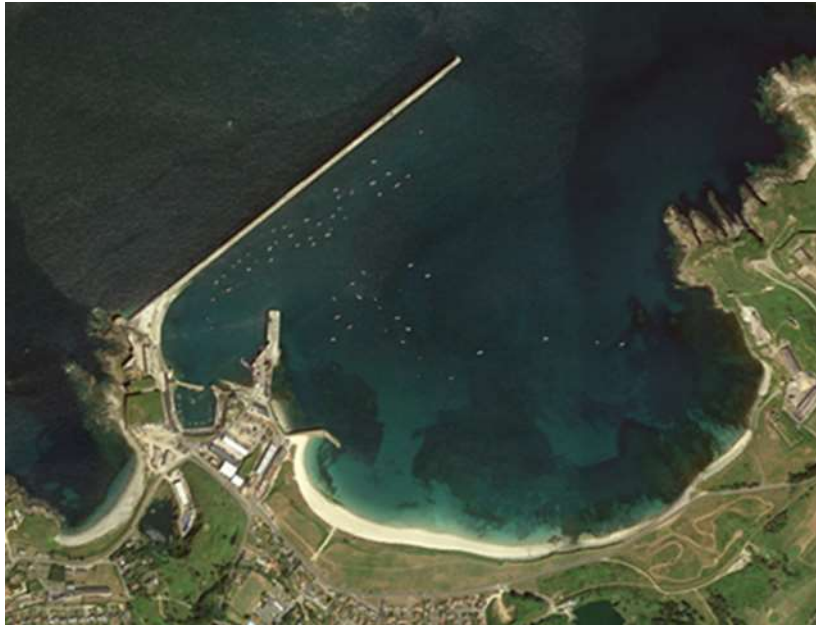
Figure 6.12 The Admiralty breakwater in 2014

About 300,000 tons of stone were tipped between 1864 and 1871, after which the Board of Trade decided to abandon the outer length. Partridge (2018) notes up to 20 breaches or defects by 1873. The main damage had been seaward of the 870m division. From 1873, repair and maintenance work covered only the inner length of 870m, and Partridge (2018) reports “*destruction of the seaward end*” by 1879 and “*outer section collapsed and submerged*” by 1889, leaving a submerged mound at about -4mLW.

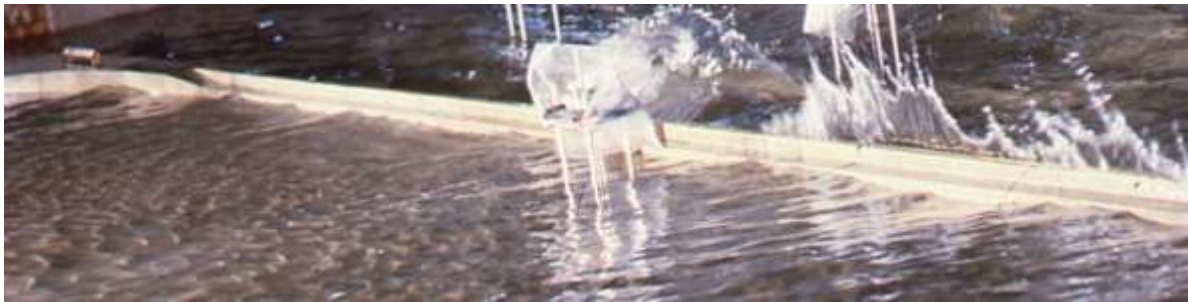
Figure 6.17 Waves breaking impulsively along mid-section

Model tests at HR Wallingford ~1990

These calculations suggest that most severe breaking occurs over the mid-length, being broken at Section A (ch. 130m) by the shallow depths near the root, see example photo from model tests in Figure 6.17. Contrarily, depths at the head (Section D, ch. 870) are greater, and the mound is lower, so impulsive breaking over the mound is less prevalent.

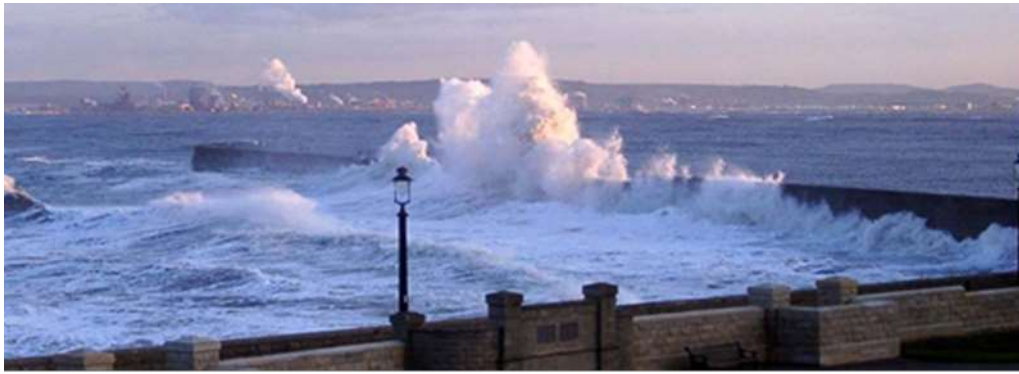
Figure 7.2 Wave attack on the Heugh breakwater at Hartlepool

If (or when) those 'orphan' breakwaters fail, flood protection to areas hitherto protected from direct wave action will reduce, see for example the analysis of protection provided by the Heugh breakwater (Figure 7.2) at Hartlepool by Hampshire *et al.* (2013). Some wave reduction will still be afforded by the collapsed structure. In assessing that protection, it is important to identify the degrees of wave transmission over the collapsed structure.

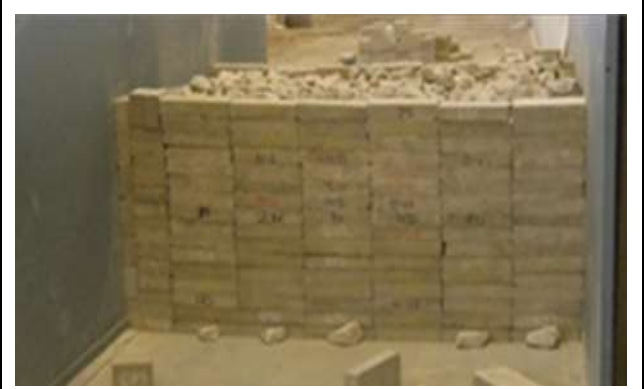
Figure 7.3 Example ‘dry-build’ wall
Before failure, with PVC ‘slip’ panels

The single clearest finding from these construction tests is that the resistance of the model wall to toppling can be significantly influenced by transverse (inter-block) forces, primarily from arching across the width of the test section. Later tests therefore tried to reduce friction against the side wall, thereby reducing their restraining effects. Without such distortions, dry-build failures were generally brittle, initiated by the horizontal component of the inter-granular forces within the core. Failure of the ~30m long section (across the test flume / box) by overturning was often resisted by arching of the top rows of the wall (of the order of 1-1.5m horizontal displacement at centre of crest). As the effect of arching increases, the wall essentially ‘unzips’ or ‘spreads’ along a vertical line down the centre. This lengthens each course. Eventually, a course will arch so much that ‘snap-through buckling’ reduces pressure between blocks and the flume walls. Using ‘slip plates’ against the ‘flume’ walls (see example in Figure 7.3) generally reduced the friction, removing some (but not all) of this artificial resistance to failure. The concrete blocks are not perfectly uniform, so columnar placement still resulted in some interlock between adjacent columns, and hence sideways transfer of loadings / reactions.

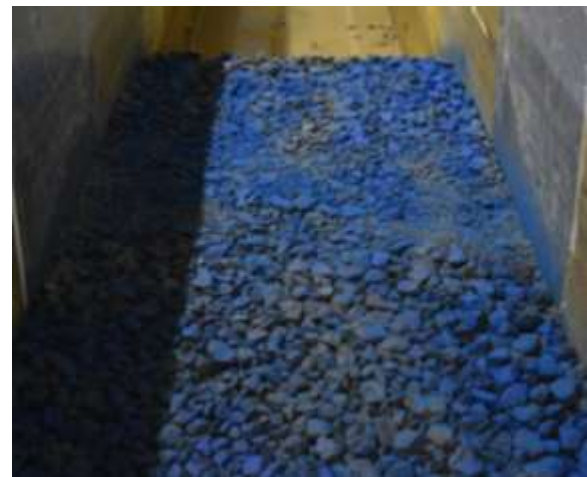
Figure 7.5 Rubble mound platform before wall construction

Each test section was constructed on a rubble mound from the flume floor at -24m (the intended test water level being at 0m) up to a mound platform level intended to be at -9m, but which had generally settled to about -10m. The build process was to build the foundation mound from roughly graded rock, tamped down and flattened, see Figure 7.5. The mound shoulders were covered by plywood during wall construction to protect the mound.

A finer (bedding) material was used to regulate the mound where the model walls were to be built giving a base width (between outer faces) of 0.815m model (24.45m). The walls were progressively built course by course with the fill poured in gently every two courses to prevent any sudden pressure changes within the model.

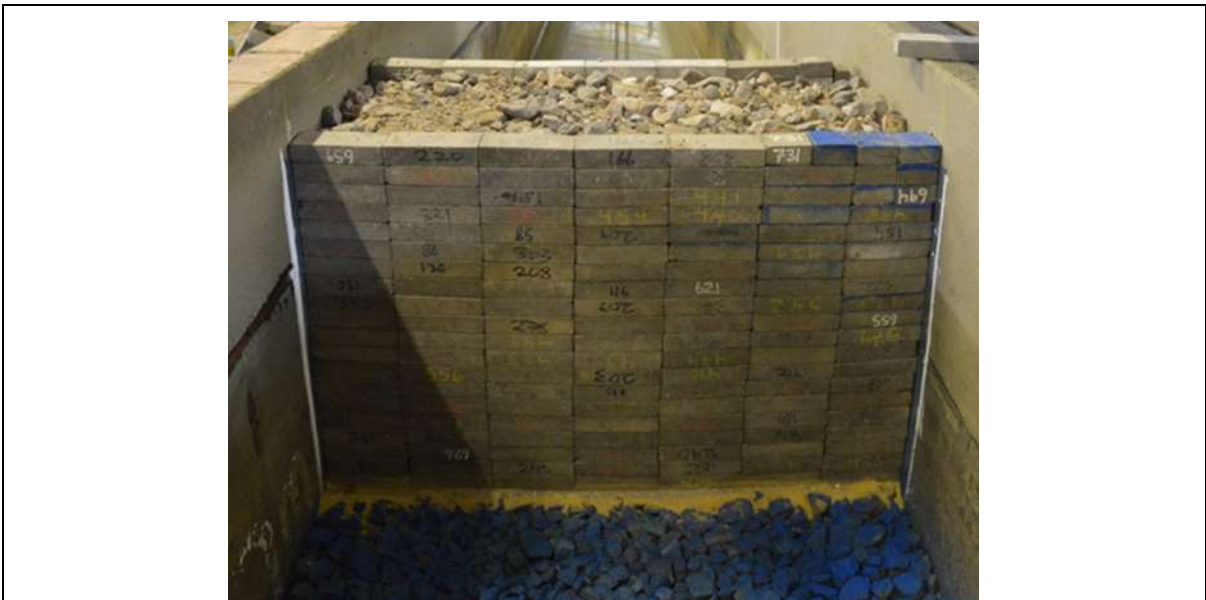
Figure 7.6 Wall construction

It is noted in Table 7.5 that there was always a (relatively small) upwards 'creep' as the net wall height exceeded the simple product of the number of rows x the nominal block height (0.9m). This upward 'creep' was greatest for the two sections where the blocks were laid bonded rather than columnar.

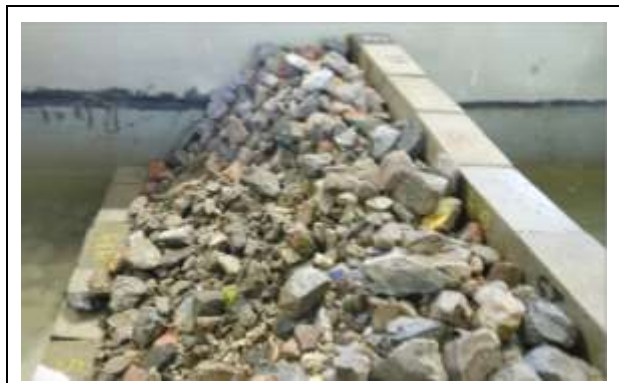
Figure 7.10 Test Series 1, post front wall failure

With the seaward wall down, the waves mainly broke onto the new rubble beach, attacking the rear wall with significantly less force. Even so, the rear wall showed considerable arching, probably leading to the wall staying upright longer than it would without lateral restraint.

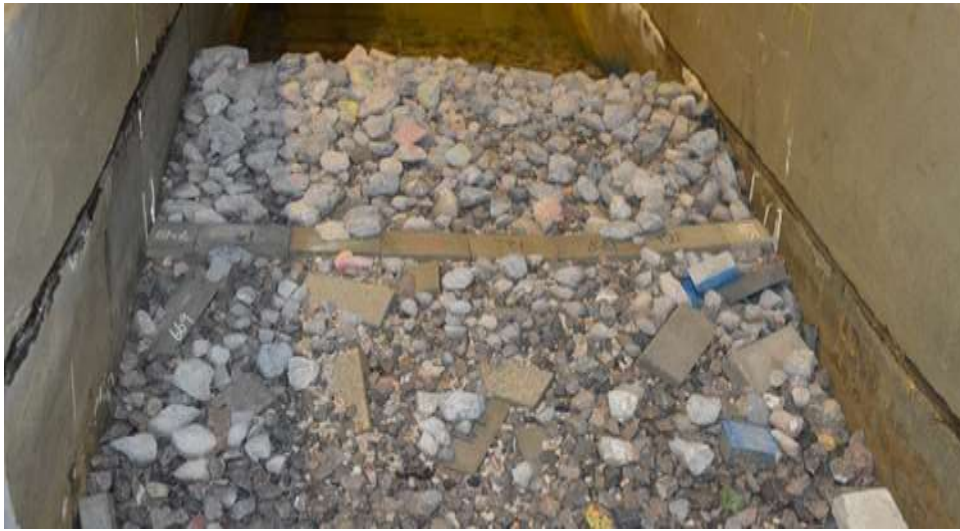
Figure 7.13 Series 2, post collapse, view from seaward

Multiple blocks were then extracted seawards from the front face as overtopping and local wave pressures caused multiple gaps in the blockwork at high level. Some courses resisted further due to arching against the flume sides. As more blocks were extracted, more overtopping penetrated into the rubble fill, forcing out further blocks. Once the seaward wall had failed, wave backwash steadily washed fill out until the seaward blocks and rubble fill were graded to a relatively shallow slope angle. down the front of the structure. By the end of the test the remaining blocks in the seaward wall were covered by fill, Figure 7.13

Following the front wall collapse, waves had direct impact on the leeward wall than in Series 1, in part due to the longer period waves, giving more impulsive bores over the block / fill beach formed by the collapsed front face. Arching once again meant that the wall stayed intact for longer than would be likely in prototype structures of any significant length. In the model, failure of the wall was therefore relatively slow, perhaps less brittle than in reality.

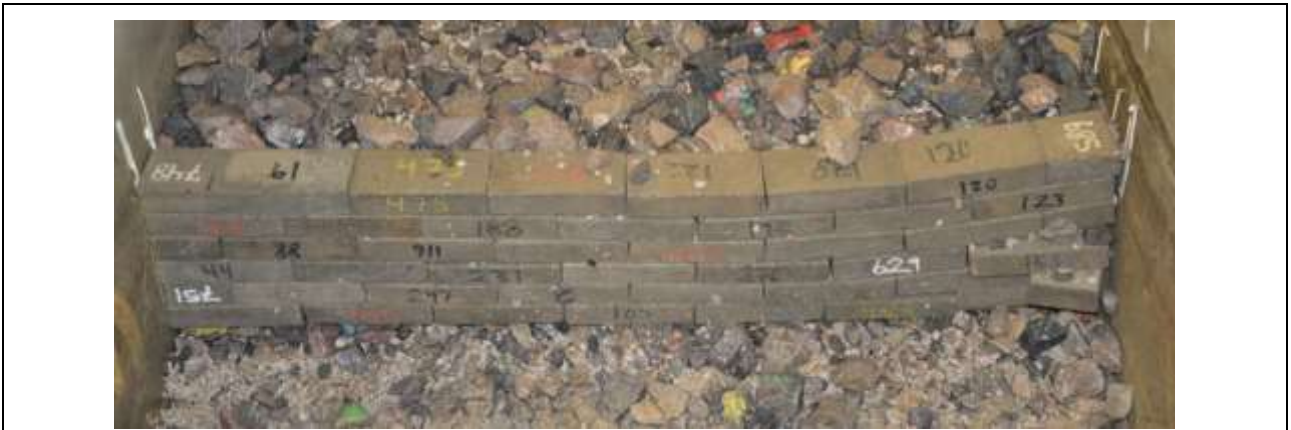
Figure 7.16 Excavated front wall, note vertical arching where foundation has scoured

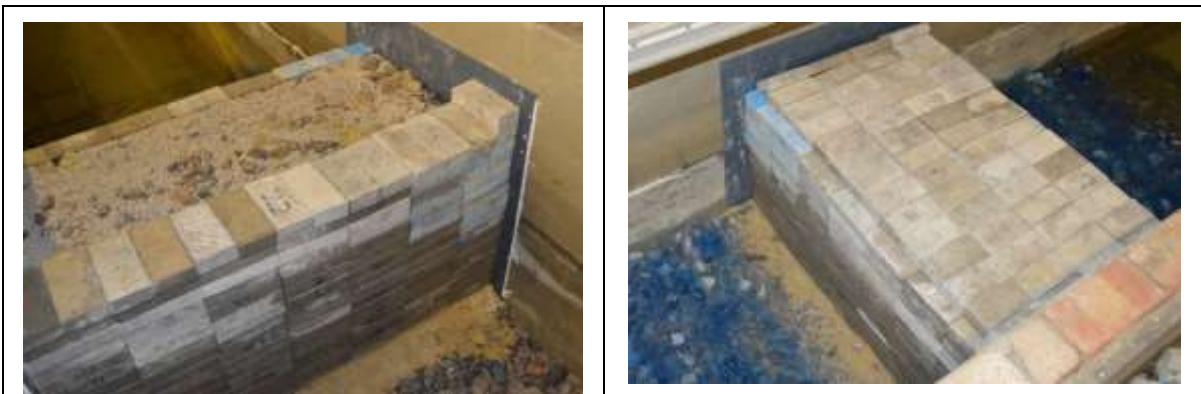
The Series 3 wall was built to 15 blocks high unbonded (columnar) following dry build A1, filled with standard fill. A layer of fines on top of the fill allowed placing of blockwork 'capping' bringing the section height to 16 blocks, see Figure 7.17.

Figure 7.17 Crest protection for Series 3, a) bedding layer for crest; b) crest blocks

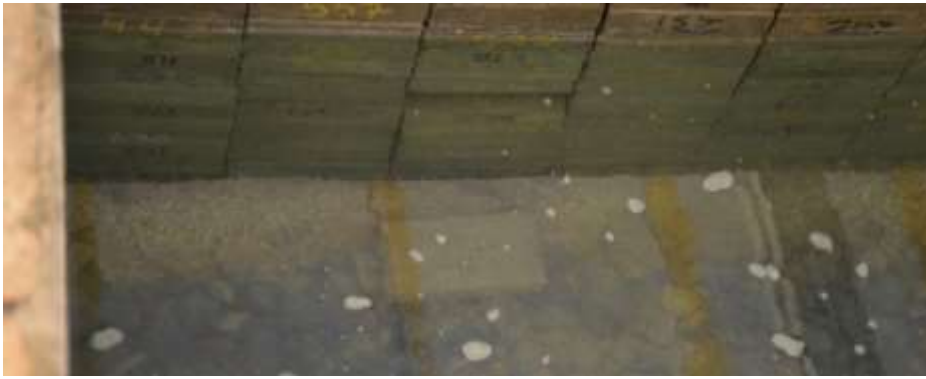
Figure 7.18 Extraction of front face block in Series 3

The seaward wall initially experienced a single block extraction Figure 7.18, showing that even with columnar placement, load transfer between columns can leave individual blocks un-restrained. With the smooth crest, the Series 3 wall transmitted more wave energy over the structure. At $H_s=7.05\text{m}$, the seaward edge of the capping layer however began to lift by up-rushing waves. This lifting and dropping caused the crest cap to deform. This movement continued until the row had been thrown backwards or washed forwards, creating a gap in the front of the wall, Figure 7.19.

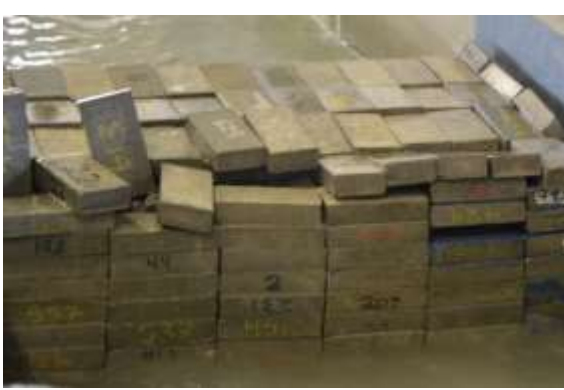
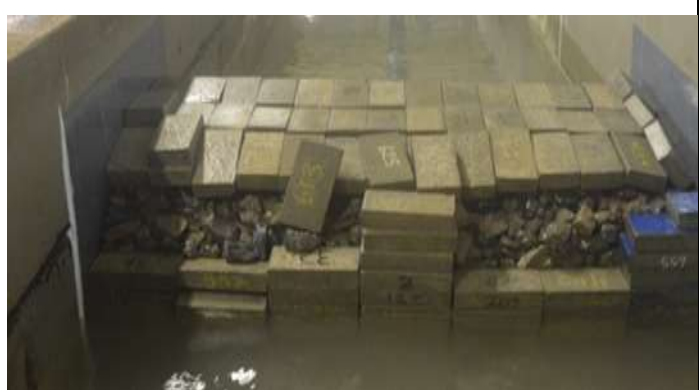
Figure 7.19 Damage in Series 3 to a) front face, b) rear face

Once this gap had been opened, waves penetrated under the cap, washing individual blocks off relatively quickly. This then allowed the waves to pull the fill and front wall down within 500 waves, forming a profile similar to that seen in Series 1 and 2. The evolution of damage to the wall through Series 3 is summarised in Figure 7.20.

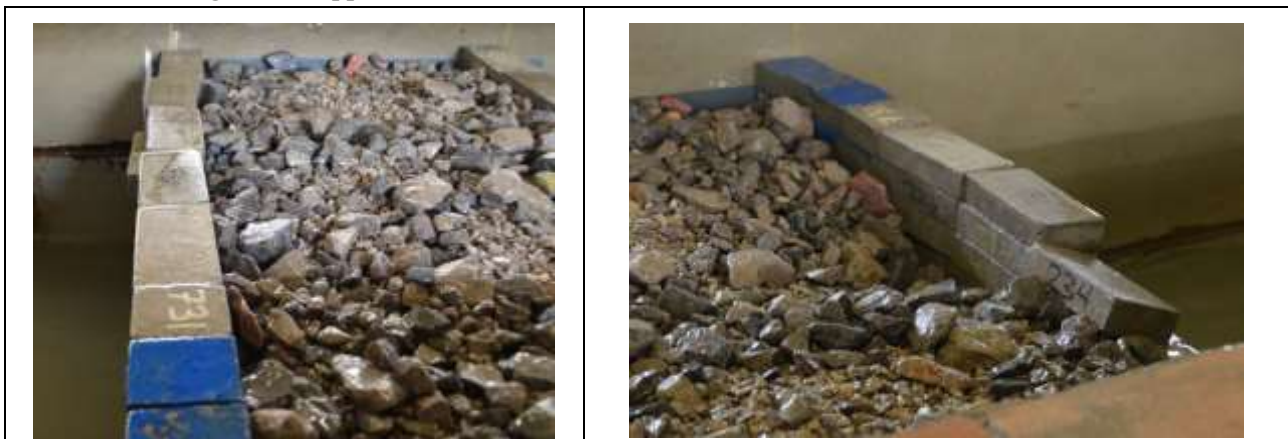
Figure 7.22 Series 4, start of damage with sink-hole in fill following loss of front face blocks

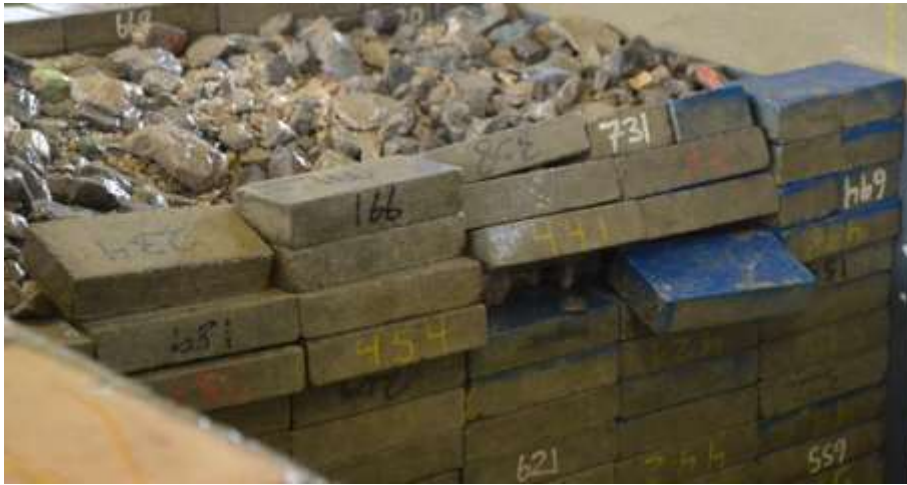
Soon after, more blocks were extracted from the central columns, allowing fill to be extracted manifesting itself as a sinkhole against the inside of the front wall. Once enough blocks had been extracted, a section of the wall began to lift and tilt backwards due to the water pushing it from underneath, some of these blocks then fell down into the gaps where the row below had been extracted, Figure 7.23 This drop in height of the wall allowed the incident waves to overtop the wall and wash loose blocks and fill down from the section. Figure 7.24 shows the seaward wall and the blocks in front of it once they had fallen. The following tests ($H_s=8\text{m}$) steadily brought the front wall down course by course, washing the fill out with it.

Figure 7.23 Series 4, progressive damage to front wall following partial loss of fill

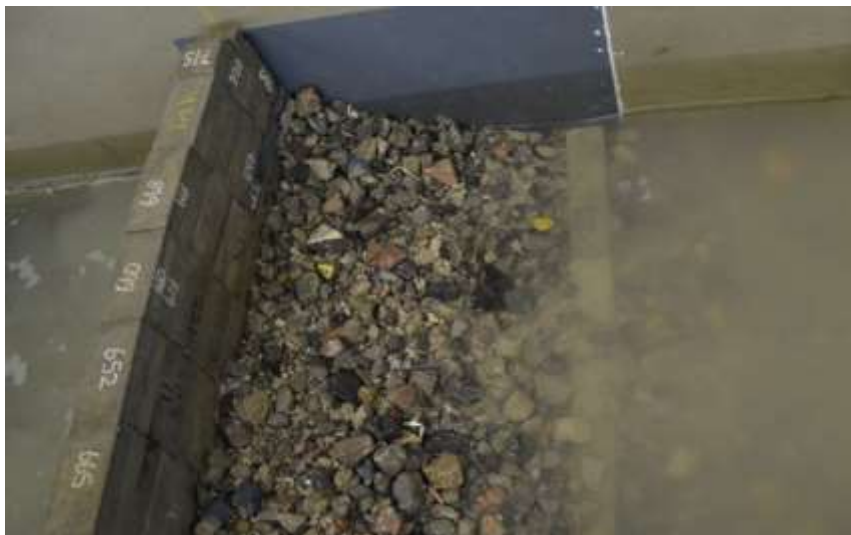
Figure 7.24 Rear face following failure of front face, Series 4

The leeward wall failed in a more brittle manner and earlier in Series 4 than Series 1-3, perhaps because of reduced arching given by the PVC slip plates. More core was washed over into the rear face when it collapsed. The rear face also collapsed more monolithically in Series 4 than in Series 3, Figure 7.25.

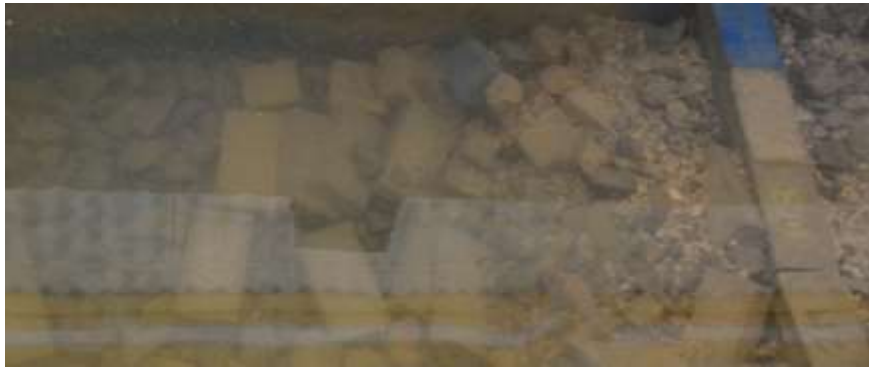
Figure 7.25 Collapsed rear face, Series 4, note close spacing of the blocks

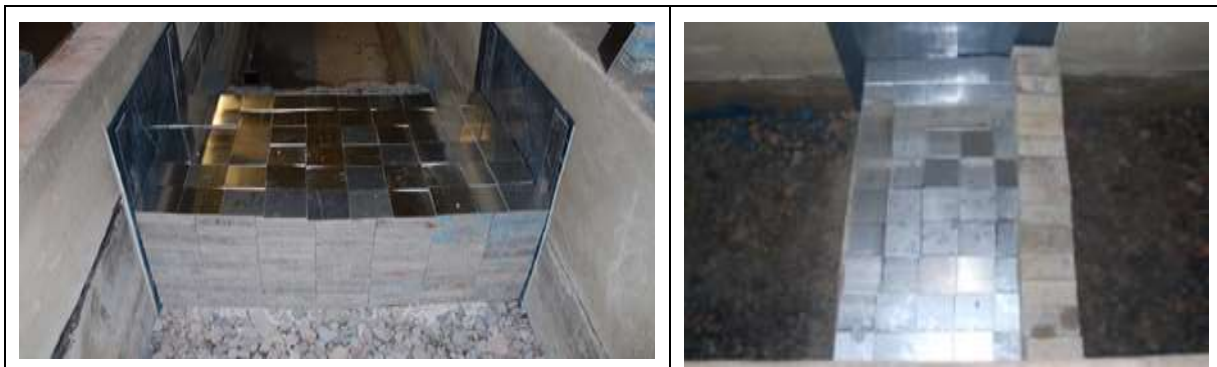
Following the experience of Series 3, it was anticipated that a reduced crest level would lead to much increased overtopping. Two measures were taken to resist overtopping causing excessive early erosion. As with most of these types of breakwater, the crest itself was protected by large slabs, in this instance simulated by aluminium sheet ($\rho \sim 2.4\text{t/m}^3$) of thickness equivalent to 0.1m and plan of 3m x 3m, Figure 7.26. Even so, it would be expected that the leading edge of such slabs could easily be lifted by overtopping flows. So, as was often done in breakwaters of the era considered, a parapet wall was added along the seaward edge, formed here by two rows of wall blocks placed end-on.

Figure 7.26 Test section for Series 5, showing crest slabs and parapet wall

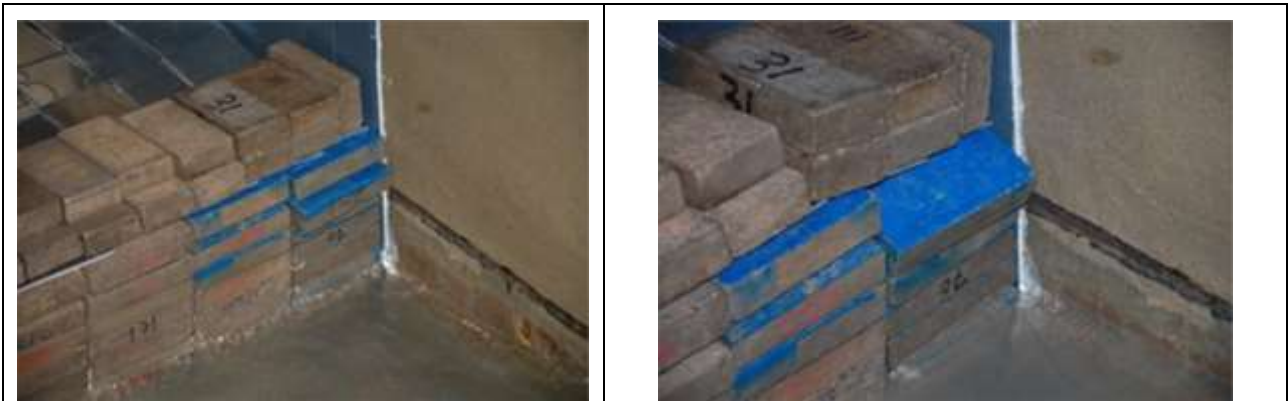
As previously, the test wave conditions were increased along the 'storm' steepness curve ($s \approx 0.06$), Figure 7.27, until Test part 138 when as the waves reached $H_s=4.3\text{m}$ some of the parapet wall blocks started to slide backwards. During Test part 139 at $H_s=4.9\text{m}$ more crest blocks were pushed backwards, thus allowing wave forces to lift the blocks above them, Figure 7.28

Figure 7.28 Onset of damage during Tests 138 and 139

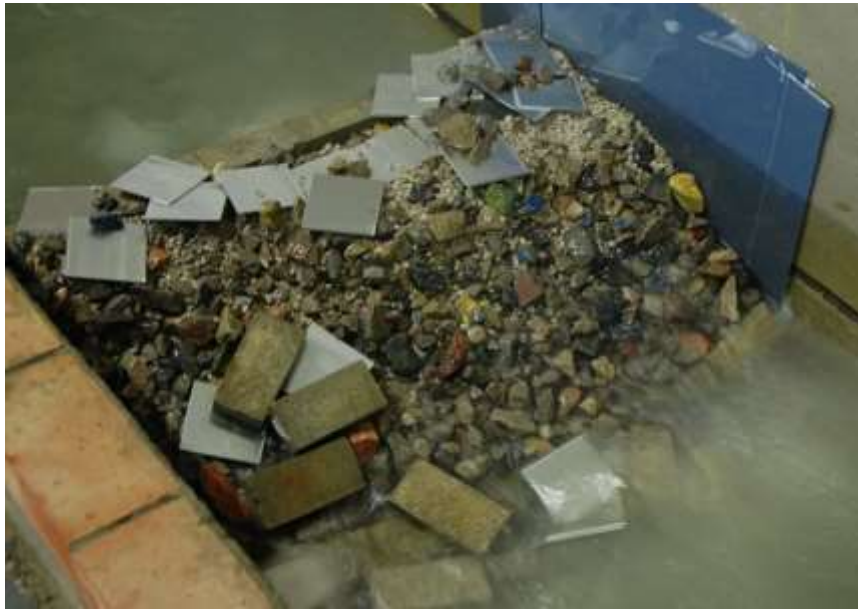
During Test 141 ($H_s=5.8\text{m}$) one half of the seaward wall collapsed around the hole left by the two blocks that had been extracted in the previous test parts. During Test 142 (at essentially the same wave condition) the remaining half of the front wall collapsed suddenly. The majority of the capping slabs were swept over the crest onto the leeward foundation, Figure 7.29. Any capping slabs that became wedged in the rubble mound were removed manually, judging that their prototype equivalents would have failed structurally.

Figure 7.29 Section 5 after collapse of the seaward wall

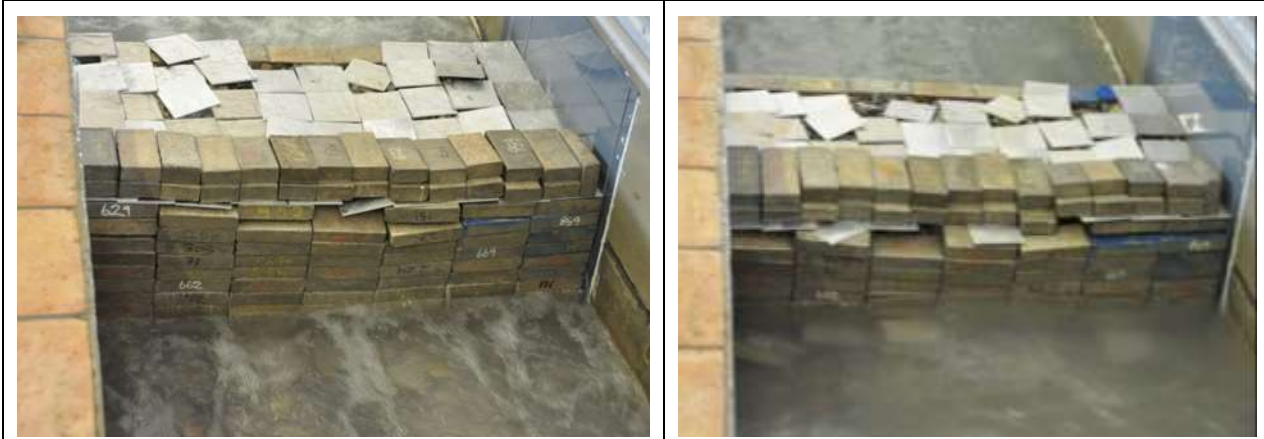
Figure 7.31 Series 6, block extraction on the front face, later damage progression

During Test Series 6, waves were increased from $H_s = 2\text{m}$ to $H_s = 5.7\text{m}$ when the first block was extracted from the front face, and capping material began to be washed off the structure. As damage at this test condition was seen to be continuing, the same conditions was re-run, steadily extracting more blocks, particularly in the rows just below the capping layer. During Run 173 a row of blocks had been extracted and the crest wall on top pushed back such that it was resting mainly on the rock material and capping layer, rather than on the main front wall blocks.
