Old British Breakwaters

How Have Engineering Developments Influenced Their Survival?

Nigel William Henry ALLSOP

Submitted for the degree of Doctor of Philosophy
at the University of Edinburgh
February 2021

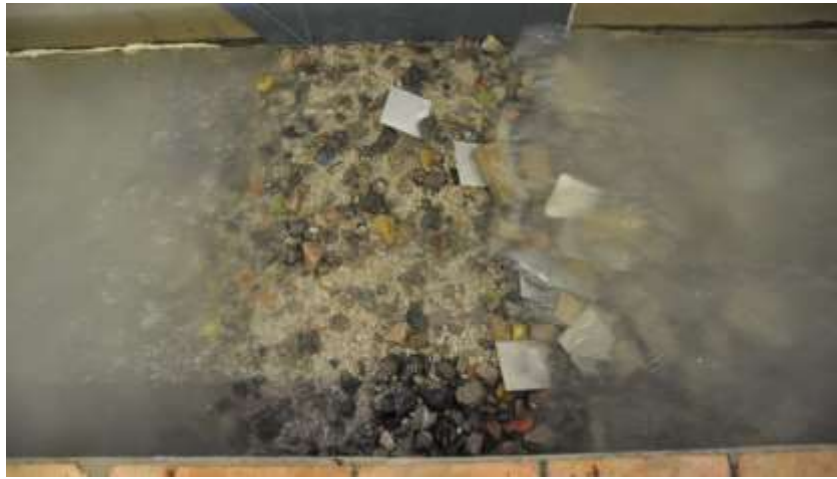
The leeward wall failed faster than in previous tests, probably due to the reduced arching effect from the double slip panels on each side. This process started with the top layers of blocks being pushed backward and then the core infilling around them to form a fairly stable slope.

Figure 7.33 Series 6, leeward wall post failure

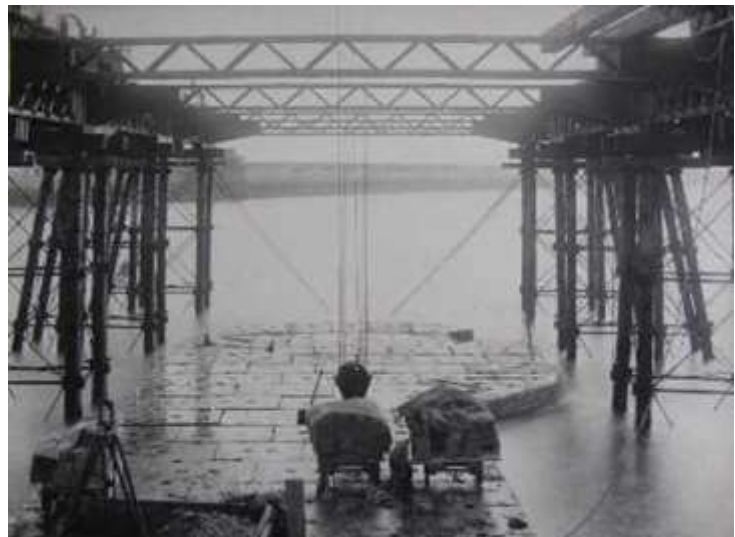
Pearson eschewed the use of Titan block placing cranes that would run directly on top of the constructed works, in favour of temporary staging above and beyond the works, supporting a number of Goliath and other (steam powered) travelling cranes weighing (unloaded) between 220 and 400t, Figure 12.11 and Figure 12.12.

The rail level for these cranes was generally above +27ft (8.2m) HWOST. The (mostly Tasmanian Blue Gum) supporting piles were upwards of 100ft (30m) long, of 18" or 20" (0.46-0.51m) square section. Wilson notes that the Blue Gum timber was heavier than water, but Oregon pine when used required weighting by old iron rails to ensure sinking. The staging piles were re-used as the work progressed along, being extracted by a floating hulk with a jib and powerful winch. After use, piles were spliced to ensure availability of an undamaged head for driving.

Figure 12.11 Dover - placing concrete blockwork from travelling cranes

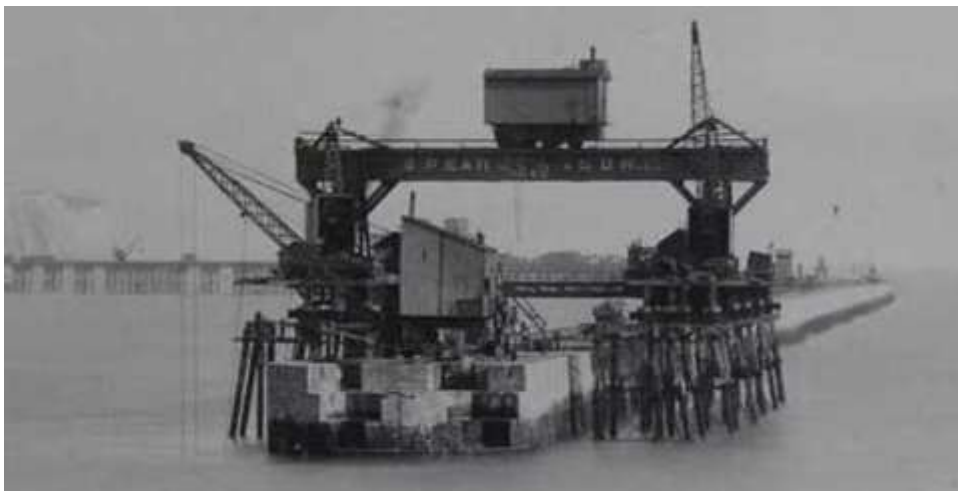
Figure 12.12 Dover - placing concrete blockwork from travelling cranes

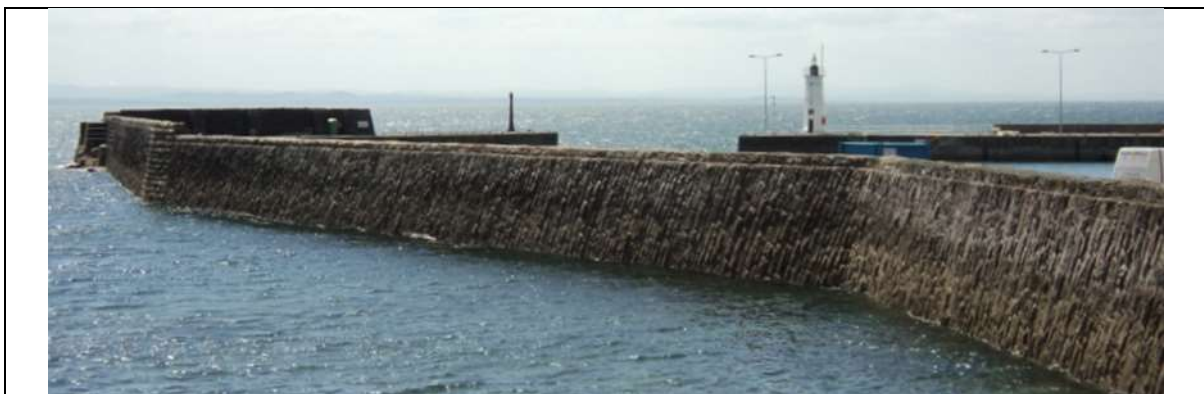
Figure D.1 Anstruther main (East) breakwater, July 2013

Anstruther Easter existed as a harbour in the 1580s and Gordon's map of 1642 shows a pier and basin, and stone pier some 540ft long existed in 1703, probably subsumed into the central pier. A second pier was added in 1753. Figure D.1 shows the East breakwater in 2013.

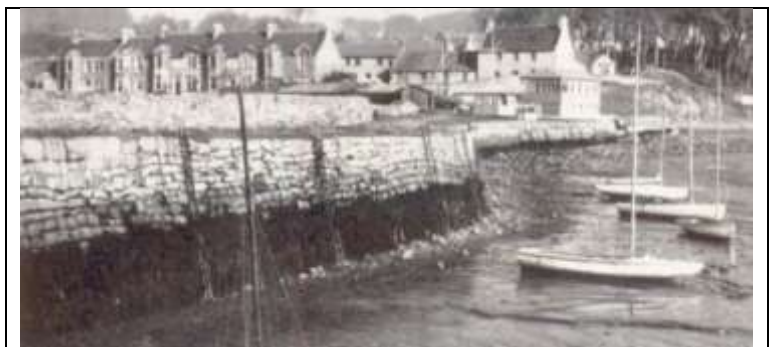
Bucehaven harbour is shown on Roy's 1755 map, approximately 130m long and 8m wide. The east face is formed by squared, coursed blocks, see Graham's photo in Figure D.2. At some stage the entrance was protected by a detached breakwater of large blocks, now reduced to the lowest courses.

Figure D.2 Bucehaven Pier
From Graham (1968)

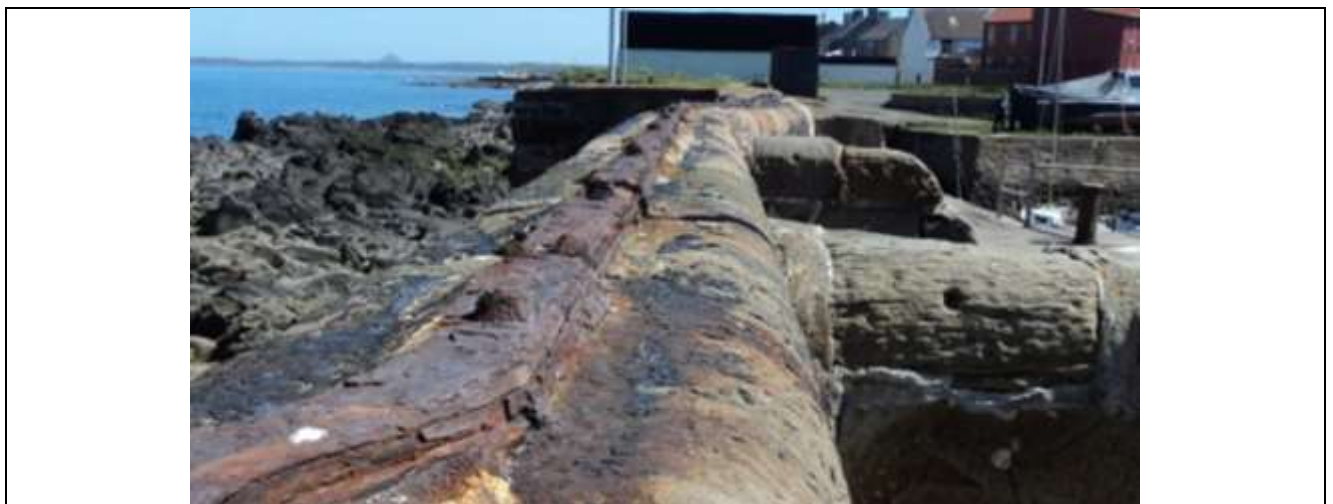
Figure D.3 **Cockenzie East Breakwater**

Parapet wall showing iron strap, May 2013

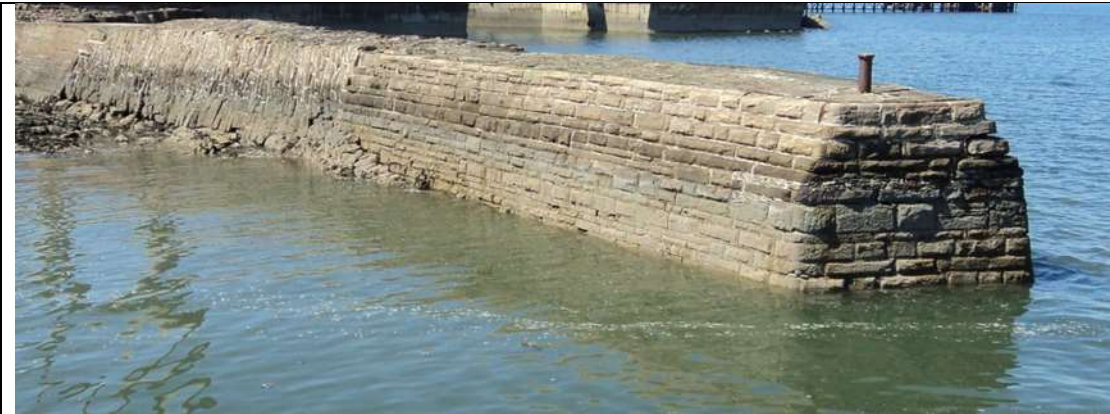
The West breakwater (Figure D.4) "*has rusticated masonry*" in its outer portion, with "*a patch of vertically set slabs further in, no doubt representing a repair*".³

Figure D.4 Cockenzie West Breakwater, May 2013

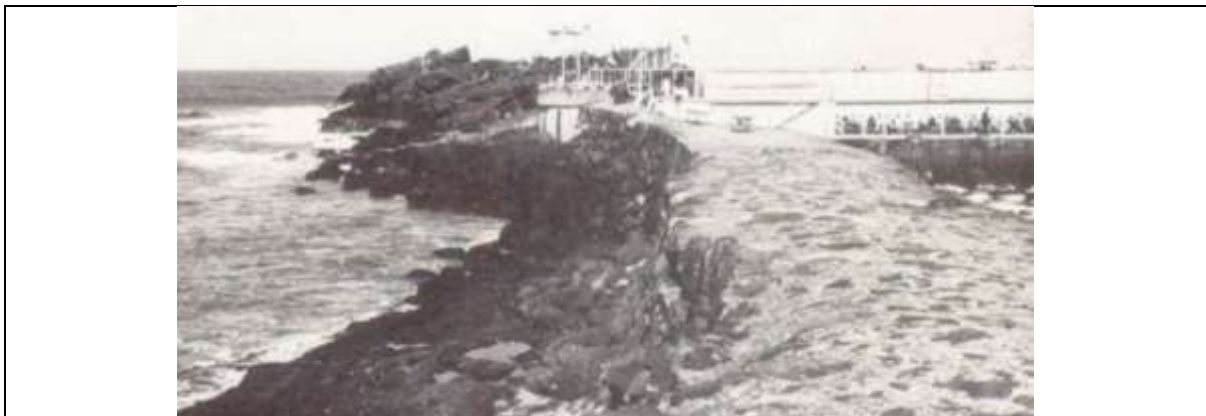
Some form of harbour at **North Berwick** may have existed well before 1658, although earlier works have been subsumed into more recent construction. The breakwater is formed of boulders and large rough blocks, irregular dry-stone masonry using wooden wedges, see Figure D.6. Robert Stevenson & Sons noted the rude workmanship and appearance of great age. In 1811 the outer end of the breakwater was levelled, and the SW pier was badly shattered. Various reconstructions and improvements followed, including chases for stop-logs, blamed by Stevensons' report after 1811 for damage to the SW pier.

Figure D.6 North Berwick breakwater

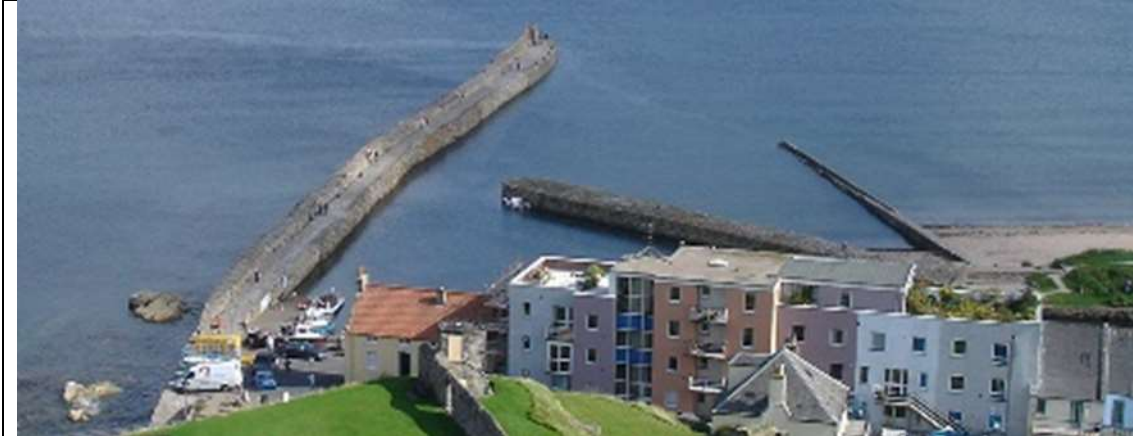
masonry of the breakwater is highly variable, including: roughly-squared and coursed blocks; vertical work; poorly coursed rubble; well-coursed long blocks; vertical blocks founded on a course of boulders; well-dressed and neatly coursed slabs. The construction of the Cross-pier shown in Figure D.9 is substantially more homogeneous than the main breakwater in Figure D.10.

Figure D.9 St Andrews harbour, September 2009

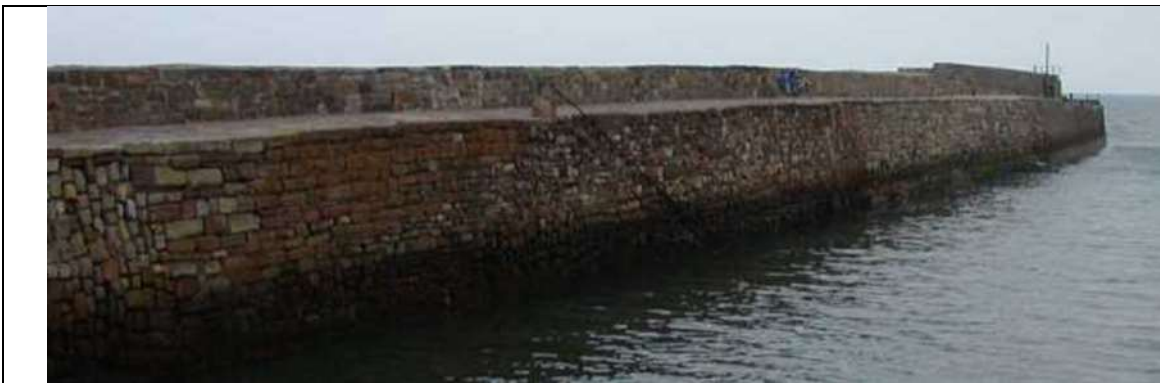
Figure D.10 St Andrews main breakwater showing variable wall construction, July 2003

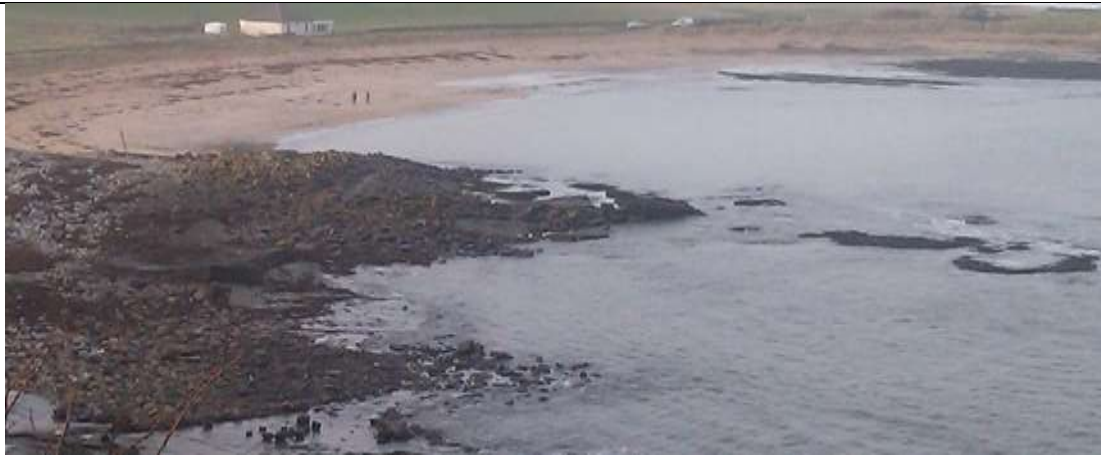
Figure D.11 Remains of Skateraw harbour, from the south, November 2014

marked by a rickle of debris". "The masonry is of long thinnish and well dressed slabs, neatly shaped to curves, but not secured with cramps or keys". Graham notes two further features on the seaward side of the breakwater below HW. A groyne (or jetty) formed by a double row of large roughly shaped blocks set on edge projects seaward for some 15m. Separately a larger and curved structure, formed by very large blocks set on edge set transversely to the line of the structure, appears to have enclosed a rock-cut pocket. This contrasts with, and does not appear to be connected to, the main breakwater. This breakwater has been discussed earlier in Chapter 2, see also Figure D.11.

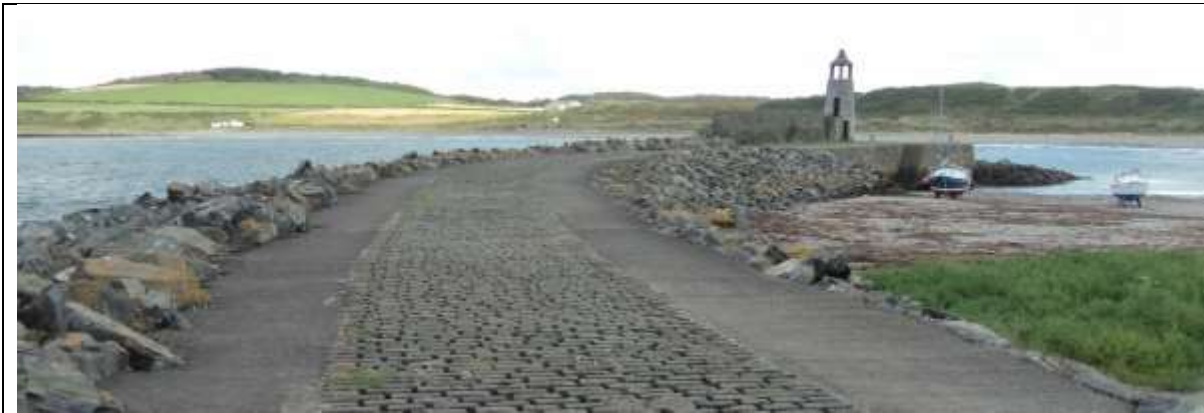
Figure D.1 Repaired mole and lighthouse at Port Logan (W. Allsop, 2017)

A small pier existed here in 1755, but was destroyed before 1791. Rennie reported in 1831 on the potential for a port to Ireland. The pier of 540ft was built by Colonel McDoull, probably to the layout suggested by Rennie's report. Mole and lighthouse were stabilised / repaired in 1980s, see Graham (1979). Later restoration is shown in Figure D.1.

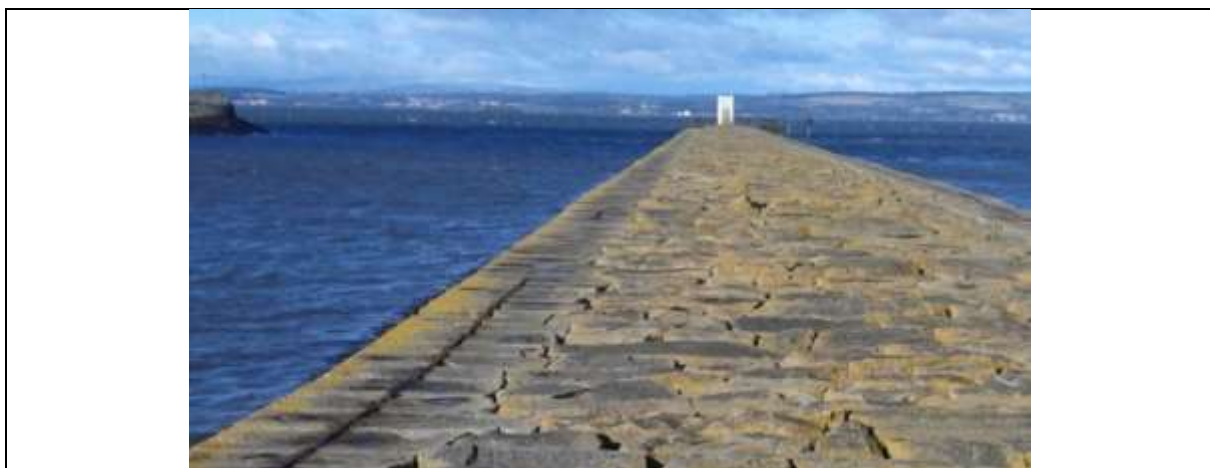
Figure D.2 Granton East Breakwater

Work on the Eastern Breakwater (Figure D.2) commenced in 1853 and completed in 1863 at a length of 3170ft. Stone for the breakwaters was quarried at Granton Quarry just west of the Western breakwater. This breakwater is battered on each side, Figure 12.15, with stones closely-fitted, but apparently not cemented, Figure D.3. Along the edge of the crest, a slender iron rail is used to link blocks together giving a tensile restraint against block movement.

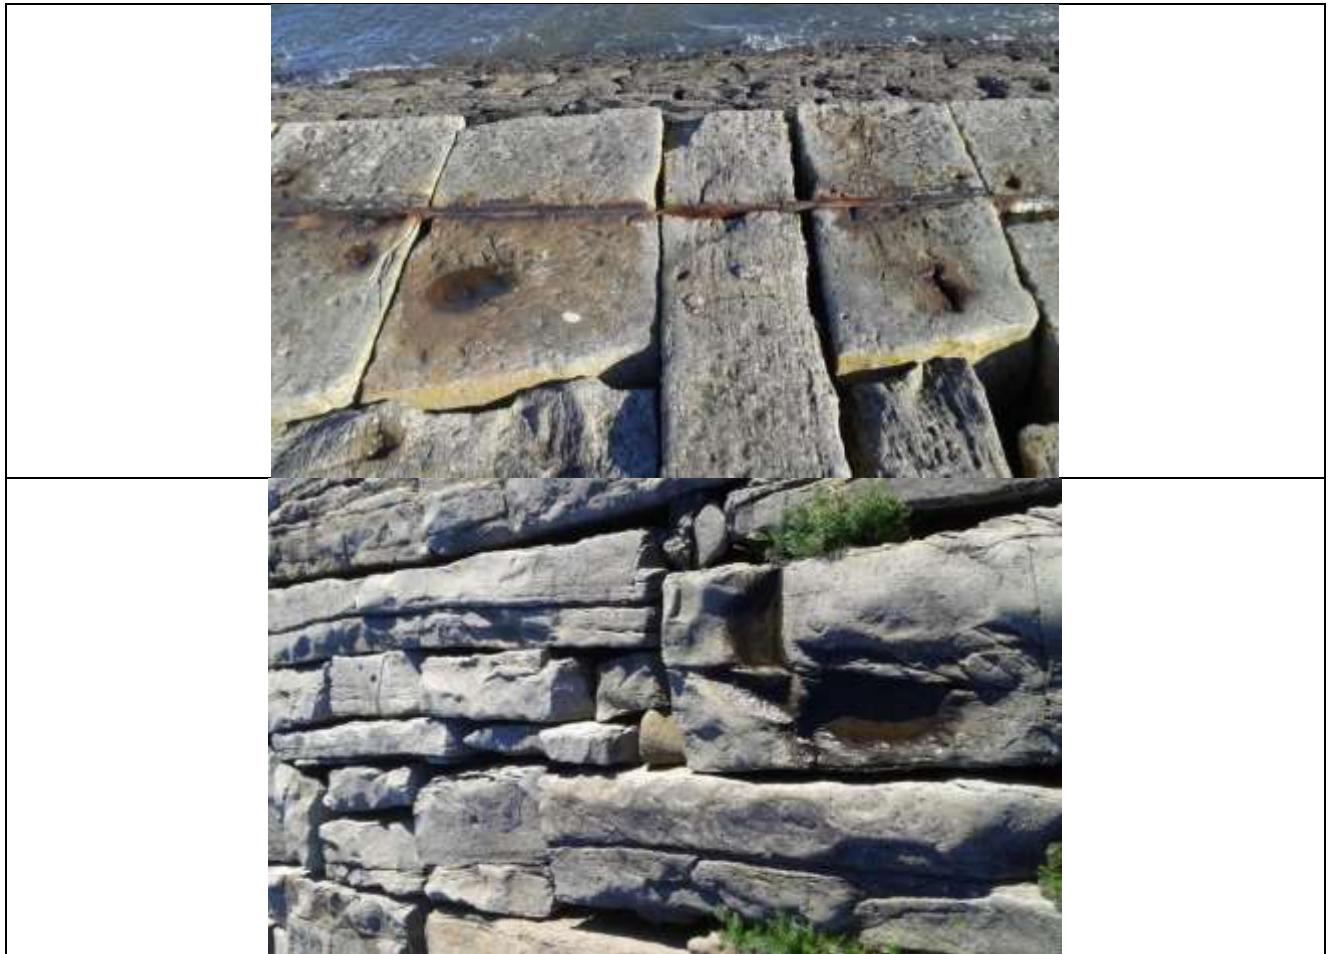
Figure D.3 Granton East Breakwater details, a) edge rail; b) end-on blockwork, 2017
