Pathophysiology of the flow impairment during carotid artery stenting with embolus protection filter

Department of Neurosurgery and Radiology*, Nagasaki University School of Medicine,
JAPAN

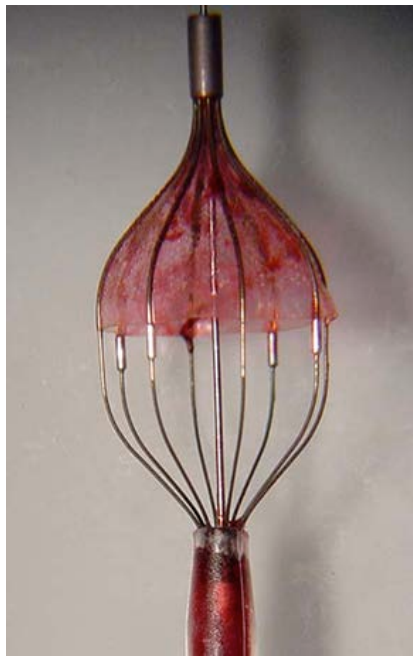
A

A: Gross inspection of Angioguard XP; AG

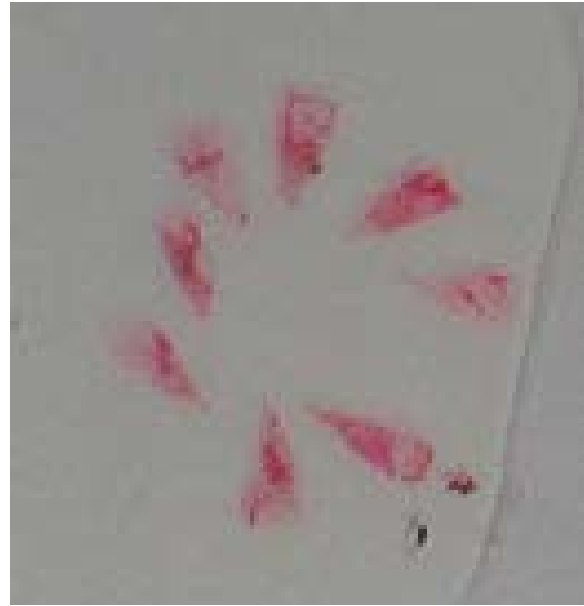
B

B: The filter membrane is removed and mounted onto glass slide.

We have reported a technique for microscopical filter observation [7, 9]. After brief washing with distilled water, the filter was placed Mayer's hematoxylin solution for 1 minutes, and then placed in eosin for another 1 minute with brief wash in between procedures. Subsequently, the filter membrane was cut off from the strut and mounted onto a glass slide using paramount. Finally, the hematoxylin & eosin (HE)-stained debris on the filter could be visualized using light microscopy. The structure of the filter was observed and the pore density and the area of the filter was measured (Fig. 1). Moreover, the percentage of the occupied area with debris was measured. The actual area was considered as amount of the debris. The subtype of debris was classified atheroma fragment or fibrin precipitation (Fig. 2). Microscopical image was save as JPEG file and imported to Adobe Photoshop CS6 (Adobe, San Jose, CA, USA) for quantitative analysis.

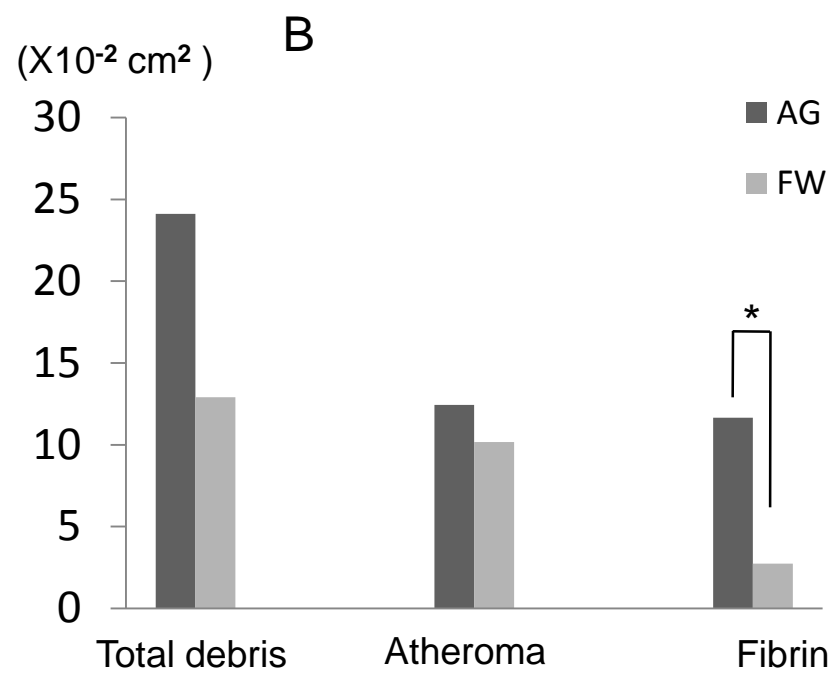
Fig. 3 Relation of captured debris and flow impairment.

A: Percentage of filter occupied area. The area is significantly more in AG group especially in cases with flow impairment.

B: Amount of the captured debris and fibrin precipitation. The total amount and the fibrin precipitation are more in AG group.

C: The relation of flow impairment and amount of the captured debris in AG. The flow impairment is significantly associated with amount of debris.

D: The relation of flow impairment and amount of the captured debris in FW. The flow impairment is not associated with amount of debris.

Regarding with flow impairment and occupied area of AG, occupied area was significantly more in the flow impairment cases ($70.32 \pm 14.19\%$, $0.415 \pm 0.084 \text{ cm}^2$) than in normal flow cases ($30.34 \pm 12.68\%$, $0.179 \pm 0.075 \text{ cm}^2$). Moreover, the fibrin precipitation was significantly more in flow impairment cases ($0.228 \pm 0.086 \text{ cm}^2$) comparing with normal flow cases ($0.077 \pm 0.053 \text{ cm}^2$). On the other hand, in the FW,

occupied area of the flow impairment cases ($10.65 \pm 5.37\%$, $0.158 \pm 0.080 \text{ cm}^2$) and normal flow cases ($8.29 \pm 6.32\%$, $0.124 \pm 0.097 \text{ cm}^2$) were not different (Fig. 3). Taken together, flow impairment was induced by the filter obstruction in AG and by the vasospasm in FW.

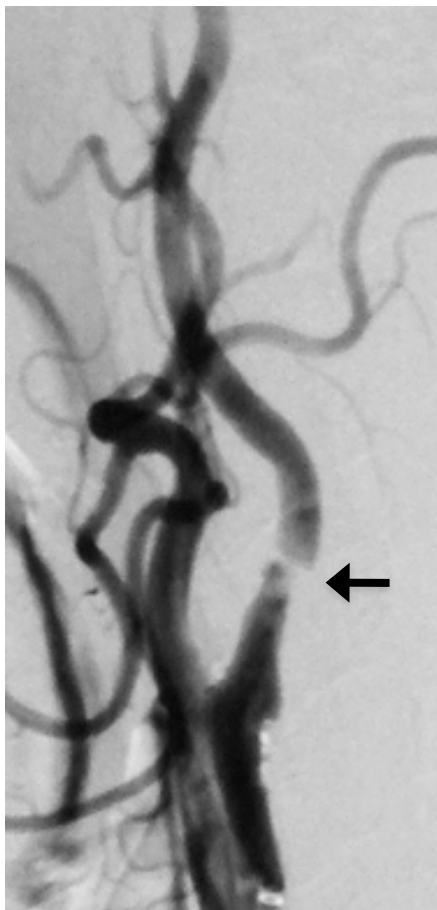
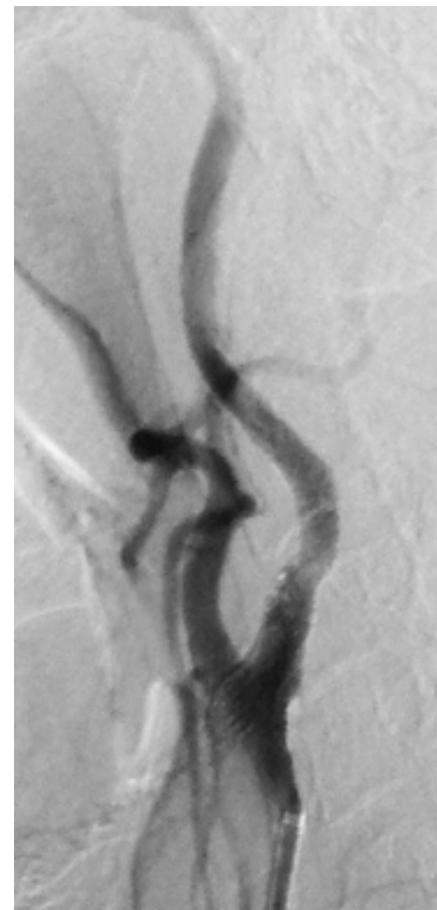
Fig. 4

A: Rt. Carotid angiogram shows high grade stenosis (arrow).

B: Following stenting, angiogram reveals flow arrest (arrow indicates AG).

C: Following filter retrieval, the blood flow is recovered.

D: Postoperative MRI shows no abnormal lesion.

E: Filter observation study shows 78.4% of the area is occupied with debris.

8 Fr guiding catheter was introduced to the right common carotid artery (CCA). Carotid angiogram showed high grade stenosis (Fig. 4A). A 5 mm AG was placed at the subcranial portion of the right ICA. Balloon angioplasty was performed and Precise stent 10 mm X 40 mm was placed from ICA to CCA. Following stenting and postdilation, angiogram revealed flow arrest (Fig. 4B). Then, AG was retrieved with capture catheter. The flow was restarted upon retrieving the filter (Fig. 4C). Postoperatively, the patient was suffered from mild left hemiparesis and MRI diffusion weighted image showed multiple high intensity lesions in the right cerebral hemisphere (Fig. 4D). Filter observation study showed 78.4% of the area was occupied with debris and fibrin (Fig. 4E). The occupied area was 0.463 cm² and the fibrin precipitation was 0.185 cm². The cause of the flow impairment was filter obstruction.

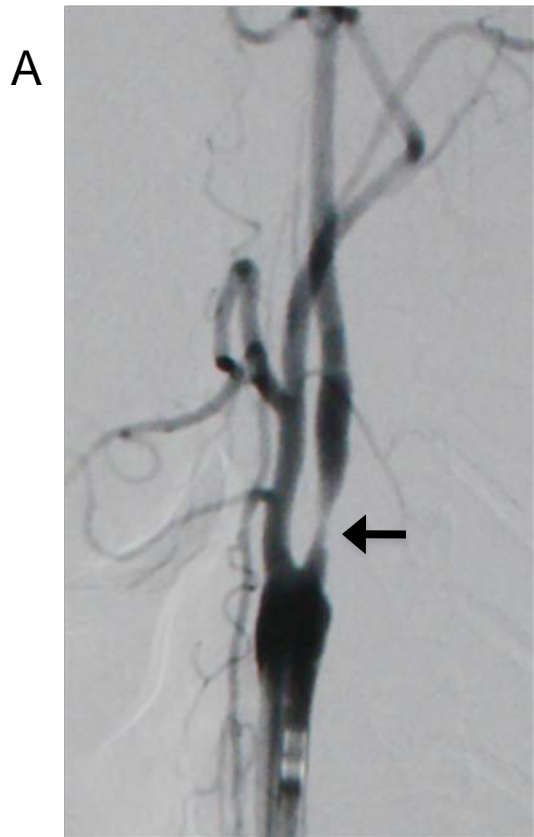
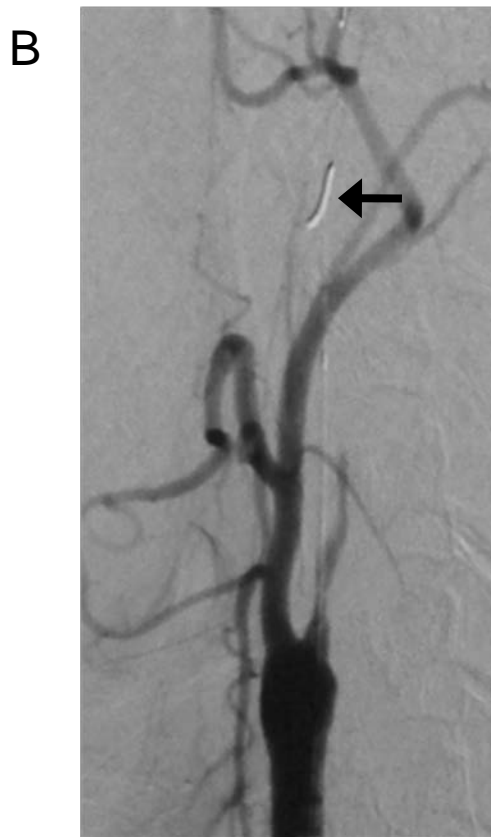
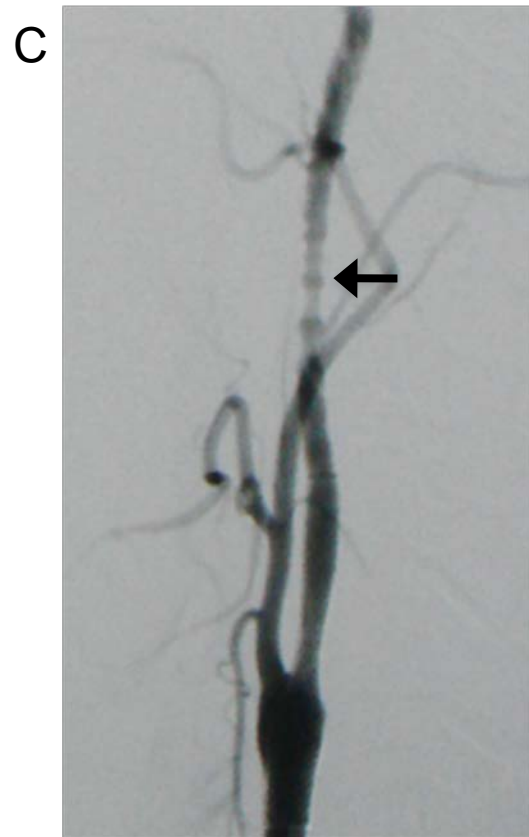
Fig. 5

A: Rt. Carotid angiogram shows high grade stenosis (arrow).

B: Following filter placement, angiogram reveals flow arrest (arrow indicates FW).

C: Following filter retrieval, the blood flow is recovered and spastic lesion is revealed at the filter placed portion (arrow).

D: Postoperative MRI shows multiple high intensity lesions in the right cerebral hemisphere.

E: Filter observation study shows 17.8% of the area is occupied with debris.

A 60-year-old man who had a history of angina pectoris was referred to our hospital for the treatment of asymptomatic ICA stenosis. Since he needed dual antiplatelet agents for coronary artery stent, CAS was planned. A 8 Fr guiding catheter was introduced to the right CCA. Carotid angiogram shows high grade stenosis (Fig. 5A). A FW was placed subcranial portion of the right ICA without difficulty. Immediately after filter placement, angiogram revealed the flow arrest (Fig. 5B). Since the patient was neurologically intact, the procedure was continued. Stenosis was dilated with 4 mm balloon and Wallstent 8 mm X 30 mm was placed from ICA to CCA. Since the dilatation was not sufficient, postdilation was performed with 5 mm balloon. Following filter retrieval, the blood flow

was recovered with residual vasospasm at the filter placed portion (Fig. 5C). Postoperative course was uneventful and MRI diffusion-weighted image showed no abnormal lesion (Fig. 5D). The filter membrane was examined, and the occupied area was measured as 17.8% (Fig. 5E). The occupied area was 0.178 cm² and the fibrin precipitation was 0.089 cm². Filter obstruction was denied and it was considered that the cause of flow impairment was vasospasm.

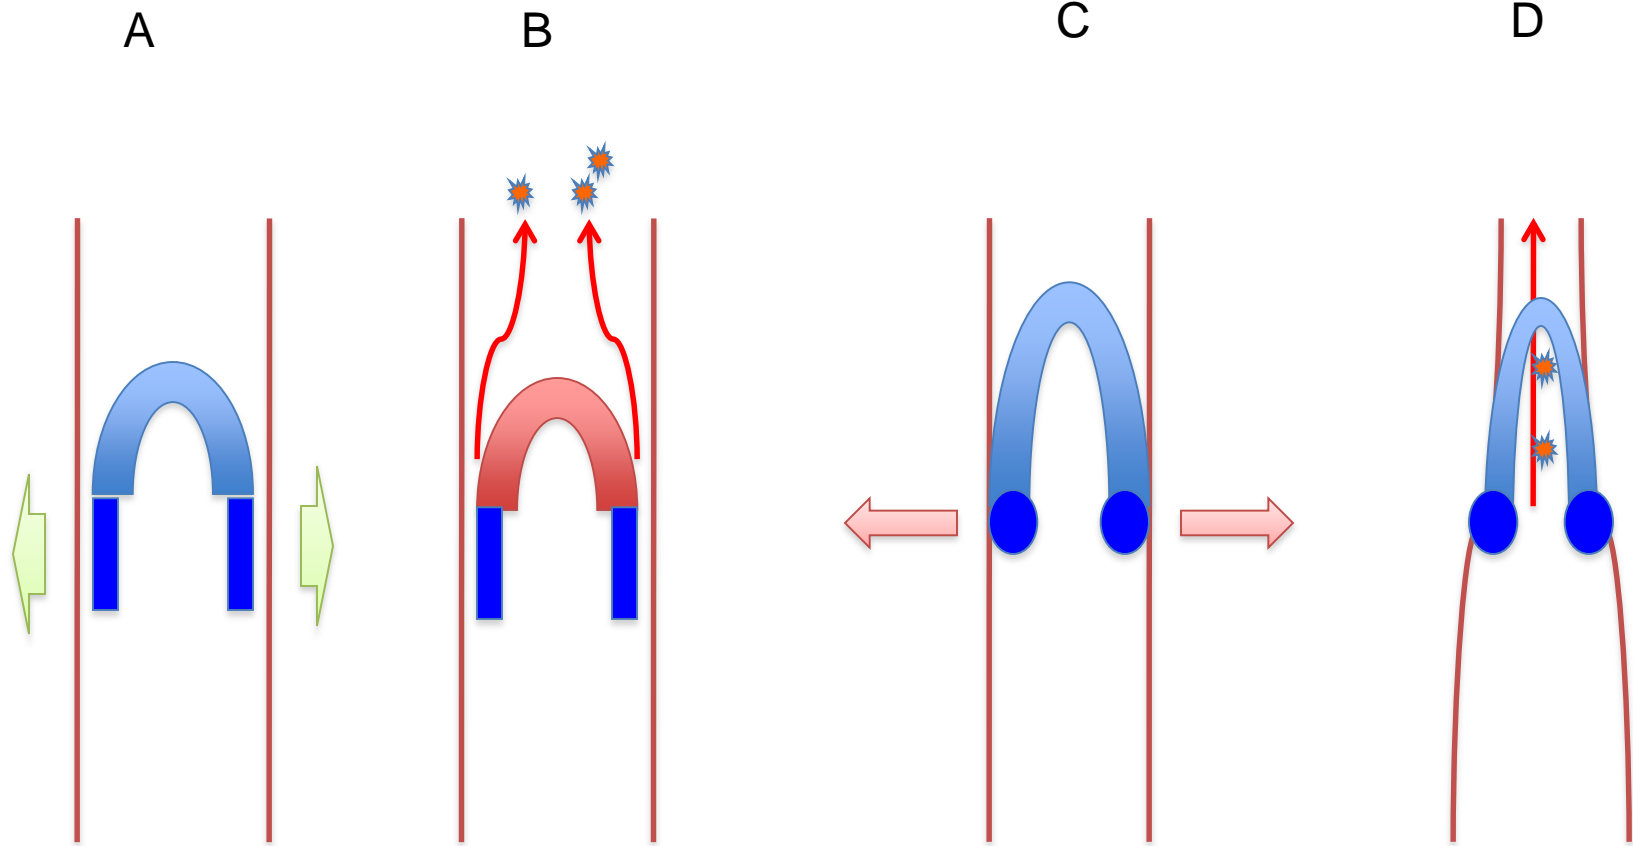
Fig. 6 Schematic illustration of the flow impairment of during carotid artery stenting (A & B; Angioguard XP, C & D: Filterwire EZ)

A: Attachment part to the internal carotid artery (ICA) is wider in AG and the stress to the vessel wall is less.

B: Filter tends to occlude due to its poor function and flow containing debris may be through between filter and ICA wall.

C: FW is only one size and the linear attachment for the ICA.

D: Stress to the ICA is more in FW and results in vasospasm. However, the filter tends to be patent and attach for the ICA wall, the debris is captured by the filter.

Flow impairment occurred more frequently with AG (6/25; 24%) than with FW (4/27; 14.8%). In term of intraoperative flow impairment and the etiology, the cases with flow impairment, the filter area was occupied significantly more in AG. In cases of flow impairment with AG, approximately 70% of filter area was occupied with debris. Against that, even in the flow impairment cases with FW, only 10% of the area was occupied. As shown in Fig. 5C, residual vasospasm was identified in the FW placed portion, the cause of the flow impairment is vasospasm. Regarding with timing of vasospasm, there are two type, i.e. immediately after filter placement and after postdilation. Later may be due to the stress of insertion or removal of the devices such as stent and balloon catheter. Size of AG can be selected depending on the size of ICA and the attachment area for the ICA is relatively wider (Fig. 6A). However, FW is only one size and the attachment for the ICA is linear (Fig. 6C). Therefore, stress to the ICA is more in FW and results in vasospasm.

Finally, we evaluated the relation of the flow impairment and perioperative stroke. Cerebral infarction occurred in 3 cases of AG group and all of them were complicated with intraoperative flow impairment. In case of AG, filter tends to be obstruct due to its poor function and flow stagnation results in fibrin precipitation. Then, flow containing debris may be through between filter and ICA wall (Fig. 6A, B). Those flow results in cerebral embolism. On the other hand, cerebral infarction occurred in a case of FW group and it was not complicated with intraoperative flow impairment. The cause of flow impairment is vasospasm. More careful handling is required for the CAS under FW. The filter tend to be patent and attach for the ICA wall, the debris is captured by the filter (Fig. 6C, D). Therefore, it is not complicated with cerebral embolism.
