Damage assessment of tunnels caused by the 2004 Mid Niigata Prefecture
Earthquake using Hayashi's quantification theory type II

Yujing Jiang^{1,2*}, Chunxiang Wang¹ and Xiaodong Zhao³

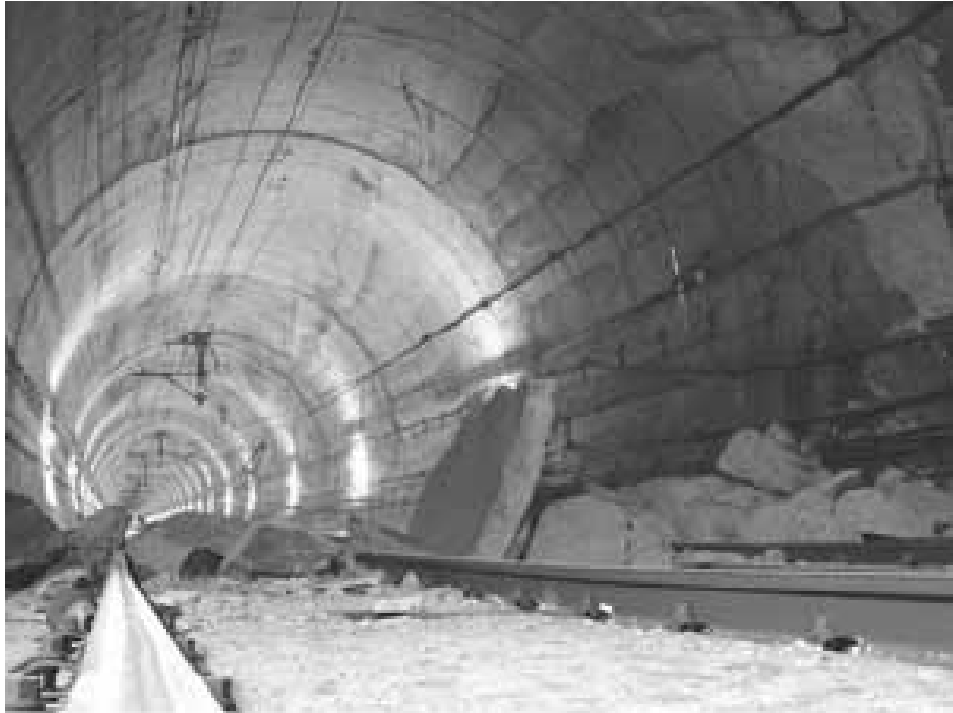
(a) Spalling of lining in Uonuma tunnel

Figure 5 Damage pattern – crack and spalling of lining (After Konagi et al. 2005)

Spalling of concrete lining is the severe damage pattern in this disaster. There are three causes for spalling: space over the arch crown; imperfection of the contact between the concrete material and the rock surrounding of the tunnel; and the aged concrete lining. The seismic shaking force is the initiation factor. Figures 5 (a) and (b) show typical examples of spalling of the concrete lining at the most heavily damaged sections in Uonuma tunnel and Kizawa tunnel respectively. Uonuma tunnel, which is located nearby the epicenter, is an 8625 m long

Shinkansen railway tunnel running through Neogene mudstone and alternating beds of sandstone and mudstone. The concrete lining broke and fell into the track and the largest concrete block was approximately 2m³ with a weight of five tons. Kizawa tunnel, a 305m road tunnel, runs through Pliocene sandstone and mudstone. The cracks on the east side wall extend over 45-83m from the north tunnel mouth, while the cracks appeared over 38-88m distance on the west side wall. Some parts of the concrete lining inflicted spalling. Kongai et al. (2008) gave a detailed analysis of the causes of the damage in Kizawa tunnel.

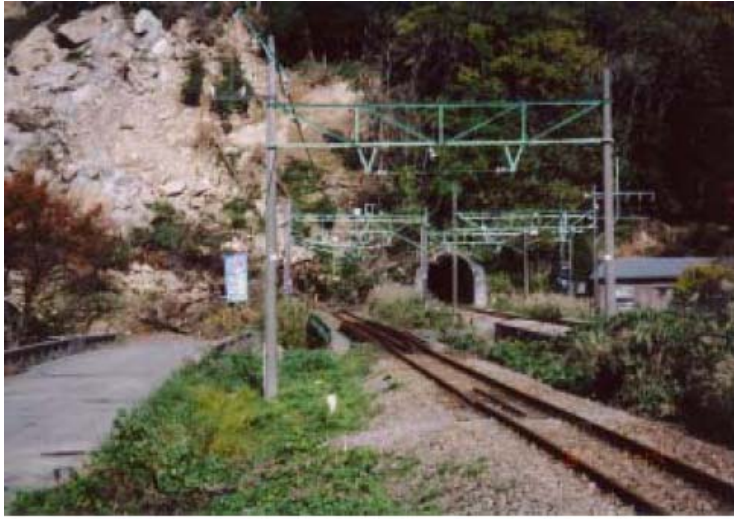
(a) A landslide obstructed the portal entrance in Enoki tunnel

Figure 6 Damage pattern - landslide and debris flow obstructed the portal entrance (After Konagi et al. 2005)

A large number of slope failures and debris-flows were also induced by the 2004 Mid Niigata Prefecture Earthquake. Fortunately, slope failures have not inflicted tunnel collapse in this earthquake. However the gravels from slope failures and debris-flows obstructed the portal entrances of the Siotani tunnel and Enoki tunnel (Fig. 6).

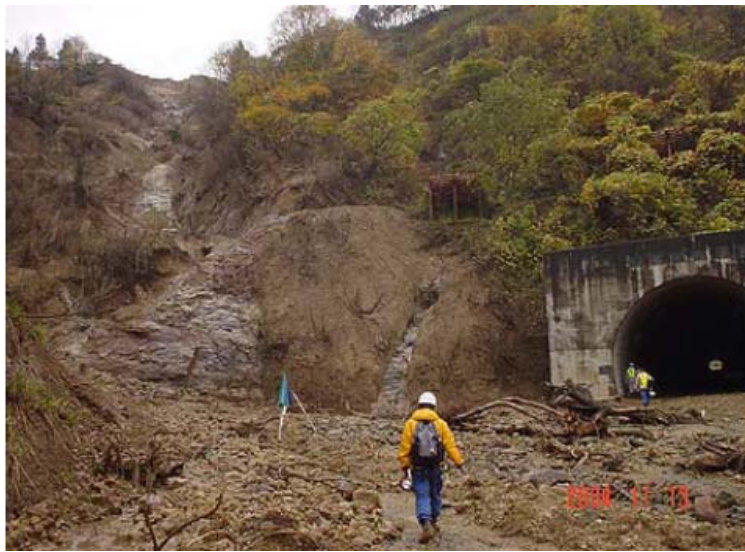
(b) Gravels obstructed the portal entrance in Sinotani tunnel

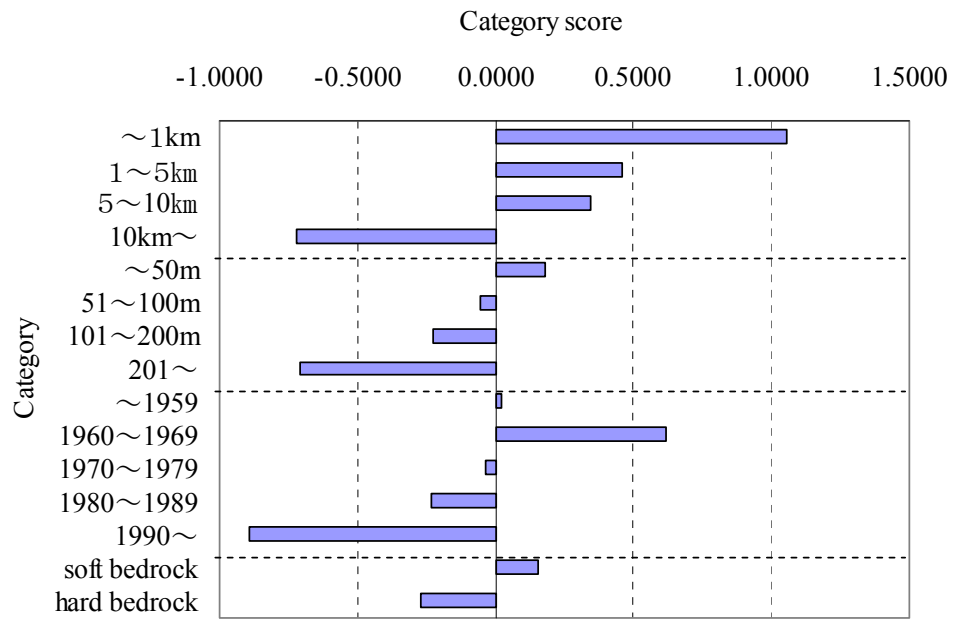
Figure 7 Category score in each item

analyze the relative contribution of the distance to epicenter, the geological conditions, the overburden and the time since completion to the degree of tunnel damage. The contribution of each item can be shown in Figures 7 and 8 by the standard category scores and item ranges. The category score on x -axis in Figure 7 expresses the contribution of the impact factors to the degree of tunnel damage. The larger the category score of factor is, the larger the contribution of factors to tunnel damage become. The positive value shows the corresponding category will promote the degree of tunnel damage; in contrast, the negative value shows the corresponding category will restrain the degree of tunnel damage.

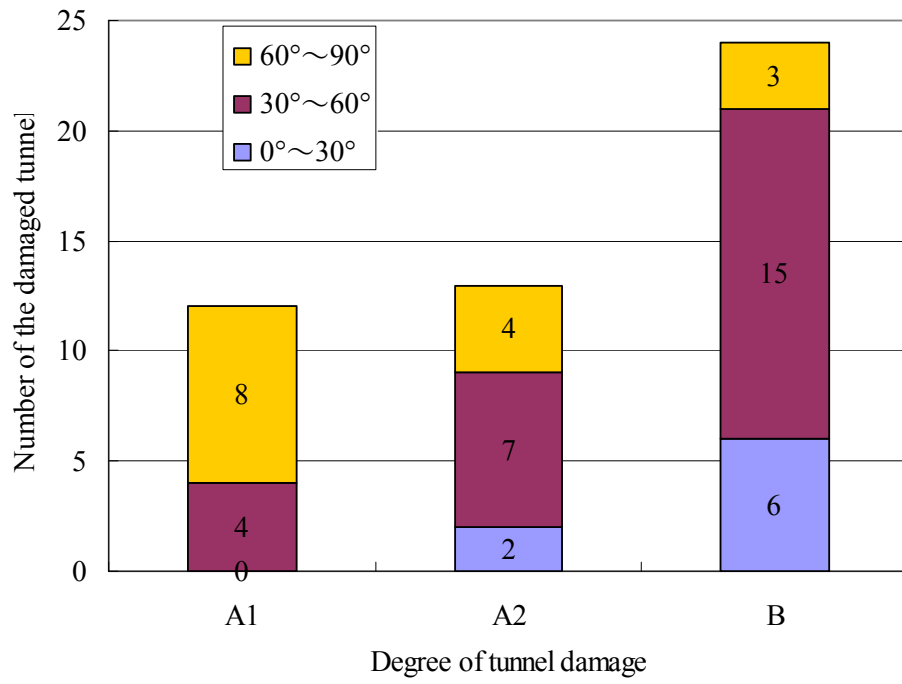
Figure 10 Influence of the angle between the presumed fault and the tunnel axes on tunnel damage

influencing factor. Figure10 shows the influence of the angle between the presumed fault and the tunnel axes on tunnel damage. Among 12 tunnels in the damage ranking A1, 8 damaged tunnels locate in the angle 60°~90°. Within the same distance to the epicenter, the damage degree of the tunnels which locate in the angle 60°~90° are greater than the tunnels in the angles 30°~60° and 0°~30°. For example, the angle between Uonuma Tunnel (No. 23 in Table 1 and Figure 9) axes and the presumed fault is about 60°~90°. This tunnel is seriously damaged and is observed as the damage ranking A1. The damage mechanism may be related to the direction of seismic wave propagation and should be further studied. The results show that the degree of tunnel damage is associated with the distance from the epicenter, the geological conditions, the completion time or the lining aging, the overburden cover, and the angle between the presumed fault and the tunnel axes.
