# Some Examples of Roof or Wall Planting Works and Temperature Measurement of Planted Vegetation

In this paper the authors presented some examples of roof or wall planting works in Nagasaki Prefecture and other places including Fukuoka City, and described the result of temperature measurement of vegetation used for roof or wall planting. As a result it was made clear that the temperature of vegetation was relatively low in comparison with those of other materials on roof and bare wall surface. This made us confirm that roof or wall planting may contribute to the reduction of heat radiated from the earth surface.

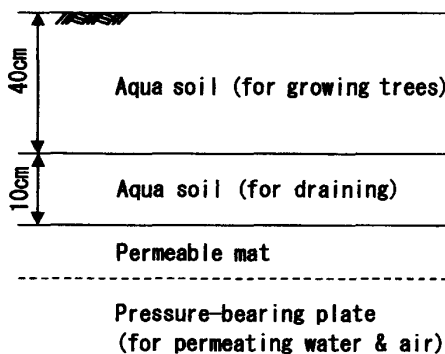
Soils on which trees are planted are light-weight soil named "aqua soil", the depth of which is 40 cm for growing trees and 10 cm for draining, respectively. Under these soils a permeable mat and a pressure-bearing plate for permeating water and air are embedded as shown in Figure 1 .

Figure 1 Construction of light-weight soil used for stepping garden of "ACROS Fukuoka"

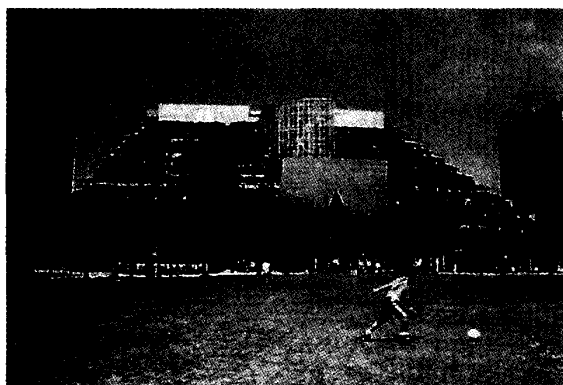
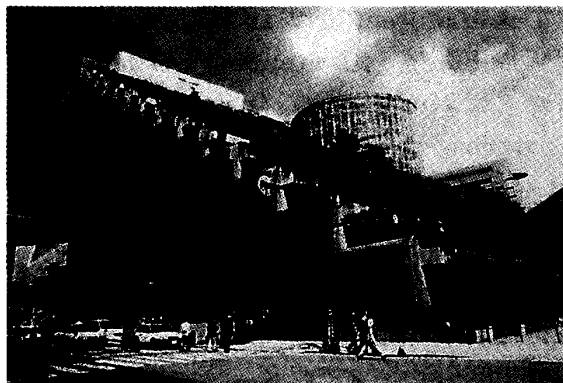
The “ACROS Fukuoka” has 14 floors on the ground, the roof of each floor which is planted a lot of trees as shown in Plate 1. Although having been of

(a) View showing trees planted on roof of each floor

(b) View showing stepping garden of building  
Plate 1 "ACROS Fukuoka" building with stepping garden planted trees

76 kinds at the establishment of this institution, the trees are of over 110 kinds at present because new kinds of trees were added to plant and tree seeds were brought by birds and others.

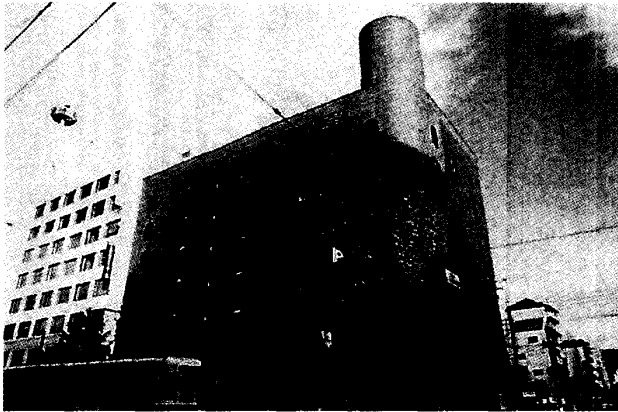
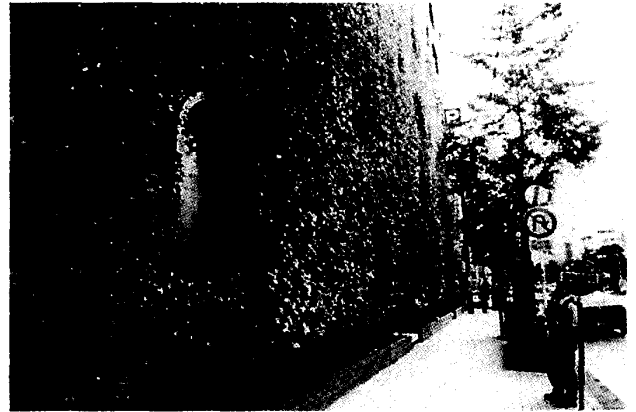
In Nagasaki City they have a parking building named "Nigiwaibashi Parking Center" with planted walls as shown in Plate 2.

(a) Panoramic view of building

(b) Wall covered with ivies

Plate 2 Parking building with planted walls in Nagasaki City

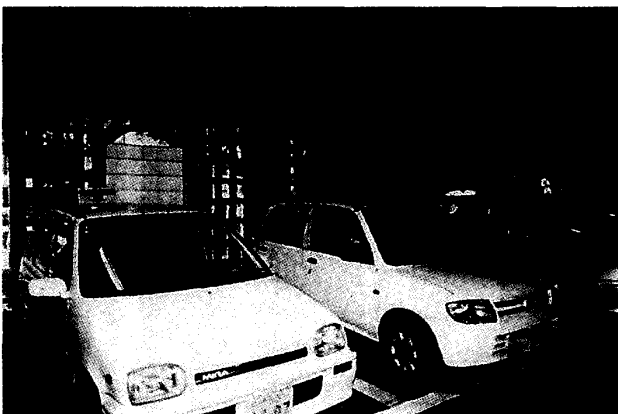
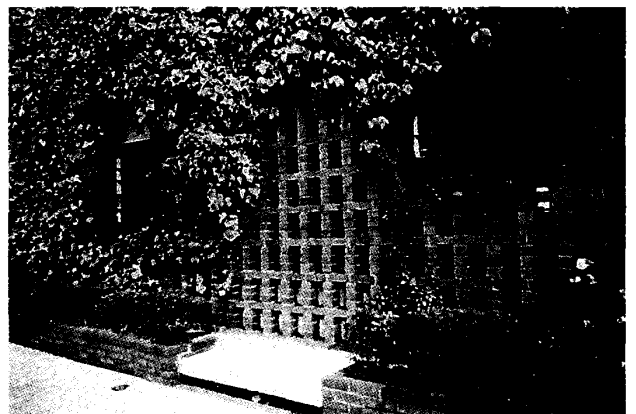
This building has 7 floors, the structure of which is steel-framed and covered with the exterior walls of latticed bricks. Plate 3 shows the frame work of the interior floor and latticed bricks of the exterior wall. The planting work was performed with ivies having roots in the earth soil surrounding the building as shown in Plate 4.

(a) Frame work of interior floor

(b) Latticed bricks of exterior wall

Plate 3 Inside and outside views of parking building

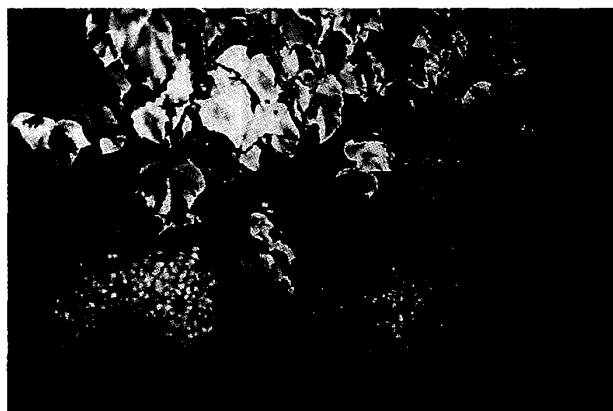
Plate 4 Ivies having roots in the earth soil surrounding building

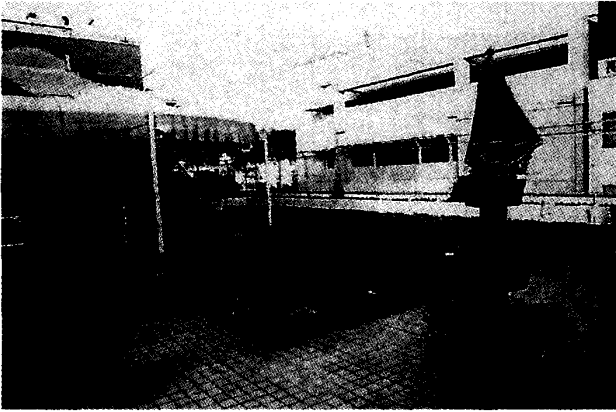
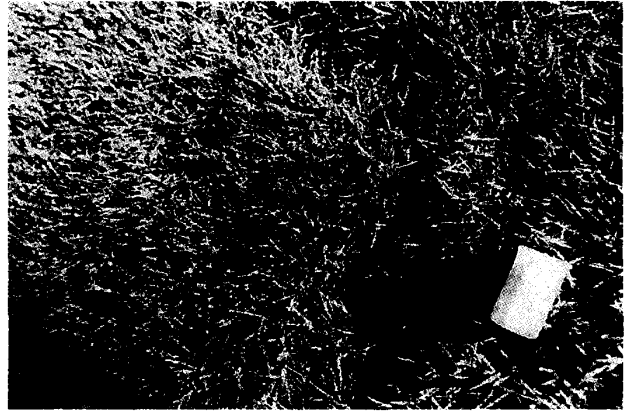
A roof planting work was performed at a department store located at the central part of Nagasaki City this September as shown in Plate 5.

(a) Panoramic view of planted roof

(b) Turf used for roof planting

Plate 5 Department store performed roof planting in Nagasaki City

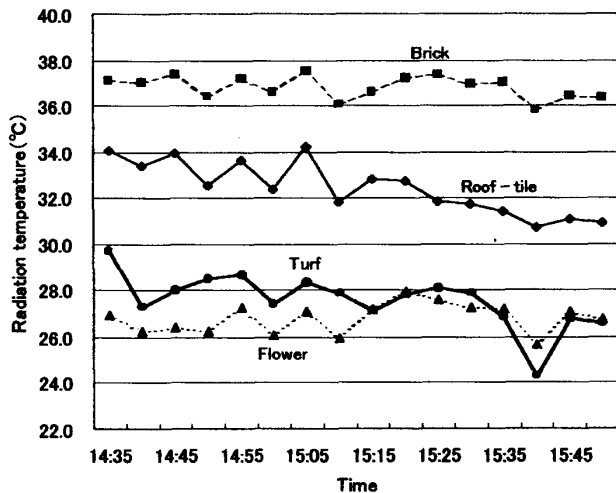
Plate 6 shows a thermal imagery obtained from the temperature measurement for the roof including turf, by which the average values of temperature are given in Figure 2. It is clarified that the radiation temperature of turf is the lowest among those of a variety of things on the roof.

Figure 2 Average value of radiation temperature of some materials on roof

- (3) A thermal imagery obtained for a department store with turf-planted roof clarified that the radiation temperature of turf was the lowest among those of a variety of materials on the roof. The temperature of concrete slab surface under the turf was also shown to be considerably low.

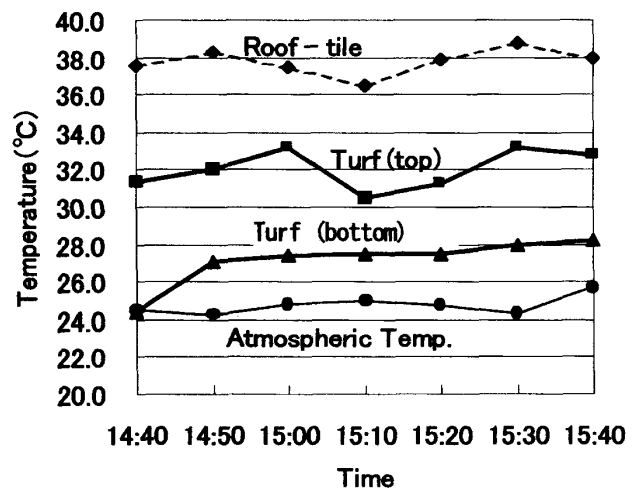
The temperature of concrete slab surface under the turf is made comparison with those of other materials on the roof and the atmosphere in Figure 3, from which the slab surface temperature under the turf is considerably low.

Figure 3 Comparison of temperature between concrete slab surface under turf and other materials

The results shown in Plate 6 and Figure 3 make us confirm that the heat reduction of the surrounding atmosphere and a building may be accomplished by planting vegetation on the roof of the building.

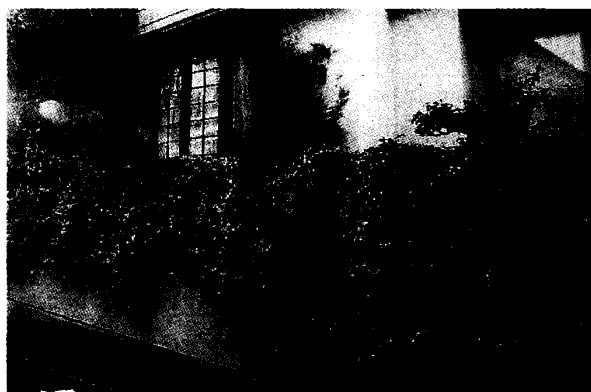
Plate 7 Exterior wall covered with ivies of private house in Fukuoka City

Plates 7 and 8 show the exterior wall covered with ivies and a handy thermometer used for the temperature measurement, respectively. This thermometer is attached with a styrol foam plate on the back so that is not problematic for the temperature measurement.

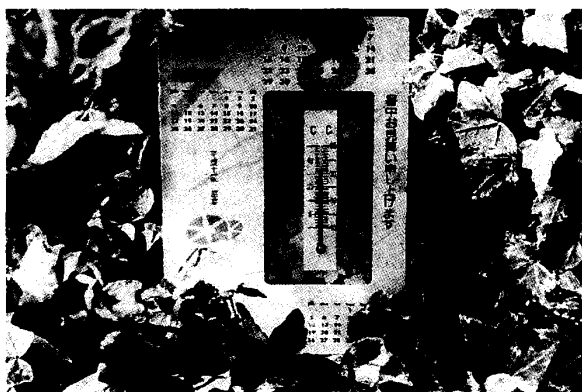
Plate 8 Handy thermometer used for temperature measurement

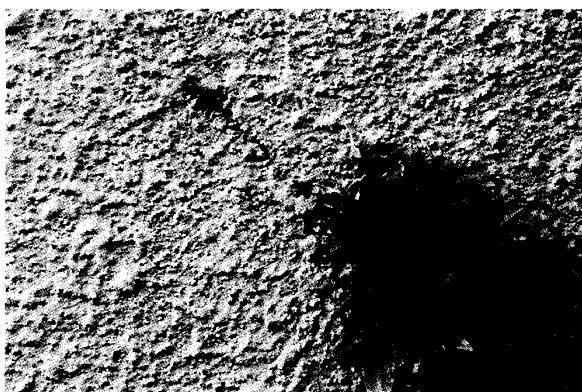
(a) View showing ivy crawl

(b) Trace of ivy taking roots on concrete wall

Plate 9 Ivies crawling on concrete wall

In addition the objected ivy may crawl on a concrete wall as shown in Plate 9 because its branch has small roots at some places as shown in Plate 10.

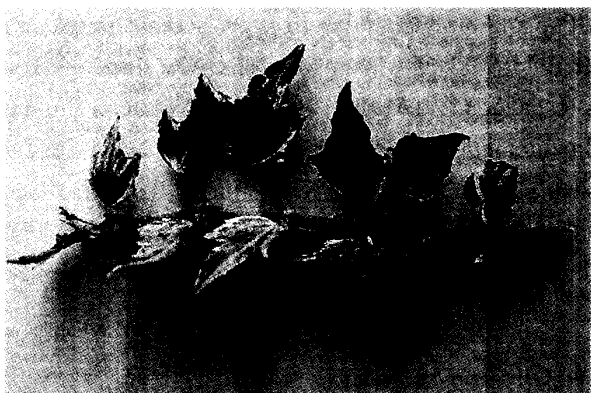
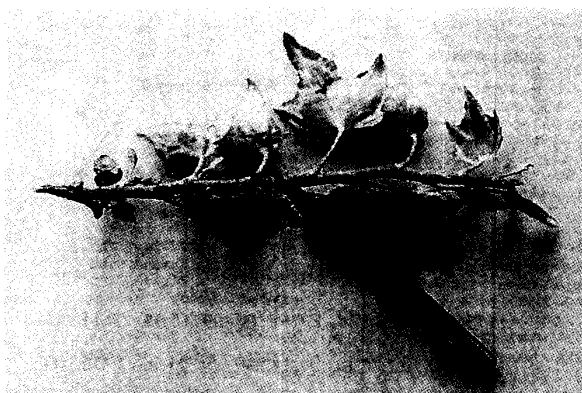
(a) Front side

(b) Reverse side with small roots at some places of branch

Plate 10 Leaves and branch of ivy

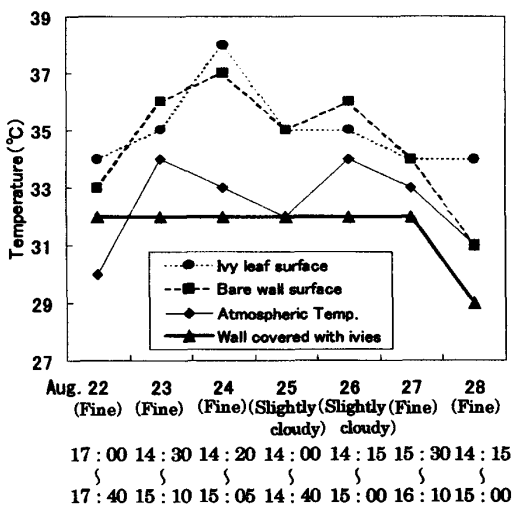
The result of temperature measurement is shown in Figure 4. As clearly seen from this figure the temperature of the wall covered with ivies is the lowest in comparison with those of the ivy leaf surface, the bare wall surface, and the atmosphere. This makes us confirm a wall covered with vegetation has such low temperature that may contribute to the reduction of heat radiated from the earth surface.

Figure 4 Comparison of temperature between wall covered with ivies and others

- (4) The temperature measurement carried out at a private house with ivy-planted exterior wall proved that the temperature of the wall covered with ivies was the lowest in comparison with those of the ivy leaf surface, the bare wall surface, and the atmosphere.
