## Post-fire behaviour of continuous reinforced concrete slabs under different fire conditions

Wang, Y, Jiang, Y, Huang, Z, Li, L, Huang, Y, Zhang, Y, Zhang, G, Zhang, X & Duan, Y 2021, 'Post-fire behaviour of continuous reinforced concrete slabs under different fire conditions', *Engineering Structures*, vol. 226, 111342. <https://doi.org/10.1016/j.engstruct.2020.111342>

# 1 **Post-fire behaviour of continuous reinforced concrete slabs under** 2 **different fire conditions**

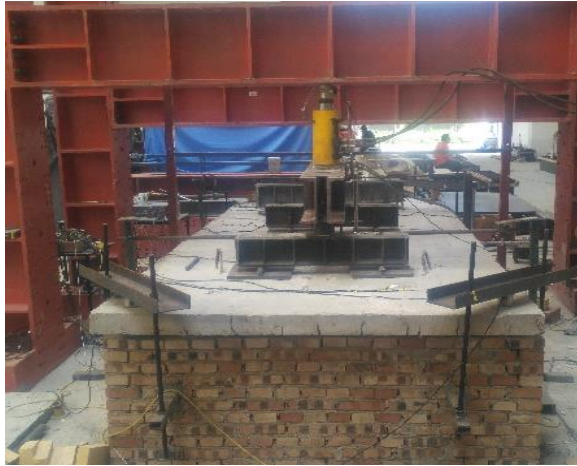
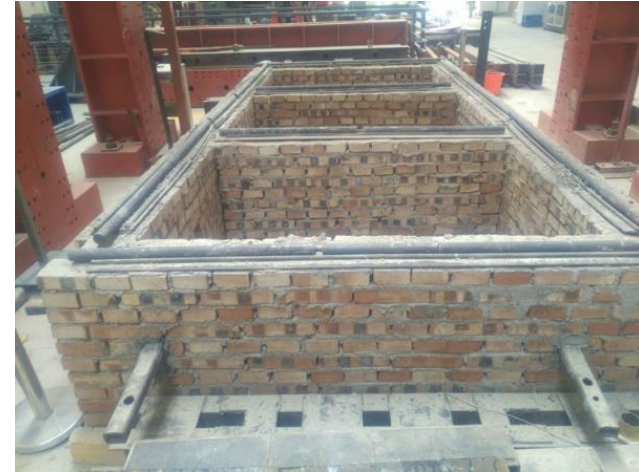
(a) Photograph of the test setup

(b) Photograph of the support

(c) Plan view

(d) Cross section 1-1

**Fig. 2.** Details of the test setup (all dimensions in mm): (a) Photograph of the test setup; (b) Photograph of the support; (c) Plan view of the test setup; (d) Cross section 1-1 of test setup

128 After the fire tests all four slabs were moved from the furnace and stored in the structural lab  
129 for approximately 3 months. Then the fire-damaged slabs were tested on the new test rig, as  
130 shown in Fig. 2. For the residual tests, the fire-damaged slabs were renamed as Slabs B1-PF  
131 to B4-PF for Slabs B1 to B4.

143 As indicated in Fig. 2(c), each corner of the slab was held down by a steel beam. The reaction  
144 forces at the corners were measured by four pressure transducers (Points P-1 to P-4). The  
145 failure of a slab was governed by: 1) conventional mid-span deflection failure criterion; 2)  
146 concrete crushing on the top surface; and 3) punching shear failure. Once any one of those  
147 failure conditions was reached, the test was terminated.

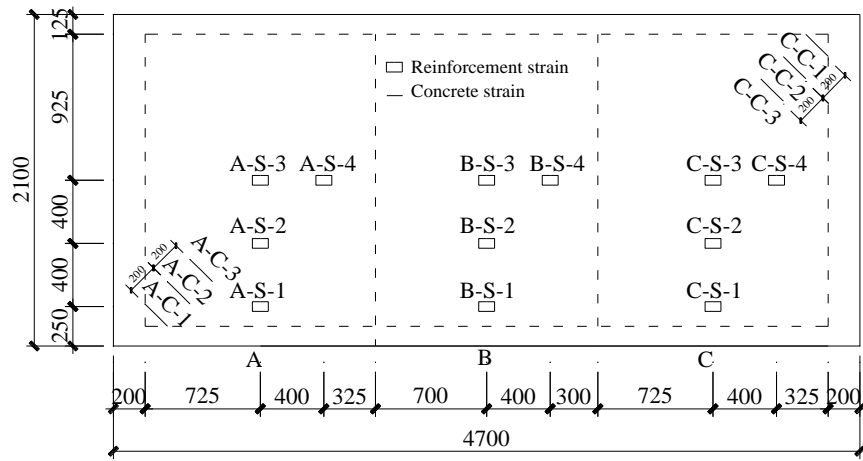
(a) Layout of reinforcement and concrete strain gages

(b) Layout of displacement transducers

**Fig. 3.** Details and instrument layout of four slabs (all dimensions in mm): (a) Layout of reinforcement and concrete strain gages; (b) Layout of displacement transducers.

149 Concrete strain gauges (such as Points A-C-1 and A-C-2) were placed on the top surface of  
150 the slabs, as shown in Fig. 3(a). To reduce the damage of the test slabs, only four bottom  
151 reinforcement strain gauges (such as Points A-S-1 to A-S-4) were arranged in each span of  
152 the slabs.

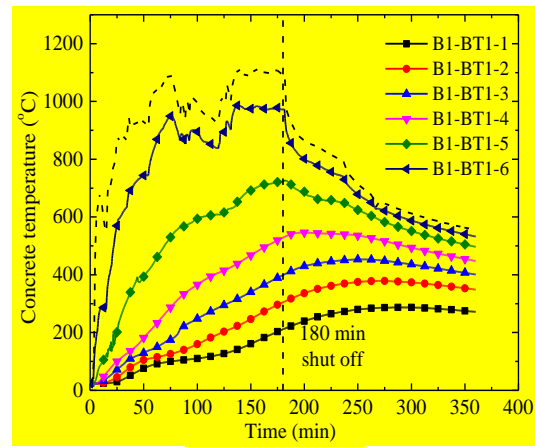
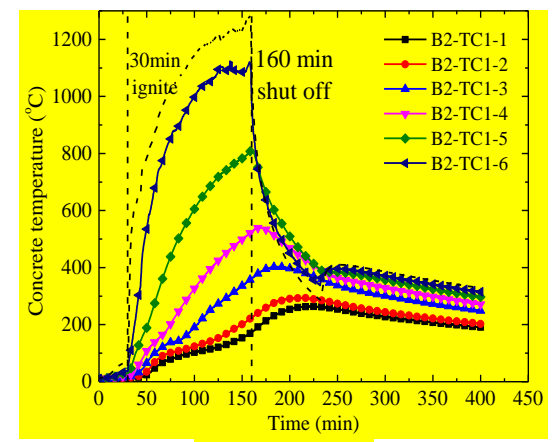
**Fig. 4.** Concrete temperature-time curves of the four slabs (the curves with broken line in the figure are the fire curves): (a) Slab B1; (b) Slab B2; (c) Slab B3; and (d) Slab B4

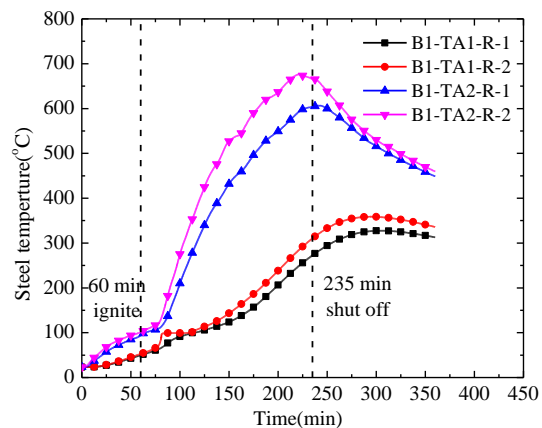
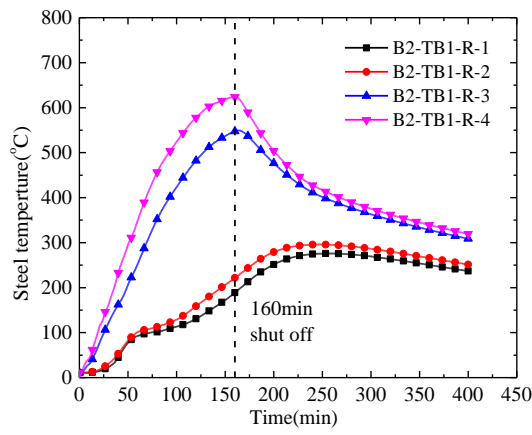
**Fig. 5** Temperature-time curves of the reinforcing steels for the four slabs: (a) Slab B1; (b) Slab B2; (c) Slab B3; and (d) Slab B4.

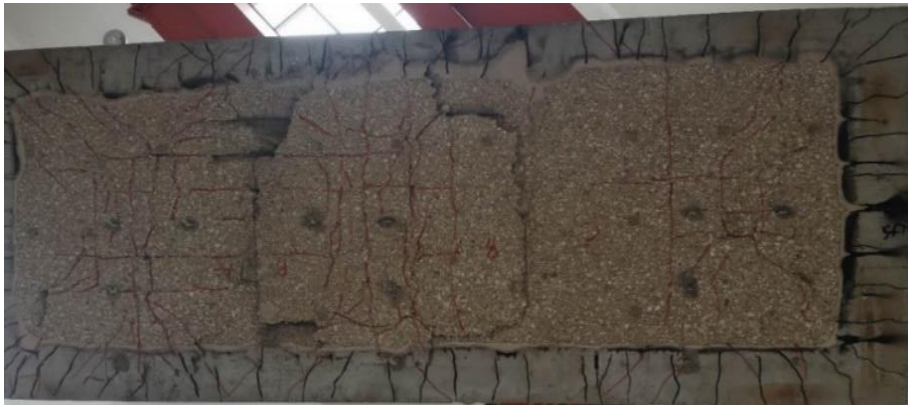
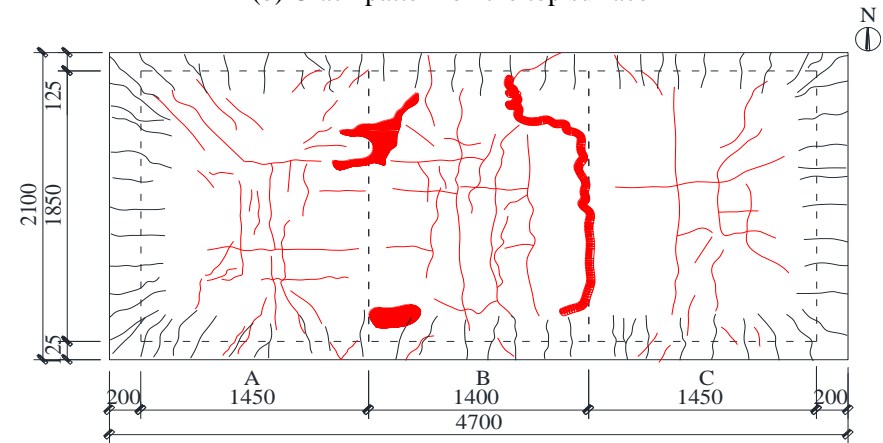
**Fig. 6** Failure modes of Slab B1-PF (all dimensions in mm): (a) Photograph of cracks on the top surface; (b) Crack pattern on the top surface; (c) Photograph of cracks on the bottom surface; and (d) Crack pattern on the bottom surface

200 Figs. 6(a) and (b) show the crack pattern on the top surface of slab B1-PF (steel spacing: 200  
201 mm). During the residual test, before the loading reached 120 kN, small new cracks appeared  
202 on the top surface, and the original cracks gradually widened with increasing loads. After 120  
203 kN, large new arc cracks appeared near the four corners of each span. Due to the higher strain  
204 on the concrete corners ( $2672 \mu\epsilon$ ), the concrete crushing occurred on the top surface of Span  
205 A. In addition, for Span B, one circular punching cone (red circle) formed in the middle region,  
206 indicating that the shear punching failure (shear-compression crush: a combination effect of  
207 both shear and compression forces) occurred in this span. However, for Span C, only arc  
208 cracks appeared on the top surface, and no brittle failure occurred.

209 Figs. 6(c) and (d) show the crack pattern on the bottom surface of Slab B1-PF. Clearly, there  
210 were two kinds of failure modes, i.e., the flexural failure mode (Spans A and C) and the  
211 overall punching failure mode (Span B). For Spans A and C, the flexural cracks extended  
212 from the centre to the edges, while the shear punching area appeared at the centre of Span B.  
213 The main reason is that there were numerous original cross cracks (+ shape) on the top surface  
214 of Span B, and fewer cross cracks appeared on the two edge spans. The original cross cracks  
215 appeared owing to the upward deflections (or negative moments) of Span B during the fire  
216 [27], and the crack spacing basically coincided with the steel spacing (200 mm) [16, 41].  
217 Clearly, these cracks led to a serious degradation of the structural integrity, decreased bond,  
218 and the stress (strain) concentration. For instance, as discussed later, the steel at three points

219 of Span B suddenly exceeded  $10000 \mu\epsilon$  at approximately 160 kN, indicating that a brittle  
220 failure and strain concentration occurred. The comparison implies that the original cracks that  
221 occurred during the fire test had important effects on the failure modes of the fire-damaged  
222 slabs.

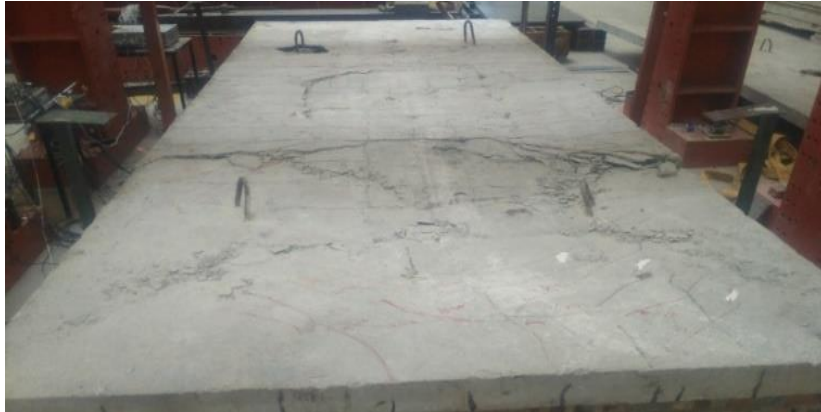
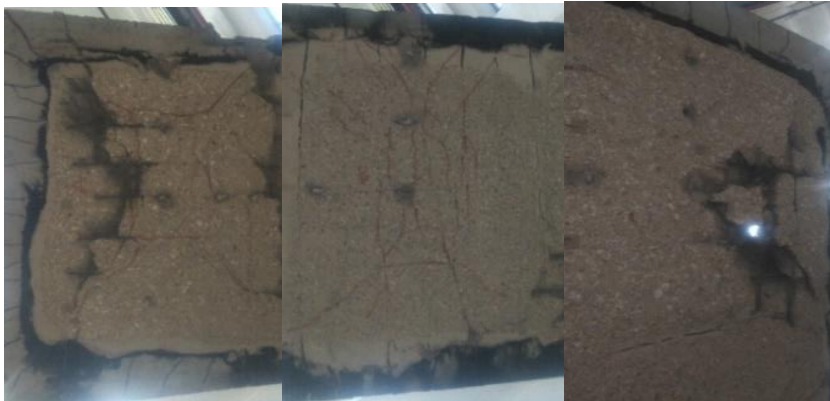
**Fig. 7** Failure modes of Slab B2-PF (all dimensions in mm): (a) Photograph of cracks on the top surface; (b) Crack pattern on the top surface; (c) Photograph of cracks on the bottom surface; and (d) Crack pattern on the bottom surface

224 Figs. 7(a) and (b) show the crack patterns on the top surface of Slab B2-PF (steel spacing:  
225 200 mm). During the residual test, before the loading reached 60 kN, many small arc cracks  
226 appeared on the top surface of Spans A and C. As the load increased, the arc cracks gradually  
227 widened. At approximately 210 kN, a punching shear failure of Span C occurred with one  
228 hole. Furthermore, the concrete crushing (maximum concrete strain: 3386  $\mu\epsilon$ ) on the top  
229 surface of Span A suddenly occurred as well as the steel yielding (reinforcement strain:  
230 exceeded 10000  $\mu\epsilon$ ), as discussed later. Thus, compared to Slab B1-PF, the structural stiffness  
231 of Slab B2-PF was larger, owing to the shorter fire duration and fewer original cross cracks  
232 (smaller fire time delay, i.e., 30 min). This observation also implies that the fire scenarios  
233 have important effects on the failure mode of the middle span in the fire-damaged slab, as

235 Figs. 7(c) and (d) show the crack pattern on the bottom surface of Slab B2-PF. Clearly,  
236 compared to Span B, serious flexural-punching shear failure occurred in Spans A and C due  
237 to higher experienced temperatures (see Table 1) and lower boundary restraint, particularly  
238 on Span C.

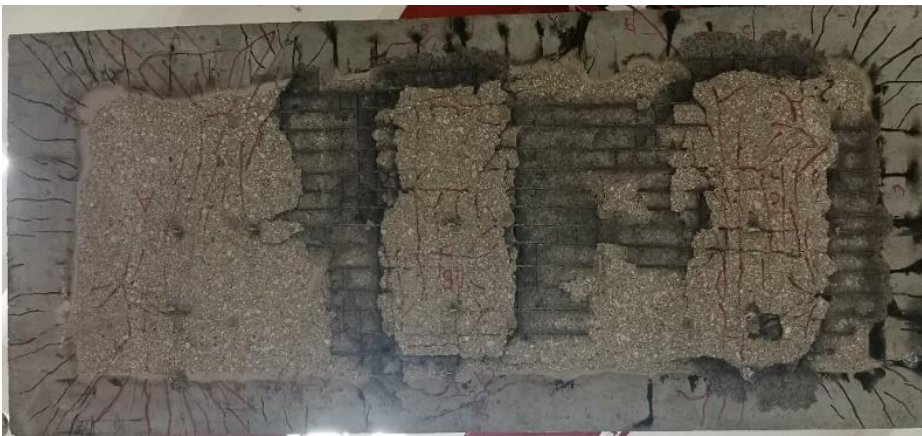
**Fig. 8** Failure modes of Slab B3-PF (all dimensions in mm): (a) Photograph of cracks on the top surface; (b) Crack pattern on the top surface; (c) Photograph of cracks on the bottom surface; and (d) Crack pattern on the bottom surface

246 Figs. 8(a) and (b) show the crack pattern on the top surface of Slab B3-PF (steel spacing: 100  
247 mm). Due to many small original cracks in Spans B and C, punching shear failure occurred  
248 with four holes on the top surface and smaller vertical deflections. These punching shear areas  
249 appeared around the loading plate on the top surface.

253 ratio led to more small and tiny original cracks [27], indicating that the bond between the  
254 concrete and steel was seriously compromised. In addition, owing to fewer original cracks in  
255 Span A, the flexural failure modes occurred, such as new corner and arc cracks. Thus, the  
256 failure mode indicated that the fire-damaged slabs with higher reinforcement ratios had a  
257 higher residual bearing capacity, but the punching shear failure easily occurred because of  
258 numerous small original cracks (negative moment). Compared to Slabs B1-PF and B2-PF,  
259 the original crack width on the top surface of Slab B3-PF was much smaller due to the smaller  
260 steel spacing (100 mm). The comparison indicates that the residual property of the steel has  
261 a large effect on the flexural carrying capacities; however, the residual property of the  
262 concrete, original crack patterns (particularly crack spacing), and load type (concentrated load)

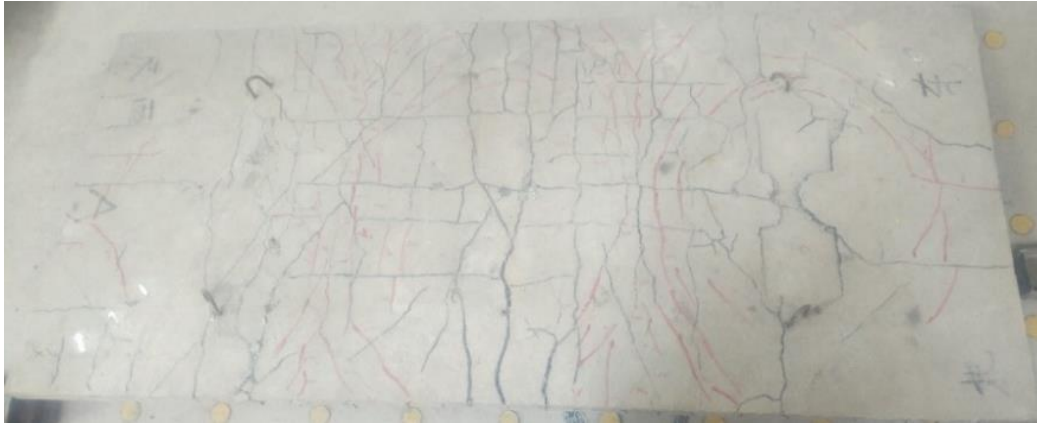
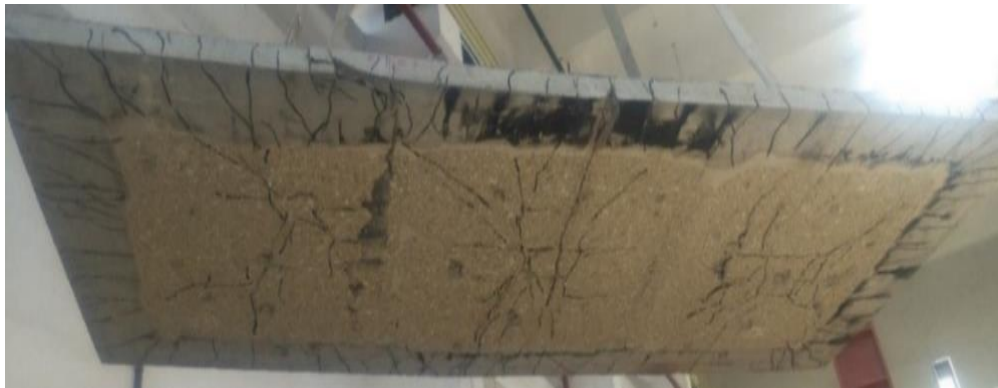
**Fig. 9** Failure modes of Slab B4-PF (all dimensions in mm): (a) Photograph of crack on the top surface; (b) Crack pattern on the top surface; (c) Photograph of cracks on the bottom surface; and (d) Crack pattern on the bottom surface

264 Figs. 9(a) and (b) show the crack pattern on the top surface of Slab B4-PF (steel spacing: 200  
265 mm). In contrast to the flexural failure (arc and flexural cracks) of Spans A and B, the  
266 punching shear failure of Span C occurred. In addition, like Slabs S1-PF and S2-PF, the  
267 bottom concrete in Slab B4-PF did not fall off, as shown in Figs. 9(c) and (d). However, due  
268 to the negative reinforcement layout, the bearing capacity (120 kN) of Slab B4-PF was the  
269 smallest. The comparison further indicates that the reinforcement ratio and reinforcement  
270 layout have a significant effect on the bearing capacity of the fire-damaged slabs. Hence, the  
271 beneficial or detrimental effects of the reinforcement ratio (layout) should be considered in  
272 the residual property judgement of post-fire continuous slabs.

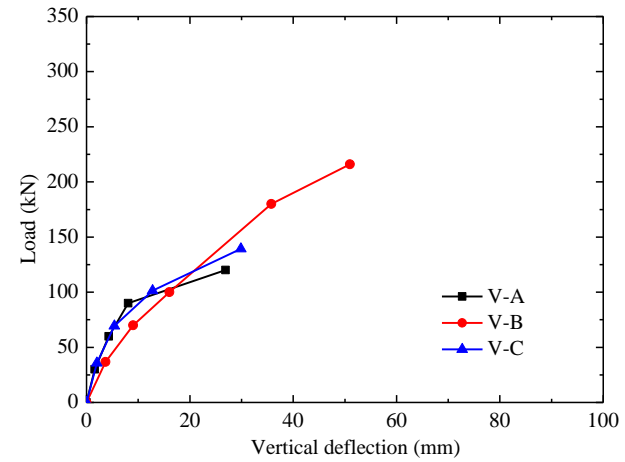
**Fig. 10** Vertical deflection-load curves of four slabs: (a) Slab B1-PF; (b) Slab B2-PF; (c) Slab B3-PF; and (d) Slab B4-PF

335 Figs. 10(a)–(d) show the load-deflection curves of the fire-damaged Slabs B1-PF to B4-PF.  
336 In addition, the initial residual structural stiffness ( $K_0$ ), the residual bearing capacities ( $P_u$ ),
