## Behavior of Overdeformed Shield Tunnel Lining under Grouting Treatment: Field Experiment

# Behavior of Over-Deformed Shield Tunnel Lining under Grouting Treatment: Field Experiment

Shield tunnel structures are commonly found to be over-deformed in Eastern China soft ground due to adjacent engineering activities. Grouting treatment could serve as a viable solution to reduce the excessive diametrical expansion of tunnel linings actively. However, understanding the grouting-induced effects on adjacent tunnel structures remains preliminary due to the scarcity of well-documented case histories. In this study, a field experiment was conducted to explore a shield metro tunnel's real performance during grouting treatments. An extensive monitoring scheme was deployed while varied geometrical grouting arrangements were carried out. The tests provided a comprehensive database of the tunnel responses in multiple temporal resolution levels, both during the entire course of the grouting treatment and within single grouting operations. Investigations are carried out over the influencing factors of the grouting efficiency. The experimental observations suggest that grouting efficiency tends t

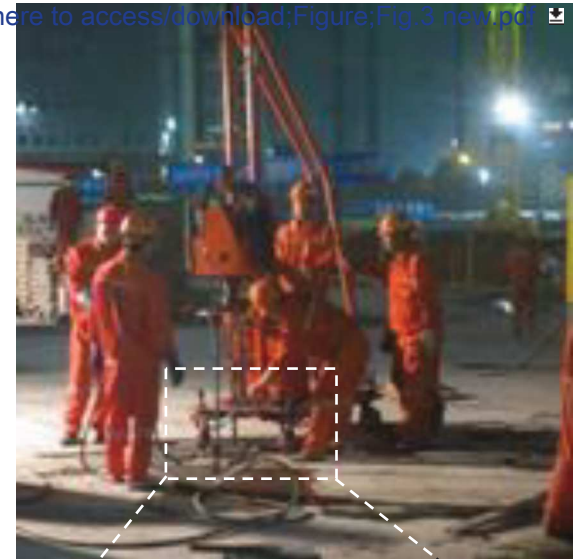
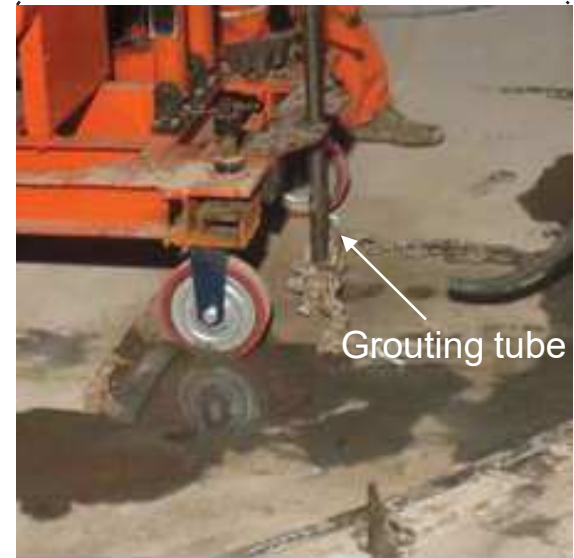
updated Fig.3

190 Fig. 3 illustrates the composition of the grouting system. The general idea was to extend grouting  
191 conductors from the ground surface to the designated grouting position in the vicinity of the tunnel to  
192 achieve grout injection. Before the grouting procedures, the tunnel's exact position was measured in  
193 terms of its burial depth and the exterior surface (extrados) coordinates. Afterward, holes were drilled  
194 from the ground to the bottom level of the tunnel lining extrados (hereafter referred to as the tunnel  
195 invert). Casing pipes of similar diameter with the drilled holes were subsequently placed in position  
196 inside the holes to prevent soil cave-in and facilitate an easier installation of grouting pipes. After this,  
197 a grouting pipe was pushed within the casing pipe to the depth where the lower end of the grouting pipe  
198 reached the tunnel's invert elevation. The key components of the grouting system were then assembled

Grouting operation at the site

199 to form an effective grouting injection system, which comprises of grouting pumps, flow meter,  
200 grouting mixer, and grouting pipes. After successfully installing the grouting injection system,  
201 preparation of the cement slurry and sodium silicate was conducted. The grouting operation was carried  
202 out utilizing two pumps simultaneously, each responsible for injecting cement (ordinary Portland  
203 cement 42.5) and sodium silicate (baume degree (°Be') 35). Initial setting time of the grout slurry  
204 affects both the grouting effect and the grouting operability. By changing the mixture ratio of the  
205 sodium silicate and Portland cement, the initial setting time of the grouting slurry can be flexibly

206 adjusted. Mixture ratios rendering optimum initial setting time were obtained via a series of laboratory  
207 testing, so that plugging of the injection pipe can be avoided and an intended diffusion radius of grout  
208 in soil can be reached. The water-cement ratio for the cement slurry was 0.6 to 0.7, and the volume  
209 ratio of about (2 to 3):1 was adopted when mixing the cement slurry and sodium silicate. These  
210 formulas generated grout slurry with an initial setting time around 10 minutes. Grouting pressure for  
211 the site was set around 0.5 MPa, which was constantly monitored by a grouting pressure gauge, and  
212 carefully controlled by experienced technicians to avoid pressure anomalies. The grouting flow rate  
213 was controlled between 14 to 16 L/min for the cement slurry, and 5 to 10 L/min for the sodium silicate,  
214 resulting in a 20 L/min total flow rate. The liquid flow rate was monitored in real-time by a flow meter.

215 The grouting procedure was established to achieve reduced disruption to the surrounding ground.  
216 During the grout injection, the grouting pipe was raised upwards steadily and slowly at a consistent  
217 pace by a pipe-lifting system. As such, the uniformity of grout spreading with respect to depth was  
218 ensured. At the beginning of the pipe-lifting process, the grouting nozzles at the end of the grouting  
219 pipe were automatically exposed to release grout when the front-end hat covering those nozzles was  
220 removed (see Fig. 3). The grouting pipe experienced continued lifting until the lower end of the casing  
221 pipe. It was kept still for around ten minutes so that the grouting material could experience initial  
222 setting. After the setting period, the grouting pipe was raised from the ground by the pipe lifting system  
223 to conclude the grouting procedure for one hole.

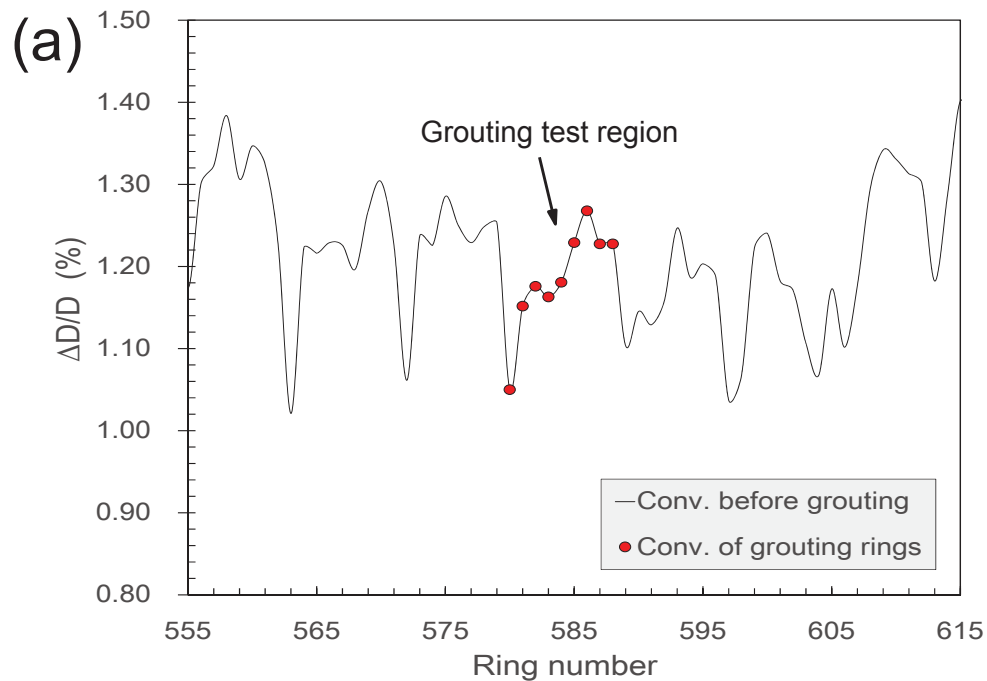
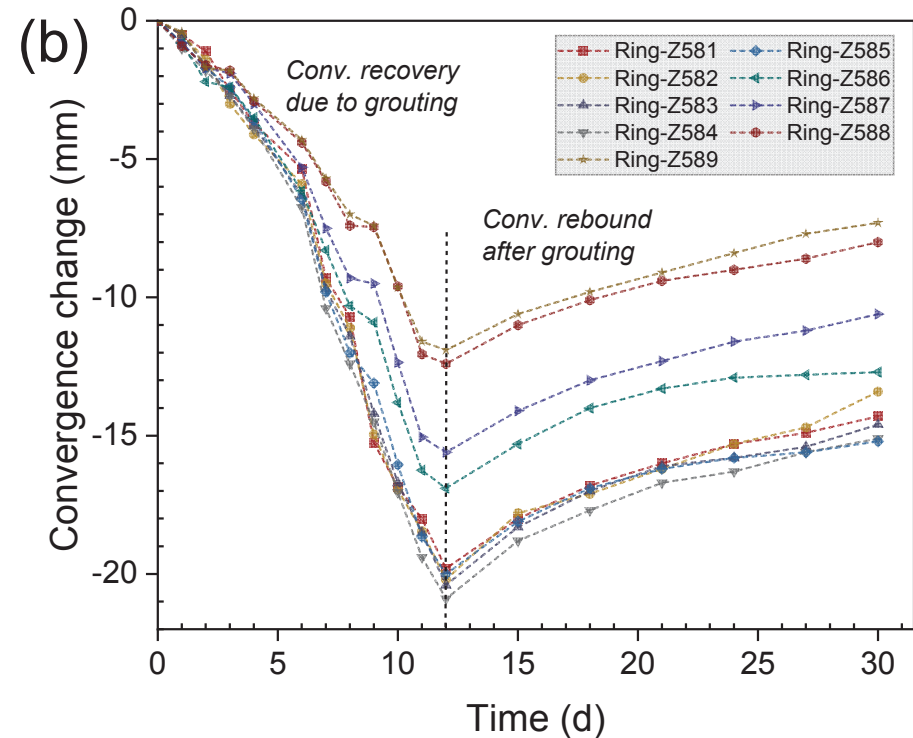
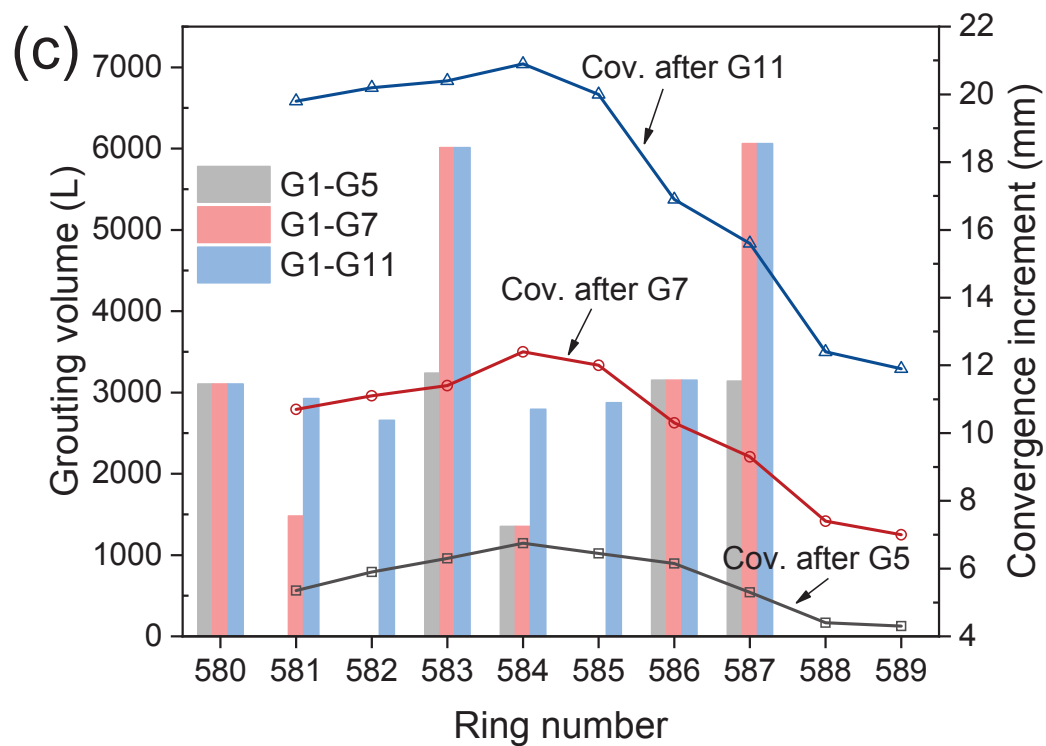
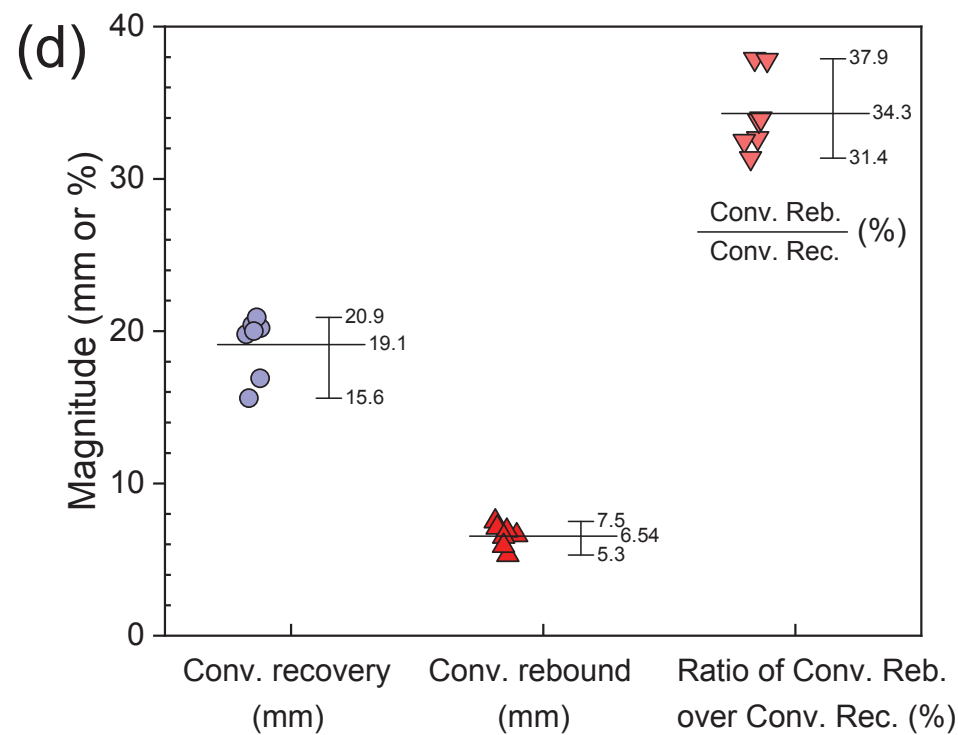
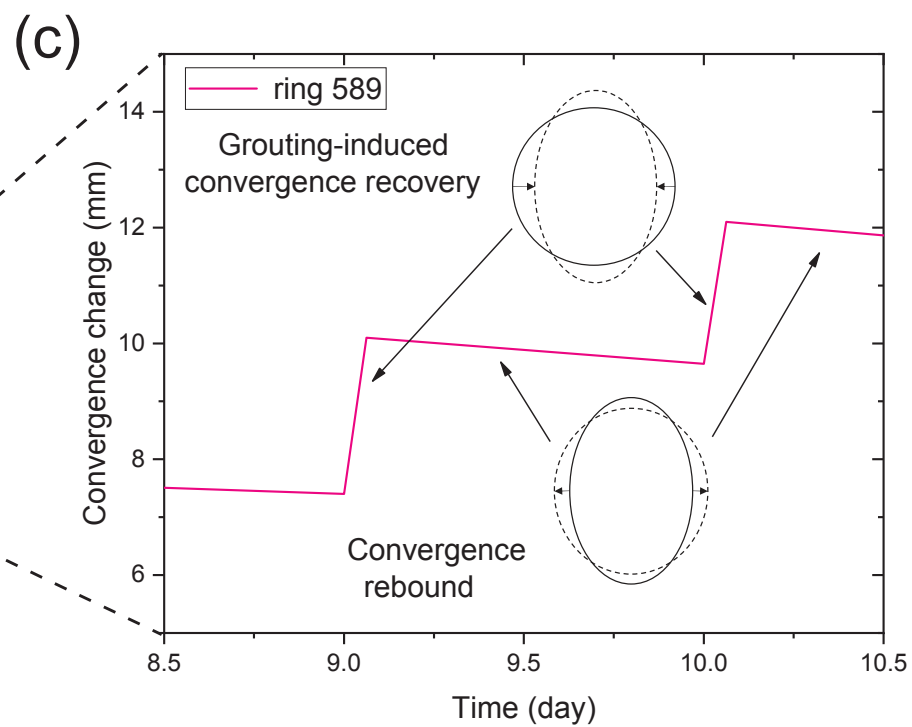
**(Fig.4)**

287 The convergence recovery and rebound values of all the rings directly under the grouting impact  
288 during the entire field experiment are illustrated in Fig. 4(d), where the maximum, minimum, and mean  
289 values for each item are also highlighted. Effects of grouting were proved to be remarkable and useful.

302 Fig. 4(c) depicts the spatial distribution of the cumulative grout volume injected and the  
303 corresponding total convergence recovery response observed at the termination of the selected grouting  
304 operations, showing that as more grout was injected and accumulated in the ground, the convergence  
305 recovery increased accordingly. It is noticeable that the cumulative grout volume distribution among  
306 different rings was substantially uneven for all selected cases. For example, after G11, for the majority  
307 of the testing rings, the grout injected was around 3000 liters. However, this amount was doubled for  
308 rings 583 and 587. Interestingly, the doubled grouting volume at ring 587 did not seem to result in a  
309 greater recovery response as one would normally anticipate. However, a large amount of grout at ring  
310 583 appeared to facilitate the recovery peak formation at ring 584. Similar effects can also be observed

290 Specifically, the average recovered convergence of the rings under testing right after the last grouting  
291 operation was reduced by 19.1 mm, about 25% of their average absolute convergence measured before  
292 the grouting treatment. Following the completion of the grouting treatment, the rebounding  
293 phenomenon led to an increment of the average convergence by 6.5 mm during 20 days. Thus a 12.6  
294 mm average net convergence recovery was measured for the tunnel rings under testing at the  
295 termination of the experiment. The convergence rebound may be subjected to the influence of various  
296 aspects such as soil permeability and grout properties. An in-depth study of these aspects is beyond the  
297 scope of this paper. However, it is worth noting that the ratios of the total rebound values over the  
298 recovery values for rings under testing fall into a relatively narrow range, with an average value of

299 34.3%, as shown in Fig. 4(d). This means, on average, about 65% of the recovered convergence was  
300 retained at the completion of the experiment. This observation suggests that the convergence rebound  
301 may be estimated in proportion to the convergence recovery response in the engineering practice.

311 for G5 and G7. These observations tend to suggest a less direct correlation between the grouting  
312 volume of individual rings and their convergence recovery values. However, the convergence recovery  
313 tends to be larger in the grouting zone center (rings 581 to 585) and much smaller around its rim (rings  
314 586 to 589), even if a more considerable amount of grout was injected (for example, in the case of ring  
315 587). Therefore, tunnel convergence response resembled the deflection curve of a beam under  
316 distributed pressure, where the most prominent displacement would usually occur around its middle  
317 portion, and the details of fluctuations in the pressure distribution would become less critical.

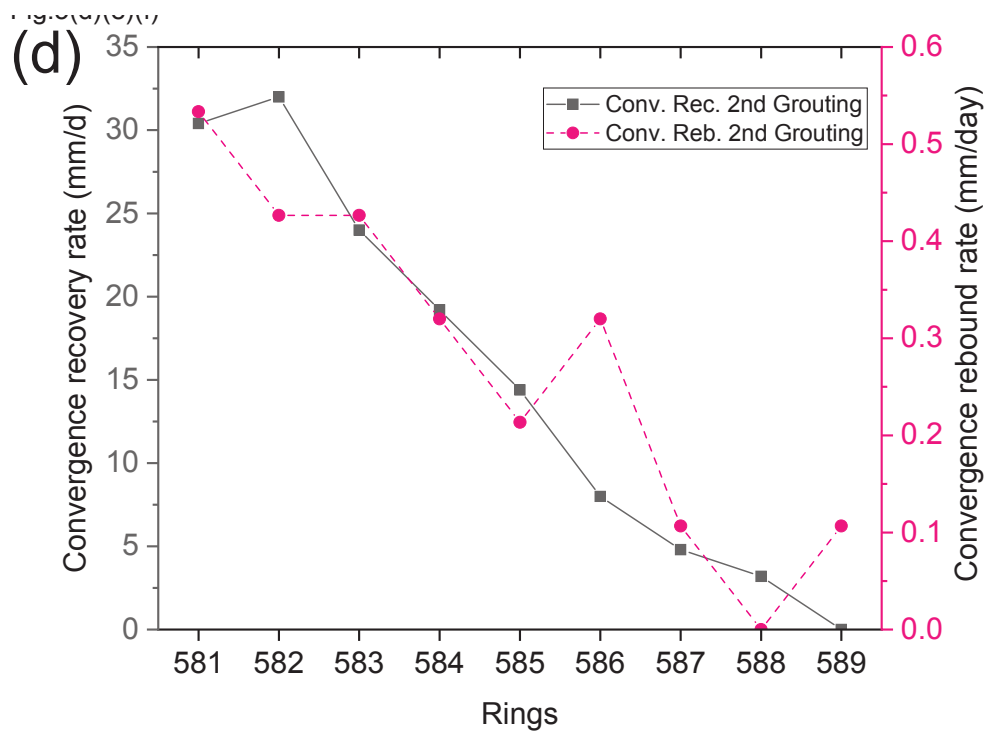
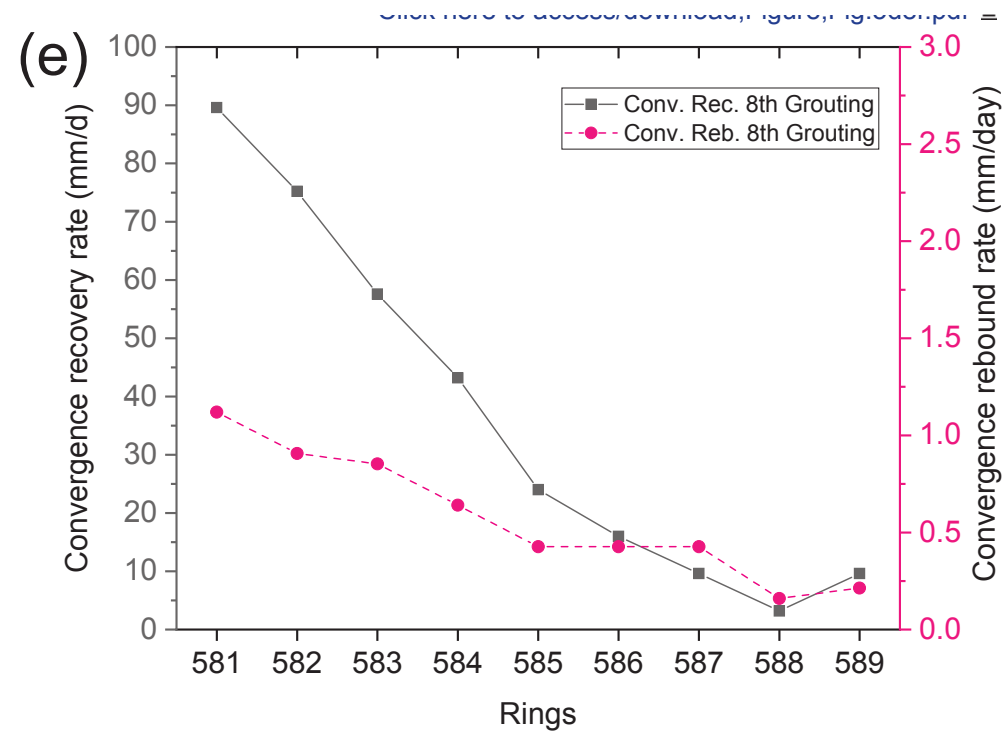
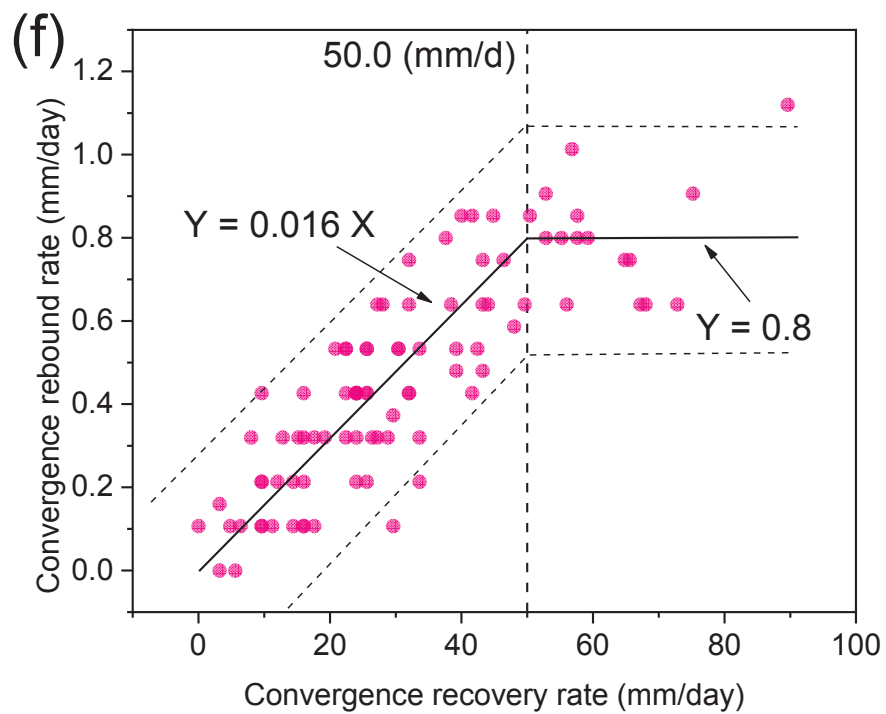
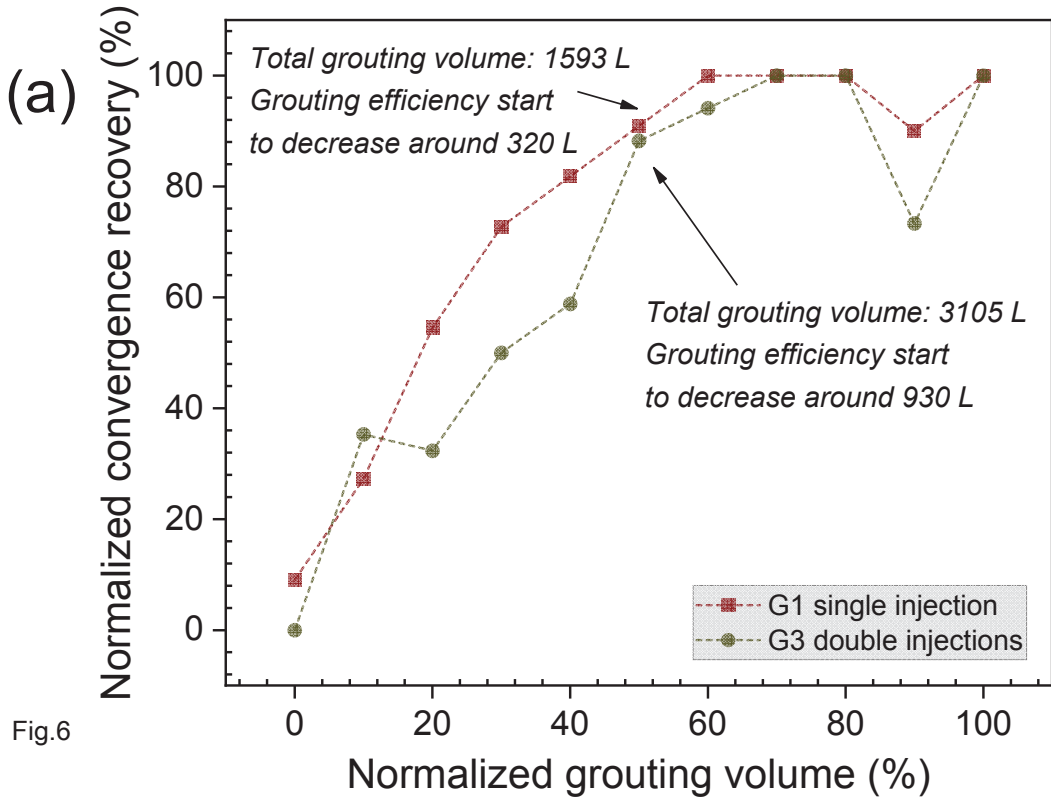
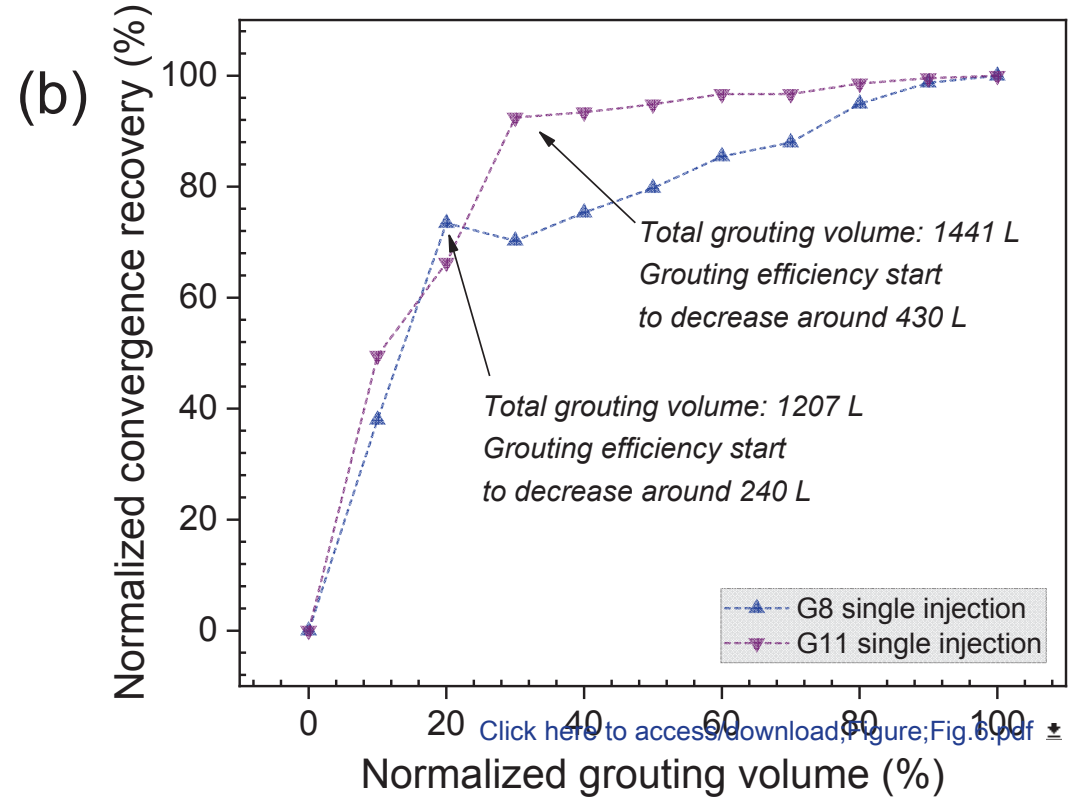
380 (Fig.5)

Fig. 5 demonstrates how the grouting-induced convergence recovery accumulates in time for all rings under testing during the grouting-treatment stage. Fig. 5(b) depicts the evolutionary histories of the relative convergence. The values shown are relative convergence comparing to the start of the grouting treatment. It is noticeable that those convergence time histories are featured in similar configurations, taking an upwards zig-zag recovery profiles. The evolutionary history curves also suggest that much larger transient tunnel convergence recoveries were achieved within a relatively short period of the grouting operations, which generally only lasted 2 to 3 hours a day around midnight. Afterward, a much longer and slower rebounding phase took over due to the absence of grouting activities, as indicated by the portion of the negative-sloped branches of the convergence recovery curves (Fig. 5(c)). Therefore, the convergence recovery accumulation behaviors in the grouting treatment are observed to resemble the inhale and exhale behavior of a person. This phenomenon is termed the 'breathing effect' in this paper. The net convergence accumulation over one round of grouting operation is the difference between the grouting-induced recovery and the reversal movement in the rebounding phase (Fig. 5(c)).

By separately presenting the effect of grouting and the subsequent rebound for each grouting operation in terms of convergence increments (recovery movement taken as negative), Fig. 5(a) demonstrates the temporal and spatial distribution of the convergence increment for all rings during the grouting treatment, with grouting rings highlighted for clearer observation of the correlation between the grouting location and the tunnel deformation response. The  $i^{\text{th}}$  grouting stage  $G_i$  spans over the initiation and the completion of the  $i^{\text{th}}$  grouting operation, while the  $i^{\text{th}}$  rebounding stage  $R_i$  starts right after the completion of  $G_i$  and terminates at the start of  $G_{i+1}$ . In total, 11 of these stage pairs exist according to the field testing record. The incremental convergences at each operational stage in Fig. 5(a) and Fig. 7 are the differential values between the corresponding stage's starting and ending values.

347 As indicated in Fig. 5(a), it is apparent that the spatial distribution of the grouting-induced  
348 convergence response relies on the spatial layout of the grouting injections. Although a clear  
349 correlation between the grouting arrangements and the induced tunnel deformational response remains  
350 to be further examined, a tendency becomes clear that the rings close to the grouting positions tend to  
351 experience a more prominent recovery effect. The columns in Fig. 5(a) that alternate in colors of red  
352 and blue indicate the existence of the 'breathing effect'. Meanwhile, the figure also suggests a specific  
353 correlation between the recovery and rebound effects of convergence variations: the more significant  
354 the convergence recovery, the more likely the tunnel will experience a more considerable subsequent  
355 rebound.

363 Fig. 5(d) and Fig. 5(e) display selected grouting operations for exemplifying the correlation of the  
364 convergence recovery rate and the rebound rate of all rings. As shown in Fig. 5(d), in the 2<sup>nd</sup> routing  
365 operation, the convergence recovery rate and subsequent rebound rate demonstrate relatively consistent  
366 distribution profiles over the testing rings. The phenomenon seems reasonable in that the tunnel  
367 experienced a relatively small magnitude of the convergence recovery rates during this grouting  
368 operation (over a range of 11.2 mm/day to 32.0 mm/day), and all data fall into the linear region  
369 categorized in Fig. 5(f). In the case of the 8<sup>th</sup> grouting operation, the rate of grouting-induced  
370 convergence recovery spanned a much broader range from 3.2 mm/day to 89.6 mm/day. The  
371 convergence recovery rate profile and the corresponding rebound rate experience a particular difficulty

377 The equation in Fig. 5(f) is arrived to approximate the correlation of the convergence recovery rate  
378 and rebound rate when convergence is smaller than 50 mm. The resulting equation could predict the  
379 rebounding behavior of the tunnel lining for sites of similar conditions.

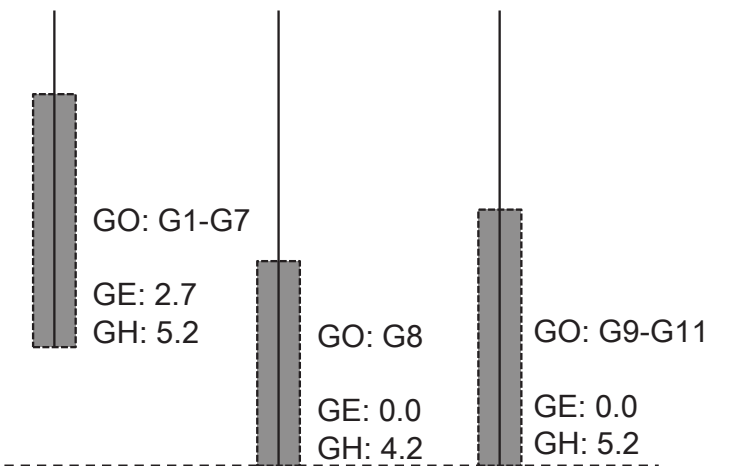
230 The grouting zone positions relative to the ground surface can be represented by two individual  
231 positioning parameters: the grouting elevation (GE) and the grouting height (GH), as demonstrated in  
232 Fig. 7. In this field experiment, various positioning parameters were adopted for different grouting  
233 operations to obtain a diverse range of testing cases to observe position-related sensitive effects.

Grouting elevation (GE) and routing height (GH) in different grouting operations (GO)

234 Fig. 7 summarizes the details of the grouting schedules and the corresponding positioning  
235 parameters from Oct 30, 2013, to Nov 10, 2013, for tunnel ring 580 to 599. Circles of three distinct  
236 colors represent the grouting position to the left line tunnel and the grouting status.

244 As for the grouting arrangement, the grouting elevations from  $G_1$  to  $G_7$  (Oct 30 to Nov 6) were 2.7  
245 m higher than the tunnel invert elevation, and the corresponding grouting heights were 5.2 m.  
246 However, starting from  $G_8$  (Nov 7), the grouting elevation was lowered to match the tunnel invert  
247 elevation. Besides, the grouting height was set to 4.2 m in  $G_8$  (Nov 7), creating a case with a shorter  
248 grouting zone.

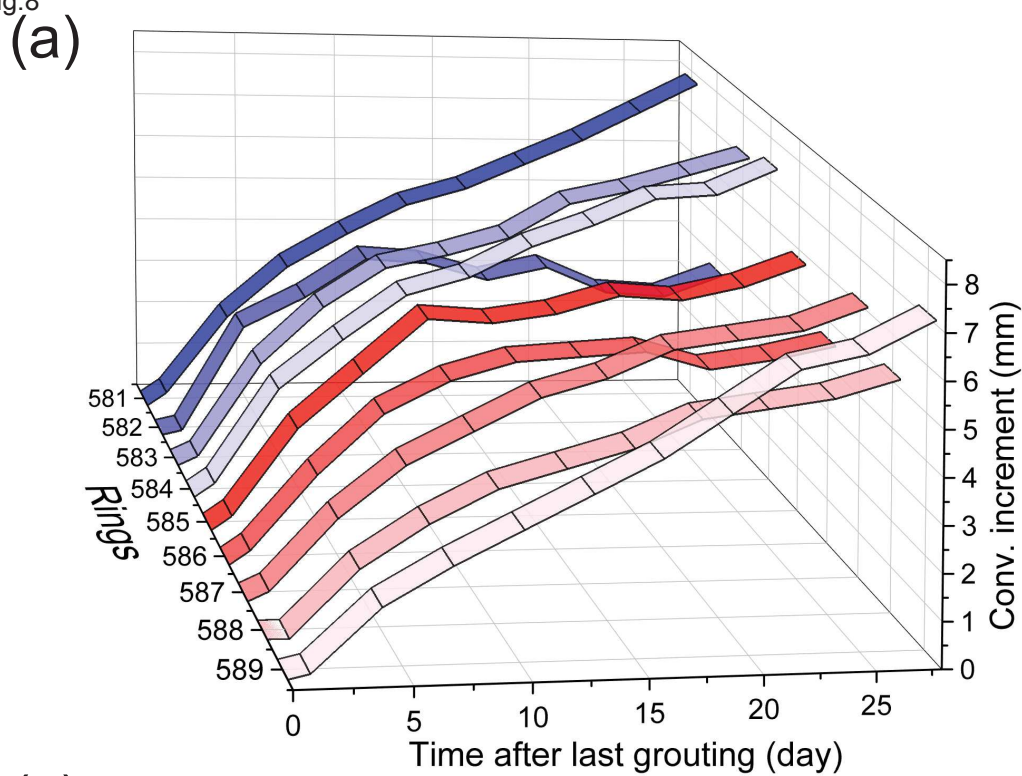
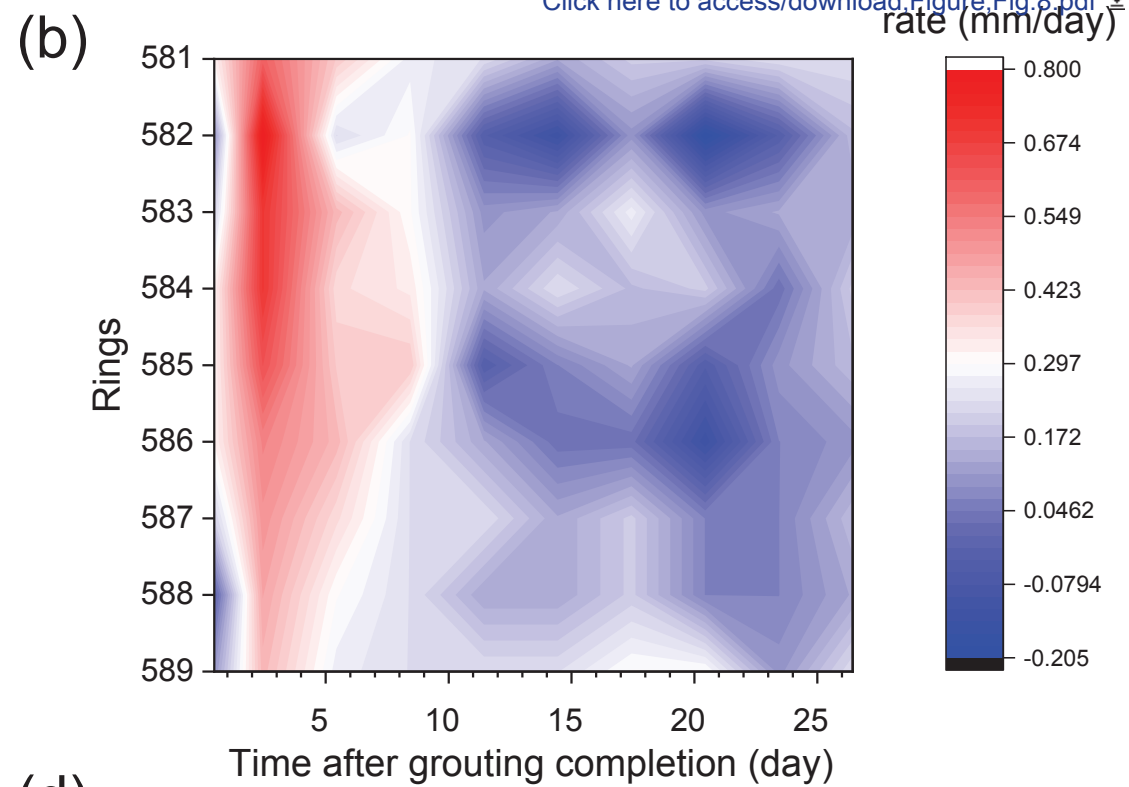
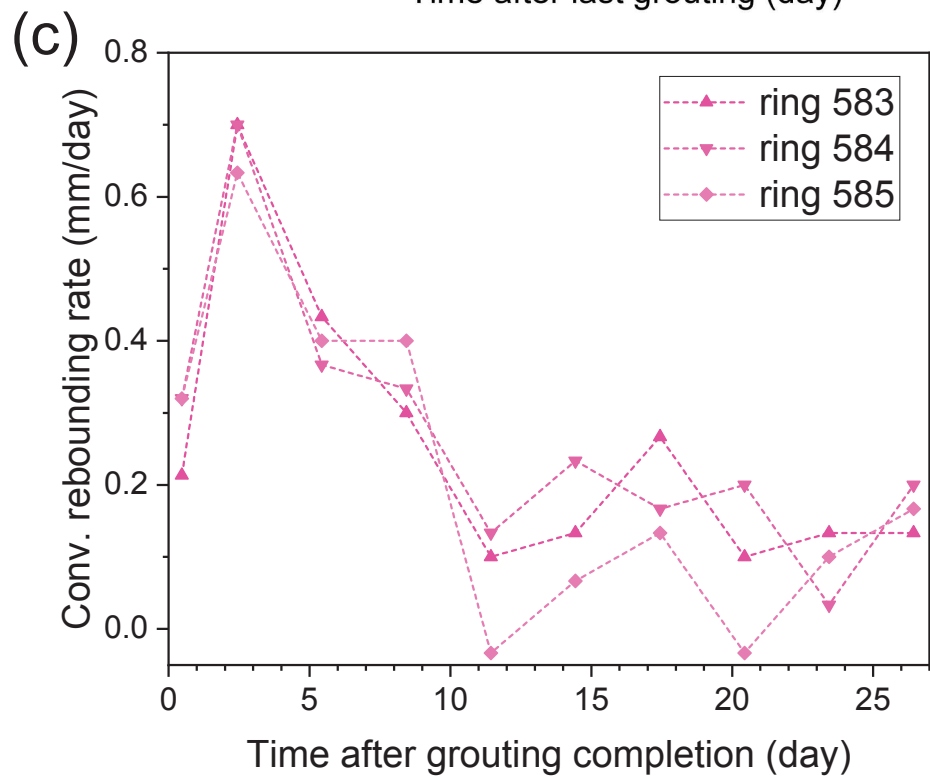
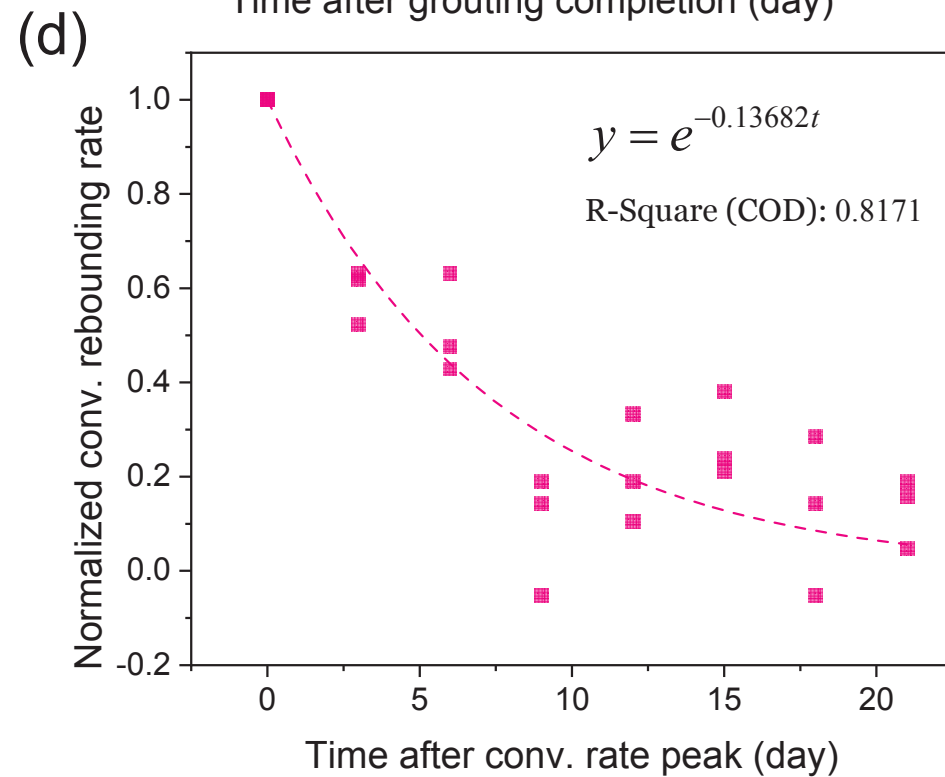
Fig.8

740 **Fig. 8.** (Color) Convergence rebound after the completion of grouting treatment: (a) convergence  
741 rebound time histories for all testing rings relative to the end of grouting treatment; (b) temporal and  
742 spatial distribution of the convergence rebounding rate; (c) the post-grouting-treatment convergence  
743 rebounding rate evolution near the grouting ring (ring 584); and (d) the exponential decay of the  
744 convergence rebound during the post-peak period for rings near the last grout injection in terms of  
745 normalized convergence rate (ring 583 to 585).

509 Fig. 8(a) depicts the rebounded convergence evolution for all rings under testing right after the  
510 completion of all grouting operations. Overall, these curves demonstrate a similar evolvement pattern  
511 where the convergence rebound tends to experience faster incremental rates at the early phase of the  
512 rebound, followed by a gradually decaying rate over time. The spatial and temporal distribution of the  
513 daily-averaged convergence rebounding rate is calculated and summarized in Fig. 8(b) based on the  
514 convergence data. Interestingly, the convergence rebounding rate of all rings only peaked at time 2.0 to  
515 2.5 days after completing the grouting treatment (peaking at 0.8 mm/day), before the decaying process.

518 The time history of the convergence rebounding rate after G11 for rings 583 to 585 is presented in  
519 Fig. 8(c), corresponding to the last grouting operation conducted at ring 584. Recordings of other rings  
520 are found to share a similar evolution pattern. It is noticeable that the initial rebounding rate,  
521 measured by the convergence change over the first 24 hours after grouting, was only about 0.3  
522 mm/day. This value experienced a speed-up on day two to reach about 0.7 mm/day. After this, it started  
523 to decrease. Although the convergence rate peaks vary in magnitudes among rings 583 to 585, a  
524 remarkably consistent evolutionary pattern can be uncovered of the convergence response during the  
525 post-grouting-treatment period when normalization was applied to the data using the respective peak  
526 values. Fig. 8(d) demonstrates the evolution of the normalized convergence rate of these rings during

527 the post-peak period. An exponential curve is found to fit the data best and adequately characterize the  
528 decaying process. A nonlinear curve fitting program is introduced to obtain the fitted equation  
529 employing the Marquardt-Levenburg algorithm (Press, et al., 1992). The relevant statistic parameters  
530 are also illustrated in the figure. The fit curve may be expressed by the following formula:
