Polymers

Article

Fretting Fatigue Performance of Unidirectional, Laminated Carbon Fibre Reinforced Polymer Straps at Elevated Service Temperature

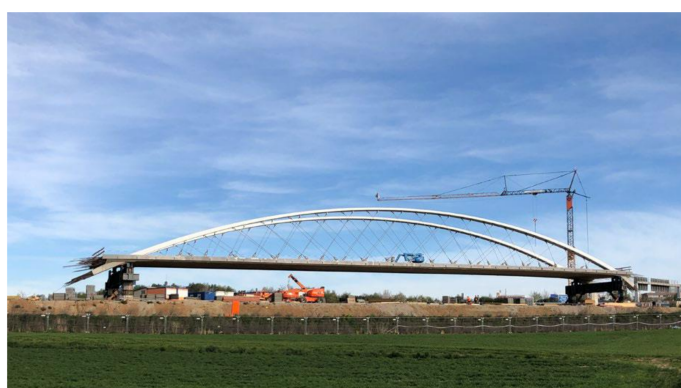
Figure 1. Network arch bridge with inclined CFRP cables [9], reproduced with permission by Prof. Urs Meier.

hangers, in this case, are pin-loaded laminated CFRP straps, wound around titanium eye connectors and connected to the bridge arch in a network-tied configuration. In addition to the well-known superior non-corroding nature and durability of CFRP, Meier et al. [9] have reported that—in this arrangement—the smaller cross-section and reduced self-weight of the CFRP hangers also resulted in beneficial dynamic characteristics guarding against wind-induced vibration. They also demonstrated significant cost savings and lower CO₂ emissions, in a life cycle assessment, when compared with conventional flat steel hangers.

Despite the fact that a small but significant number of structures relying on CFRP tensile elements have been realized to date, there remains a paucity of information on the laminated, pin-loaded CFRP straps used in the above case study, and particularly with respect to their fatigue performance when subjected to high (tensile) fatigue loads combined with a fretting process due to pin-loading at the straps' ends. In the absence of sufficient data and design guidance, the design of such structures must be based on single-case approvals by the responsible authorities, supported by bespoke full-scale testing of the innovative CFRP elements under investigation; a description of such a procedure for the hangers of a bridge is shown in Figure 1 and given in [9].

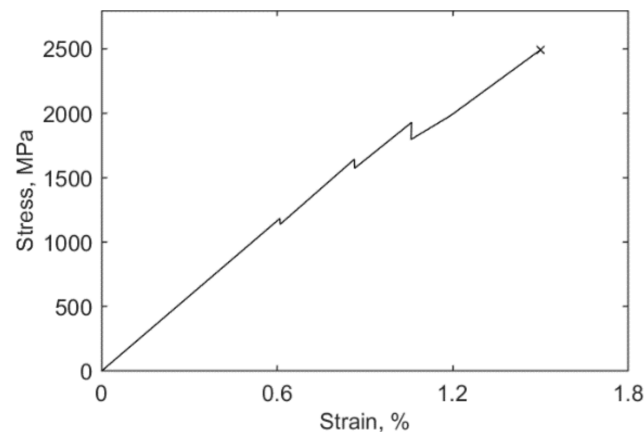
Figure 2. Typical stress vs. strain curve for a CFRP specimen.

Observations from static tension tests of conventional, laminated unidirectional (UD) CFRP specimens have shown that their first failure involves intralaminar crack formation in the matrix between the fibres, followed by propagation [11] starting at a so-called 'kink' in the strain versus strain diagram (Figure 2).

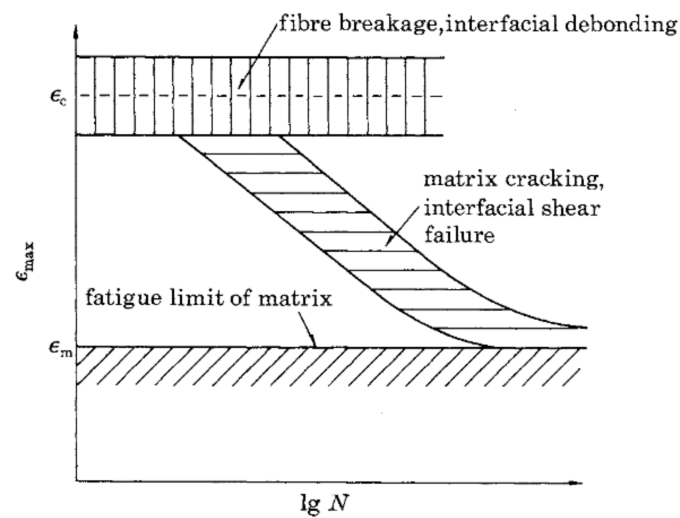
Figure 3. Maximum strain vs. logarithmic number of cycles to failure as presented in [20].

Three main regions are evident in Figure 3, each corresponding to one or more fatigue-damage mechanisms: fibre fracture/interfacial debonding (Region I), matrix cracking/interfacial shear failure (Region II), and the fatigue limit of the polymer matrix in which cracks are arrested (Region III). Each damage mechanism is schematically illustrated in Figure 4a–c. Similar fatigue failure mechanisms, and hence regions, are reported by Dharan in a study of glass fibre-reinforced composites [22].

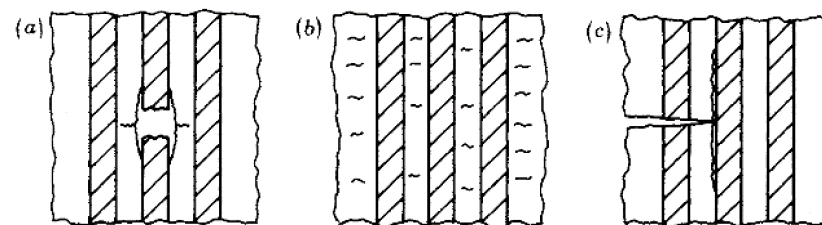
Figure 4. Fatigue damage mechanisms in UD composites under loading parallel to the fibre direction: (a) fibre breakage/interfacial debonding; (b) matrix cracking; (c) interfacial shear failure, as depicted in [20].

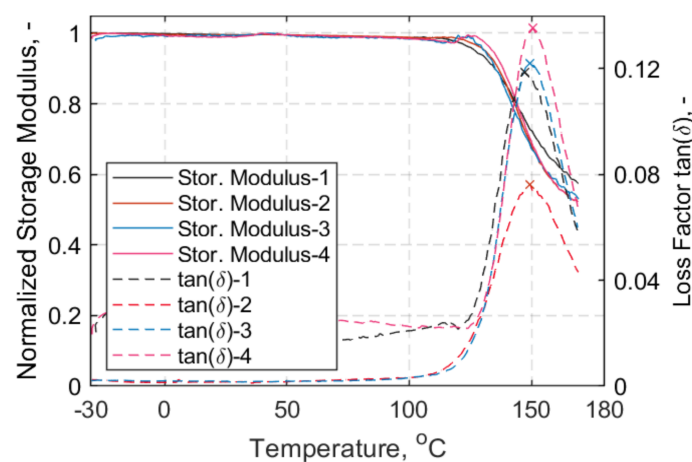
Figure 5. Normalized storage modulus vs. temperature (°C) (left); loss factor, $\tan\delta$ (right). All samples -3PB mode.

The glass transition temperature (T_g) was obtained through dynamic mechanical thermal analysis (DMTA). Four samples were analysed with DMTA using a three-point-bending (3PB) mode and imposed frequency $f = 10$ Hz with a thermal analyzer EPLEXOR 500 (Gabo Qualimeter GmbH, Ahlden/Aller, Germany). The temperature range for the DMTA tests was between -30 and 170 °C, with a heating rate of 2 °C/min. ‘Method B’, according to ISO standard 6721 [42], was followed to obtain the T_g values, in this case by taking the peak value of the loss factor, $\tan\delta$. In Figure 5, the DMTA traces are presented and the peak value of the loss factor for each sample is indicated with an “x”. It is noteworthy that the T_g onset, which is estimated by the intercept of the tangents below T_g , appears at slightly lower temperatures, between 130 and 140 °C. The average T_g value at peak $\tan\delta$ for the four DMTA traces was 149.2 ± 1.4 °C, which is in agreement with previous measurements in [43], and within the anticipated range of 140 °C, which is suggested in the datasheet of the hot melt epoxy used herein [38]. Thus, the behaviour of the straps is expected to be rather elastic, as indicated in Figure 5, where the storage modulus and $\tan\delta$ traces show that, at 60 °C, the viscous part of the material response is negligible.

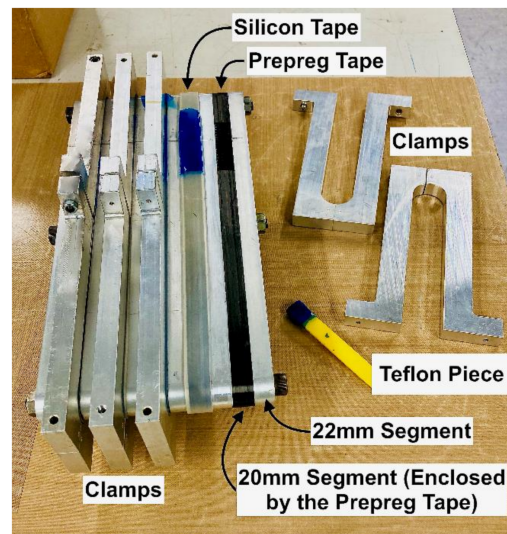
Figure 6. Mould, with features labelled.

The straps were manufactured by winding the continuous UD carbon prepreg tape around an aluminium mould that was then fully enclosed/co Mpacked by aluminium clamps. At the extremities of the carbon tape an additional $\pm 45^\circ$ carbon twill ply was placed to aid in preventing delamination of the start/end points of the straps. Between the prepreg tape and the clamps a silicon tape was placed to aid in the demoulding process. The main body of the mould consisted of two types of segments: one that was 20 mm in height and enclosed by the prepreg tape, and one that was 22 mm in height, providing lateral support. The segments were placed next to each other, alternately, beginning and ending with the taller one, and three M8 bolts (fasteners) kept the assembled segments together. The assembled mould, with its main components labelled, is shown in Figure 6.

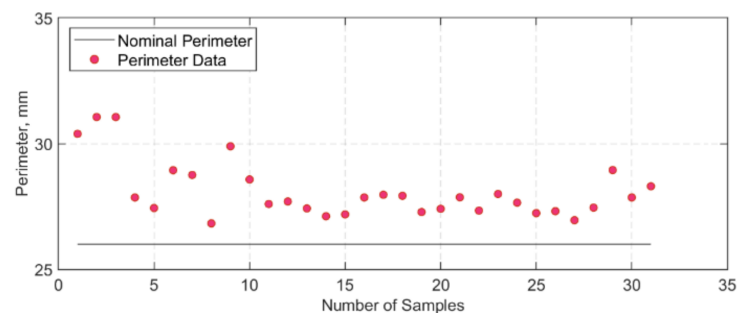
**Figure 8.** Perimeter values of each sample, after analysis in ImageJ.

The average area and perimeter values computed were 14.31 ± 1.21 mm² and 28.10 ± 1.13 mm, respectively. When compared with the nominal (ideal) area (12 mm²), it is evident that the computed area from the thirty samples is approximately 15% higher. Similar observations can be made for the perimeter (nominal perimeter: 26 mm). This is significant since cross-sectional variations could affect the geometric values later used in fatigue performance calculations. For instance, the wavy and uneven perimeter of the

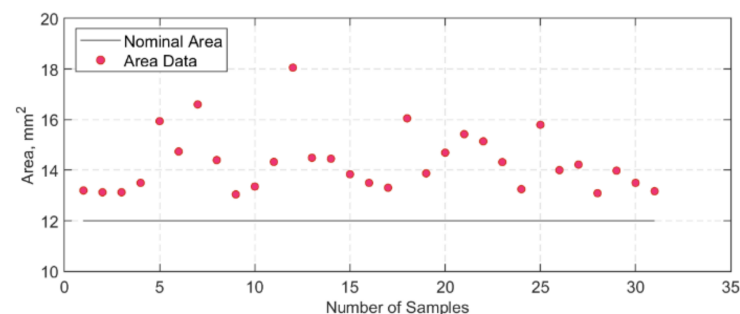
**Figure 9.** Area values of each sample, after analysis in ImageJ.

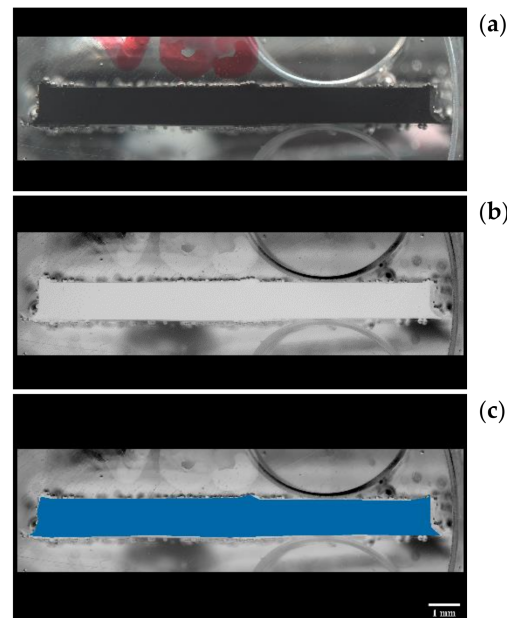
Figure 10. (a): initial image. (b): grayscale inverted image. (c): shaded RoI. Example of a cross-section of a strap used in our ImageJ analysis.

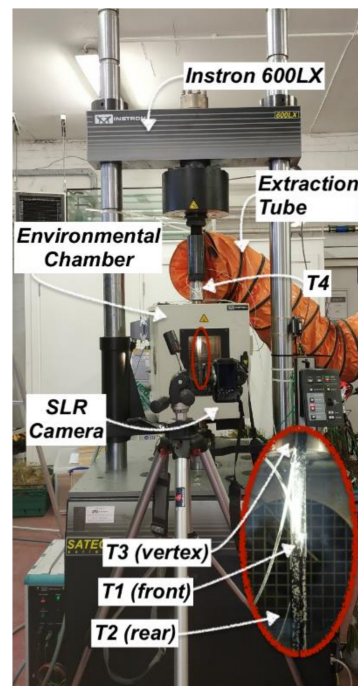
Figure 11. Test set-up for SS tests, with details of thermocouples' position in the chamber (bottom right).

Two main set-ups, and hence two different machines, were used in this work, as the elevated temperature static tests were performed at The University of Edinburgh (UK), while the fatigue tests at sustained temperatures—and subsequent post-fatigue tensile tests—were performed at E Mpa, Switzerland (refer to Figures 11 and 12). Regarding the elevated temperature static tests, an Instron 600LX hydraulic universal testing machine with an integrated environmental chamber was used (load capacity: 600kN, upper temperature limit of chamber: 600 °C). This is, however, not a fatigue-rated machine. During the steady state thermal (SS) tests, the strain and deformation fields (DIC RoI in Figure 11) of the straps were obtained using digital image correlation (DIC) analysis with a Canon EOS 600D camera and a remote trigger timer at a sampling rate of 0.3Hz. The DIC data were processed using Python and Matlab R2019b. Four type-K thermocouples were used to monitor the temperature development: three inside the environmental chamber and one outside. Thermocouples 1 and 2 were placed at the central region of the front and rear (closest to heating elements) shaft length of the strap, respectively, while Thermocouple 3 was located at the vertex area of the strap. Thermocouple 4 was placed on the top pull rod outside the environmental chamber. The test set-up is presented in Figure 11 and is the same as the one used in [43]. The steady state thermal (SS) experiments involved two target temperatures, namely 24 (ambient) and 60 °C. The choice of 60 °C as a target temperature was based on the sustained service temperature at which the tension–tension fatigue tests were performed. In the SS tests, the straps were loaded and kept at a constant tensile load of 0.5kN under load hold mode, until the target temperature was reached. They remained for 10 min more at the allocated temperature to ensure even temperature distribution in the strap. Subsequently, the hold mode was changed to displacement control mode and the straps were loaded until failure, with a displacement rate of 2 mm/min. Five tests per target temperature (24 and 60 °C) were performed.

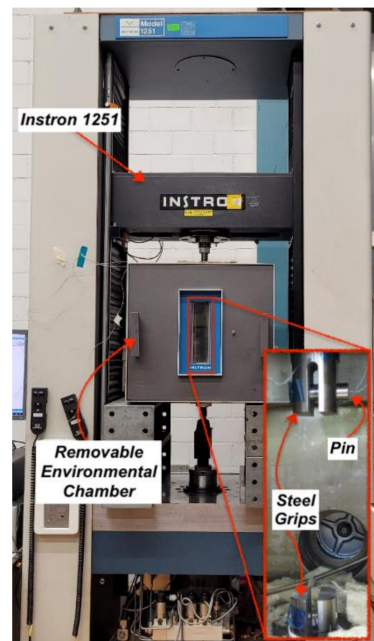
Figure 12. Test set-up for fatigue tests at service temperature (60 °C).

The fatigue tests at elevated service temperature (60 °C) were performed using an Instron 1251 (load capacity: 250 kN) machine with a removable Instron (upper limit temperature: 300 °C) environmental chamber under load control mode, as seen in Figure 12. A frequency $f = 10$ Hz and a load ratio $R = 0.1$ were used in all tests. In addition, two type-K thermocouples were used to monitor the temperature progression: one located at the apex of the strap and one inserted in the centre of the pin, which was previously drilled (1 mm hole) to accommodate the thermocouple. In all fatigue tests, the straps were loaded on titanium pins, which were then placed in the pull rods inside the environmental chamber (refer to Figure 12). Prior to fatigue testing, the temperature inside the oven would first

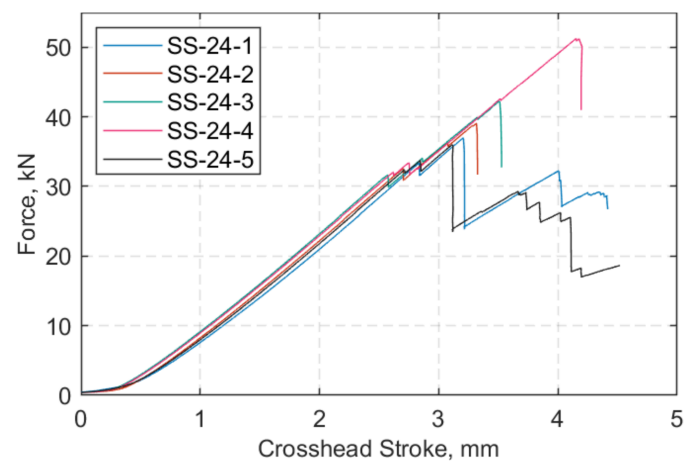
Figure 13. Force (kN) vs. crosshead stroke (mm) at 24 °C.

At both target temperatures of 24 and 60 °C, five tests were performed. The axial force versus crosshead displacement is shown in Figures 13 and 14 at 24 °C and 60 °C, respectively. The hold mode at 0.5 kN is excluded in Figure 14. At both temperatures, there was initially delamination of the outer ply of the inner side of the straps at approximately 30–34 kN, which appears as the first ‘step’ in the figures below. The straps then, as the load was increased, exhibited increasing fibre breakages, with the final failure being sudden and explosive in nature.

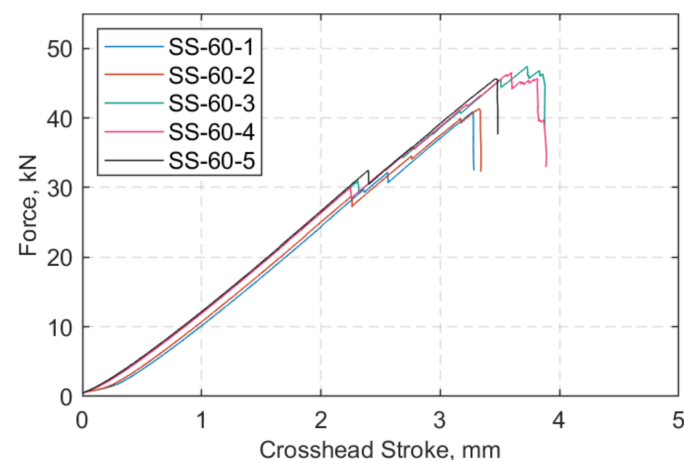
Figure 14. Force (kN) vs. crosshead stroke (mm) at 60 °C.

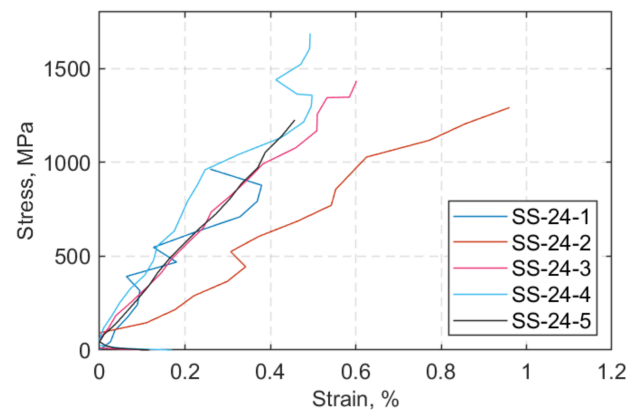
Figure 15. Stress (Mpa) vs. strain (%) at 24 °C.

The stress-versus-strain responses of the straps at 24 °C and 60 °C are shown in Figures 15 and 16, respectively. In all the SS tests, the specimen-naming notation designates SS as steady state thermal test, 24 or 60 as the target temperature, and 1 . . . 5 indicates the

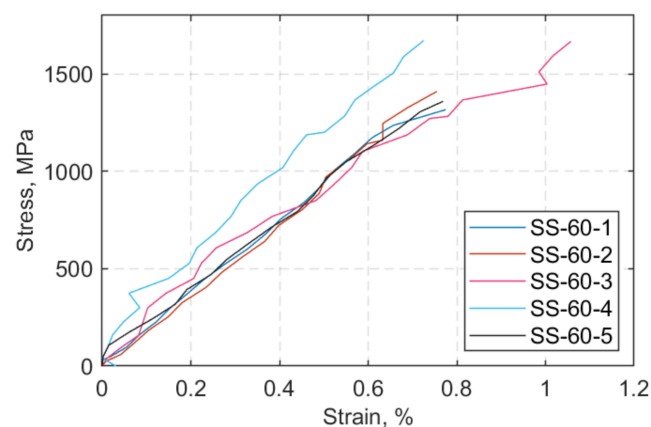
Figure 16. Stress (Mpa) vs. strain (%) at 60 °C.

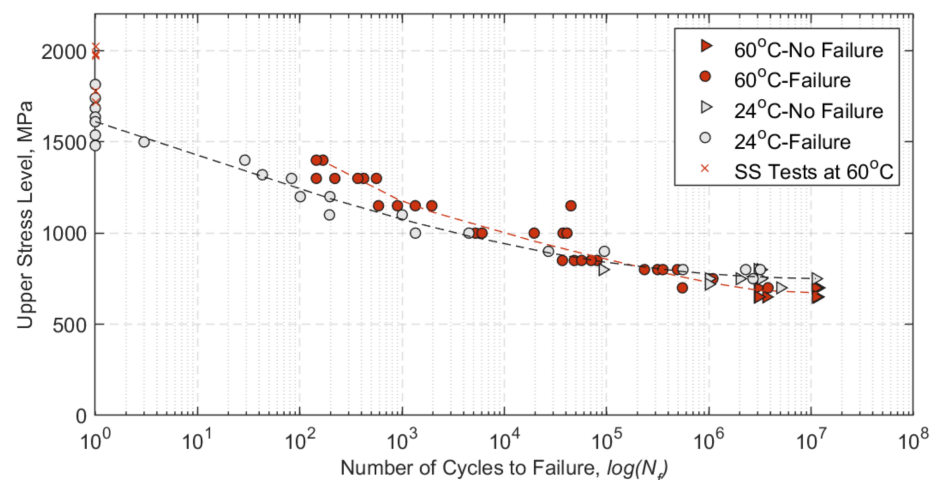
Figure 17. S–N curves with logarithmic best-fit ($R^2 = 0.93$) at 60 °C and at 24 °C (reproduced with permission from [28]). UTS values from SS tests at 60 °C ($N = 1$) are also included.

The S–N curve at 60 °C shows an improvement at USLs above 800 Mpa, with a small decrease of the endurance limit (of around 50 Mpa) when compared with the S–N curve at 24 °C. The main difference between the strap/pin systems investigated here and in [28], besides the temperature at which the tests were performed, is the pins’ material. In the present work, titanium pins were used, while Baschnagel et al. used CFRP, pultruded pins. The choice of titanium over CFRP pins was due to their increase in service temperature, as having the adversely affects CFRP pins via extensive surface wear from the CFRP pins, which can lead to premature failure of the straps. The material removal from the CFRP pins was, at times, so intense that the pin was jammed at the grip region.

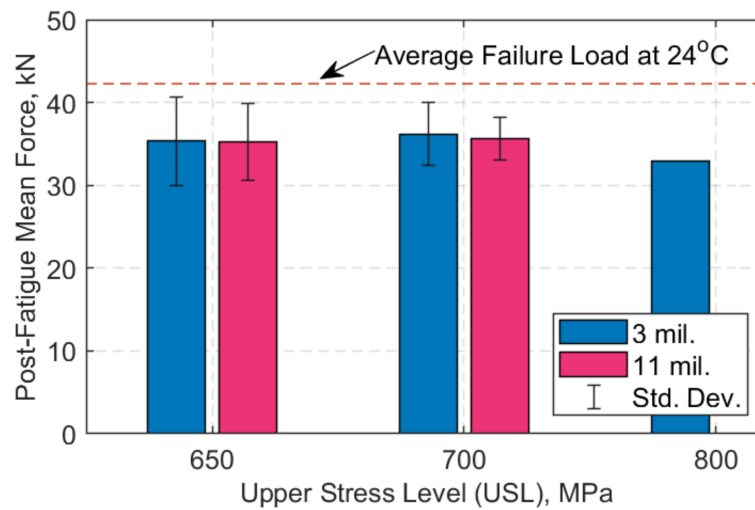
Figure 18. Average force (kN) vs. upper stress level (Mpa); post-fatigue.

The straps that endured 3 and/or 11 million loading cycles were further tested in static tensile tests to obtain their residual post-fatigue loading strength; the results are shown in Figure 18, where the average and standard deviation values—where applicable—are also presented.

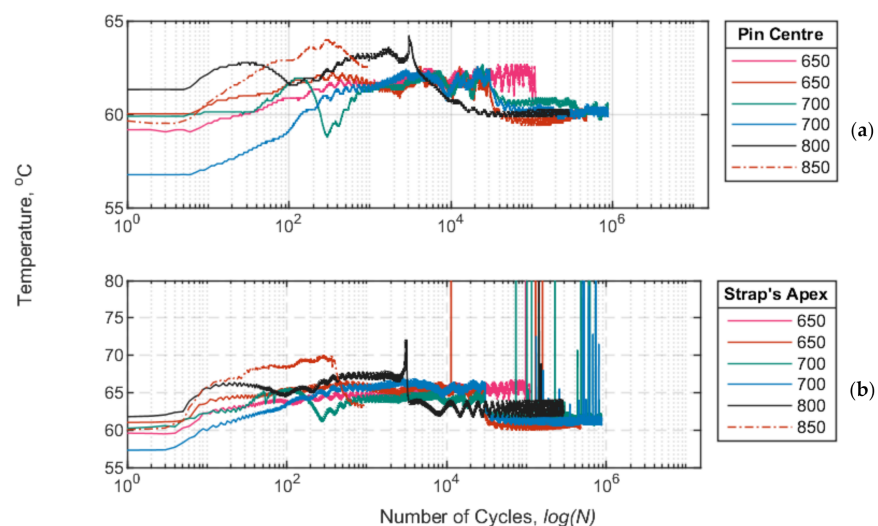
Figure 19. Temperature ($^\circ\text{C}$) vs. number of cycles ($\log(N)$) at the pin's centre (a) and at the strap's apex (b) for USLs between 650 and 850 Mpa.

The temperature development during the fatigue tests, at a sustained temperature of $60 \text{ }^\circ\text{C}$, was obtained at the straps' apex and at the centre of the pins. More specifically, the pins were drilled at the centre of their cross section to such a length that the tip of the type-K thermocouple was located at the centre of the contact region between the pin and the strap. Representative curves of the temperature development of the two thermocouples used in the fatigue tests for USLs of 650, 700, 800 and 850 Mpa are shown in Figure 19. It is evident that the constant air temperature of $60 \text{ }^\circ\text{C}$ during the fatigue tests did not seem to affect the titanium pins, as seen in Figure 19 (top). On the other hand, the straps seemed to experience, overall, a $5 \text{ }^\circ\text{C}$ gradual temperature increase at the strap's apex during the loading cycles, which, however, did not seem to influence either their fatigue performance or their remnant strength (refer to Figure 18). The reason that the temperature profiles do not all commence at $60 \text{ }^\circ\text{C}$ is that there was a $\pm 2 \text{ }^\circ\text{C}$ deviation in the chamber's air temperature.

An increase in the USL (i.e., 850 Mpa) does, however, affect the temperature progression of the straps, as there is a gradual and steady increase in temperature at a USL of 850 Mpa. The combination of increased USL and higher recorded temperatures at the apex of the straps might have consequently led to the failure of the straps at an 850 Mpa USL. This behaviour was also observed in [28], wherein a more sudden rise in temperature was noted as the USL increased from 750 to 1100 Mpa.

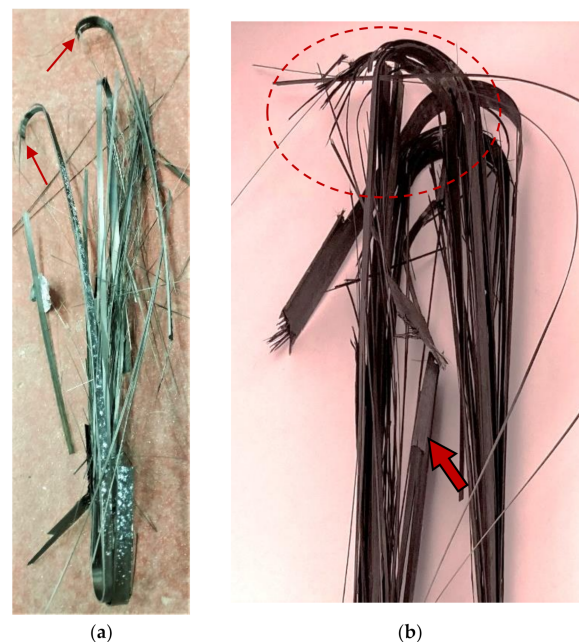
Figure 20. Strap failure modes in SS tests at 24 (a) (left) and 60 °C (b) (right).

The SS tests at 24 and $60 \text{ }^\circ\text{C}$ demonstrated similar failure modes. In both cases, initial delamination of the outer ply of the innermost layer of the straps was consistently the first visual failure mode, as indicated with an arrow in Figure 20 (right). Following, visible fibre breakages occurred and intensified as the load increased, a behaviour also reported in [28,29]. The final failure of the straps was explosive and sudden in nature, and was fibre-dominated. Such failure modes in UD CFRP specimens were previously reported by Hamada et al. [47], who also noted that the fracture process in UD specimens depends on the fibre–matrix interface and the brittleness of the epoxy resin. The initiation of the fibre breakages occurred consistently at the vertex area (stress concentration region), which

is indicated in Figure 20 with arrows on the right and a dashed circle on the left and is consistent with respect to the failure mode observations made in [28].

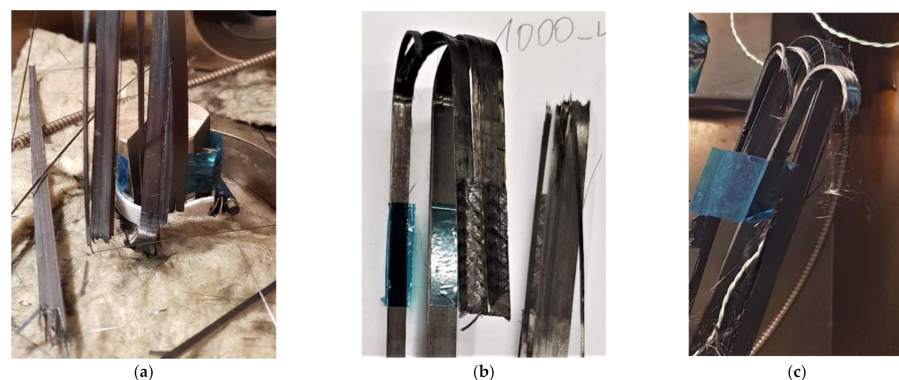
Figure 21. Failure mode of the straps in fatigue tests at a service temperature of 60 °C at (a) 1000 Mpa USL, (b) between 1150–1300 Mpa USL, and (c) at 1400 Mpa USL.

The straps tested for fatigue exhibited similar failure modes as the straps in the SS tests as seen in Figure 21, particularly the straps at USLs of 1000 Mpa and higher. At USLs between 1000 Mpa and 1400 Mpa, the amount of sustained tensile fatigue cycles was lower than 44,800 and a visual analysis of the contact surface of the pin to the strap showed clear signs of fretting, very similar to the ones described in [28]. This explains the observed brittle failure at lower cycle numbers for these straps under higher USLs. For the lower USLs, the influence of fretting on the amount of sustained tensile fatigue cycles was less pronounced. Ultimate failure of the straps generally occurred as clean brittle breaks (non-explosive) in the fatigue tests, as opposed to SS tests at 24 and 60 °C, where explosive failure caused individual broken fibres to be scattered around the environmental chamber.

In Figure 21, the main failure modes observed for the straps between 1000 and 1400 Mpa USL were delamination and fibre breakages/splitting at and around the vertex area. There were no clear signs of the delamination propagating around the vertex area and in-between the plies, which is observed in SS tests. The failure modes experienced by the straps are in accordance with the failure modes reported by Talreja [20] that belong to

Region I of the fatigue-life diagram (see Figure 3,4). In Figure 21 (middle), a longitudinal split is also evident. Similar observations, regarding the fatigue failure modes of the CFRP straps, were reported in [28].
