An empirical investigation on the correlation between solar cell cracks and hotspots

Mahmoud Dhimish¹✉ & Pavlos I. Lazaridis²

In recent years, solar cell cracks have been a topic of interest to industry because of their impact on performance deterioration. Therefore, in this work, we investigate the correlation of four crack modes and their effects on the temperature of the solar cell, well known as hotspot. We divided the crack modes to crack free (mode 1), micro-crack (mode 2), shaded area (mode 3), and breakdown (mode 4). Using a dataset of 12 different solar cell samples, we have found that there are no hotspots detected for a solar cell affected by modes 1 or 2. However, we discovered that the solar cell is likely to have hotspots if affected by crack mode 3 or 4, with an expected increase in the temperature from 25°C to 100°C. Additionally, we have noticed that an increase in the shading ratio in solar cells can cause severe hotspots. For this reason, we observed that the worst-case scenario for a hotspot to develop is at shading ratios of 40% to 60%, with an identified increase in the cell temperature from 25°C to 105°C.

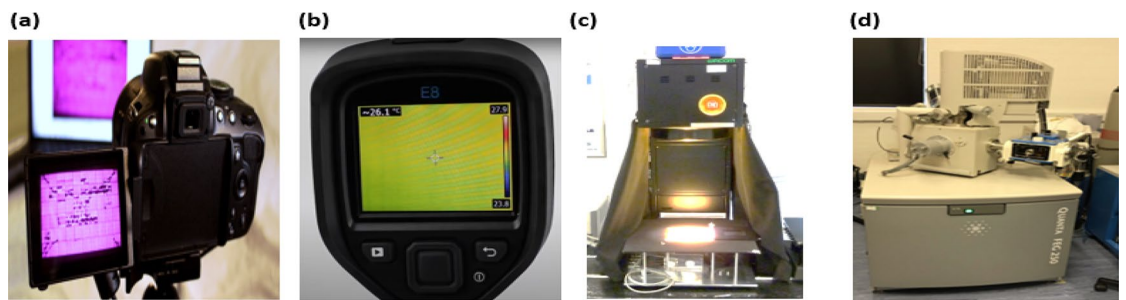
Figure 3. Experimental setup (a) EL imaging camera, (b) thermal camera, (c) solar simulator, and (d) scanning electron microscope.

Electroluminescent, thermal imaging, solar simulator, and SEM. The EL images of the solar cell samples are taken using the EL camera shown in Fig. 3a. The camera comprises a digital single-lens reflex with a high resolution of $6\text{ k} \times 4\text{ k}$ pixels. The infrared cut-off filter is removed and calibrated to allow sensitivity to the electroluminescence picture with a peak wavelength of 1150 nm . The camera has an adjustable lens of $18\text{--}55\text{ mm}$. The accuracy of the EL image depends on the distance between the EL camera and the solar cell. In our experiment, the distance was 2.4 m , which produces the highest quality EL images.

To capture the thermal image of the solar cells, a FLIR E8-XT thermal imaging camera is used (Fig. 3b). The thermal camera has a thermal resolution of 320×240 -pixel and 0.05°C thermal sensitivity. The camera was placed 2.4 m apart from the solar cells to detect the entire area of the inspected cells.

Finally, to investigate the performance of the solar cells under varied solar irradiance ($0\text{--}1000\text{ W/m}^2$), a steady-state solar simulator is used, presented in Fig. 3c. The solar simulator is a class A + spectral match, IEC60904-9, with a $\pm 2\%$ illumination sensitivity. In addition, we have used the Quanta FEC250 SEM, Fig. 3d,

to inspect the microstructure of the examined solar cells. The SEM has an adjustable magnification of up to 2,000,000x, and the resolution of the digital output image can be as high as 4096×3536 .

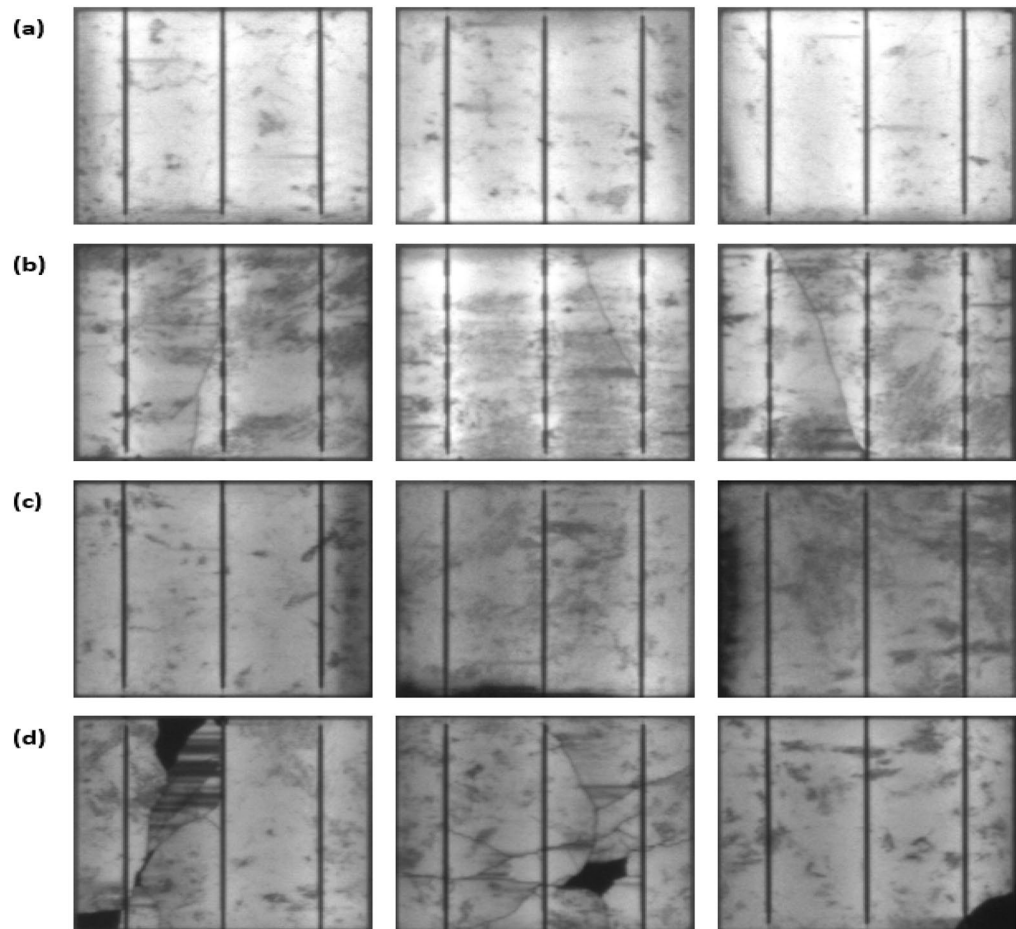
Figure 4. EL image of the examined solar cell samples (a) mode 1, (b) mode 2, (c) mode 3, and (d) mode 4.

EL imaging. Every solar cell was subjected to EL imaging to inspect the fracture and the crack mode. In this study, we have investigated four different modes: (i) crack free (mode 1), (ii) micro-crack (mode 2), (iii) shade area (mode 3), and (iv) breakdown (mode 4). For every mode, three different solar cell samples were selected, all presented in Fig. 4. Here the cracks were classified into four different modes. In contrast, in previous research^{25,26}, solar cell cracks were distinguished by either a singular crack mode, named micro-crack or μ crack. We find our classification is significant because not every crack mode can lead to hotspots or a substantial drop in the output power.

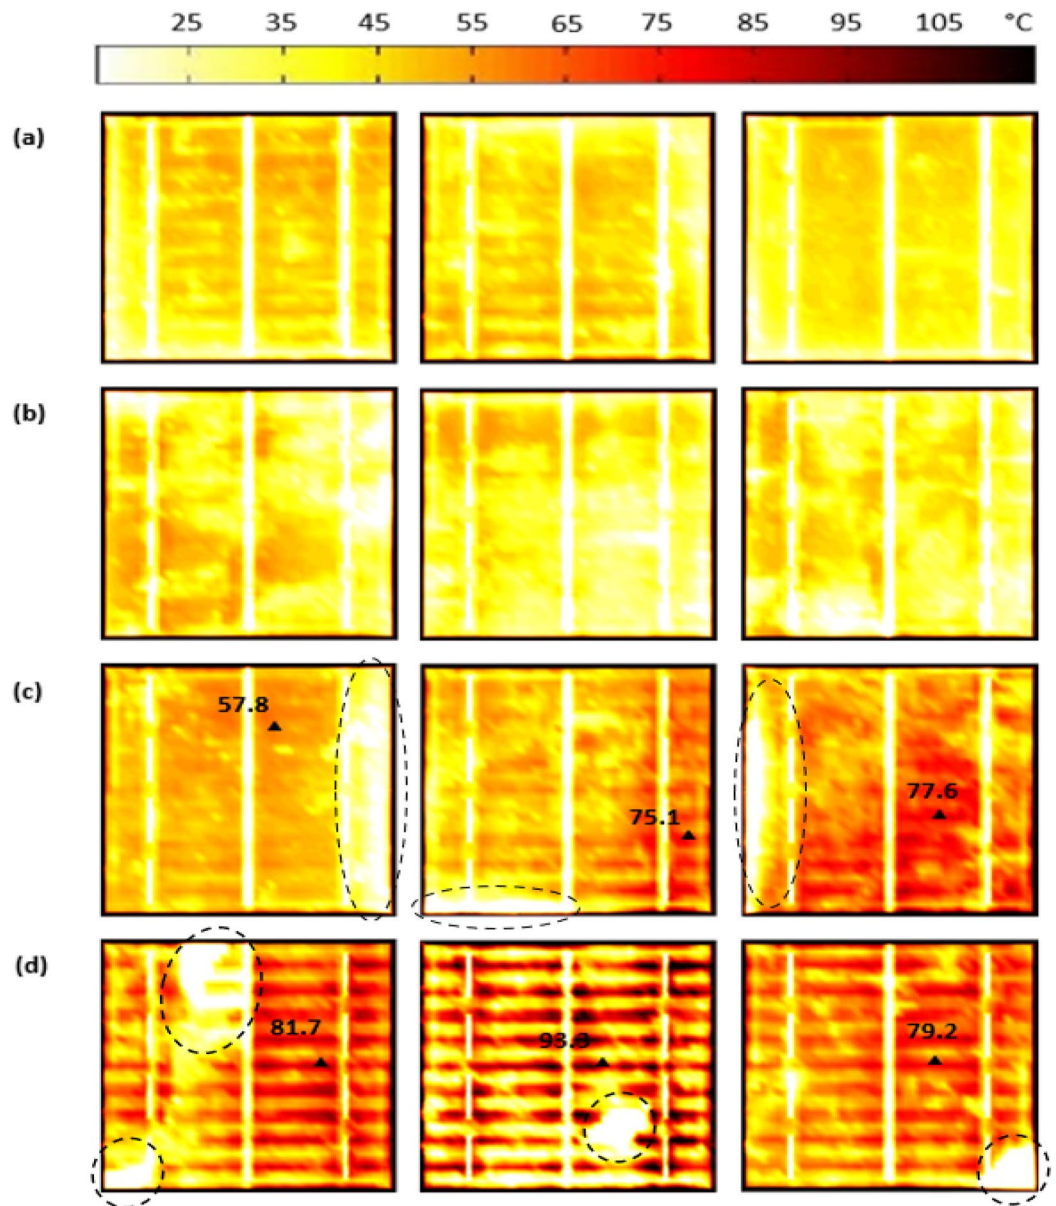
Figure 5. Thermal image of the examined solar cell samples under STC condition (a) mode 1, (b) mode 2, (c) mode 3, and (d) mode 4.

Thermal performance of the tested solar cell samples. The results of the thermal testing are shown in Fig. 5. According to Figs. 5a,b a uniform distribution of the heat across the solar cell surface was detected. Accordingly, the temperature is approximately at the standard testing condition, 25°C. It is noticed that no hotspots are exposed to the solar cell samples with crack-free (mode 1) and micro-cracks (mode 2). Furthermore, for crack modes 1 and 2, there was no increase in the cell's temperature, which confirms that crack-free or micro-cracks do not change the temperature of the cells and are unlikely to develop a hotspot.

In contradiction, if we consider Fig. 5c, mode 3, the shade in the cells causes no increase in the temperature, labelled in dashed circles. The shade will create an uneven distribution of the current flow in the busbars; this would generate stress in the cell and then cause an increase in the temperature. We can observe that the samples are affected by the rise to the surface temperature up to 77.6°C. Hence, if these samples were under field operation, hotspots would be expected. We yet do not fully understand the correlation between the shading ratio in the original EL image and the presence of hotspots; this case will be detailed later in the article.

According to mode 4, Fig. 5d, the breakdown regions in the solar cells have no increase in the temperature, labelled in dashed circles. This is explained by the fact that there is no contact in the inner and outer layers of the cells. Hence, no photo illumination is observed. In contrast, the cells are now being impacted by an increase in the surface temperature (of up to 93.3°C) due to these breakdown regions. The same explanation is valid as in crack mode 3, where breakdown regions affect parts of the solar cells, which would create an uneven distribution of the current flow in the busbars, leading to this significant increase in the cell surface temperature. A similar observation was made in the recent study by Akram *et al.*²⁷, where they discovered that a hotspot could lead to an increase in the cell surface temperature of up to 110°C .

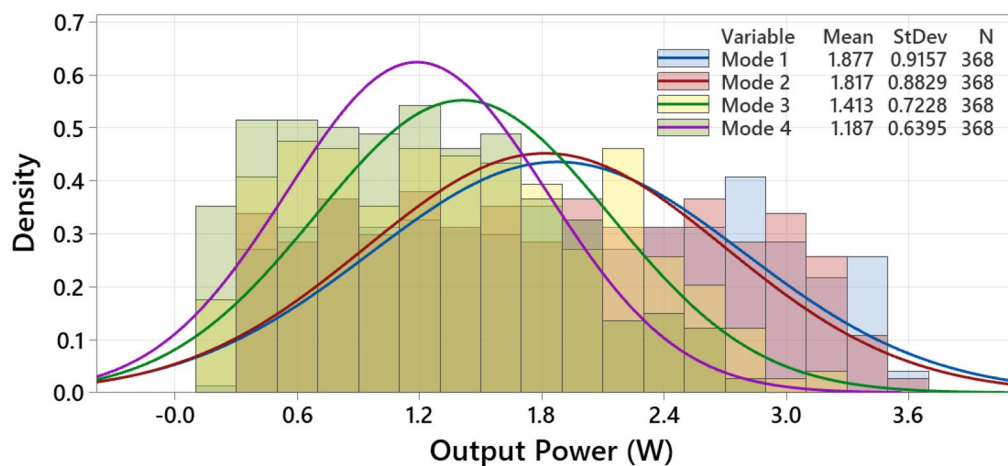
Figure 7. Normal distribution function applied for all measured data points.

Additionally, we summarise that the measured output power of the solar cell samples follows a normal distribution as presented in Fig. 7. However, a lower standard deviation (StDev) for modes 3 and 4 indicates that the output measure power tends to be close to the mean value. This result suggests that a significant drop in the

solar cells' output power is likely to be noticed if the EL image exhibits a shaded area or breakdown regions. Finally, please note that for Fig. 7, the y-axis (density) represents the percentage of the observations in the dataset.

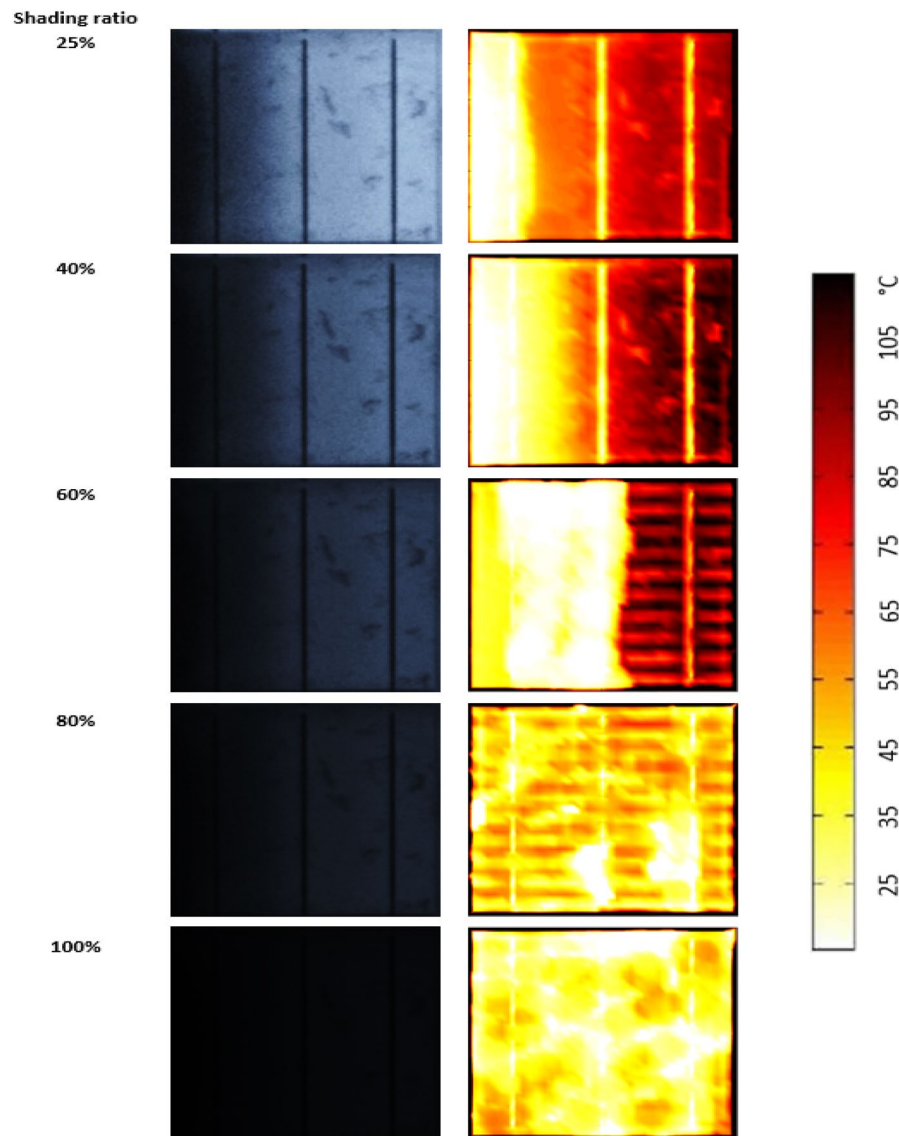
Figure 9. Progressive shading of a solar cell affected by mode 3 crack; the samples were subjected to illumination under STC conditions.

Shading ratio vs hotspots development. So far, we have evidence that solar cells affected by modes 3 and 4 are expected to have hotspots. Therefore, we have further investigated the correlation between the shade ratio in mode 3 and the presence of hotspots. The outcome of this experiment is presented in Fig. 9.

The progressive range of shade, including 25%, 40%, 60%, 80%, and 100%, is examined. If the solar cell is affected by 25% shading ratio, a maximum increase in the cell's temperature of approximately 75°C is detected. Progressively, if the solar cell is affected by a greater shading ratio, 40% or 60%, the hotspot area has a significant

increase in temperature, equivalent to 105°C . Therefore, a hotspot is likely to develop for these three shading ratios.

For the last two shading ratios, when the solar cell is affected by 80% or 100%, no hotspot in the cell area is witnessed. The hotspot disappears due to the absence of the photo-generated current. The remaining dark current flows within the cell for insignificant cell heating and an average temperature approximately at the experimental condition, 25°C . Thus, the worst-case scenario for the hotspot to develop occurs at the shading ratios of 40% to 60%, with an expected increase in the cell temperature from 25°C to 105°C .

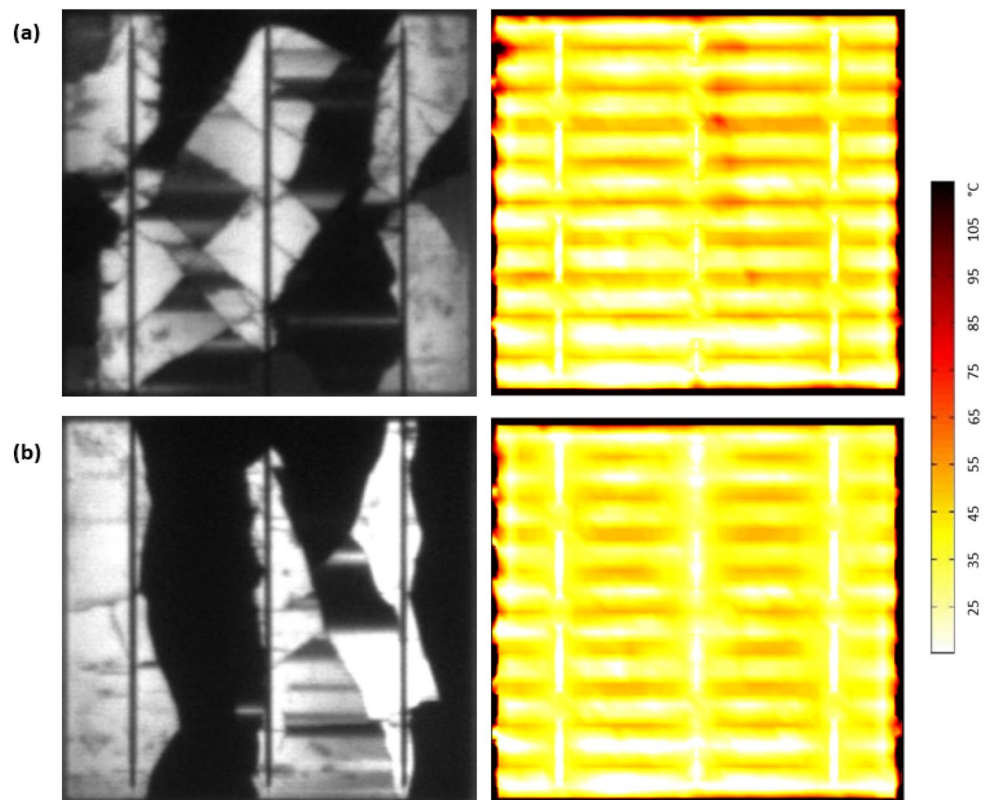
Figure 12. Solar cells affected by mode 4 with severe breakdown regions (a) sample #1, and (b) sample #2.

Finally, two solar cells (Fig. 12) were tested for further validation of the above-mentioned results. Both samples are affected by mode 4, with severe breakdown regions. The inactive part is approximately higher than 70%, represented by the dark black areas in the EL image. Both samples were tested under STC conditions using the

solar illuminator. Because the inactive region is very high, no increase in the cell's temperature was detected. This result confirms that when the solar cell is impacted by a high ratio of shading or breakdown regions, the hotspots are unlikely to develop.
