PRELIMINARY ASSESSMENT OF THE SEISMIC VULNERABILITY OF LOAD-BEARING MASONRY BUILDINGS IN MALTA THROUGH NUMERICAL MODELLING.

Cicero C.¹, Borg. R. P.², Bonello M.³, Lombardo G.¹

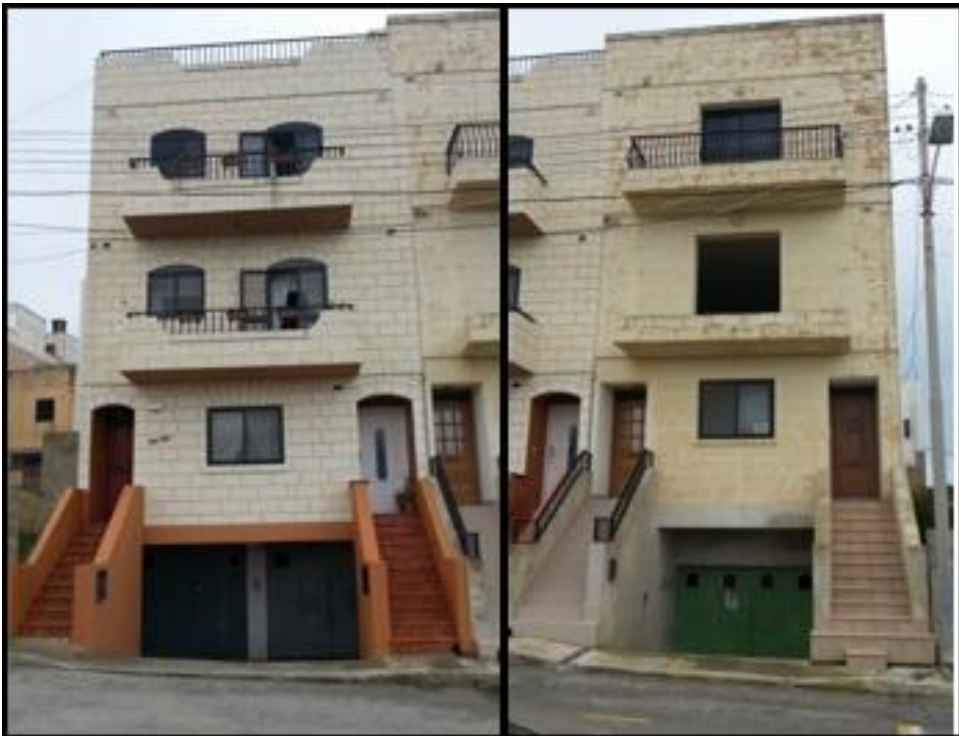
Figure 1. Structural Units 1 and 2 (Xemxija – Malta).

In the preliminary analysis of this building typology using numerical modelling through 3D Macro, structural units, located in a specific urban area, namely Xemxija in Malta, have been analyzed (Fig.1). In a first phase of research, the influence of the soft storey has been assessed. In particular, the structural units have been modelled, using the specific software, 3D Macro, with and without the soft storey. The safety factor was obtained through the analysis and the results are reported in Table 1. Results obtained in this first phase of research show that the presence of the soft storey is a very influential indicator on the assessment of damage of the buildings, with the safety factor being reduced significantly.
