# Structural Health Monitoring of Existing Reinforced Cement Concrete Buildings and Bridge Using Nondestructive Evaluation with Repair Methodology

*Aman Kumar, Jasvir Singh Rattan, Nishant Raj Kapoor, Ajay Kumar and Rahul Kumar*

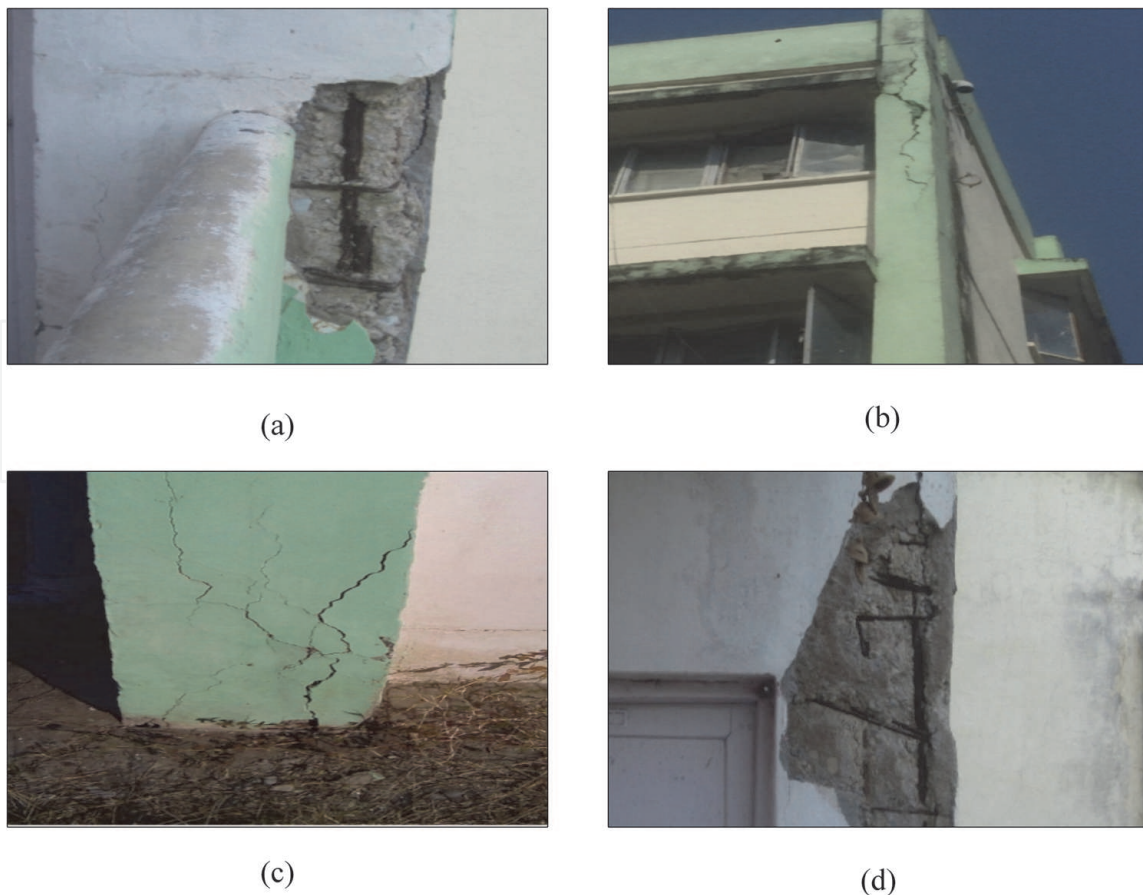
**Figure 3.** Damage detection (a) spalling of concrete, (b) vertical cracks on column surface, (c) cracks in the bottom of column, (d) corrosion in steel.

- a. From the investigation, it was observed that the exterior columns of the building were having vertical cracks and spalling at some of the locations.
- b. Dampness and efflorescence on walls were also observed, especially at the lower level of the building.

- e. Spalling of concrete and exposed corroded reinforcement in exterior columns of both the buildings.
- f. Ground floor and the first floor of the building were attacked by termite.
- g. Backside staircase along with the servant quarter of the building was completely damaged.
- h. Brick tiles on the terrace of the building were damaged due to ingress of moisture through them.
- i. Due to growth of plants on the terrace of the building and the rainwater pipes, there were damages.

The visual inspection checks found the presence of efflorescence, permeable, and unsound concrete, cracks, and gradual disintegration of concrete, spalling of concrete and cracking, etc. The flow chart of the visual inspection is shown in **Figure 2** [19–25]. Different types of distresses such as cracks, spalling, and corrosion in the building are shown in **Figure 3**.

- The strengthening of outer columns of the building needs to be done with jacketing with micro-concrete, and reinforcement is to be provided where steel has rusted more than 20%.
- All the traps and manholes should be repaired to prevent the seepage into the foundations from such locations.
- Water tanks on the roof are causing dampness due to the overflow of water or due to leakage, all the tanks should be repaired, and overflow should be stopped by providing a suitable float valve.
- Exposed concrete was found to be carbonated and hence should be provided with anti-carbonation coating if the spalling of cover concrete has not started.
- If the spalling of cover concrete is taking place, the same should be repaired by treating the affected reinforcement and repairing the cover with micro-concrete.

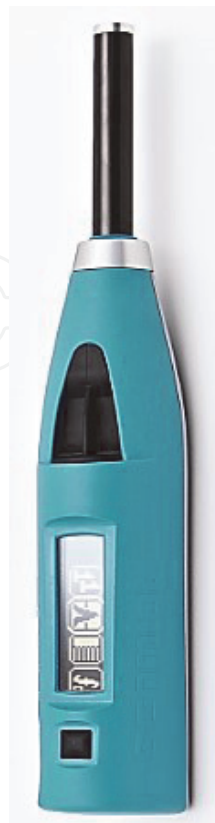
**Figure 4.**  
*Rebound hammer.*

This is the fastest method to evaluate the quality of concrete based on hardness, which is indicated by rebound number. If the strength of concrete is high, the rebound number is also high. The principle of this test is that when the plunger of the rebound hammer is pressed against the surface of the concrete, the spring controlled the mass rebounds and the extent of such rebound depends upon the surface hardness of the concrete. The surface hardness of the concrete gives the rebound number, which is further related to the compressive strength of the concrete. In latest rebound hammer, there is no need for angle correction. The average

value of rebound hammer for a different quality of concrete as per Indian Standard IS: 13311 Part-21992 is given in **Table 1 (Figure 4)** [26].

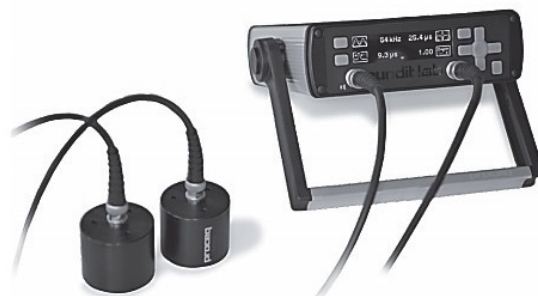
**Figure 5.**  
 UPV.

UPV Test method is generally used for determination of uniformity of concrete, to find crack depth, honeycombing, and to check the condition assessment of deterioration of concrete. The principle of this test is based on the propagation of electroacoustic pulse through the concrete pathway and then calculating the transit time taken, for a known distance. UPV mainly depends on the elastic modulus of the concrete. The general guidelines for quality of concrete as per Indian Standard IS: 13311 Part-11992 are given in **Table 2 (Figure 5)** [27].

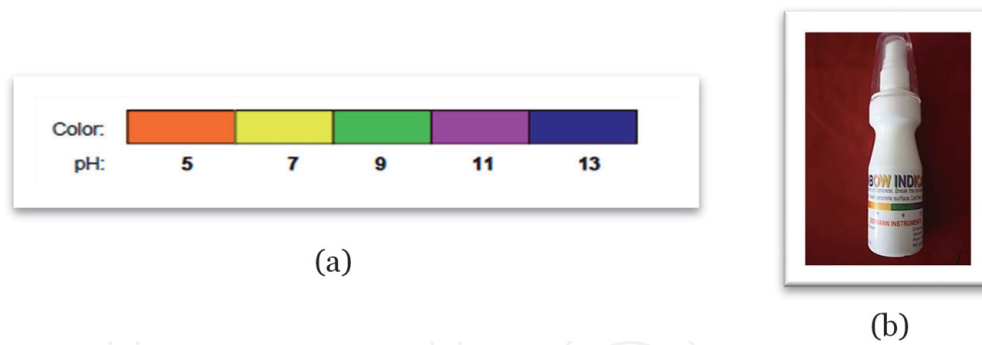
**Figure 6.** Concrete carbonation: (a) pH scale for concrete carbonation. (b) Rainbow indicator.

Concrete has micropores, and these pores are filled with liquid, having pH values up to 12.5. Thus, the concrete is alkaline in nature. Carbonation of the concrete is the reaction of  $\text{Ca(OH)}_2$  with the atmospheric  $\text{CO}_2$  and its conversion into  $\text{CaCO}_3$ . This reaction decreases the pH value of the pore water up to 8.5. As time passes, the outer zone of concrete is affected first, and carbonation proceeds deeper into the mass as  $\text{CO}_2$  diffuses inward from the surface. If the carbonation depth reached the depth of steel in concrete, then the steel is prone to corrosion damage. By carbonation test, we can measure the carbonation depth of the concrete. In order to determine the path of the carbonation, drilling a hole is done in stages and the phenolphthalein solution spread over it after every stage. As soon as the color of the concrete becomes pink, we stop the drilling process and the depth of the hole is measured (**Figure 6**) [28].

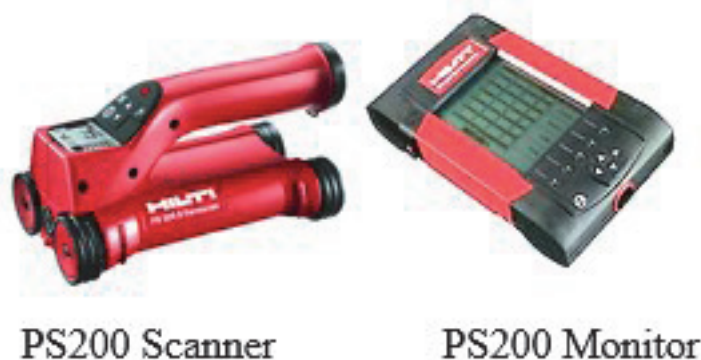
**Figure 7.** Ferro-scanner.

Ferro scanner is a device used to locate reinforcing bars and to estimate the diameter and depth of cover. This device is based on interactions between the bars and low-frequency electromagnetic fields. The ferro scanner works on the principle of electromagnetic induction, in which alternating magnetic field induces an electrical potential in an electrical circle intersected by the field. The test for reinforcement scanning is done with the help of HILTI PS 200 Ferro scan [29], a portable system for detecting rebar in concrete structures. The tools help in obtaining a real image of the reinforcement and evaluate the reinforcement mesh. HILTI PS 200 Ferro scan records the depth and positions of rebars over long stretches and obtains average coverage and statistics of the rebar diameter. The tools consist of image scanner that records the data, then the recorded data is transferred to the monitor for further analysis at the site itself. The major analysis is done on the computer by the analysis software to produce reports of the recorded data, and later the data is further submitted to the structural consultant for preparation of structural drawing, thereby ensuring the stability of the structure. The major limitations of this test are that the interferences may occur in images due to scraps of reinforcement in concrete, tie wires near rebars cross, and aggregates with ferromagnetic properties (Figure 7).

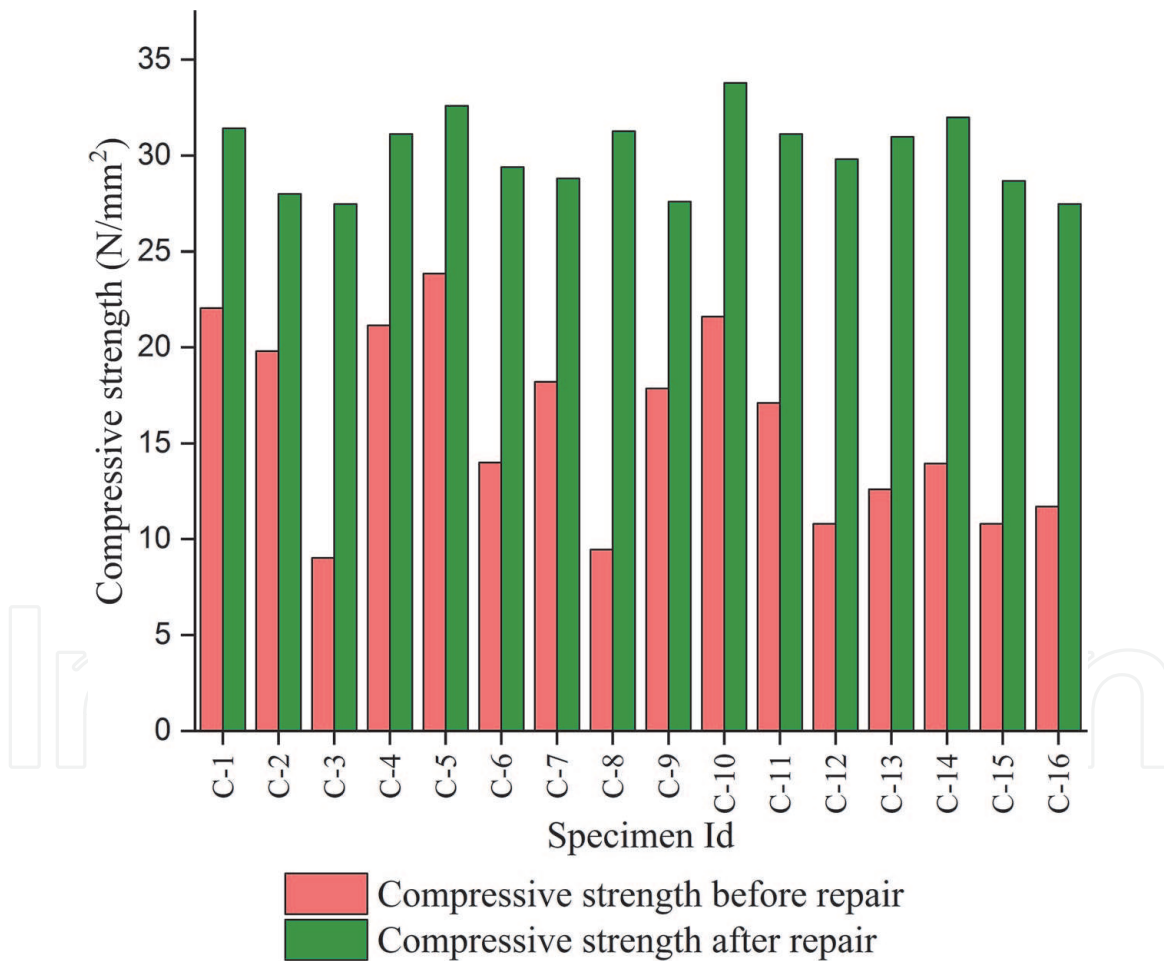
**Figure 17.**  
*Comparison of compressive strength before and after repair.*

The NDT carried out after repair showed that the concrete strength was in the range of M25–M30 grade of concrete. The UPV also showed the quality of concrete improved from poor to good. **Figures 17 and 18** show that after repairs, the strength

and quality were enhanced, which will also result in improvement of durability of structures in the long run.

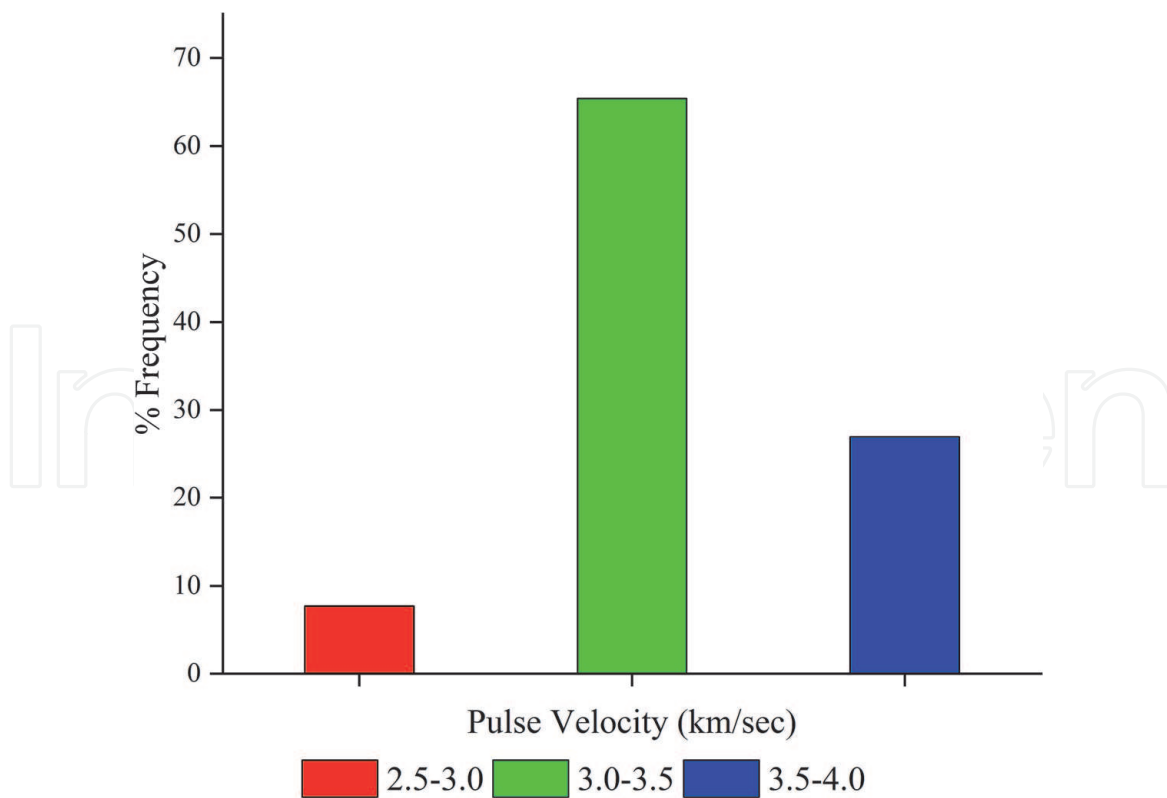
**Figure 19.**  
*Pulse velocity (km/sec).*

There is no carbonation present in the concrete, so that the compressive strength and corrected compressive strength after carbonation are the same. The UPV values lie in the range of medium to good. Steel is free from the corrosion as the data given by concrete resistivity meter. The compressive strength of the deck slab varies in the range of 35–39 N/mm<sup>2</sup>. The pH value of concrete is also in the normal range.

**Figures 19–22** show the UPV values of deck slab (km/sec), compressive strength of deck slab (N/mm<sup>2</sup>), cover depth (mm), and concrete resistivity (kΩcm), respectively.
