**RIVER CHANNEL CHANGE IN THE MIDDLE YANGTZE
RIVER IN THE LAST 50 YEARS
– A CASE STUDY IN THE JIANLI SUB-REACH**

2005

**THESIS SUBMITTED
IN PARTIAL FULFILMENT OF THE REQUIREMENTS FOR
THE DEGREE OF MASTER OF SOCIAL SCIENCE
DEPARTMENT OF GEOGRAPHY
NATIONAL UNIVERSITY OF SINGAPORE**

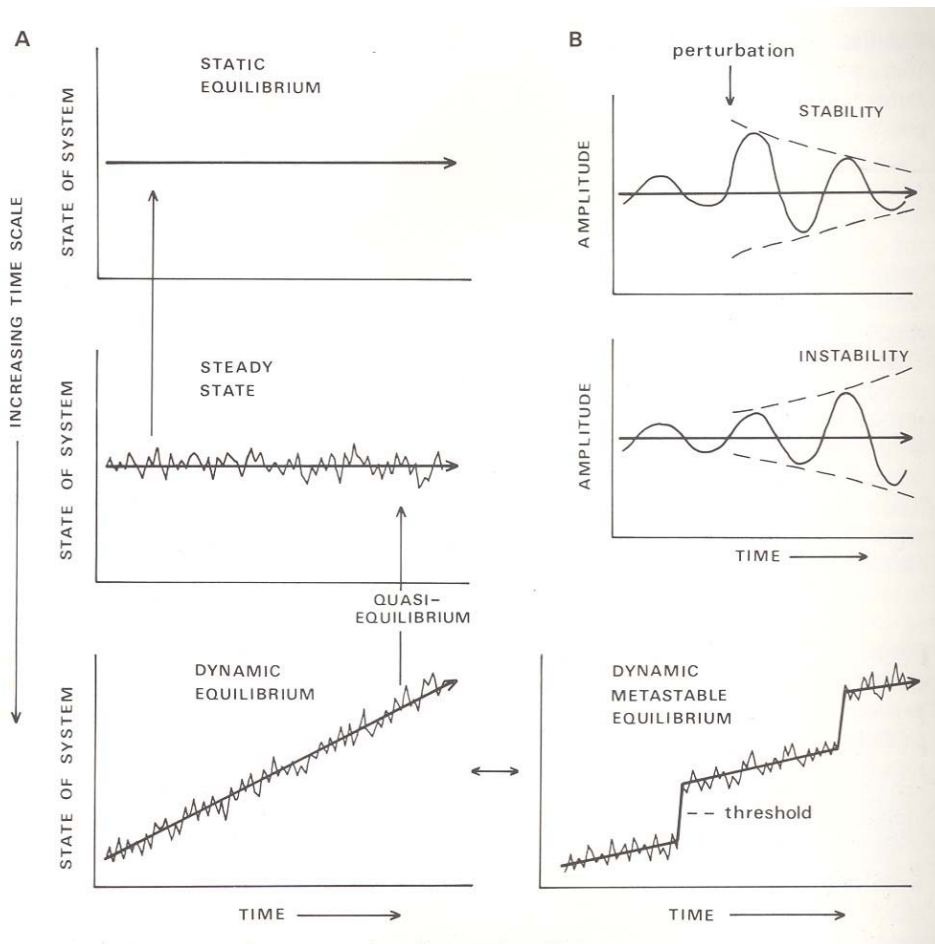
Fig.2.1 a. Diagrammatic representation of types of equilibrium. b. Definition sketches of stability and instability in an oscillating mechanical system subject to a perturbation (adopted from Knighton, 1984).

In geomorphology, the term “dynamic equilibrium” refers to an open system in a steady state in which there is a continuous inflow of materials, but within which the form or character of the system remains unchanged (Leopold *et al*, 1964; Park, 1995). When a river system is observed over a short time period, oscillations about any trend may be so much greater than changes in the trend itself that the system looks like steady-state equilibrium (Fig 2.1b). This tendency toward a steady state is termed “quasi-equilibrium” (Knighton, 1984; Ritter *et al*, 1995) (Fig 2.1a).

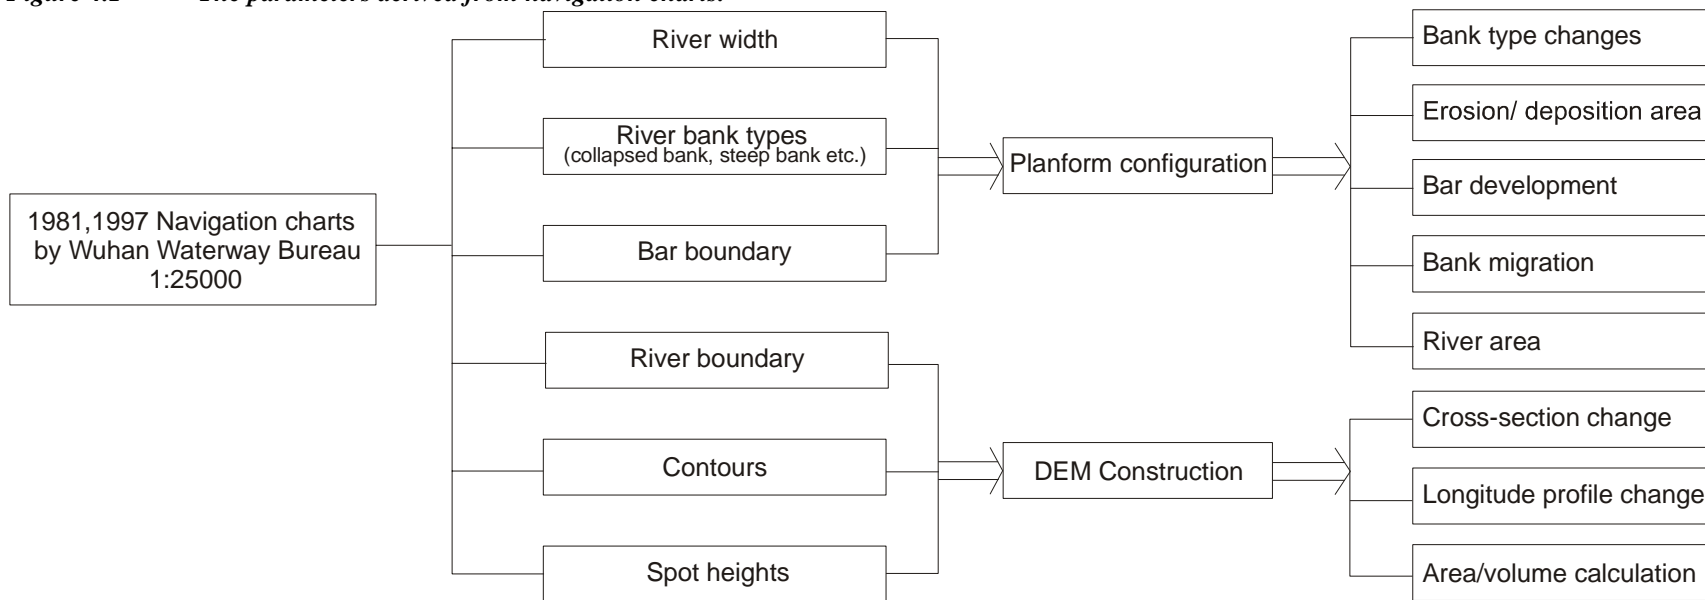
Figure 4.1 *The parameters derived from navigation charts.*

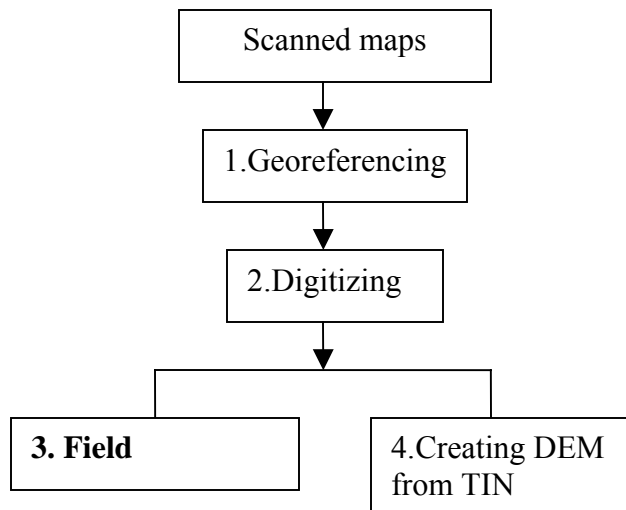
Figure 4.2 **The process of DEM construction**

1987. It helps to calculate the volume of erosion and deposition in the channel. Still rather few DEMs based on navigation charts were set up along the Yangtze River to discuss the channel change and its effect on floods (Yan *et al*, 2001). Building up DEM involves four steps (see flowchart 2):

- 1) Georeferencing,
- 2) Digitizing,
- 3) Field calculation and
- 4) Creating DEM from TIN.

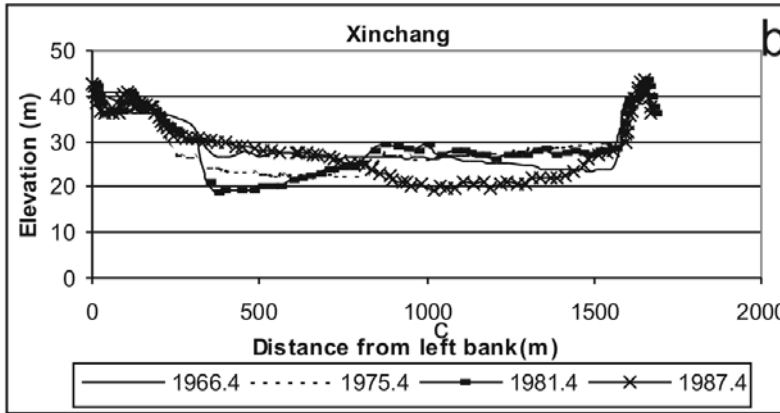
Figure 5.2 Cross-sections at major stations along the middle Yangtze River (Data source: YWCC Cross-section survey data).

Different from cross-sections at Yichang and Xinchang, which have a “V” shape channel valley with extinct thalweg, cross-section at Jianli has a much flat riverbed, although it has two channels near the toe of both banks (Figure 5.2c). The deepest channel for navigation was near the south bank in 1965, and shifted nearer the north bank in 1975. However, the left channel (north channel) was silted from 1975 to 1980, while the south channel was scoured about another 3 m during the same period (Figure 5.2c). Besides, south bank retreated around 50 m from 1966 to 1975 (Figure 5.2c).

Cross-section at Luoshan looks like an irregular “W” (Figure. 5.2d). The left part of riverbed at Luoshan station received massive sediments from 1965 to 1975, these deposits (about 10 m in depth) were again removed from 1975 to 1981, meanwhile sedimentation happened on the opposite part, about 12 m of deposits was silted in the right channel from 1975 to 1981 (Figure 5.2d).

Hankou station has a "V" type cross-section (Figure 5.2e), alike the cross-section at Yichang. Basically, this channel is quiet stable, especially at the right side. Siltation mainly occurs at the north bank, north bank moved inward gradually from 1965 to 1987.

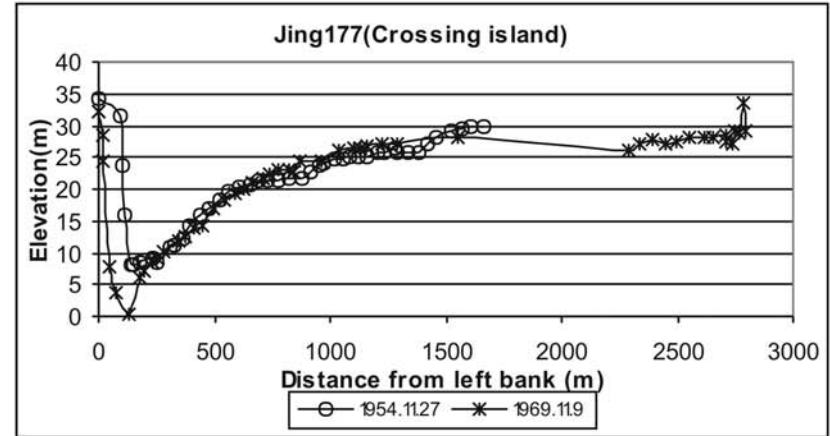
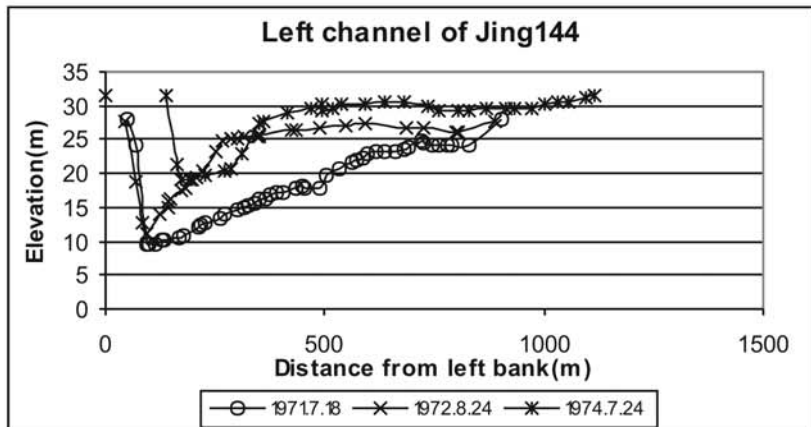
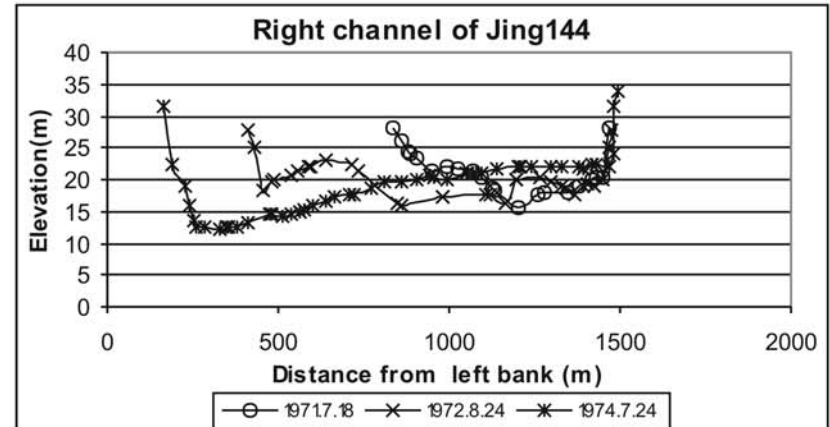
Figure 5.4 Cross-sections at anabranch meander. Data source: YWCC cross-section survey data.

A mid-channel bar separated trans-section Jing144 into two channels: left (north) channel and right (south) channel. It is obvious that left channel received sedimentation from 1971 to 1974. Channel narrowing and channel aggradation occurred in the left channel, meanwhile the middle channel bar developed with the sedimentation in the right channel. In contrast, right channel had a wider and deeper channel from 1971 to 1974. South bank of the mid-channel bar endured a serious bank collapse, from 1971 to 1972, channel width in the right channel almost doubled from 1971 to 1972, and increased by about 200 m from 1972 to 1974 due to the bank retreating at the north bank of right channel. The significant changes in both channels from 1971 to 1974 may be related with cutoff events in the lower Jingjiang reach, which disturbed the equilibrium status in river channel (Figure 5.4).

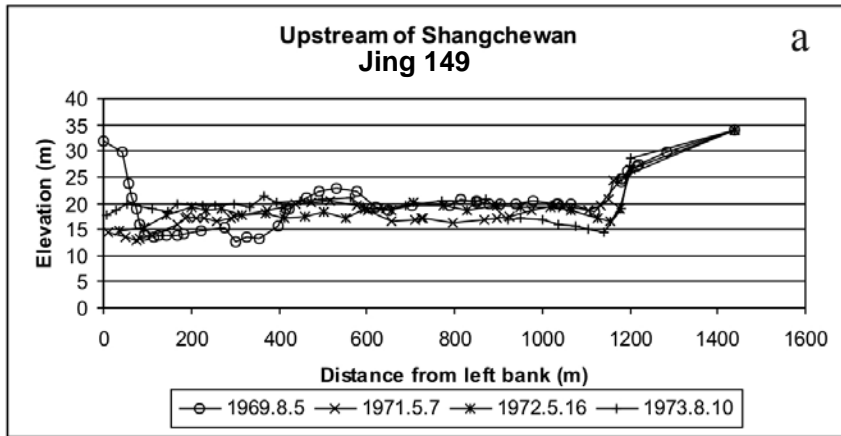
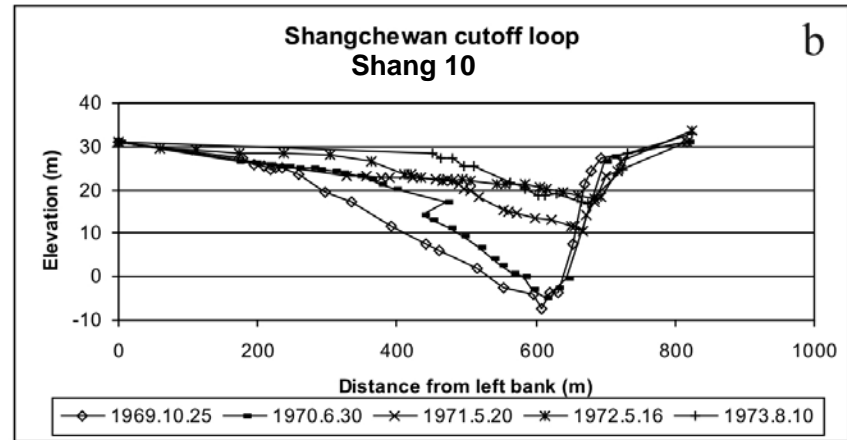
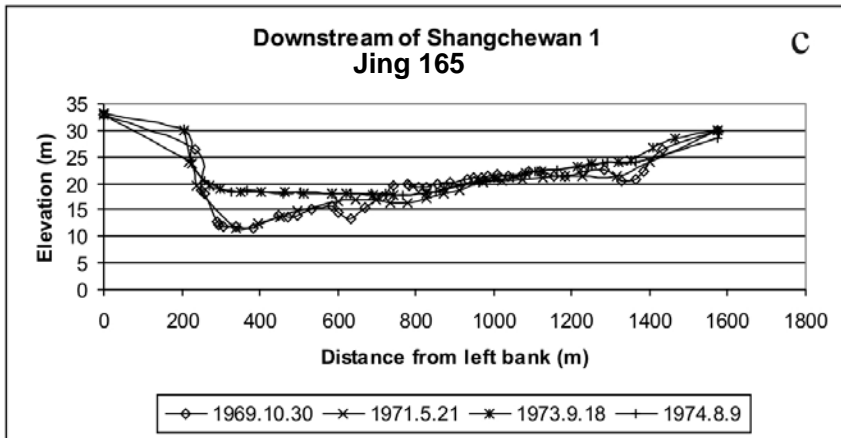
Figure 5.5 Cross-section at the Shangchewan cutoff bend. Data source: YWCC cross-section survey data

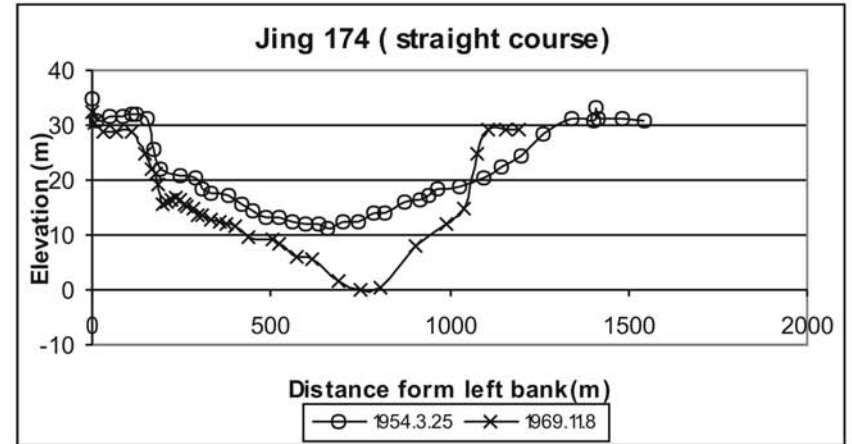
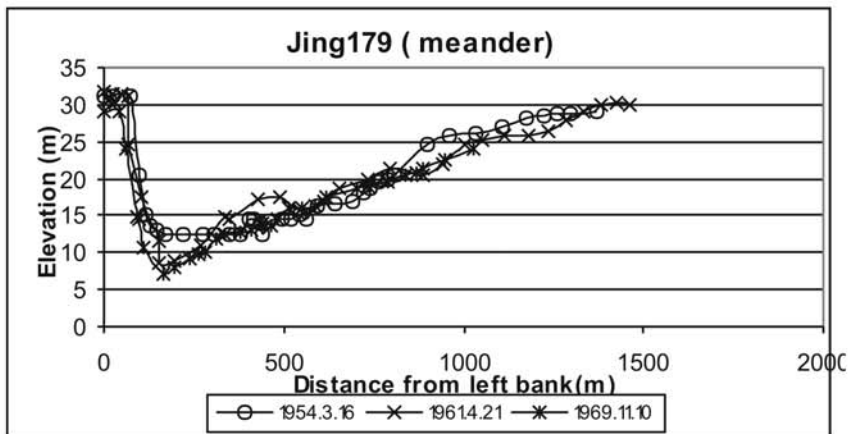
Figure 5.6 Cross-section changes at the straight course and meander cluster. Data source: YWCC cross-section survey data

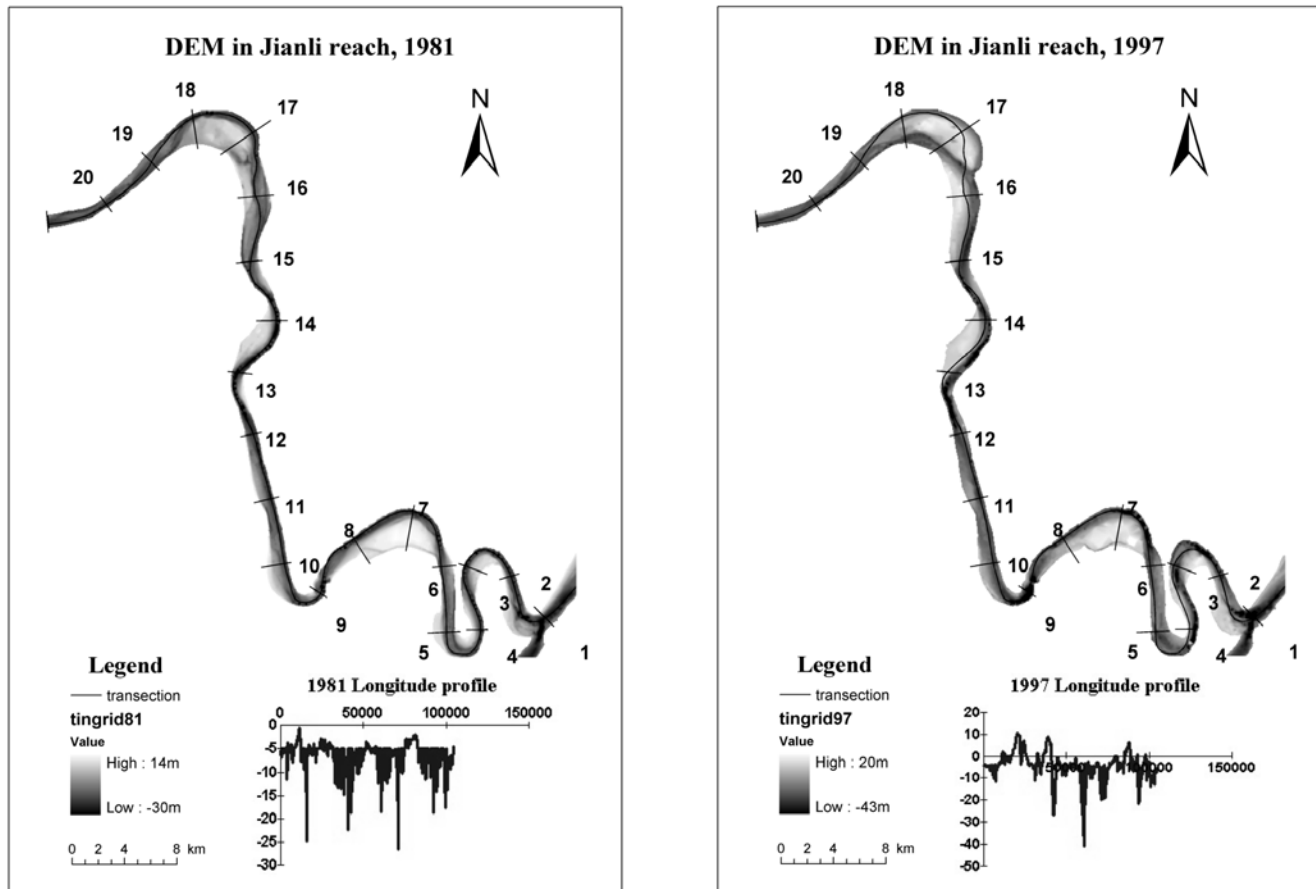
Fig 6.4. Grid of DEMs and longitude profiles in the study reach in 1981 and 1997. Longitude profiles were both interpolated along the navigation reference route in 1981.

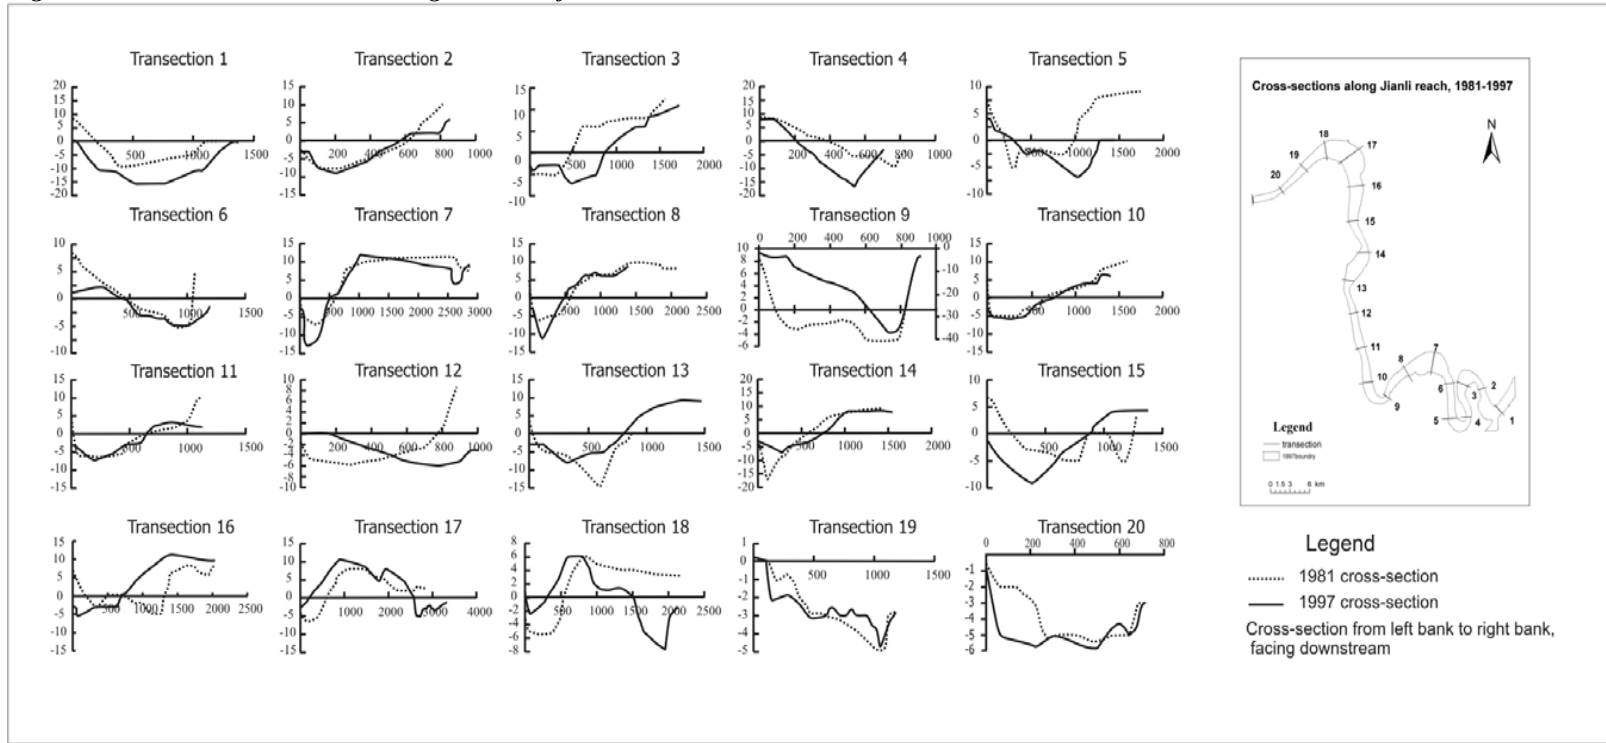
Figure 6.5 Cross-sectional changes derived from DEMs in 1981 and 1997.

The cross-sections at twenty sites are extracted from the two DEMs (Figure 6.5). As was proposed by Leopold and Wolman (1960), the deep thalweg along meandering bend is located along the outer concave bank, but the point bar attached with inner bank due to the interaction between helical flow and primary longitudinal flow, such as the cross-sections 3, 4, 5, 7, 8, 17. Riverbed scouring below navigation reference plane dominates most of the cross-sections except cross-sections 10 and 11, which are located at the Yanchuantao straight watercourse. In contrast, obvious depositions above the reference plane can be seen at the cross-sections of 13, 15, 16 and 17 at the meander bends. The channel geometry in the Yanchuantao course is relatively stable, like at cross-sections 10 and 11. Furthermore, channel widening can be also observed from many of the cross-sections, such as the cross-sections 3, 9, 12, 13, 14 15 17 and 18 (Figure 6.5).

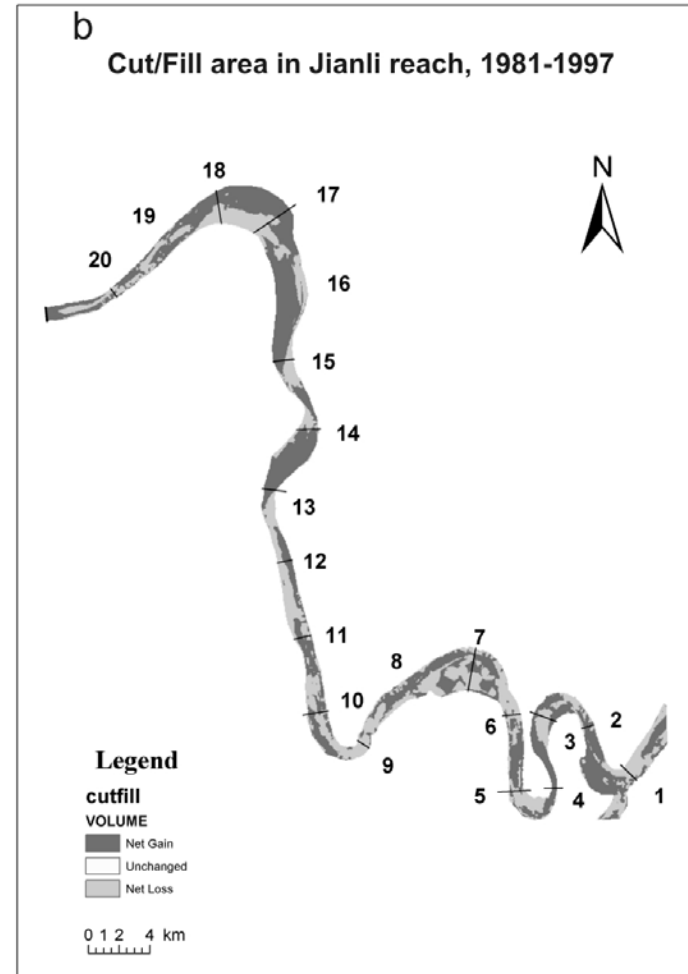
Figure 6.6 Erosion/deposition area in the Jianli sub-reach

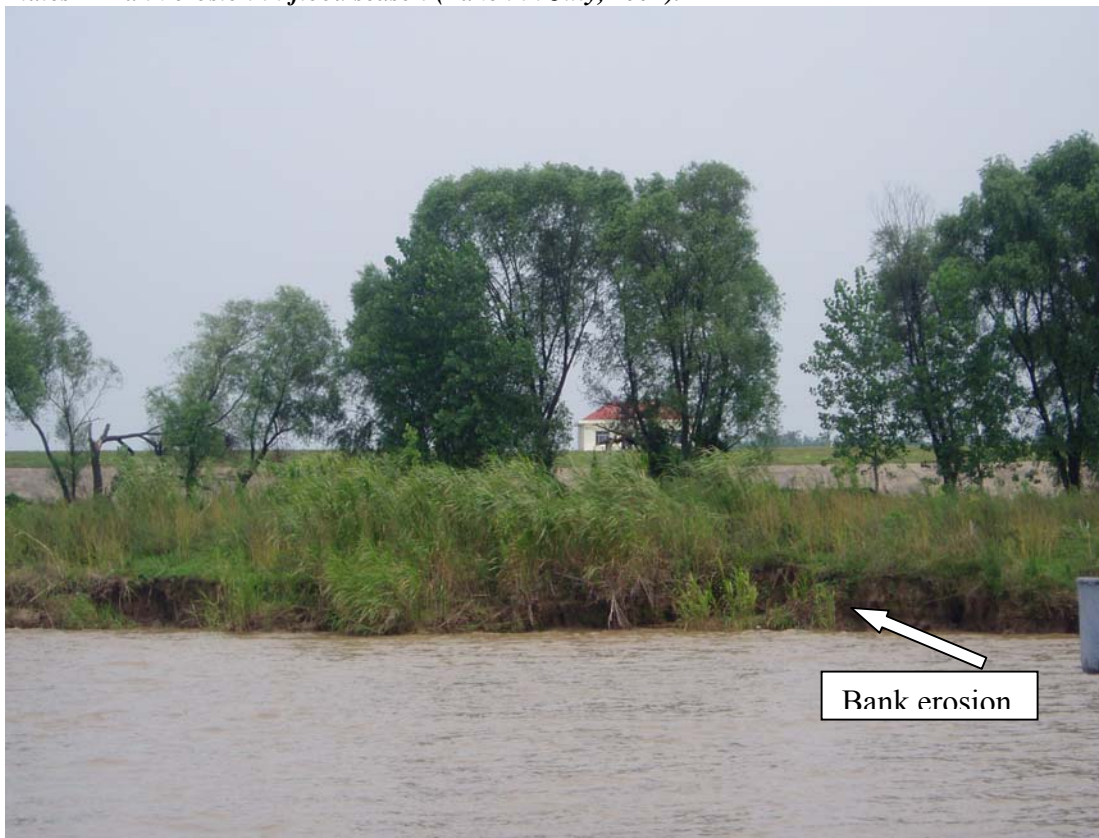
Plates 4 Bank erosion in flood season (Taken in July, 2004).

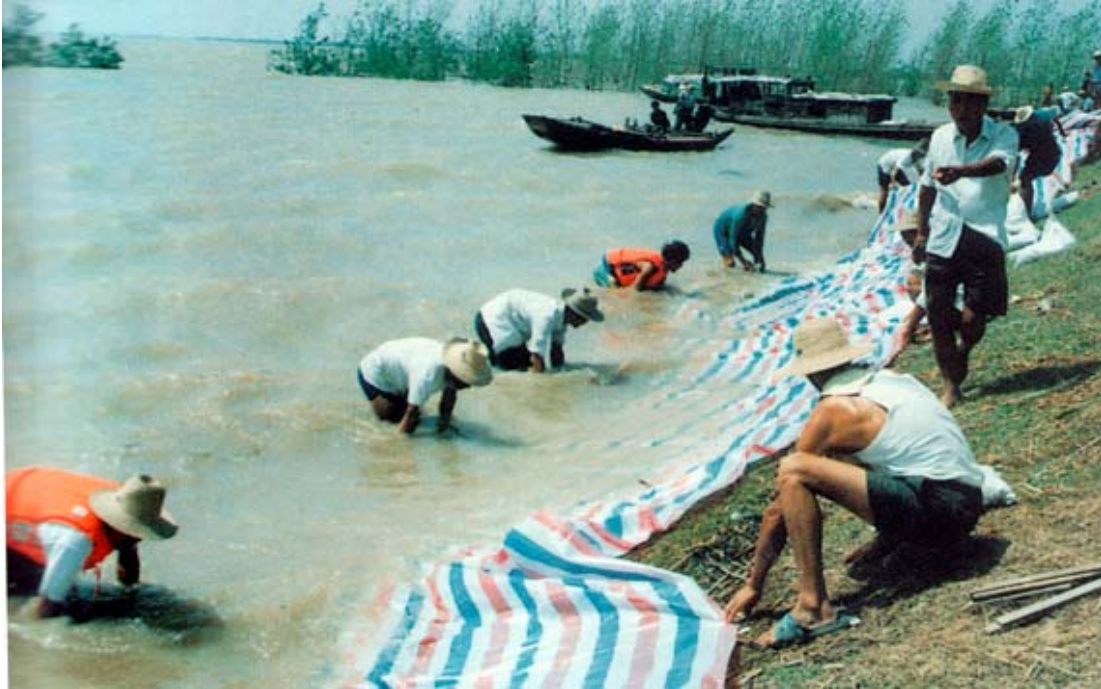
Plates 5 Overtopping of levee during flood in 1998.
