# Floodplain sediment from a 100-year-recurrence flood in 2005 of the Ping River in northern Thailand

**Abstract.** The tropical storm, floodwater, and the floodplain-sediment layer of a 100-year recurrence flood are examined to better understand characteristics of large monsoon floods on medium-sized rivers in northern Thailand. Storms producing large floods in northern Thailand occur early or late in the summer rainy season (May–October). These storms are associated with tropical depressions evolving from typhoons in the South China Sea that travel westward across the Indochina Peninsula. In late September, 2005, the tropical depression from Typhoon Damrey swept across northern Thailand delivering 100–200 mm/day at stations in mountainous areas. Peak flow from the 6355-km<sup>2</sup> drainage area of the Ping River upstream of the city of Chiang Mai was 867 m<sup>3</sup>s<sup>-1</sup> (river-gage of height 4.93 m) and flow greater than 600 m<sup>3</sup>s<sup>-1</sup> lasted for 2.5 days. Parts of the city of Chiang Mai and some parts of the floodplain in the intermontane Chiang Mai basin were flooded up to 1-km distant from the main channel. Suspended-sediment concentrations in

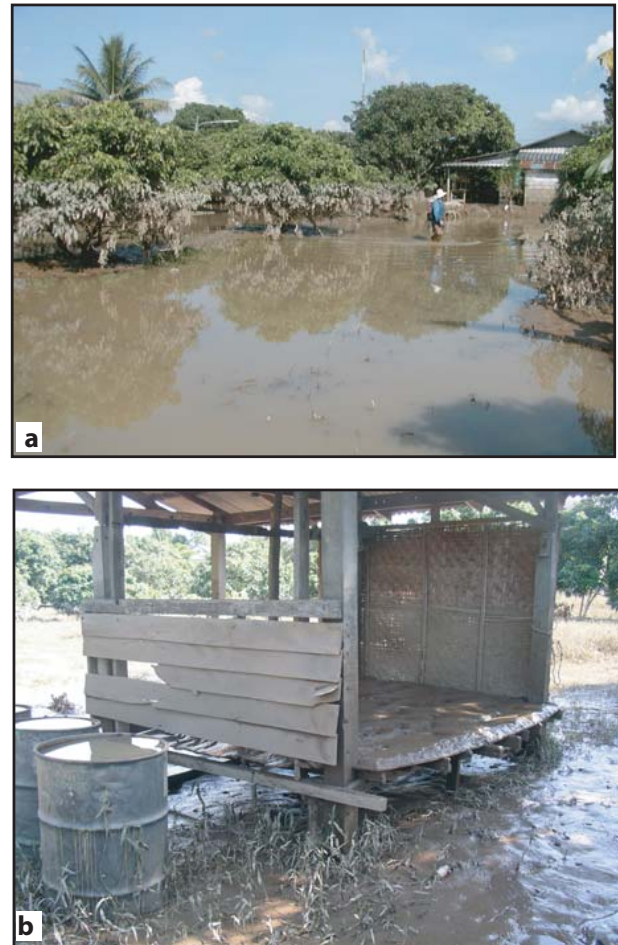
**Fig. 8.** (a) High water line on fruit trees. Floodwater depth was 1.3 m. Location is at point B of Fig. 11. View is to the southeast. (b) hut located at point H1 on Fig. 11. Five cm of sediment deposited on platform elevated 0.55 m above ground and 8 cm of sediment on surrounding ground (see Fig. 12). Photos taken on 2 October.

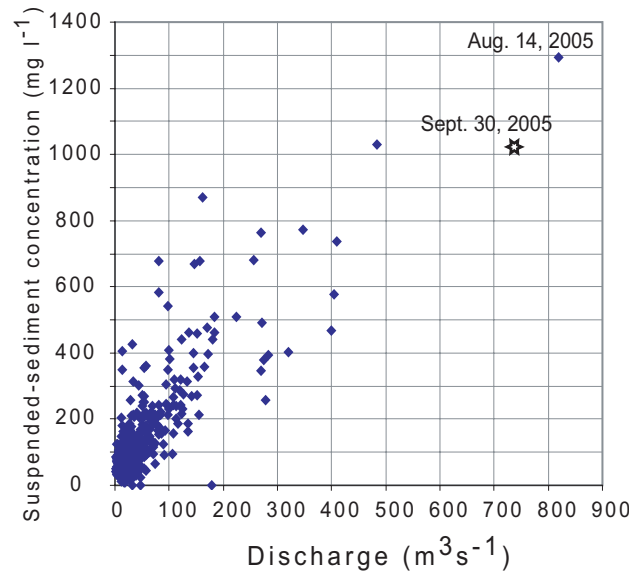
**Fig. 10.** Suspended-sediment rating data for the Ping River at the Chiang Mai P.1 gage site from Royal Irrigation Department for 1991–August, 2005. Samples obtained monthly and bimonthly using a US D-49 depth-integrating sampler. Shown on the graph are the high values of the one near-surface sample taken on 30 September, and also the one depth-integrated sample taken by the Department during the August 14 flood.
