A case study of foundation failure of a residential building: From diagnosis to reparation

Ahmed Merah

University AmmarTelidji of Laghouat , Faculty of Civil Engineering and Architecture, Research Laboratory of Civil Engineering (LRGC), Laghouat, 03000, Algeria.

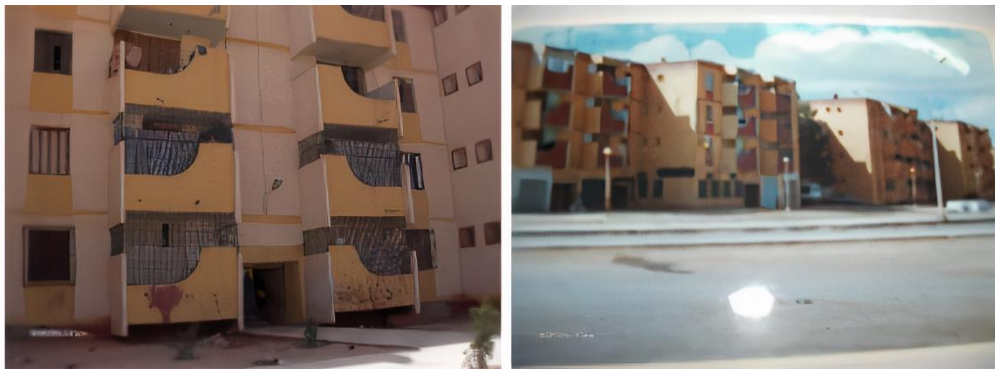
Fig. 1. Building (R + 3)

This study concerns a reinforced concrete building with 3 floors and crawl space situated in Laghouat, Algeria, for residential use, started exploiting in 1985. The structure is designed as a beam column system with foundations in insulated foundations and floors in solid slabs. It is part of a group of six buildings. (Fig. 1).

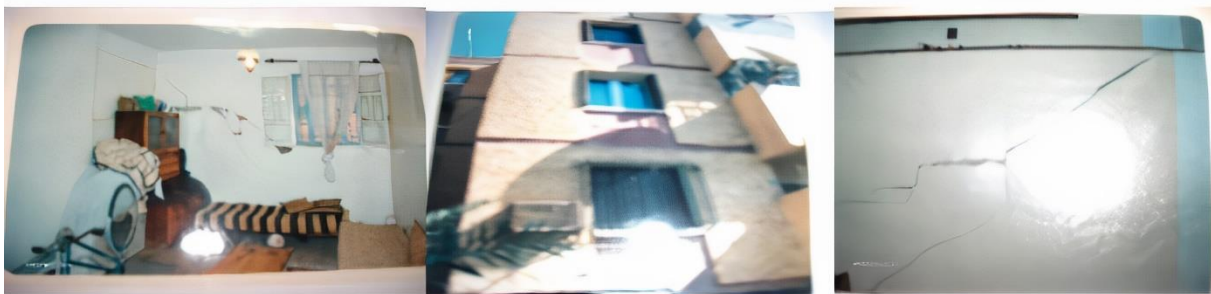
Fig. 2. Cracks in exterior and interior walls

A pre-diagnosis show the appearance of cracks inclined at 45 ° on the exterior walls in double partitions and on the partitions in plaster tiles (Fig. 2), these cracks started appear in 1997.

Some pipes drain into the crawlspace. The nature of the sitting soil is clay nature. From that preceded, the foundations of the building underwent a differential settlement which caused the damage observed, (Burland et al., 1978).

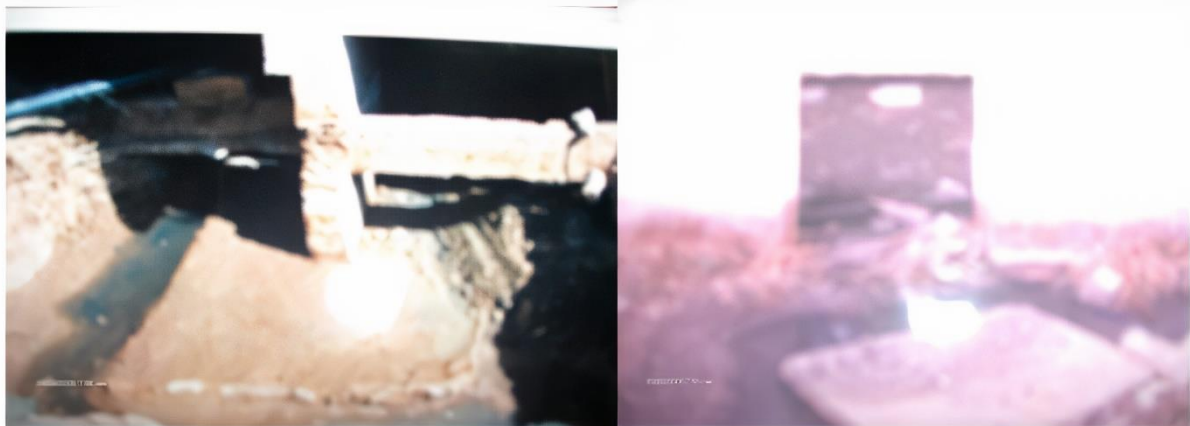
Fig. 3. The soil of foundations is completely saturated and sanitary collector were damaged.

In this sense, for a better understanding of the problem lead to correct technical solution. To follow the steps of diagnosis mentioned above, soundings to diagnose foundations were made, after sounding, Fig. 3 shows that the soil was completely saturated with sanitary water. this figure (Fig. 3) clearly shows that the sanitary pipes of the building are damaged, and the soil of foundation is completely saturated.

The soil of the crawl space of the building was highly humid, showing a failure in the pipes of drinking water or sanitation.

More ever, permanent stagnation of wastewater inside the crawl space caused by the saturation of pipes as well as the deterioration of the pipes and manholes. Sanitary collectors are heavily degraded in which walls are made walls with masonry blocks.

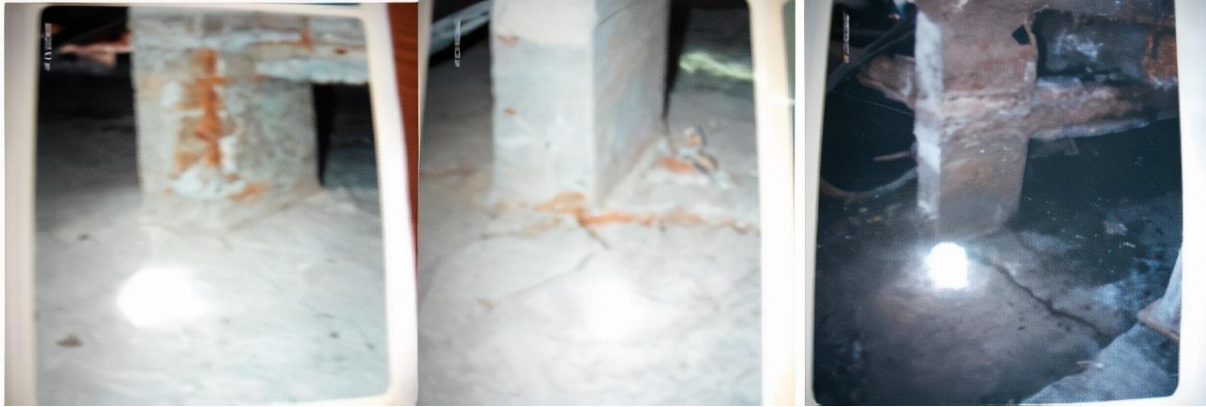
Fig. 4. Primary columns rusted and important cracks in foundation.

It was recommended that the company remove the spoil under the foundations and repair them alternately to avoid any sudden movement for the building and to ensure the safety of the workers. During the removal of spoil under the first foundations and primers columns, it was found that some of them are heavily damaged (Fig.4).

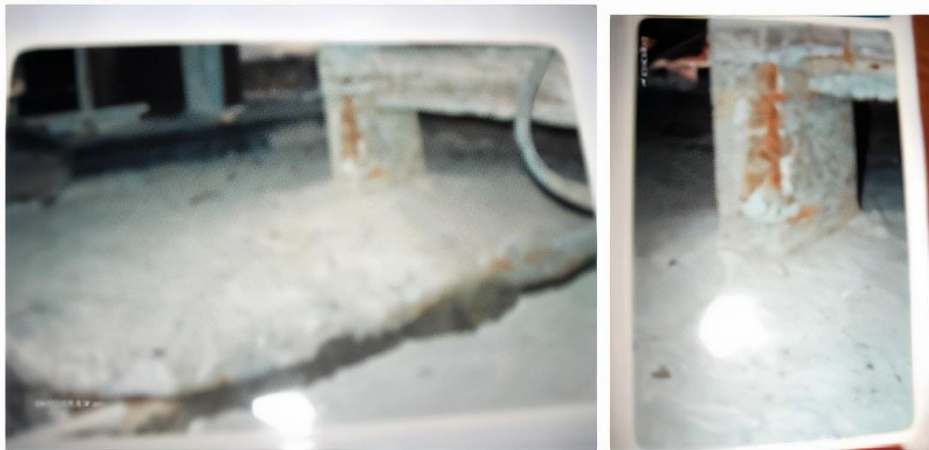
Fig. 5. Foundation casting without formwork.

In addition, a complementary soil study was recommended. This study shows that the bearing capacity of the soil is reduced with 50% compared with the initial bearing capacity, caused by the new conditions of change of water content of the ground. Other problems of poor workmanship have been found, namely casting of foundations without formwork or the thickness of foundations have some differences from the plans (Fig.5).
