**CEES  
2020**

INTERNATIONAL CONFERENCE  
CONSTRUCTION, ENERGY  
ENVIRONMENT & SUSTAINABILITY

## **MONITORING DEGRADATION PATTERNS OF SANDSTONE MONUMENTS AFTER CONSOLIDATION TREATMENTS**

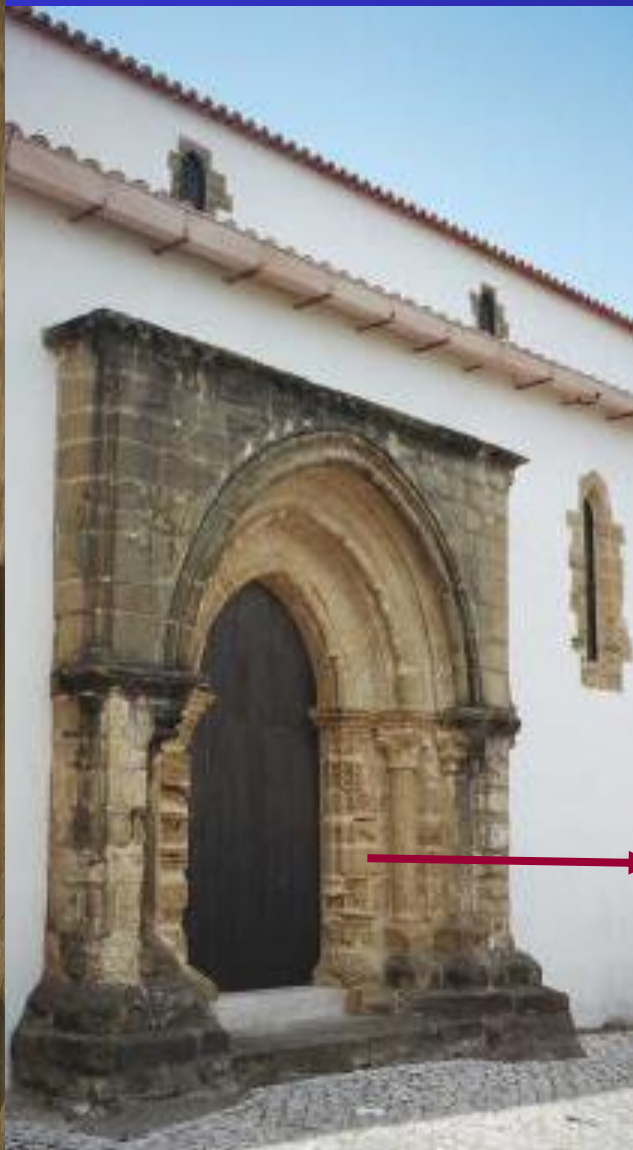
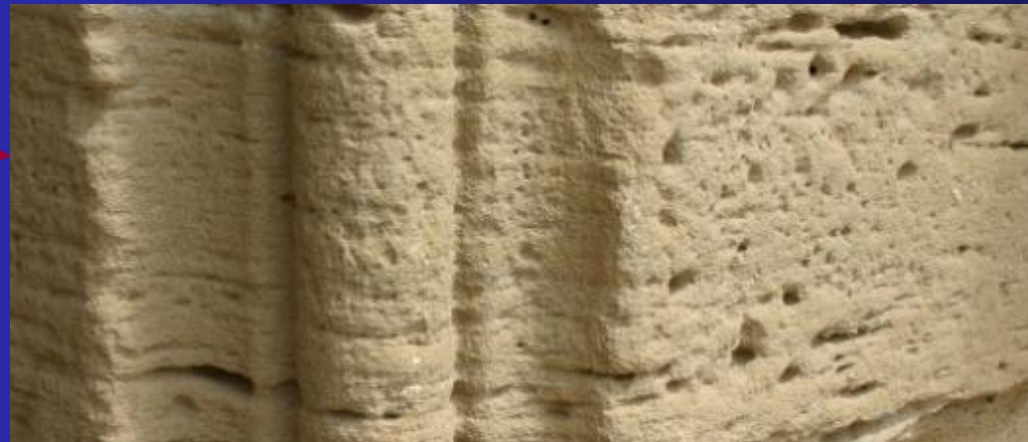
St. Leonard's Medieval Church

# DEGRADATION PATTERNS ON THE SANDSTONE FAÇADES OF ST. LEONARD'S CHURCH

Five types of stone deterioration patterns (ICOMOS-ICS glossary):

Crack & deformation

Detachment

Features induced by material loss

Discoloration & deposit and biological  
colonization.

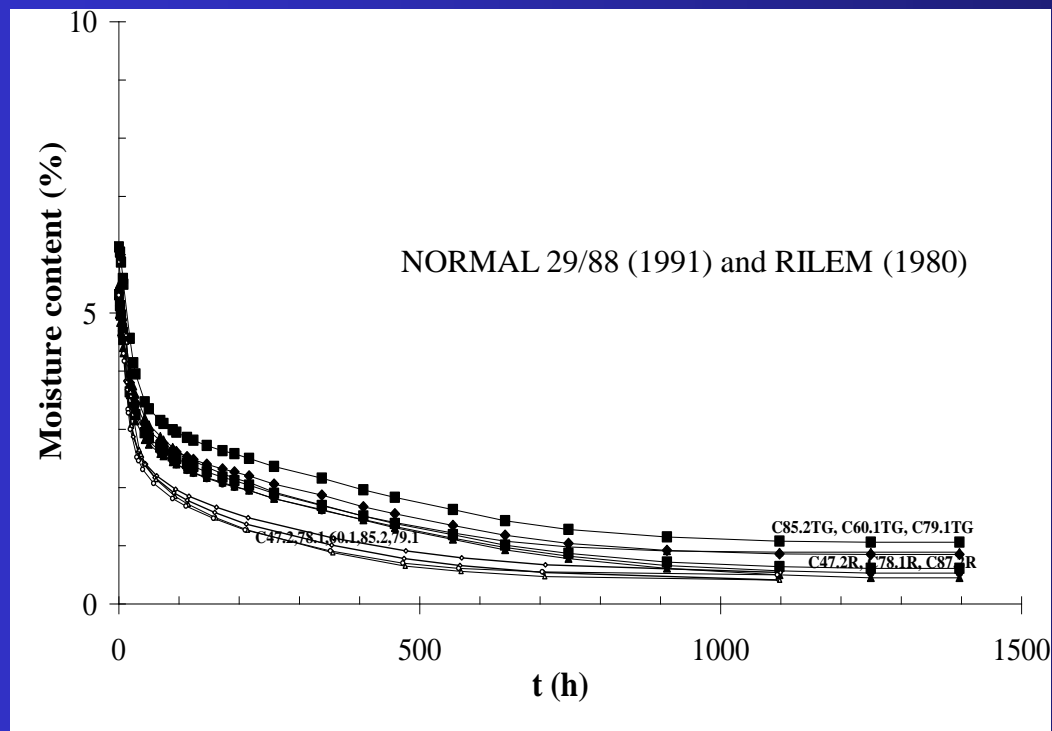
NORMAL 29/88 (1991) and RILEM (1980)

## PHYSICAL BEHAVIOUR (DI)

Variety	Drying Index Average $\pm$ SD (CV %)
C	0.17 $\pm$ 0.01 (5.88)

Consolidating product	Drying Index Average $\pm$ SD (CV %)
TG	0.29 $\pm$ 0.01 (3.45)
R	0.25 $\pm$ 0.01 (4.00)

Major increase

71% on TG

47% on R

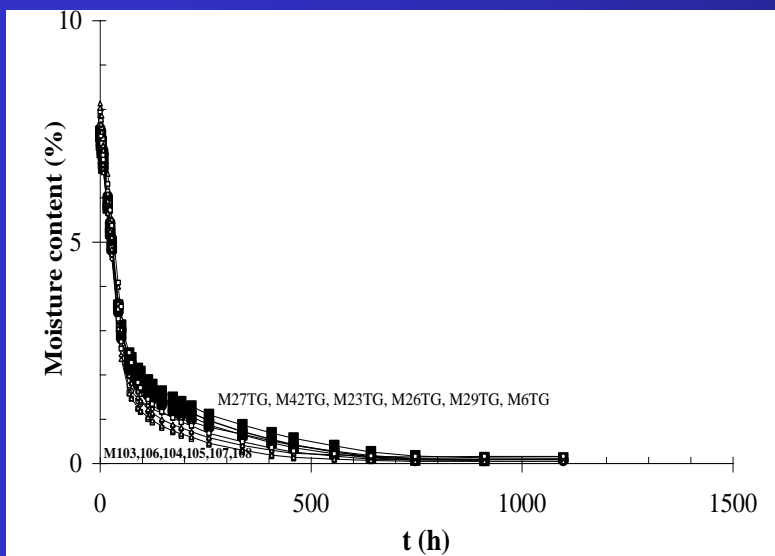
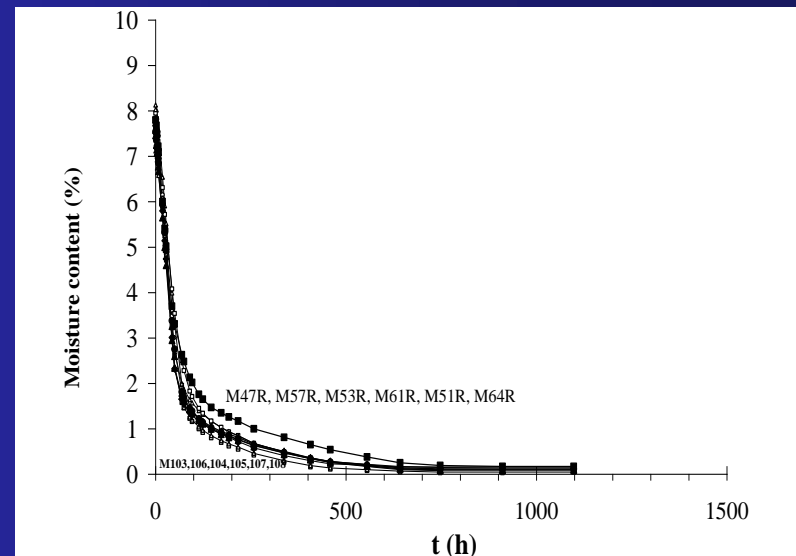
NORMAL 29/88 (1991) and RILEM (1980)

## PHYSICAL BEHAVIOUR (DI)

Variety	Drying Index Average $\pm$ SD (CV %)
M	0.10 $\pm$ 0.01 (9.80)

Consolidating product	Drying Index Average $\pm$ SD (CV %)
TG	0.12 $\pm$ 0.01 (8.33)
R	0.11 $\pm$ 0.01 (9.09)

Minor increase

20% on TG

10% on R

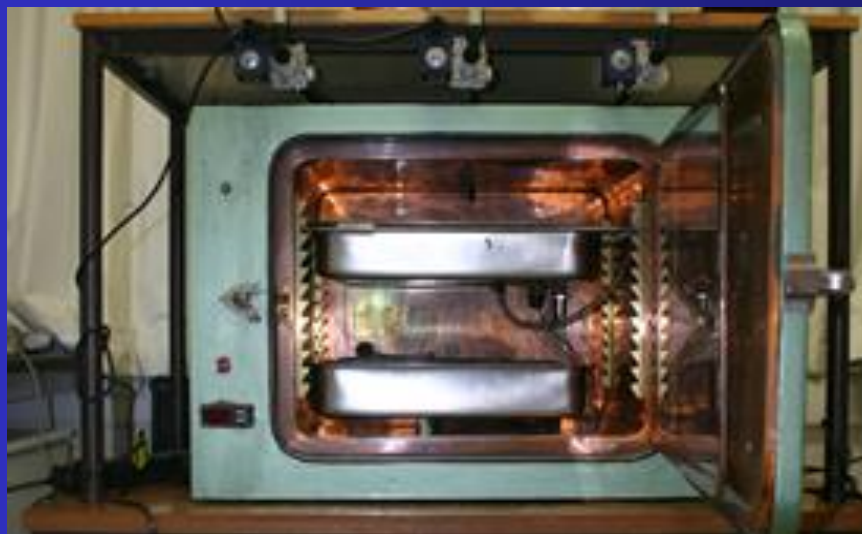
RILEM V.1a, b, V.2 (1980) and EN 12370, replacing sodium sulphate solutions by sodium chloride solutions.

- Salt crystallization-dissolution ageing tests were carried out in an automatic ageing chamber prototype (M typology).

- The variation of mass loss ratio is lower on treated specimens with R than on treated specimens with TG, ranging between a mean value of 3% after 70 salt cycles on R to 3% - 15% after 60 salt cycles on TG. The variation of mass loss ratio is even lower on R than on non-treated specimens (mean value of 8%).
- TG treated specimens had an average UCS reduction of circa 75% after 60 cycles of accelerated salt crystallization, in comparison with sandstone specimens treated with R that had a minor reduction of about 18% at 70th cycle. Non treated specimens decreased the mean compressive strength values of about 56%.

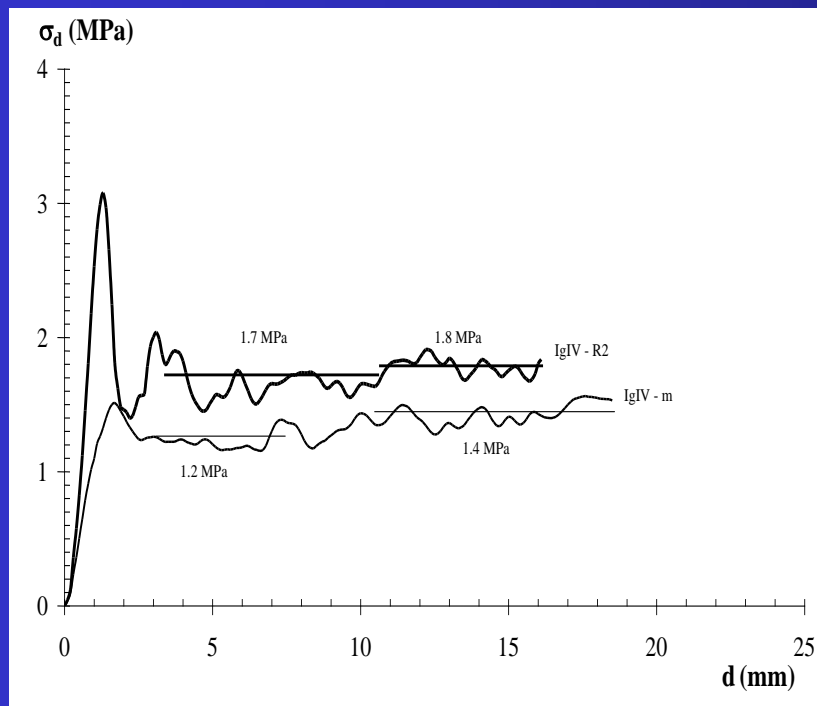
## MECHANICAL BEHAVIOUR (Drilling Strength)

Mean values increased from 1.2 – 1.4 MPa on C sandstone to 1.7 – 2.0 MPa on R applications (up to 40%).  
 Drilling depths reached up to 20 mm.  
 Impregnation thickness higher than 15 mm.

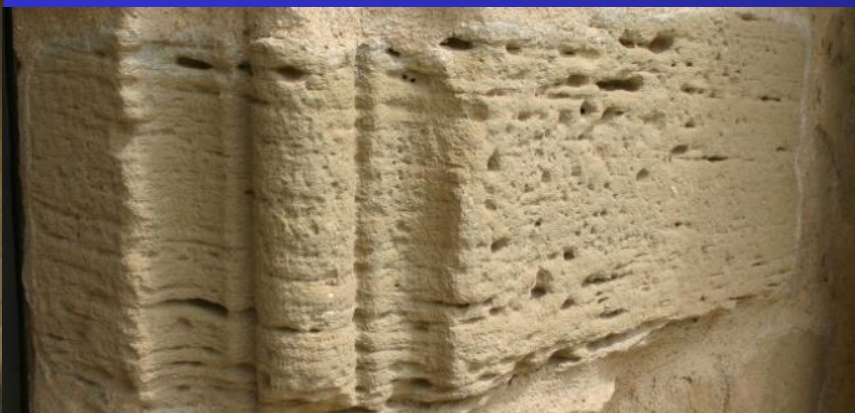
Before treatment

assessment by Karsten tube  
& water absorption under  
low pressure coefficient

Coefficient of absorption of the area of non-treated block (NTM) is a value of  $6 \text{ kg/m}^2/\sqrt{\text{h}}$ , i.e. between mean values of  $7.9 \text{ kg/m}^2/\sqrt{\text{h}}$  on non-treated specimens and  $4.5 \text{ kg/m}^2/\sqrt{\text{h}}$  on R, being closer of R value than non-treated specimens value.

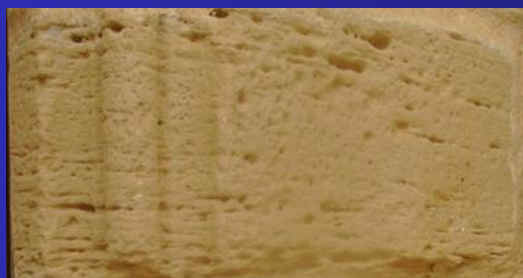
The consolidated area of the selected block of St. Leonard's church is still well-preserved, as visible in Figure, in spite of the higher value of water absorption.
