**Published in**  
Natural Hazards

# Geomorphological mapping and geophysical profiling for the evaluation of natural hazards in an alpine catchment

**Abstract.** Liechtenstein has faced an increasing number of natural hazards over recent decades: debris flows, slides, snow avalanches and floods repeatedly endanger the local infrastructure. Geomorphological field mapping and geo-electrical profiling was used to assess hazards near Malbun, a village potentially endangered by landslides, and especially debris flows. The area is located on the tectonic contacts of four different nappe slices. The bedrock consists of anhydrite and gypsum, dolomite, shale, marl, and limestone. The spatial distribution and occurrence of debris flows and slides is evaluated through a combination of geomorphological expert knowledge, and detailed visualization in a geographical information system. In a geo-database a symbol-based 1:3000 scale geomorphological map has been digitized and rectified into polygons. The polygons include information on the main geomorphological environment, the Quaternary material distribution and of geomorphological processes, which are stored in attribute tables. The spatial

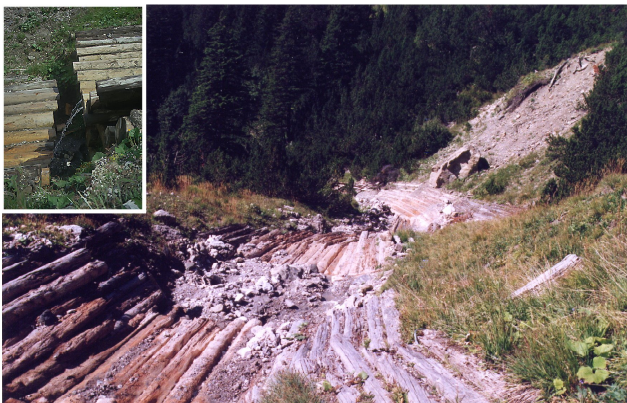
**Fig. 2.** The wooden drainage system is disrupted by the eroding power of debris flows, by small slides from the adjacent slopes (top right) and by differential movements within the landslide (detail top left), which leads to increased displacements rates.

displacements within the landslide and the erosive forces of debris flows (Fig. 2). The resulting infiltration increased the displacement rates. It was noticed by Wenzel (1985) that the landslide could pose a serious threat to Malbun; in the event of a sudden failure over 500 000 m<sup>3</sup> of material could be released. We therefore decided to evaluate the landslides and especially the displacement *pattern and depth* of the landslide in the central part of the catchment (see Fig. 3). The objectives of the study were: 1. to prepare a detailed 1:3000 geomorphological map that shows the spatial distribution of all landforms and processes; 2. to carry out a geophysical analysis over the gypsum underlain landslide, and 3. to present a GIS-supported hazard zonation of debris flows.

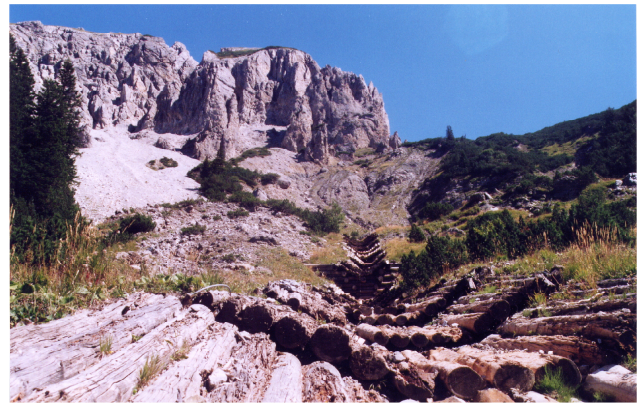
**Fig. 4.** Upslope view with the steep Hauptdolomite cliffs and associated scree slopes in the upper left part. The central part of the photo shows the major scarp of the gypsum underlain landslide. In the foreground the eroded drainage system is shown.
