Nondestructive Condition Assessment of Civil Infrastructure Using Ultrasonic Technique

**Problem Report submitted to the
Benjamin M. Statler College of Engineering and Mineral Resources
at West Virginia University
in partial fulfillment of the requirements
for the degree of**

**Master of Science
in
Civil Engineering**

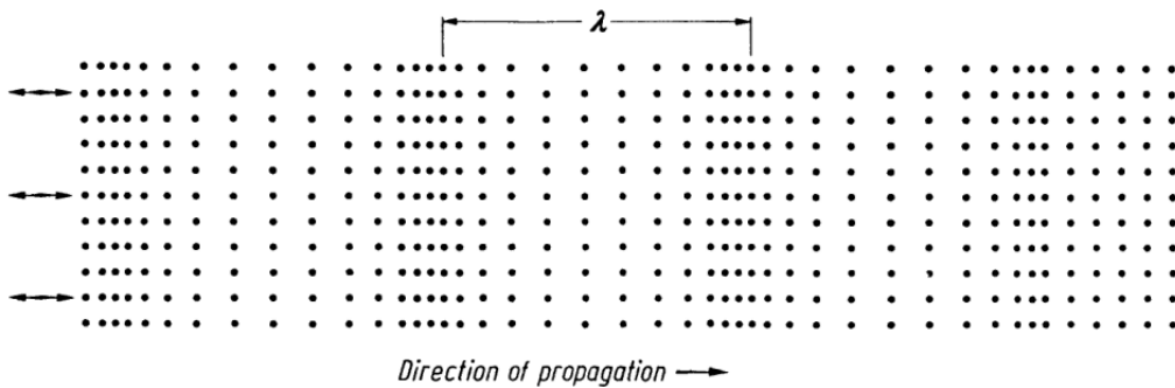
Figure 2.2: Longitudinal waves showing excited zones. (Krautkrämer et al. 2013)

These zones are considered compression zones and occur as the wave travels through the body. Longitudinal waves oscillate in the direction of the propagation. Transverse waves are another

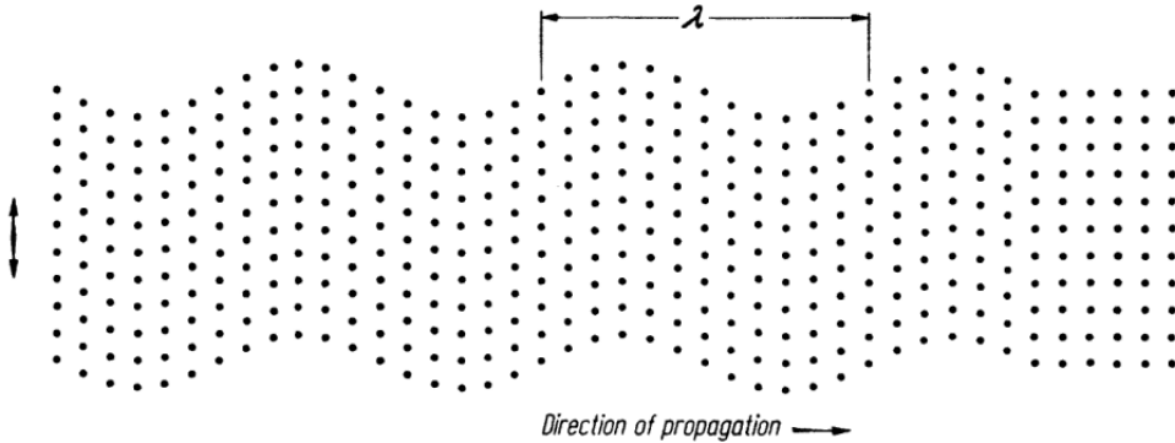
occurrence of wave within a member which are shown in Figure 2.3. Transverse waves occur perpendicular to the member rather than in the same plane as the P-Waves travel. These transverse waves are also considered shear waves or ‘S-Waves’ and are conducted at right angles of the propagation.

Figure 2.3: Transverse or Shear (S-waves) from left to right (Krautkrämer et al. 2013)

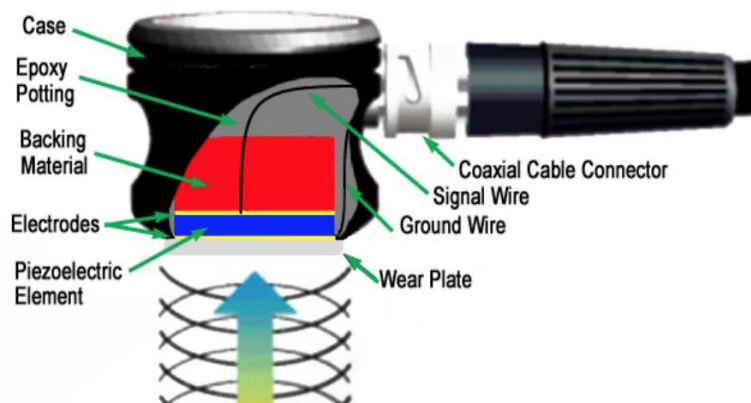
Figure 2.4: Cut away of standard transducer used in ultrasonic testing (Kishore, 2014)

Figure 2.4 , is a typical cut away of a transducer. Transducers do not always need to touch the surface of the element to get the waves through the system. Most of the cases the transducer does make contact since it can lead to a smoother interface resulting in better information (Ryuzono et al. 2020). The one shown in the figure is a contact transducer.

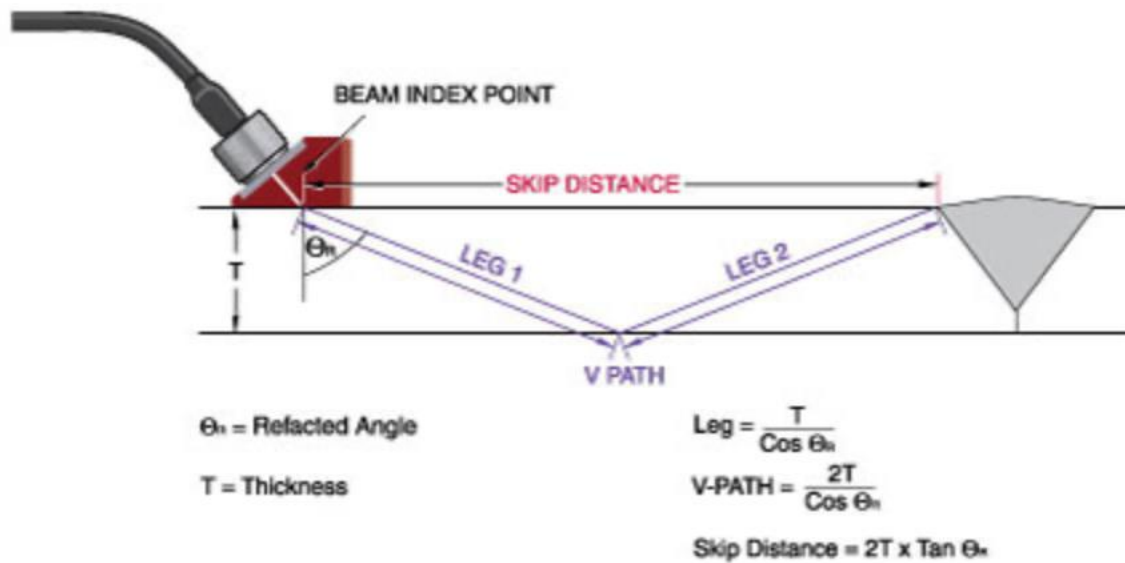
Figure 2.5: Angle Beam Transducer Position (Kishore, 2014)

By putting the transducer at an angle on the coupling surface it allows for the sound to travel a better path to detect flaws around the welded areas. Figure 2.5 shows the path taken to get slightly underneath the altered area and the equations used to calculate the path. The skip distance will always be shorter than the actual path traveled by the wave since the sound rebounds off the back wall in the component. When the angle is zero the weld blocks the path, but the angle deflects the sound of the back wall covering the hidden area. Another commonly applied application for angle beam transducers are when surface waves are required to locate a defect. These surface waves find flaws and defects on the face of the system or the surface of the testing subject.

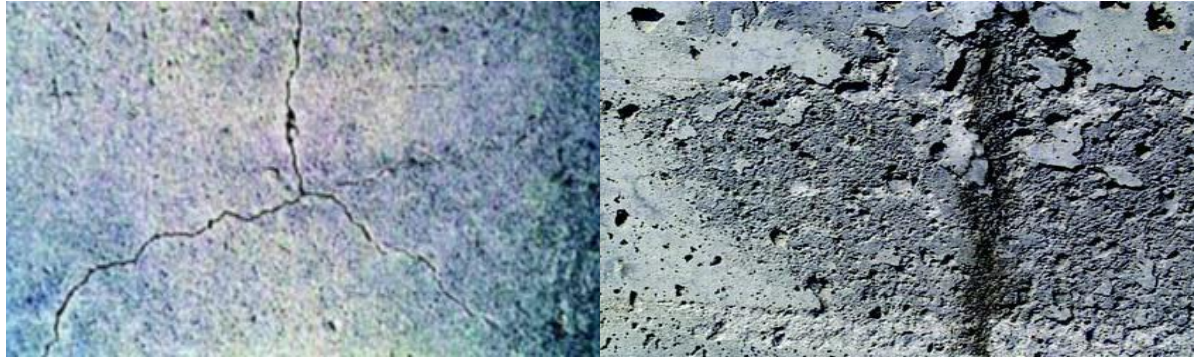
Figure 3.1: Example of spalling and cracking in concrete samples (Roblero, 2017)

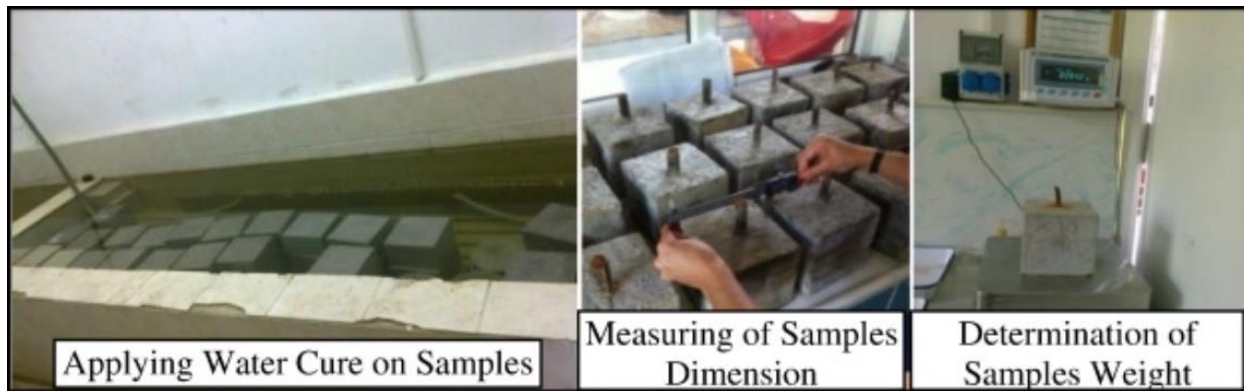
Figure 3.2: Demonstration of sample cubes being evaluated for testing (Sabbag & Uyanik, 2017)

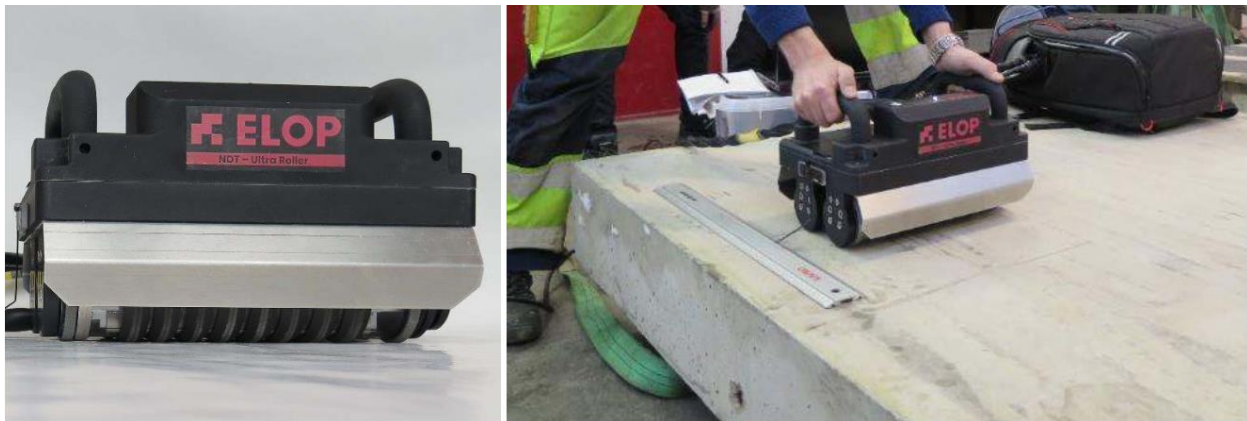
This paper introduces a multilayered ultrasonic rolling scanner intended to assess the structural properties in concrete. The scanner consists of an eight-element transducer array units that utilizes a piezoelectric polyvinylidene fluoride (PVDF). The ultrasonic scanning array system was designed by ELOP to analyze defects in concrete structures at a frequency range of 50-250 kHz. Since the system has multiple layers, it makes up for the low electro-mechanical coupling efficiency compared to the commercial ceramic transducers used in other systems. The

Figure 3.4: Multilayered Ultrasonic Rolling Scanner built by ELOP (Chapagain et al. 2018)

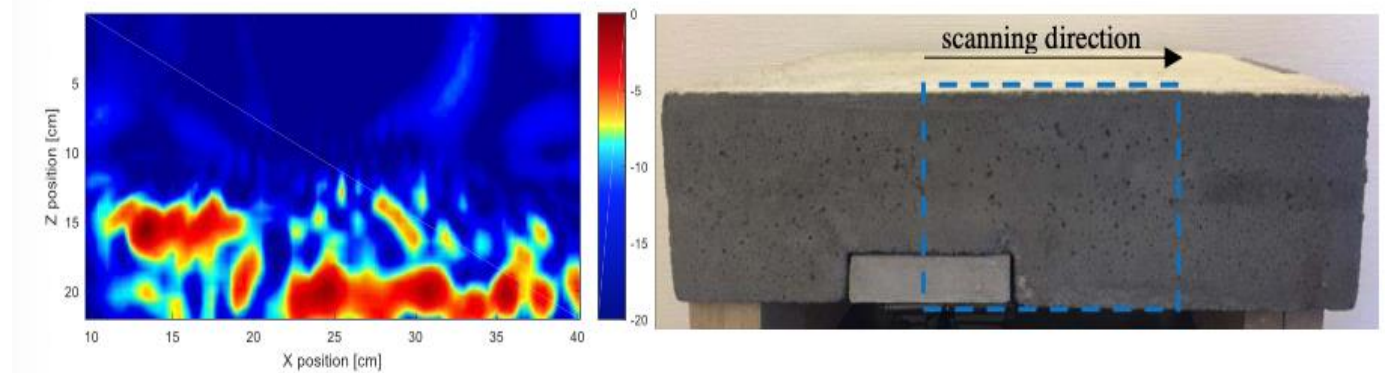
A concrete block, 20 mm thick, was analyzed for defects using the ultrasonic scanner in the along-track and cross-track direction. The blocks were prefabricated with defects before the tests were initiated to see if the scanner was capable of locating the air tubes or rebar inside. A 150 kHz frequency was used to scan the block at a 0.1 cm interval.

Figure 3.5: Example of 20 mm slab with a defect at a depth of 15 cm (Chapagain et al. 2018)

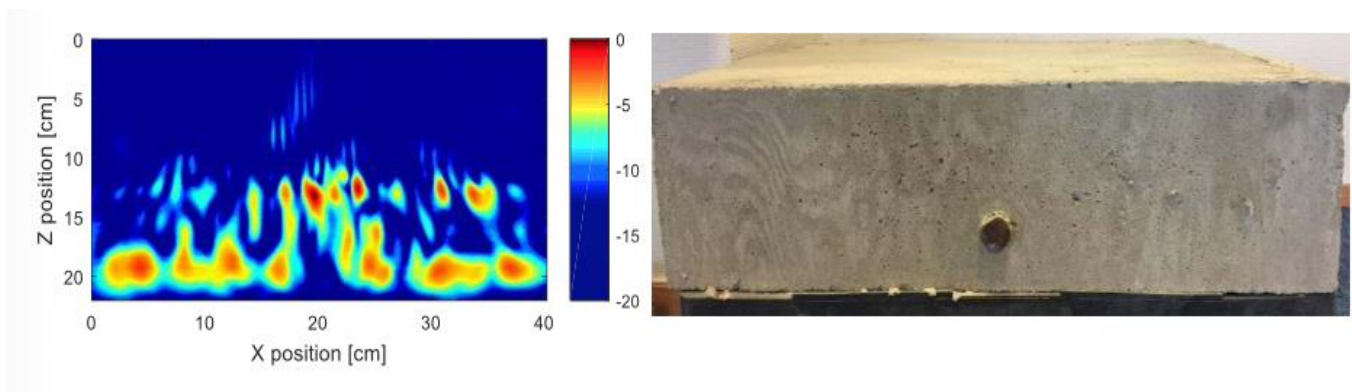
Figure 3.6: Concrete block with a steel rebar placed at 12.5 cm depth (Chapagain et al. 2018)

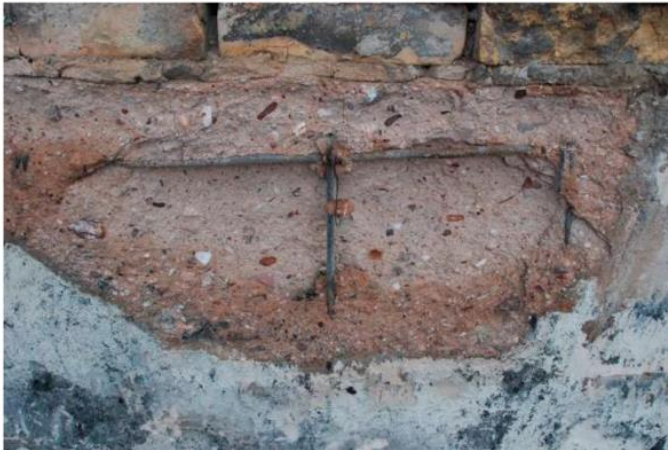
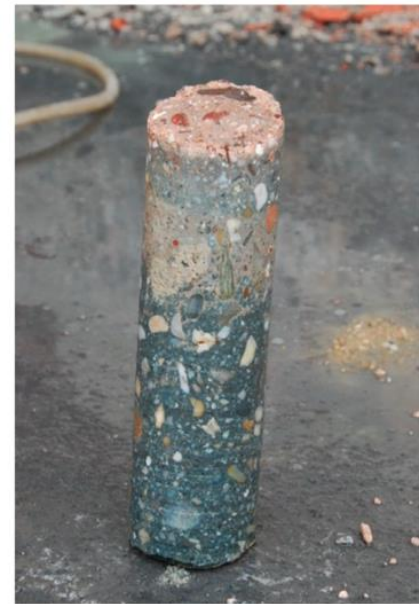
Figure 3.7: (a) Steel rebar exposure (b) color change after effects of fire exposure on core sample (Wroblewski & Stawiski, 2020)

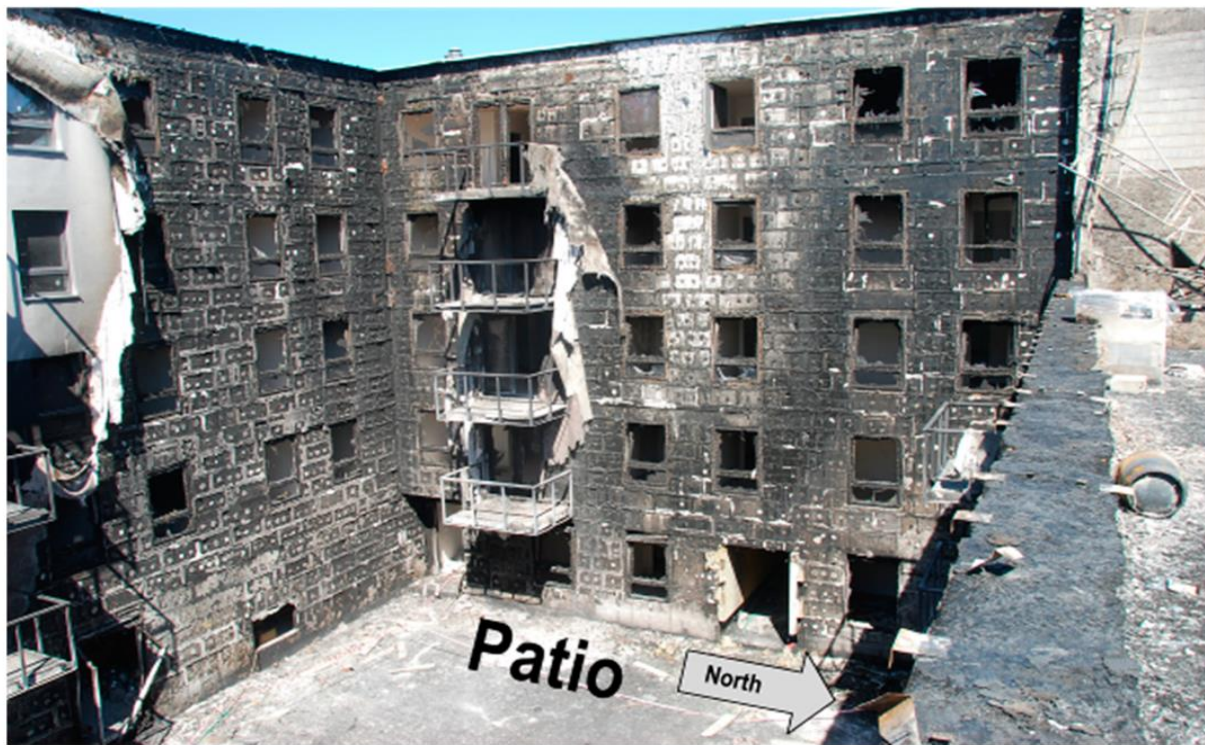
The case study was conducted based off a 64-apartment building that had been exposed to a fire while being constructed. Figure 3.8 below, shows the face of the building where the fire originated and was the strongest point. The weather during the fire was favored the spread ultimately allowing the fire to spread the whole building. The temperature, humidity, rain, and wind were all at appropriate levels that did not impeded the spread, but rather assist. The fire was aided by materials stored near the strongest area of exposure.

Figure 3.8: Face of 64-apartment complex building after exposure to fire (Wroblewski & Stawiski, 2020)

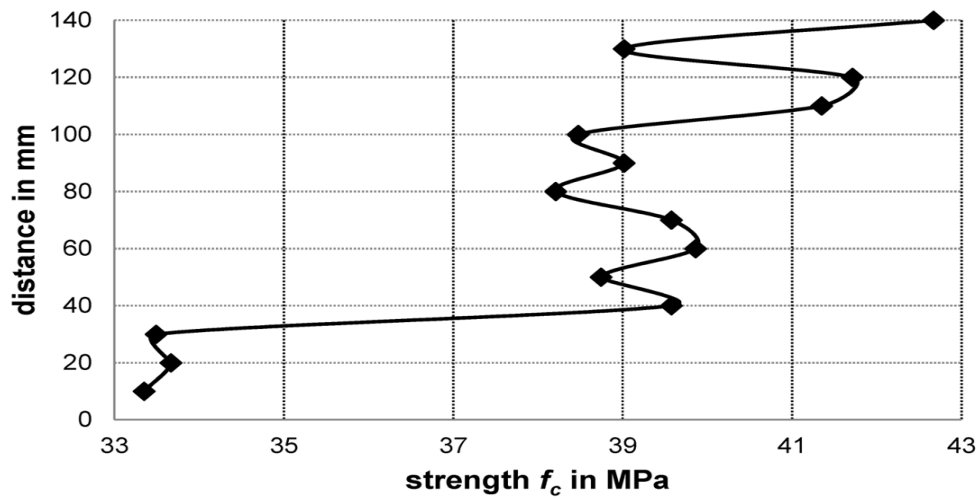
The strengths varied depending on the concrete sample since each was exposed to a different level of the fire and temperature. Throughout most of the concrete samples tested, the strength towards the surface of the concrete is roughly half that of the bottom layer. The middle section, between the top 25% and bottom 25%, the strength of the concrete indicated that it was only 25% reduction from the bottom section of the layer. Not all of the samples followed the same pattern, but the numbers above reflect the vast majority of the samples taken. The change in the strength consistently jumped in strength starting right around 30 mm deep in the concrete samples. Since the jump in strength is so large, this area is considered the fire effect. Figure 3.10 shows the strengths of one of the sample cores over different increments of depth.

Figure 3.10: Strength of concrete sample after exposure to fire based on depth of testing (Wroblewski & Stawiski, 2020)

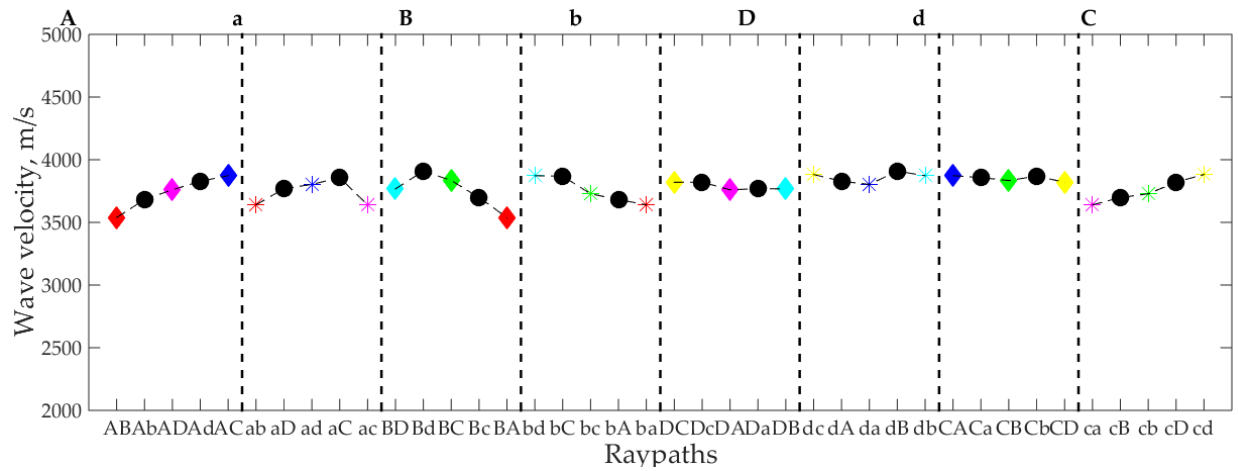
full extent. The two plots below demonstrate the velocity profiles for the given experiment.

Figure 3.11: Computed velocities for grease only coupling (Roblero, 2017)

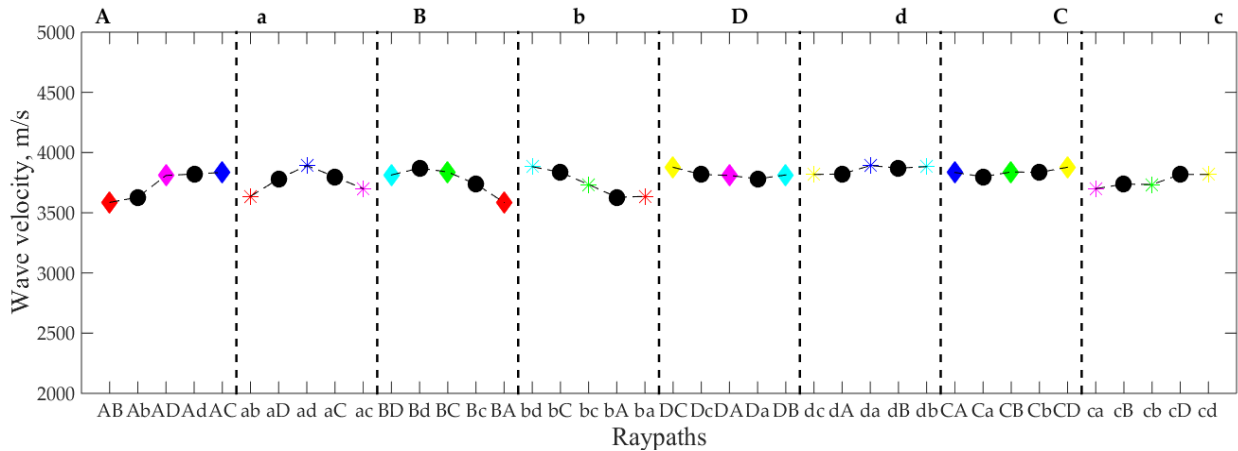
Figure 3.12: Computed velocities for a grease and duct tape coupling system (Roblero, 2017)

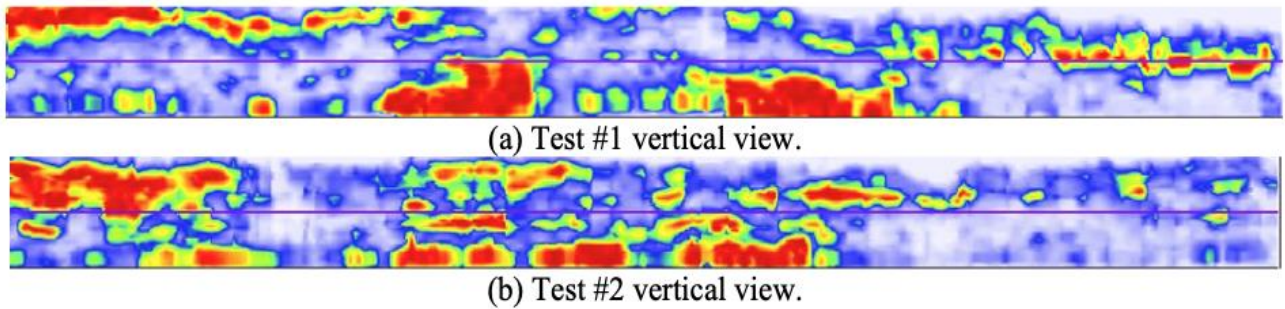
The Bayesian compression sensing (BCS) is able to turn an infrequent set of measurements and quantify the statistical uncertainty. Using different vectors and matrices for the given data the BCS converts the information into the statistical uncertainty. Once the probably is found using these principles, the confidence interval can be found for the certain level. When examining a weld, even with the best phased array techniques, the images presented for the weld were inadequate and varied between tests even on the same weld. The measurement data is too sparse for accurate readings. Figure 4.1 demonstrates how two tests on the same weld will vary in results. Information can be perceived and a generalized idea of where defects may be, but the results are different enough to cause the high levels of uncertainty.

Figure 4.1: Two separate tests conducted on the same weld (He et al. 2020)

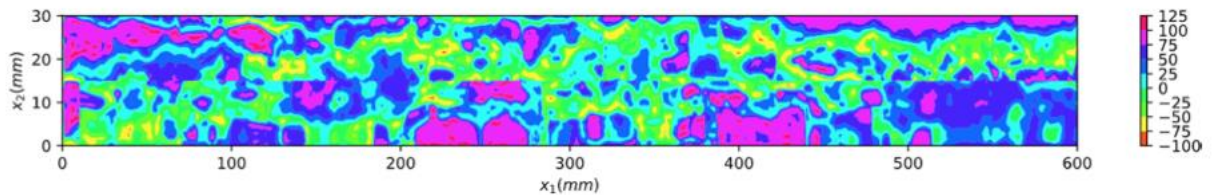
With the BCS completed for the given scenario and the vertical view of the welds, the two methods work together to create a more accurate answer. The two measurements for the steel weld (shown above) are averaged together to create one solid image. Certain peaks that only appeared in one test are eliminated since they may have been out of place or an error on the array results. The weight of the peaks (different color areas) play a role in the BCS to allow for the heavier areas to carry more levels of certainty.

Figure 4.2: Averaged result of the given steel weld (He et al. 2020)

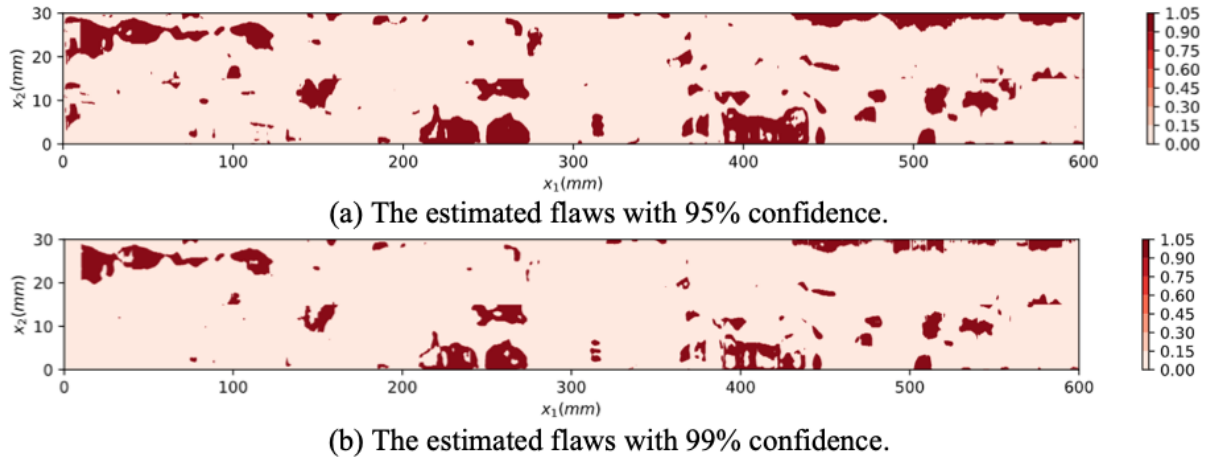
Once the BCS has completed the rest of the certainty on the averaged welds, the confidence interval for the 95% along the weld are calculated. The flaws for the welds are shown below in figure 4.3 for the 95% and 99% confidence intervals in the binomial state fields.

Figure 4.3: Flaws for steel welds at 95% and 99% confidence intervals (He et al. 2020)

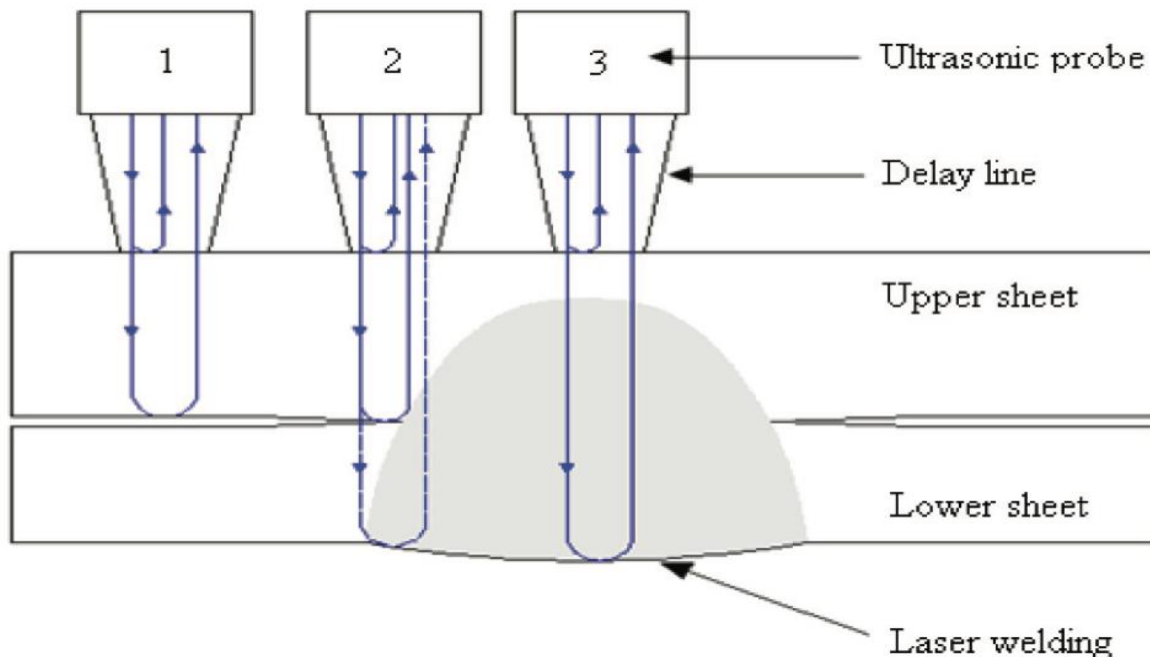
The experiment for the laser welding process began by using a stainless steel plate (SUS304) with a thickness of 1 mm and 2 mm and applying a lap joint weld. The transducer frequency used for the experiment was set at 15 MHz in order to develop a 2D scan of the specimen being examined. Figure 4.4 shows the setup used for the ultrasonic testing of the weld and interface of the base joint. At the interface of the two mediums, the wave reflected and transmitted back to the system. The sound pressure was calculated using the sound of incident wave, sound pressure of the reflective wave, and the sound pressure of the transmitted wave. The different acoustic impedance of both mediums also played part in calculating the sound pressure.

Figure 4.4: Setup for ultrasonic testing method showing the three different locations of testing (Gu et al. 2013)

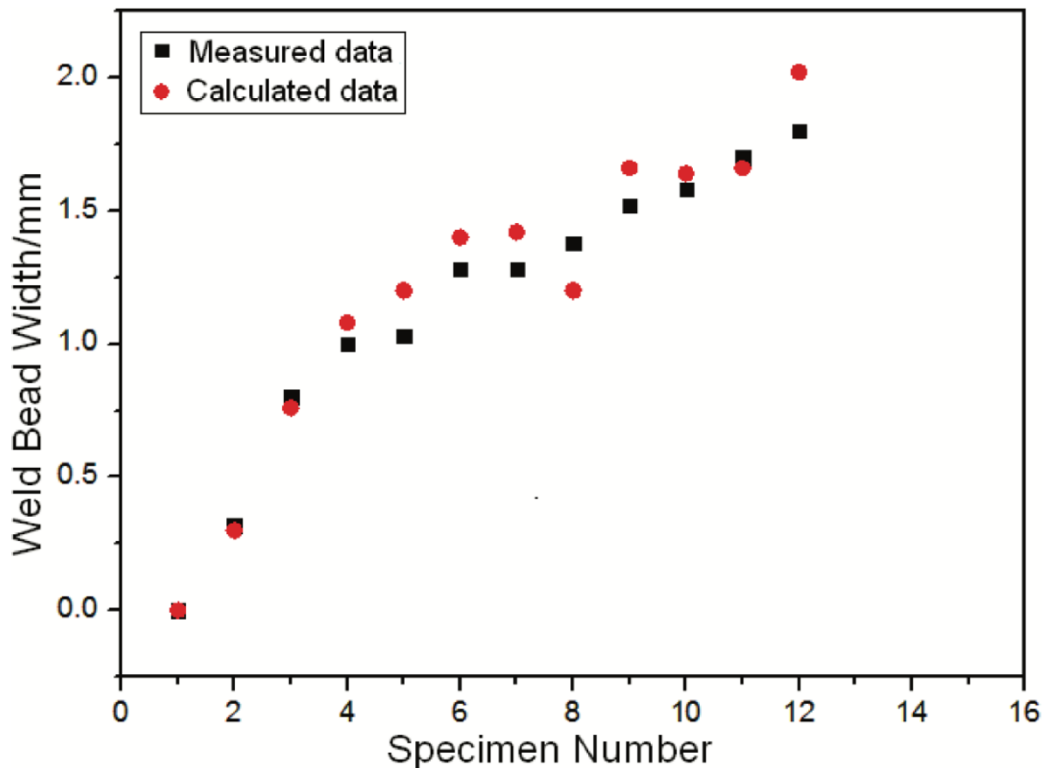
of 30% proved to be provide the highest level of accuracy. Figure 4.5 shows the accuracy from the real measured weld width compared to the results from the 30% attenuation.

Figure 4.5: Comparison between real measured weld widths and calculate data at 30% attenuation (Gu et al. 2013)

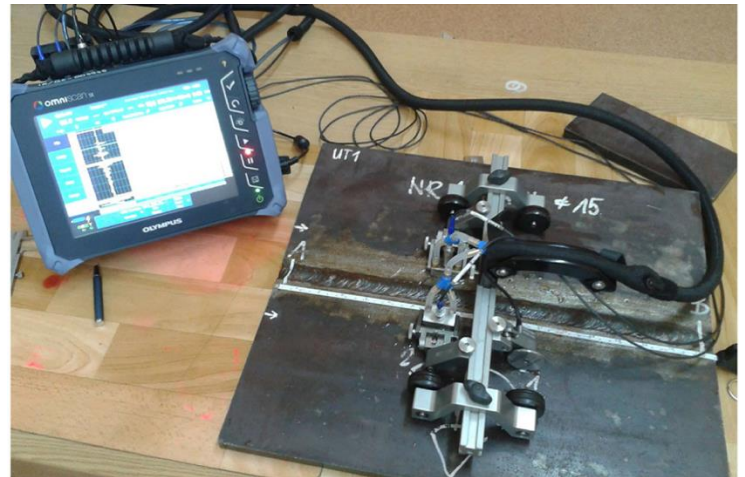
The experimental test relates the non-destructive testing method of TOFD to the regular destructive, metallographic examinations. A MAG weld on the joints was performed for a butt joint with thickness of 15 mm. The experiment setup consisted of an angle beam method where the transducer (SL-C563) sat on a wedge set at 70 degrees. The examination was performed using an OmniScan SX flaw detector and semiautomatic HST-Lite scanner. The

Figure 4.6: Setup for TOFD and equipment used in experiment (Kaczmarek et al. 2018)

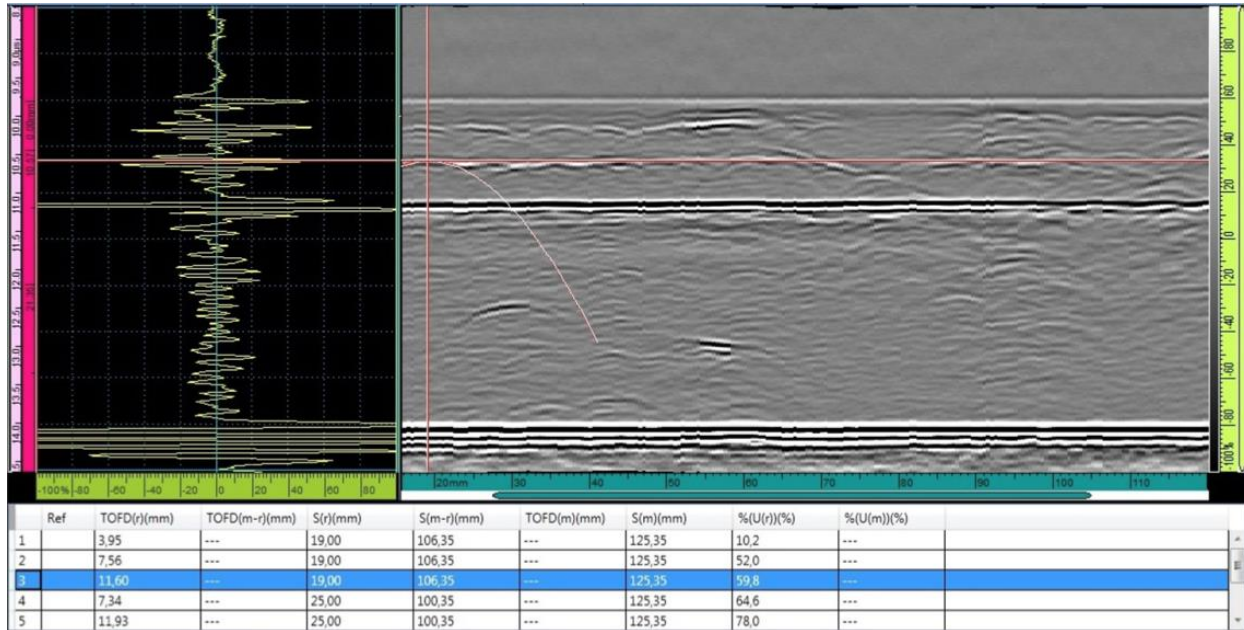
located between weld beads at the side of the groove. After comparing all of the data through both methods, the presence of all discontinuities found by the TOFD imaging method were confirmed by the metallographic examination. The figure below indicates the depth of the discontinuities displayed on the device.

Figure 4.7: OmniPC software displaying the determination and depth of discontinuities (Kaczmarek et al. 2018).

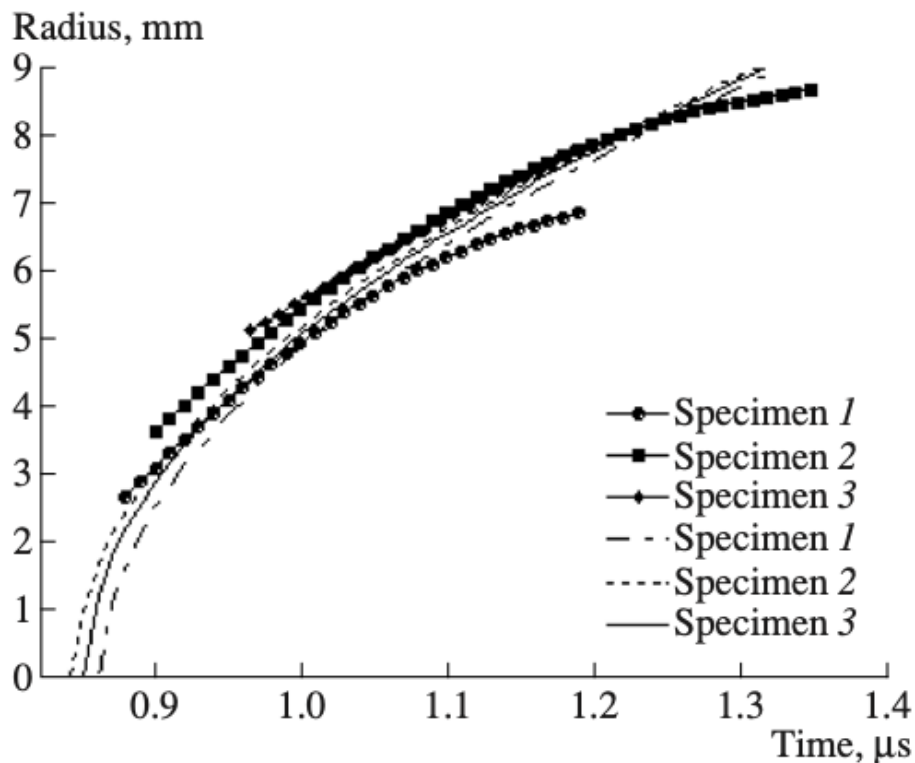
Different specimen were put under different parameters causing cracks in the 3 metals. A PCUS-10 ultrasonic flaw detector measured the three metals and yielded longitudinal and transverse waves. As microdamage increases in the mediums, the velocity of longitudinal elastic waves decrease as predicted. The metals were formed into 25 mm in diameter and 5 mm in thickness disks for testing. A transmitter was on one side of the disk resonating at 5 MHz, while the other face was used to detect the acoustic field of longitudinal elastic waves. The results from the ultrasonic beam projection increase with time at a slower rate in a defective medium rather than a defect-free specimen. The microflaws also have a lower propagation velocity than a defect-free system.

Figure 4.8: Experimental and calculated data for the three specimen with different defect sizes and patterns (Zhitlukhina & Perov, 2008)

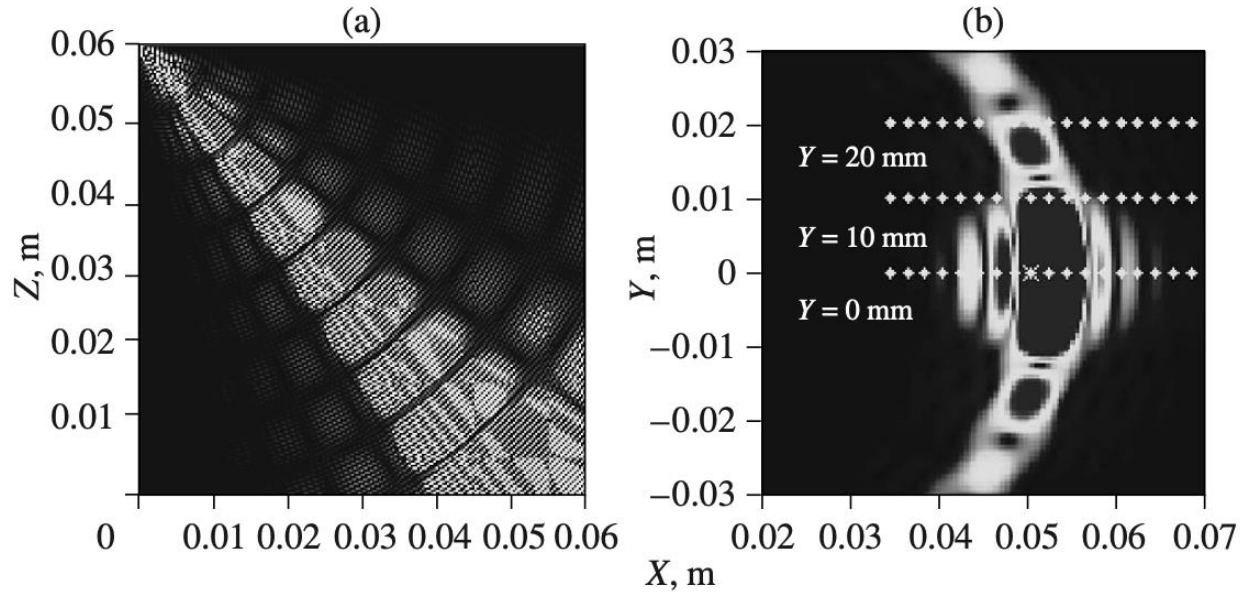
In the transverse wave direction, the sensitivity increases exponentially as the probe angle increases. After running through multiple calculations using geometry and trigonometry, the simulated data was able to be calculated. An ultrasonic transverse wave beam took a single passage through the specimen thickness for simplicity. A pulsed piezoelectric transducer producer an acoustic field created inside the specimen and on the surface.

Figure 4.9: Elastic displacements in a transverse wave for the (a) inside of the specimen and (b) surface of the specimen (Zhitlukhina & Perov, 2008).

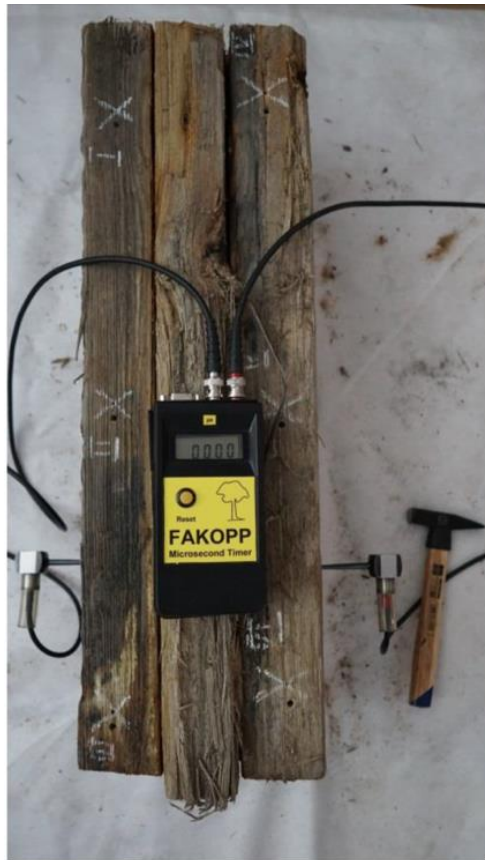
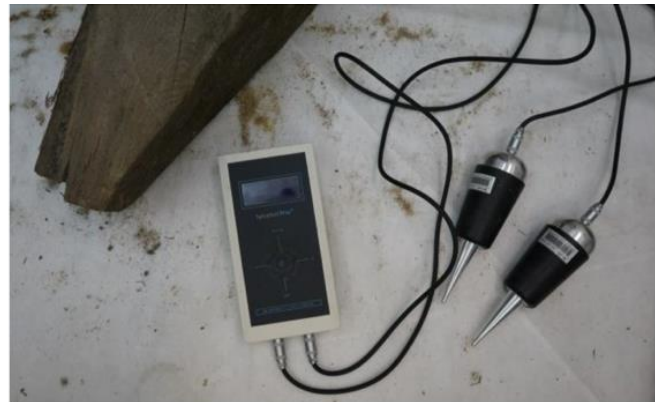
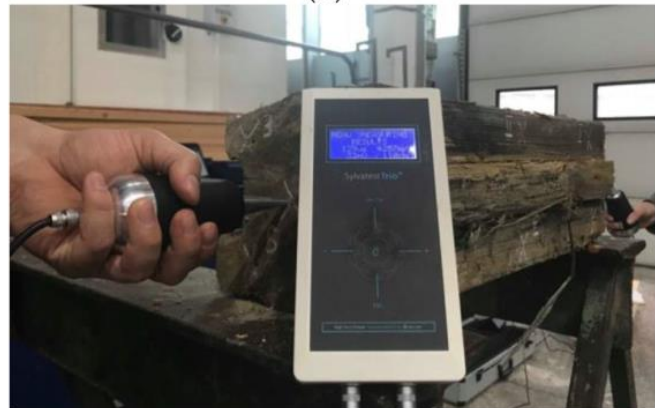
The equipment used in the study to produce the ultrasonic waves can be seen in the figure below. The Fakopp Microsecond Timer was the device used for complete NDT, while the Sylvatest Trio needed to drill 5 mm wide and 10 mm deep holes into the specimen being tested for the probes. Both devices send an ultrasonic wave into the medium to secure the results. The Fakopp Microsecond Timer uses two probes on each side of the sample to conduct the test and a single strike from a special hammer excites the waves in the material. Fakopp produces multiple other NDT machines to provide other modes of inspection. Different point and directions were tested to better determine accurate results for the medium.

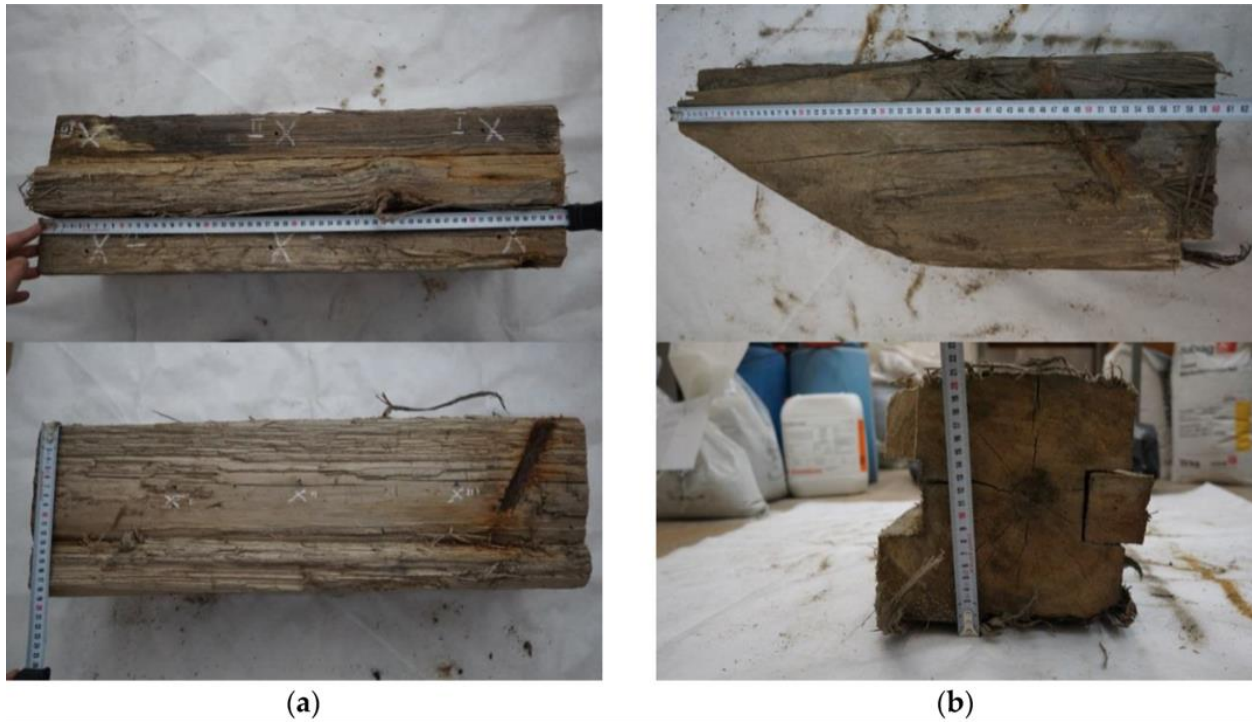
To conduct the test, an 18 mm x 20 mm x 60 cm sample cuts were taken from the removed timber wall. Samples were pulled from each of the zones previously mentioned since the structural integrity and properties would be different because of exposure to the different scenarios. The type of material the wharf timber sheet wall was made of pinewood. Other species of wood could drastically change the results. Once the equipment ran the tests for the stress waves, the destructive test was conducted by drilling into the medium.

Figure 5.3: Shown are (a) sample taken for test. (b) Sample for tests with a cut (Nowak et al. 2019)

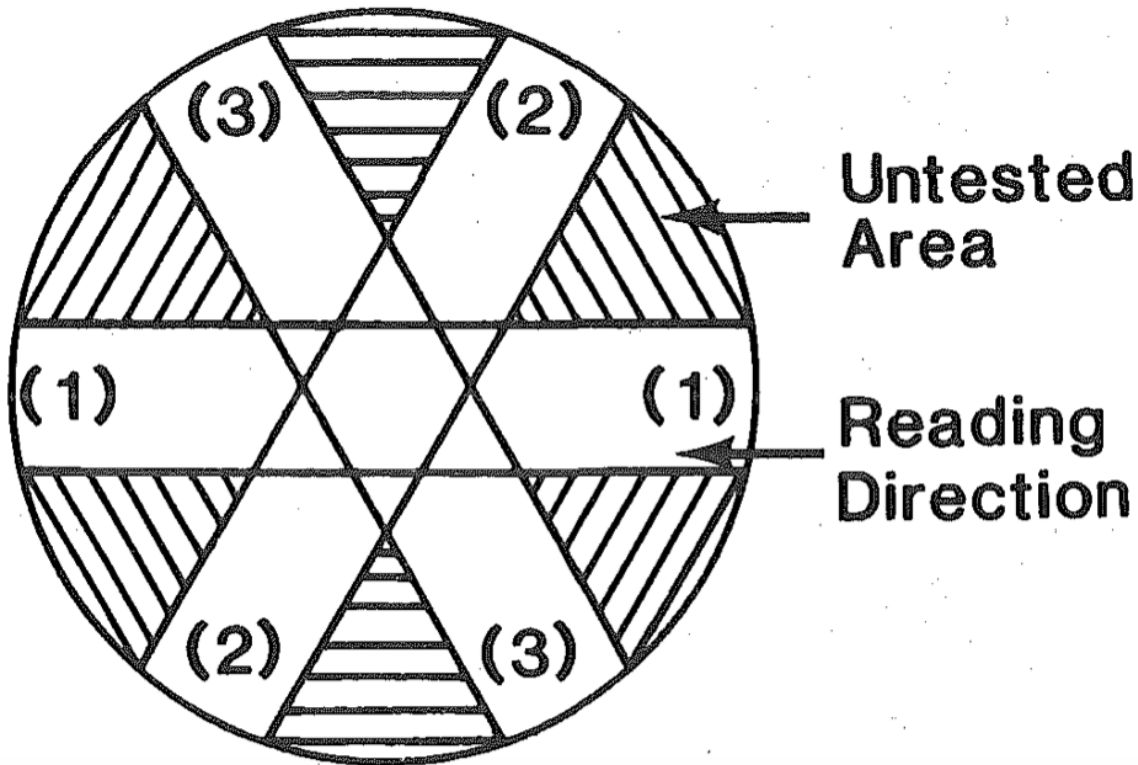
Timber bridge piles appear above and below water for tests that involve using ultrasonic testing techniques. The ultrasonic techniques pair with compressive tests to determine strength and material properties for the members. The pulses for the test were sent in the radial direction of the timber piles for a direct transmission setup. The strength for the cross-section varies, so the setup shown below provides the best results for an in service strength test. The direct transmission method was preferred for the timber bridge pile analysis for a couple reasons, with one of them being the path length was well defined since the transducers were just on opposite sides.

Figure 5.4: Cross-section of timber bridge pile showing setup for the ultrasonic testing (McCuen et al. 1988)

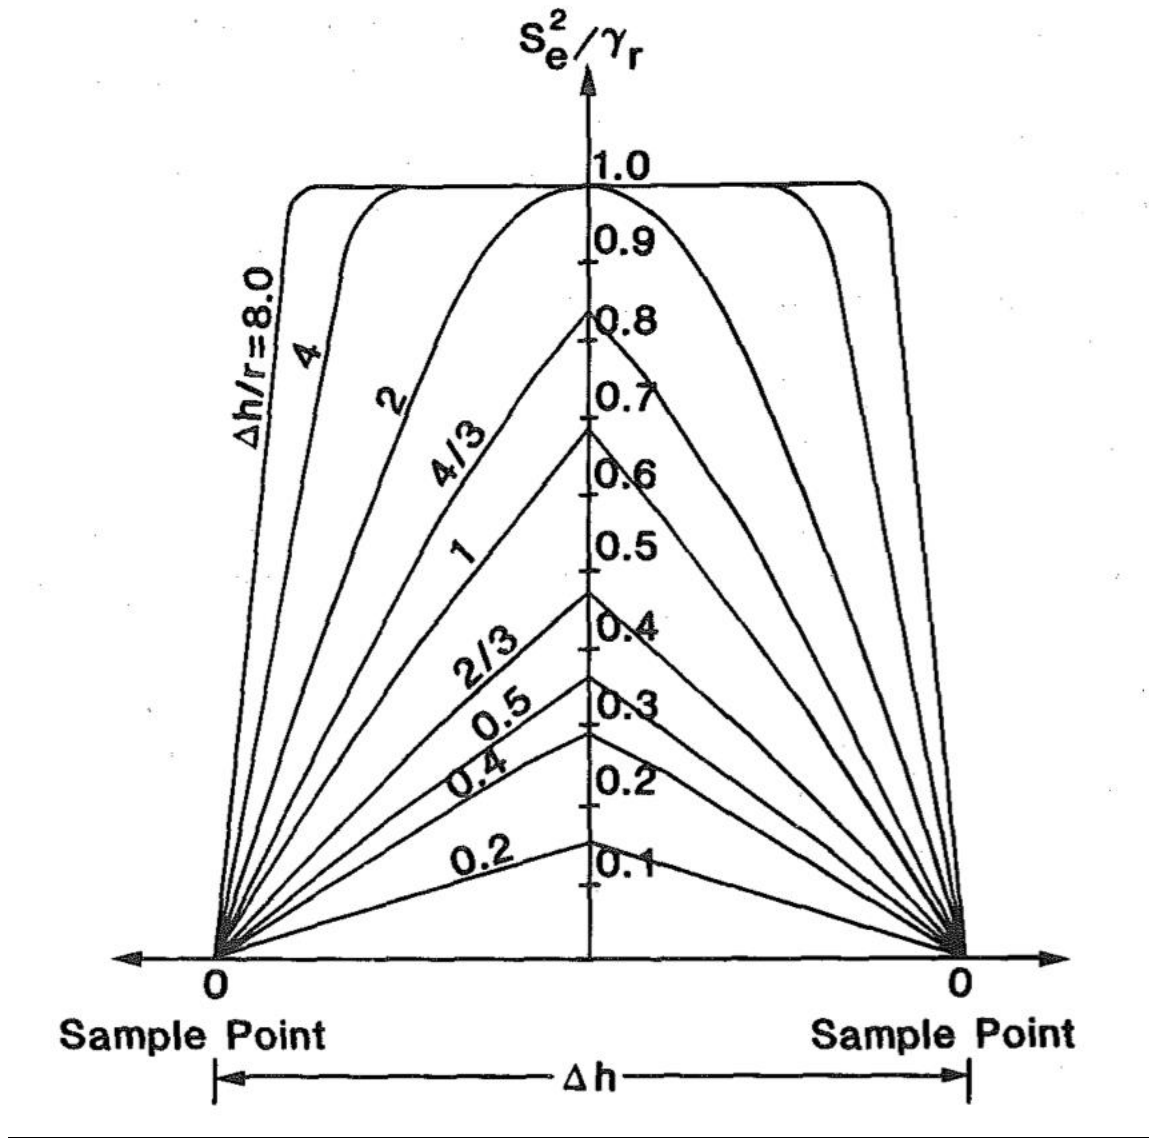
Figure 5.5: Relative error of estimation between sampling points separated by distance (McCuen, 1988)

The figure above can be used to determine the change in accuracy as the spacing in velocity measurement change.

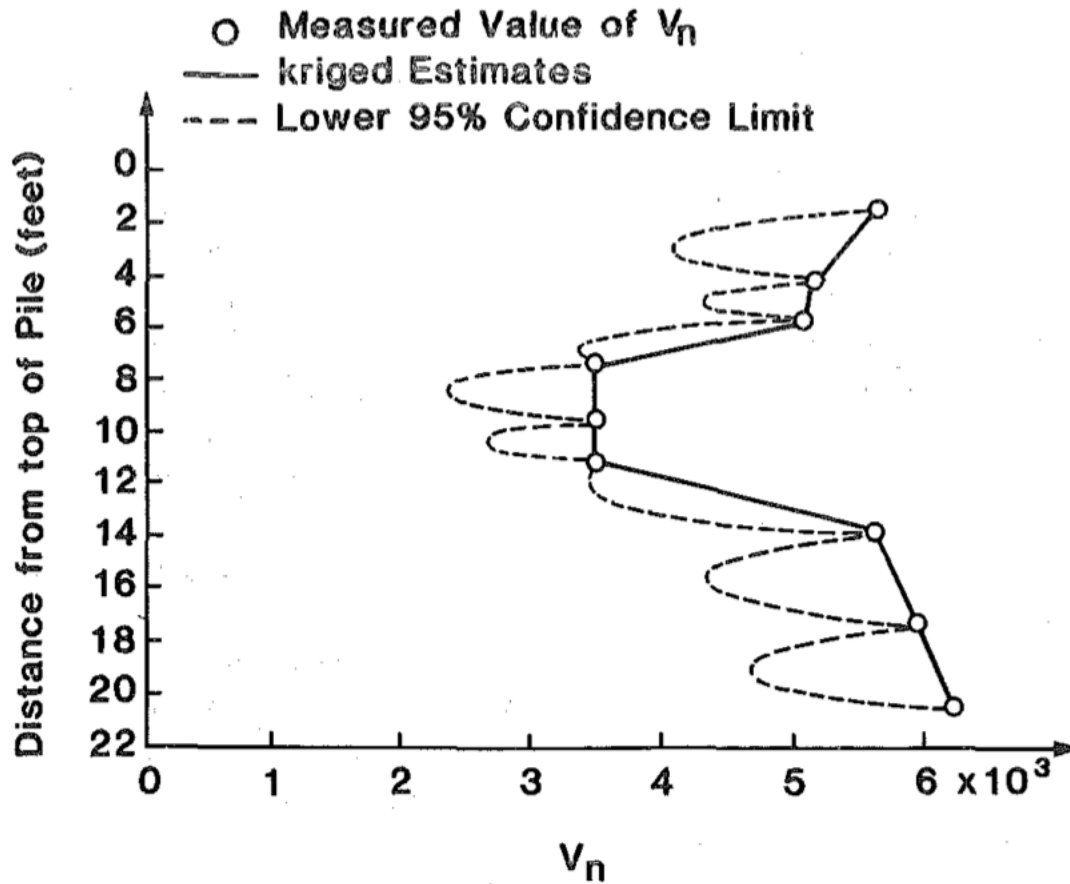
Figure 5.6: Intervals and Kriging estimations (McCuen et al. 1988)
