A scanning electron microscopy study of projectile entry fractures in cortical bone; genesis and microarchitectural features

The present paper presents a scanning electron microscope (SEM) analysis of the genesis and microarchitecture of experimentally induced cortical entry fractures in porcine scapulae impacted at velocities ranging from 54 to 897 m/s. SEM observation was conducted on polyurethane replicas cast from negative silicone moulds. Analysis of the sequence of fracture processes operative during projectile impact revealed the presence of ring cracks at the site of impact, confirming that penetration in sandwich bones is achieved by cone crack propagation. Despite impulsive loading, two forms of plastic deformation were identified in the cortical bone surrounding the entry fracture up to a maximum velocity of 871 m/s. Microscopic radial and concentric cracks were associated with projectile impact, and the role of pores and pits as stress concentrators was captured. Possible underlying mechanisms for the observed plastic deformation are described, and the diagnostic utility of SEM analysis is presented.

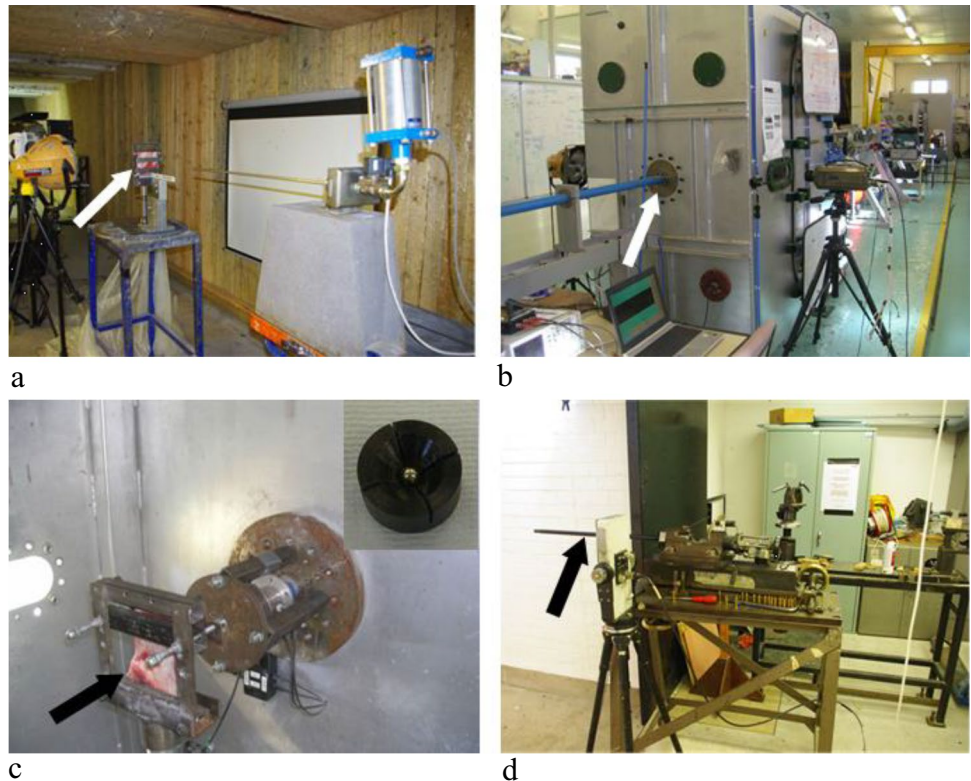
Fig. 2 Projectile delivery systems; **a**, compressed air gun with 6 mm barrel situated in front of a clamped specimen (arrow); **b**, 21.3 mm calibre gas gun chamber with high-speed camera located on a tripod at the viewing window; the 21.3 mm barrel enters the chamber at left (arrow); **c**, view inside the 21.3 mm gas gun chamber showing specimen clamped in front of the barrel (arrow); part of the viewing window is illuminated at left; inset shows a 6 mm projectile housed in a plastic sabot; **d**, image of Enfield number three proof housing with barrel located at left (arrow)

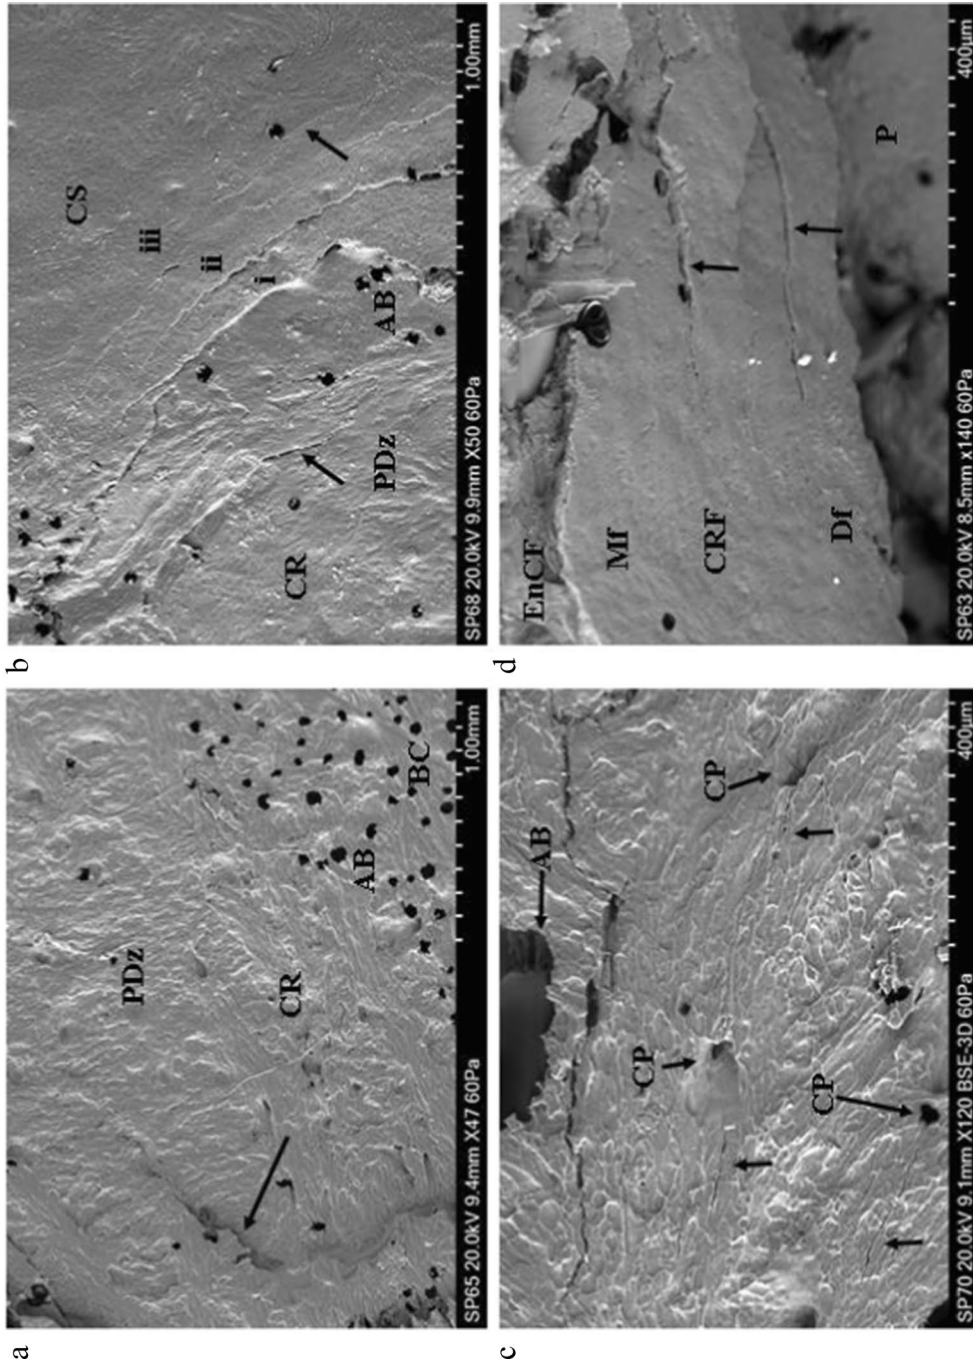
Fig.3 Genesis of the cortical entry in sandwich bones; plastic deformation and ring cracks (BC, base of compressed region; CS, cortical surface; CR, cortical roof; CRF, cortical roof fragment; MF, medial fracture edge of cortical roof fragment; Df, distal fracture edge of cortical roof fragment; P, putty used to seal the floor of the entry; AB, air bubble artefact); **a**, 54 m/s rebound impact, fleshed specimen (*Ei* 1.30 J; *E'* 0.05 J/mm²), CS located just out of view top left and across the top of the micrograph; micrograph indicates extensive plastic deformation is involved in formation of the concavity (PDz); a ring crack is visible at left (arrow) with the base of the concavity located at the bottom right (BC); **b**, 57 m/s rebound impact, fleshed specimen (*Ei* 1.44 J, *E'* 0.05 J/mm²); micrograph of the right edge of a depressed fracture showing three generations of larger ring cracks (annotated i–iii) and two smaller cracks (arrowed); deformation forming the cavity occurs both along the ring crack fracture margins and in plastically deformed zones without visible fracture; **c**–57 m/s impact (defleshed specimen) showing cortical surface adjacent to impact site (located along top of micrograph); concentrically orientated nascent ring cracks (white arrows) can be seen arising from cortical pores (CP); **d**, 96 m/s perforating impact (*Ei* 4.08 J, *E'* 0.14 J/mm²); cortical roof fragment with the distal edge displaced downwards into the cortical entry and displaying concentric fractures consistent with ring cracking during the initial stages of impact (arrows)

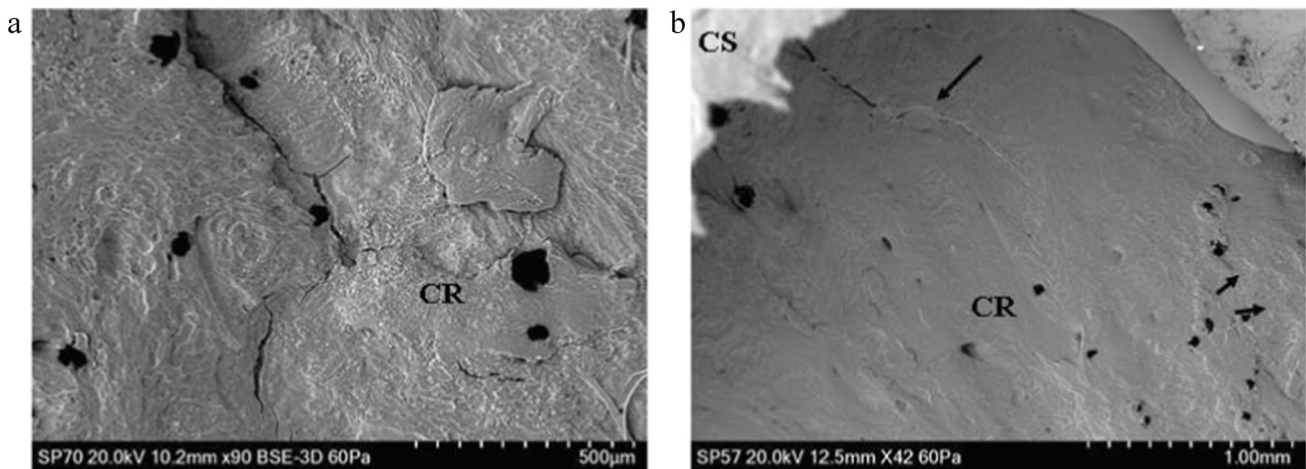
Fig. 4 Genesis of the cortical entry in sandwich bones; failure of the cortical roof (CS, cortical surface; CR, cortical roof); **a** \sim 57 m/s rebound impact (defleshed specimen); surface of cortical roof showing vertically orientated fracture dividing the roof into two halves; fracture resulted from tensile failure of the inner surface of the cortical plate under compressive loading; **b** 75 m/s perforating impact

($Ei=2.47$ J, $E'=0.09$ J/mm²), view of the cortical roof of a nearly intact conoid displaced downwards so it is beneath the cortical surface and protruding from the inner cortical plate; the surface has not been modified by impact but bears a fracture ending before the mid-section (arrow)

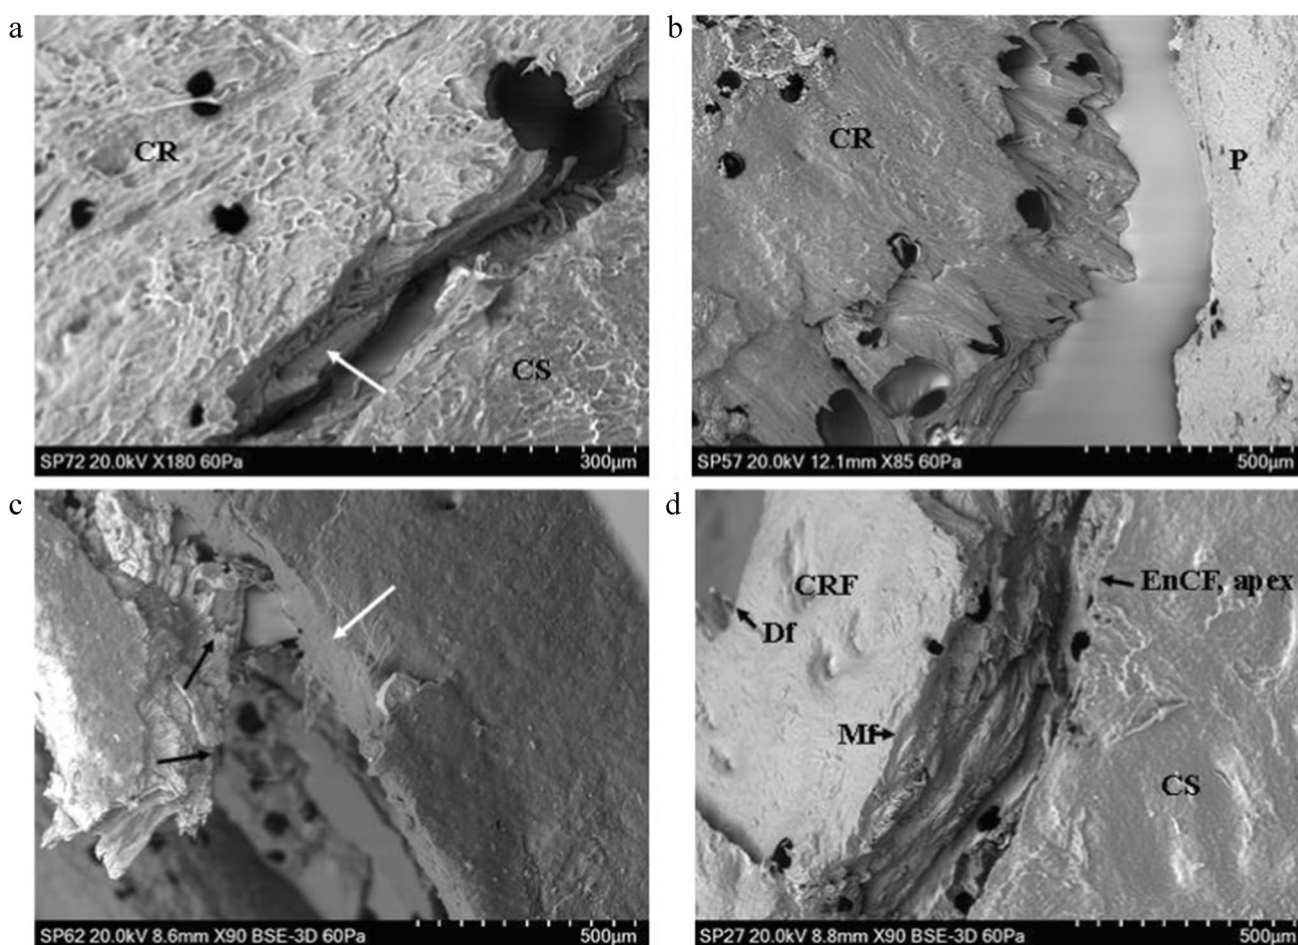
Fig. 5 Genesis of the cortical entry in sandwich bones; stepping of the cortical roof (CS, cortical surface; CR, cortical roof; CRF, cortical roof fragment; MF, medial fracture edge of cortical roof fragment; Df, distal fracture edge of cortical roof fragment; P, putty used to seal the cortical entry for negative moulding; EnCF, entry cortical fracture edge); **a** ~57 m/s rebound impact (defleshed specimen), mode I (tensile, crack opening) fracture mode indicated by stepping of the fracture edge across lamellar planes inside the cortical roof (arrow); **b** 75 m/s perforating impact ($E_i=2.47$ J, $E' = 0.09$ J/mm²) showing right fracture edge of the cortical roof of the nearly intact conoid

seen in Fig. 4b, complex stepped morphology resulting from mode I fracture across lamellae; fracture edge is angulated to match the corresponding angulation of the EnCF; **c** 94 m/s perforating impact (E_i 3.94 J, $E' 0.14$ J/mm²), cortical roof fragment with the distal surface facing upwards and displaying internal lamellae on the medial side orientated in different planes (highlighted by the small arrows); large arrow indicates an area of smooth bone consistent with being surface-modified plastic deformation; **d** 161 m/s perforating impact (E_i 11.44 J, $E' 0.40$ J/mm²) showing cortical roof fragment with pronounced stepping across the lamellae of the medial fracture margin

components (Fig. 5, b–c) or presented a more uniform stepped morphology (Fig. 5d). The pointed lamellar morphology is illustrated in Fig. 5b, which shows the lower right margin of the cortical roof of the intact conoid seen in Fig. 4b. In this part of the conoid, the stepped region was angled to match the corresponding angulation of the EnCF, and the overlapping pointed lamellar fracture edges produced a complex fracture surface. This morphology may have resulted from the plane of the crack in relation to the lamellar structure in that region or from a pull-out process as the conoid was compressed downwards. Stepped fracture margins with pointed fracture edges were also observed on a smaller scale in a fragment of cortical roof resulting from a 94 m/s impact; in this specimen, the pointed ends of the

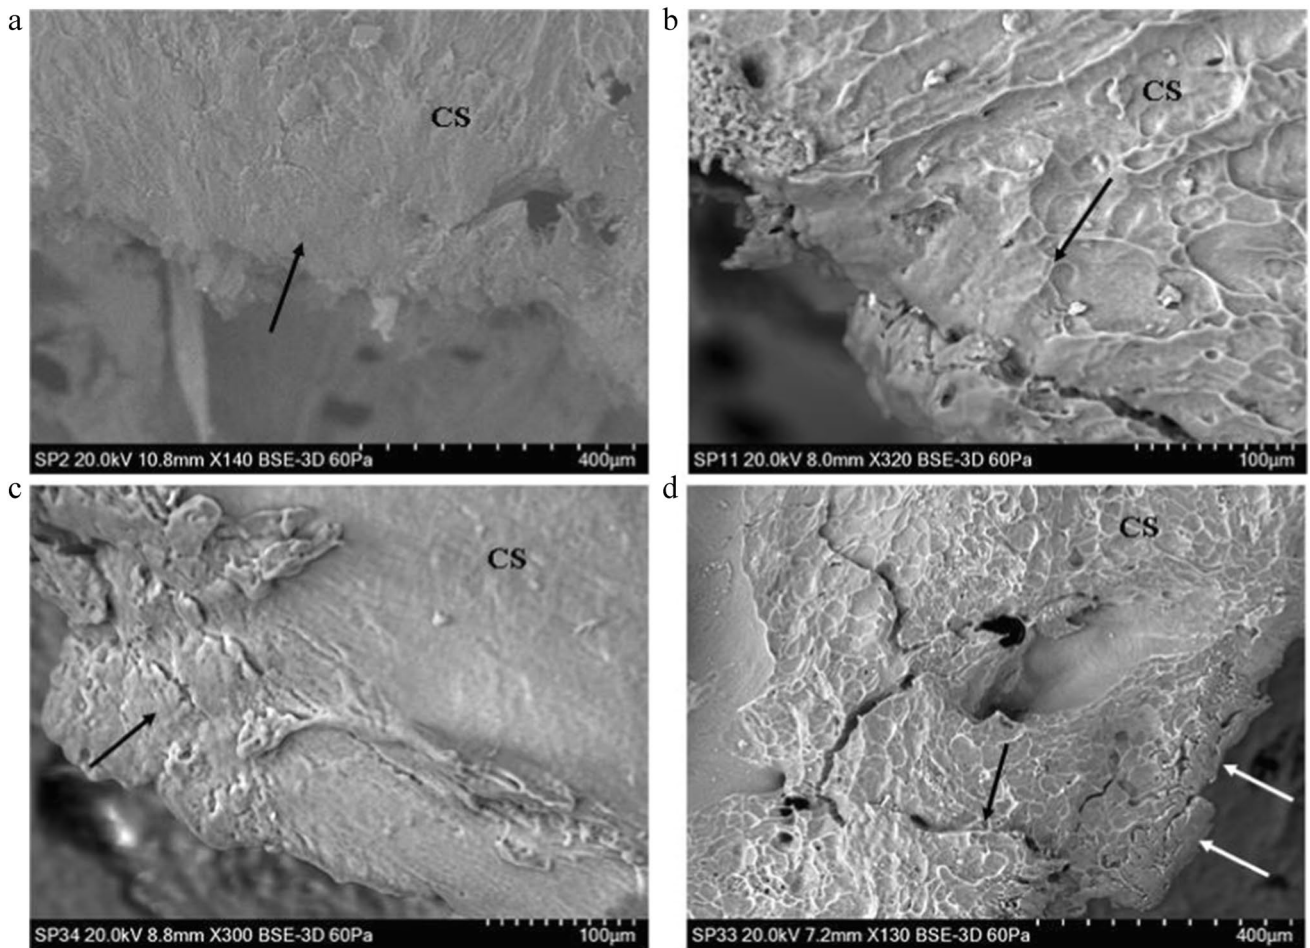
Fig. 7 Surface modified plastic deformation (SPD), 149–609 m/s perforating impacts (CS, cortical surface); **a** 149 m/s impact ($E_i=9.78$ J, $E' = 0.35$ J/mm²) showing loss of surface detail (arrow); **b** 333 m/s impact ($E_i=49.07$ J, $E' = 1.74$ J/mm²) showing SPD with transition of cortical sculpturing (arrow), **c** 591 m/s impact ($E_i=154.37$ J,

$E' = 5.46$ J/mm²) showing SPD (black arrow) with small transverse fractures; **d** 609 m/s impact ($E_i=163.89$ J, $E' = 5.80$ J/mm²) showing SPD along the apex of the EnCF (lower white arrows) in relation to the immediate cortical landscape; note the radial crack emanating from the EnCF (black arrow)

This transition zone is illustrated in specimens impacted at 74–75 m/s Fig. 6, a–b and in specimens impacted at 149–333 m/s in Fig. 7, a–b. Additional features of SPD, present to varying extents in each affected region, were a compressed, deformed cortex and down-bending in the absence of visible fracture. These features are illustrated in a 96 m/s impact in Fig. 6c and in a 591 m/s and 609 m/s impact in Fig. 7 c–d, respectively. The down-bending associated with SPD resulted in a ductile morphology at the apex of the EnCF. Figure 6d shows a cortical roof fragment where bending was extensive enough to allow it to descend into the cortical entry without visible fracture at the top edge (B in the image). Areas of SPD sometimes showed circumferential fractures running along the modified cortical surface (Fig. 7c); these were indistinguishable from ring cracks when they were of large size. The contrast between the cortical surface in the immediate cortical landscape and SPD

along the apex is illustrated in Fig. 7d. In this example, the cortical surface adjacent to the apex was markedly sculpted; this morphology contrasted greatly with the region of SPD which showed complete loss of sculpturing, bending without visible fracture and a compressed, smoothed appearance.

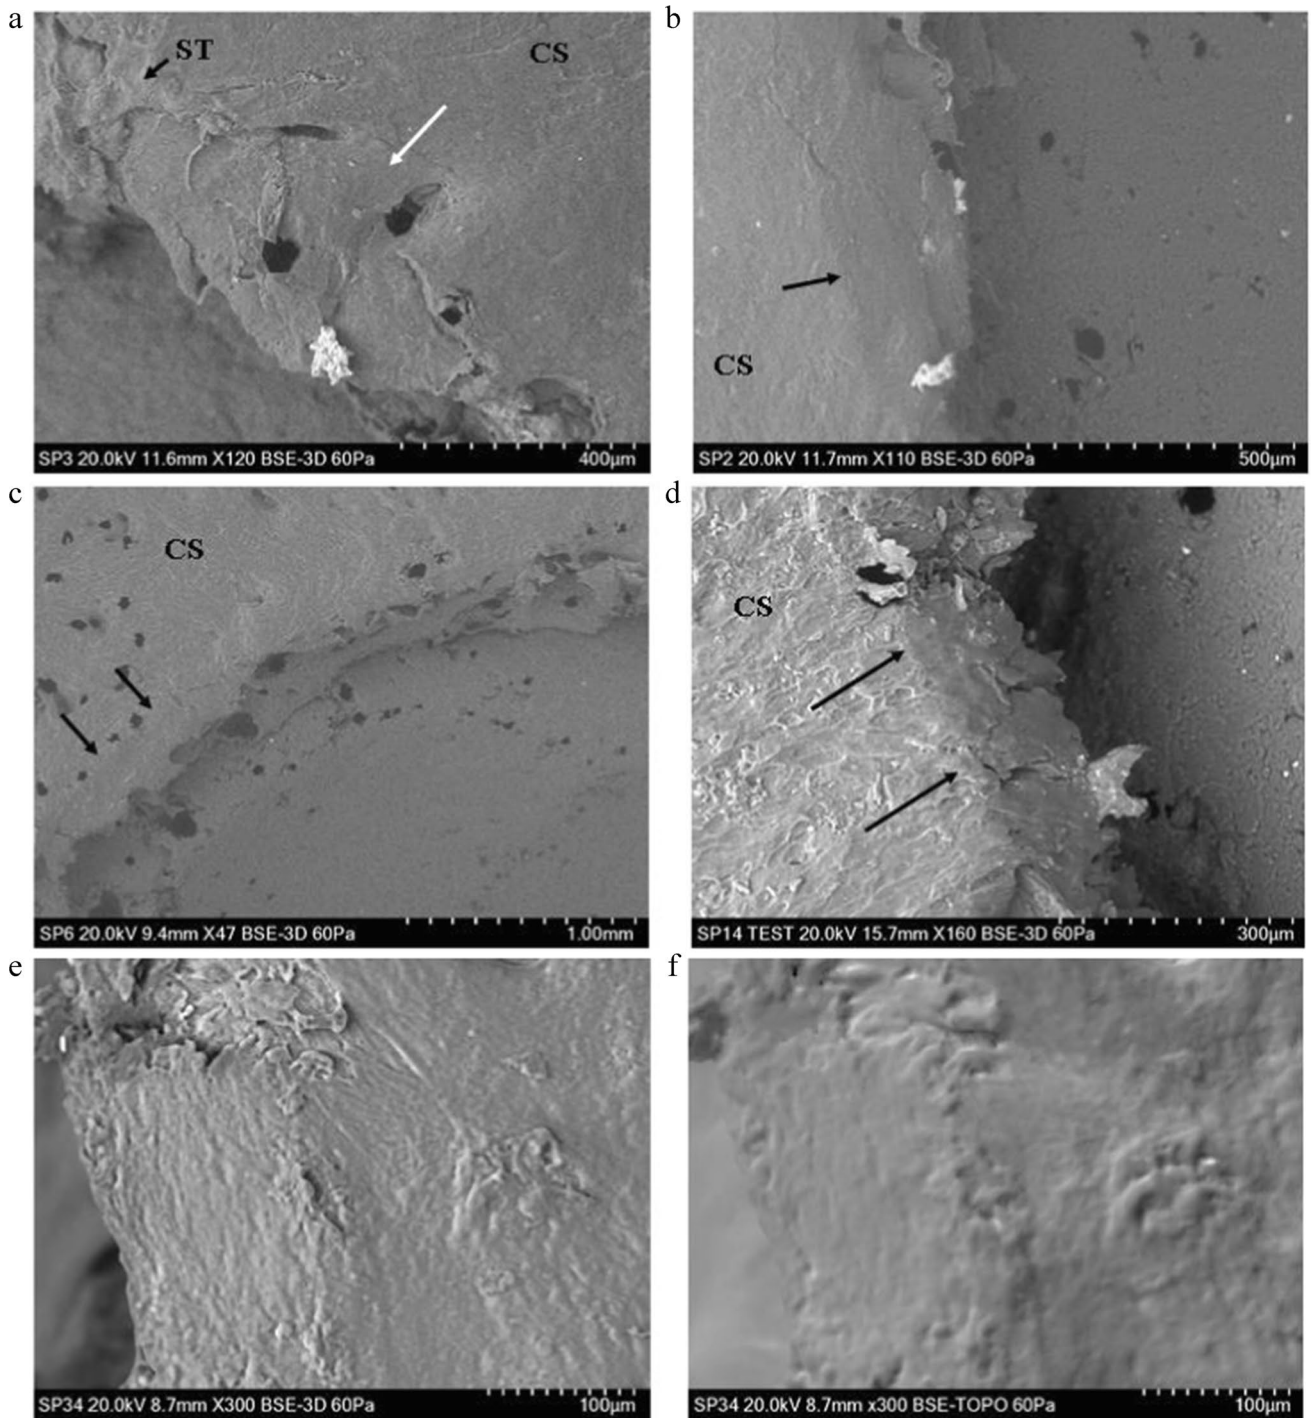
Fig. 8 Peripheral plastic deformation and associated ductile morphology (perforating impacts), (CS cortical surface; ST, soft tissue); **a** 163 m/s impact ($Ei = 11.72 \text{ J}$, $E' = 0.41 \text{ J/mm}^2$), showing small area of plastic deformation with intact surface sculpturing; note that the CS is continuous with the bent section of bone (white arrow); **b** 149 m/s impact ($Ei = 9.78 \text{ J}$, $E' = 0.35 \text{ J/mm}^2$), area of plastically deformed bone with intact surface sculpturing and fold identified by arrow; this area is at the lower edge of a section of cortical roof fragment; **c** 165 m/s impact ($Ei = 12.05 \text{ J}$, $E' = 0.43 \text{ J/mm}^2$) showing margin of cortical

entry with cortical bending due to plastic deformation, particularly at the area identified by black arrows; **d** 570 m/s impact ($Ei = 143.96 \text{ J}$, $E' = 5.09 \text{ J/mm}^2$); area of plastic deformation with the fold identified by arrows; note that this region combines pronounced cortical sloping with some surface modification; **e** 591 m/s impact ($Ei = 154.37 \text{ J}$, $E' = 5.46 \text{ J/mm}^2$) showing figure continuity of the cortical surface with the plastically deformed region; **f** topographic view of **e** confirming bending of the cortex

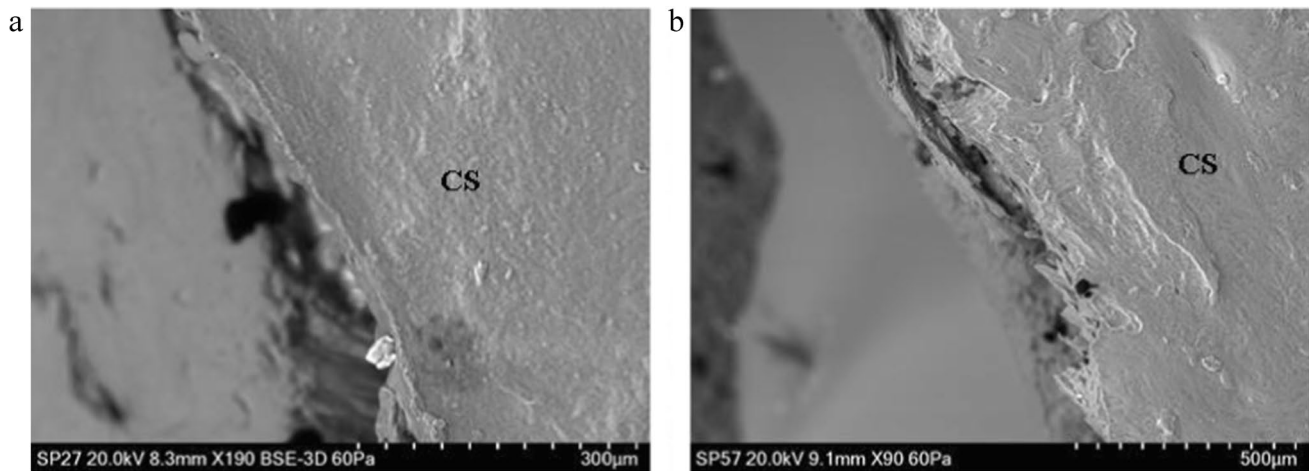
Fig.9 Apex of the EnCF in non-plastically deformed zones, perforating impacts (CS, cortical surface); **a**, 161 m/s impact (E_i 11.44 J, E' 0.40 J/mm²), abrupt and straight-edged apex; **b**, 75 m/s impact

($E_i=2.47$ J, $E'=0.09$ J/mm²), showing more complex fracture morphology with re-entrant geometries; both fracture edges seen here differ markedly from zones of SPD and PPD

Neither SPD nor PPD were distributed uniformly around the whole circumference of the cortical entries and when absent the EnCF presented with abrupt edges (Fig. 9a) or complex edges with re-entrant geometries between fragmented cortical components (Fig. 9b).

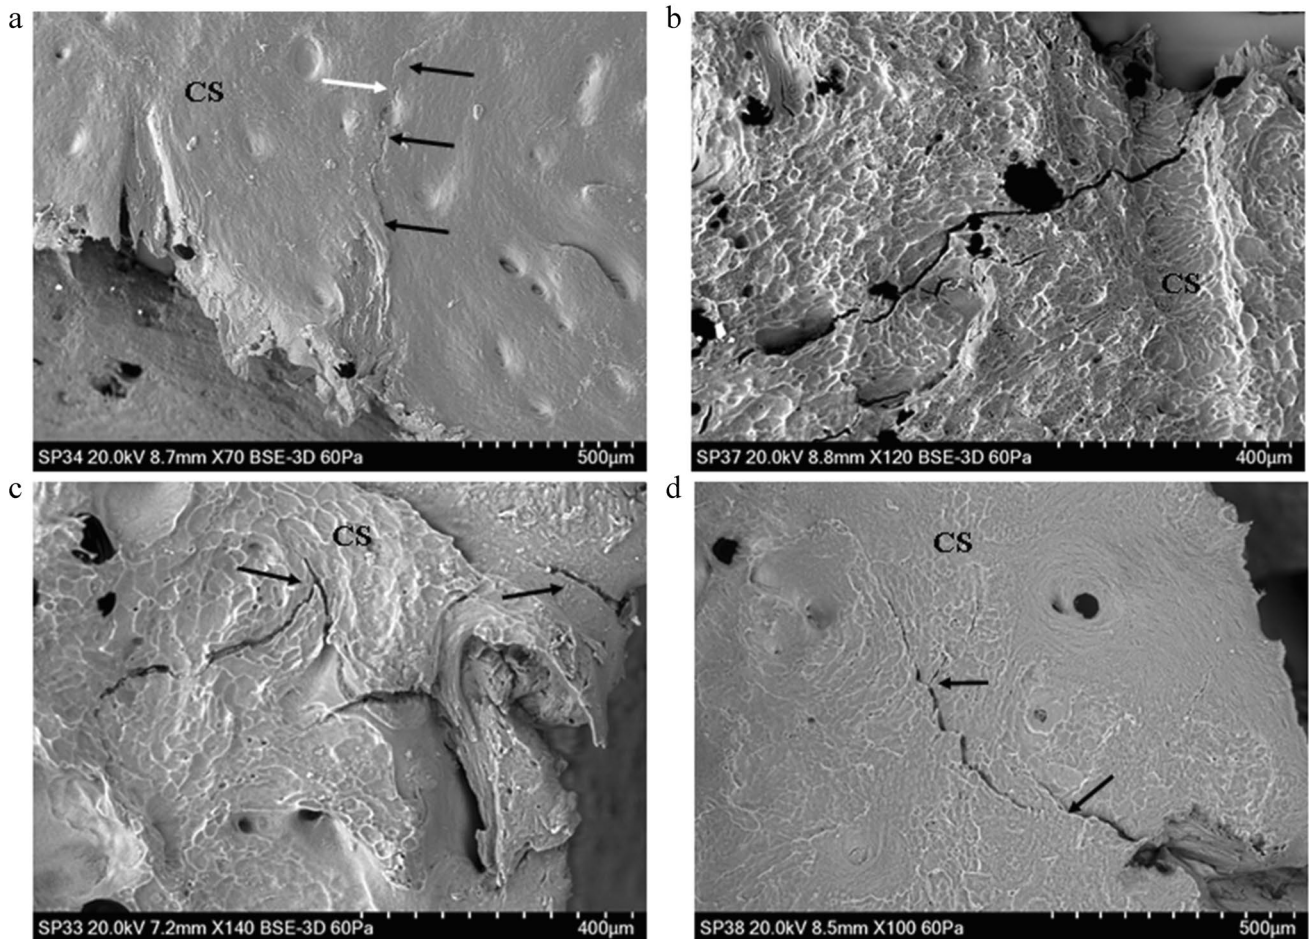
Fig. 10 Radial cracks originating from the entry cortical fracture edge, perforating impacts (CS, cortical surface); **a** 591 m/s impact ($Ei=154.37$ J, $E'=5.46$ J/mm²), narrow crack crossing cortical pit and showing a small ligament bridge (white arrow); **b** 850 m/s impact ($Ei=319.60$ J, $E'=11.31$ J/mm²) showing large, wide radial crack

crossing cortical furrow; **c** 609 m/s impact ($Ei=163.89$ J, $E'=5.80$ J/mm²), showing crack with a bifurcation (left arrow) and a separate straight radial crack inside a cortical furrow (right arrow); **d** 871 m/s impact ($Ei=335.71$ J, $E'=11.88$ J/mm²), long radial crack with two points of bifurcation (arrows)

Radial cracks were observed in 19 of the 21 perforated specimens across the velocity series (illustrated for impacts from 591 to 871 m/s in Fig. 10, a–d). Radial cracks were identified in 12 of the 14 impacts between 58 and 168 m/s and in all 7 impacts between 333 and 897 m/s. Radial cracks followed both relatively straight (Fig. 10, a–b) and tortuous (Fig. 10c) paths. Tortuosity is not clearly associated with velocity; for example, the tortuous crack in Fig. 10c is associated with a 609 m/s impact, whilst the straight crack in Fig. 10b is created by an 850 m/s impact. Some of the radial cracks exhibited uncracked ligament bridging despite high impact velocity (e.g., white arrow in Fig. 10a). Radial cracks ranged from being narrow (Fig. 10a) to open (Fig. 10, b–d) and occasionally exhibited bifurcations along their path (Fig. 10, c–d, arrows). Estimates of crack length using the scale in the images indicated that radial cracks > 1 mm in length were more common in high-velocity impacts. Of the 14 perforated specimens impacted between 58 and 168 m/s, only three possessed radial cracks longer than 1 mm (impacted at 58 m/s, 165 m/s and 167 m/s, respectively). In contrast, a total of 4 out of 6 specimens impacted between 333 and 897 m/s had radial cracks greater than 1 mm in length (impacted at 591 m/s, 850 m/s, 885 m/s and 897 m/s).

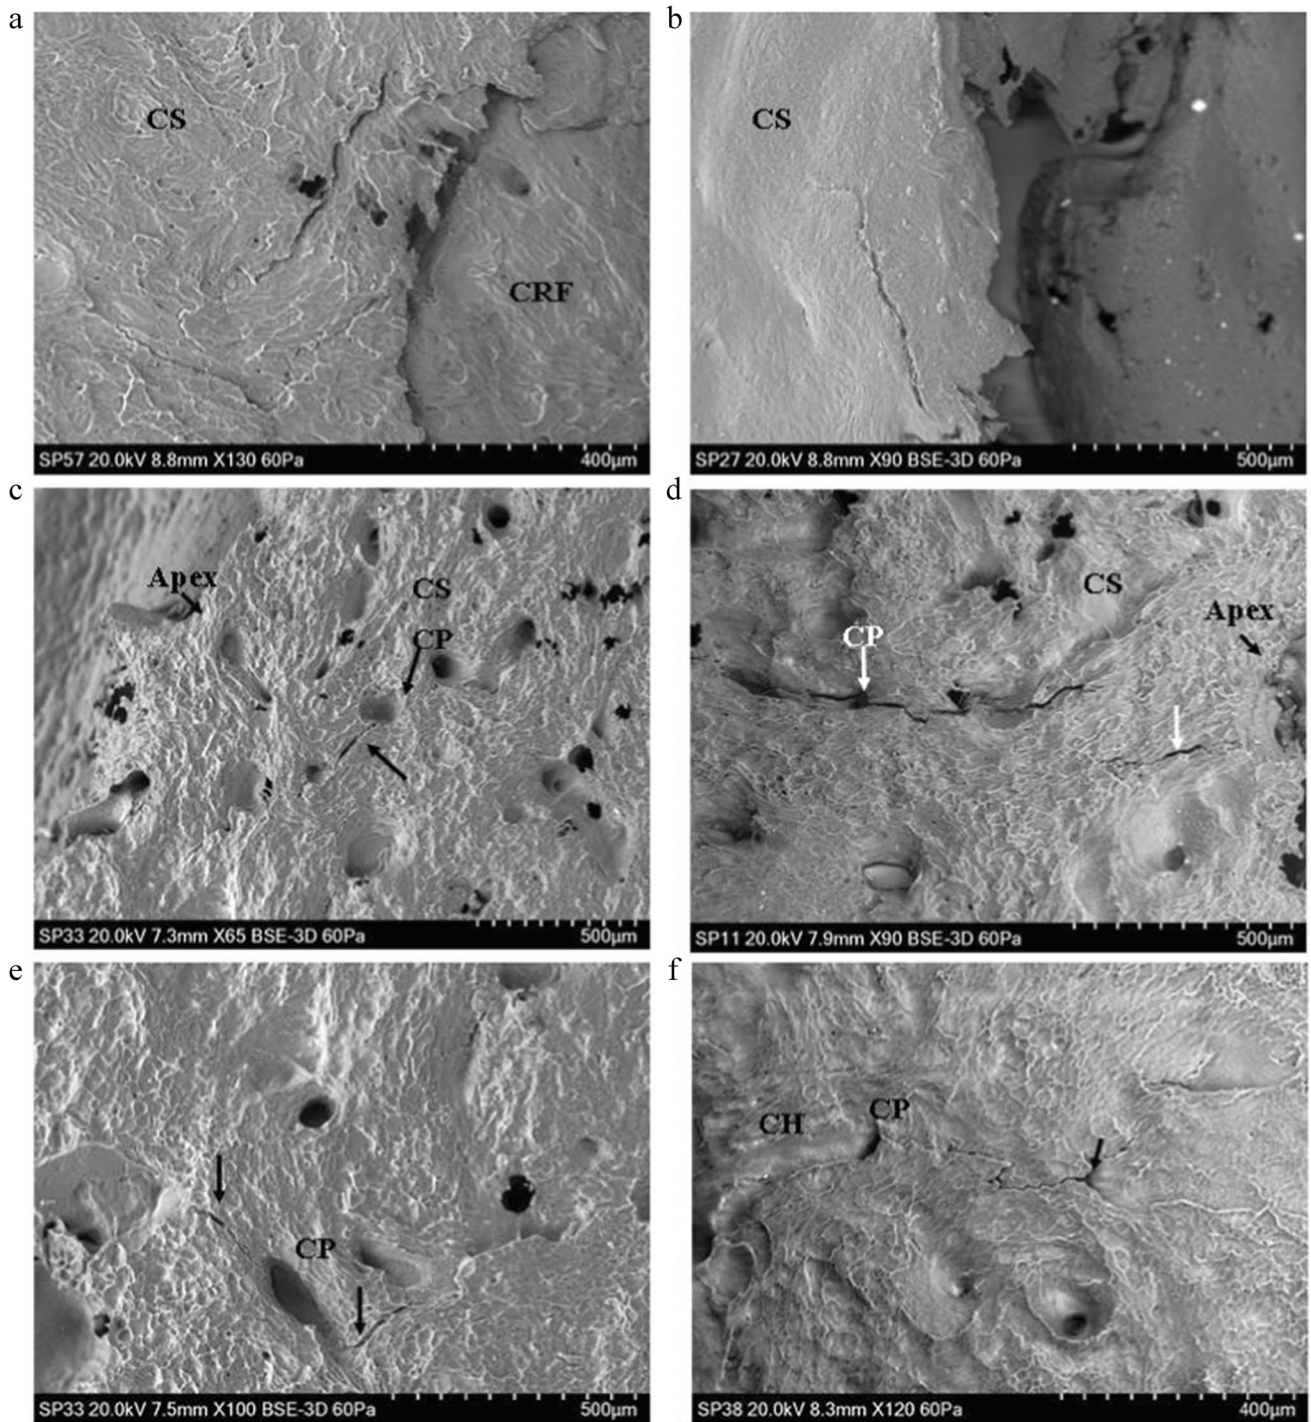
Fig. 11 Concentric cracking and cracks arising from cortical stress concentrators, perforating impacts (CS, cortical surface, CR, cortical roof; CRF, cortical roof fragment, CP, cortical pore; CH, channel); **a** 75 m/s impact ($Ei=2.47$ J, $E'=0.09$ J/mm²), showing concentric crack adjacent to a fragment of cortical roof; **b** 161 m/s impact (Ei 11.44 J, $E'=0.40$ J/mm²) with concentrically orientated crack near the EnCF; **c** 609 m/s impact ($Ei=154.37$ J, $E'=5.46$ J/mm²) showing concentric crack arising from cortical pit adjacent to the apex of the EnCF; **d** 333 m/s perforating impact ($Ei=49.07$ J, $E'=1.74$ J/mm²), large radially orientated crack adjacent to the apex and associ-

ated with a cortical pore; note the smaller radially orientated crack (lower arrow) that arises within the cortex not a pore; **e** same specimen as in **c**, showing elliptical cortical pore with the major axis running upwards from right to left; stresses acting normal to this axis resulted in stress concentrating at the tips of the elliptical cavity and resulted in cracking at both ends [34]; **f**, 871 m/s perforating impact ($Ei=335.71$ J, $E'=11.88$ J/mm²) showing figure crack associated with a cortical pore/ channel complex and extending to a smaller pore-type structure at right (arrow)

Circumferential cracks were identified in a total of 9/14 impacts between 58 and 168 m/s and 4/7 impacts between 333 and 897 m/s. These cracks were found both near the apex of the EnCF (Fig. 11, a–b) and further away in the

cortical landscape; in one case, a concentric crack was found approximately 1.5 mm from the cortical entry. Unlike the rebound impacts, circumferential cracks in the perforating impacts did not appear to form concentric generations but were dispersed diffusely around the cortical entry. Cortical pits and pores acted as stress concentrators during impact and were detected as the origin for some circumferential (Fig. 11c) and radial (Fig. 11d) cracks. In elliptical pores, stresses acting normal to the major axis resulted in cracking at each end due to concentration of stresses there (Fig. 11e) [34]. Pore and pit cracks did not always occur in isolation, with an example of a linked pore-crack complex occurring in an 871 m/s impact (Fig. 11f). Cortical pore cracking occurs both near the apex of the EnCF (Fig. 11, a–b) and more distant, with the pore in Fig. 11e being over 1 mm away from it.
